Bath Village Covered Bridge Bath, New Hampshire

Rehabilitation Project Report

November 2011

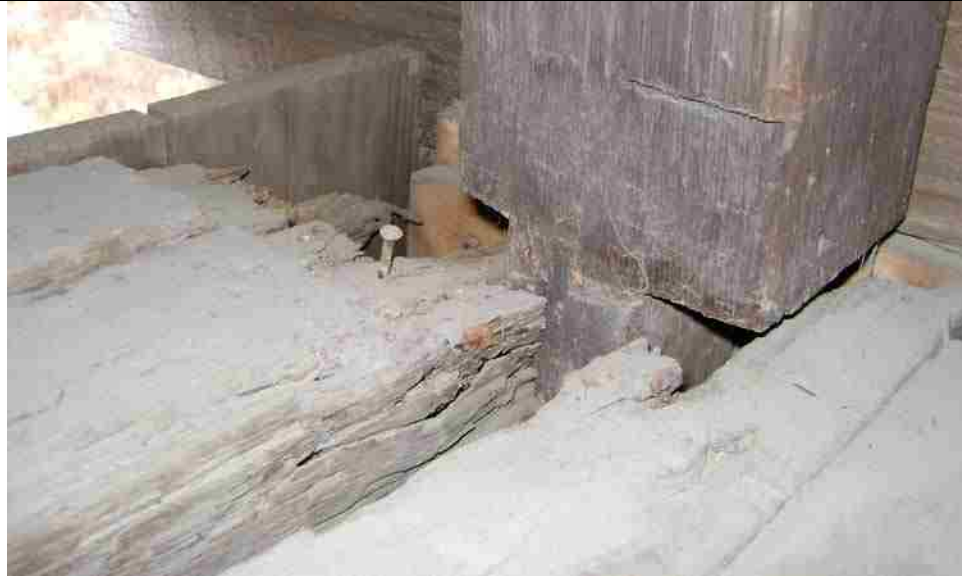
Photo No. 1-1 Top Chord N6 – N14 B, Rot near Node N12, N13

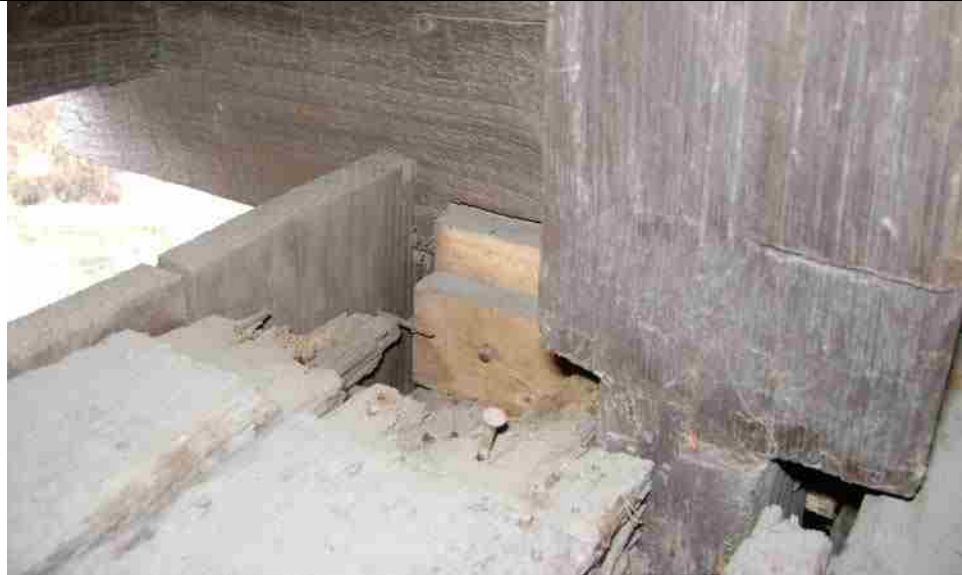
Photo No. 1-2 Top Chord N6 – N14 B, Rot near Node N12, N13

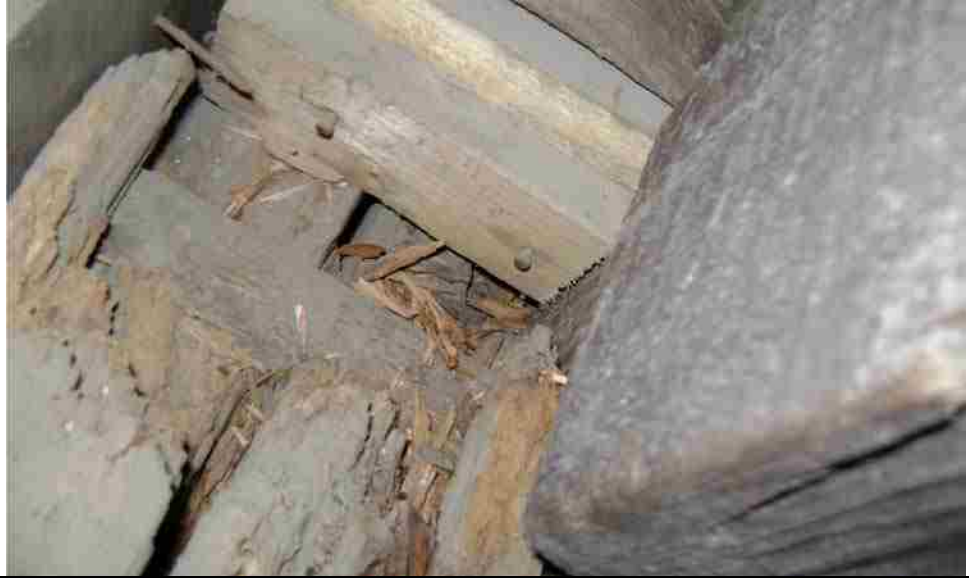
Photo No. 1-3 Top Chord N6 – N14 B, Rot Near Node N12, N13

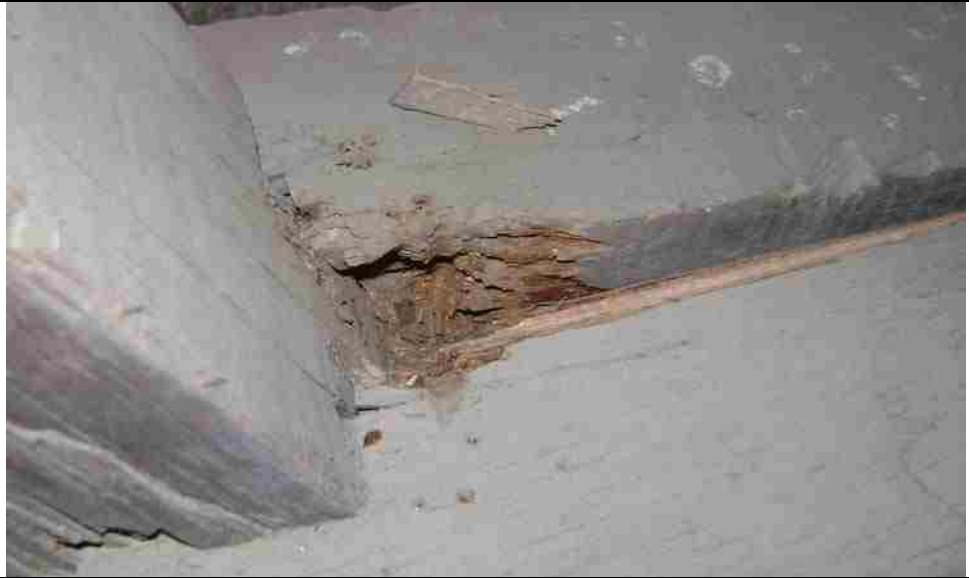
Photo No. 1-4 Top Chord N22 – N30 B, Rot near Node N22, N24

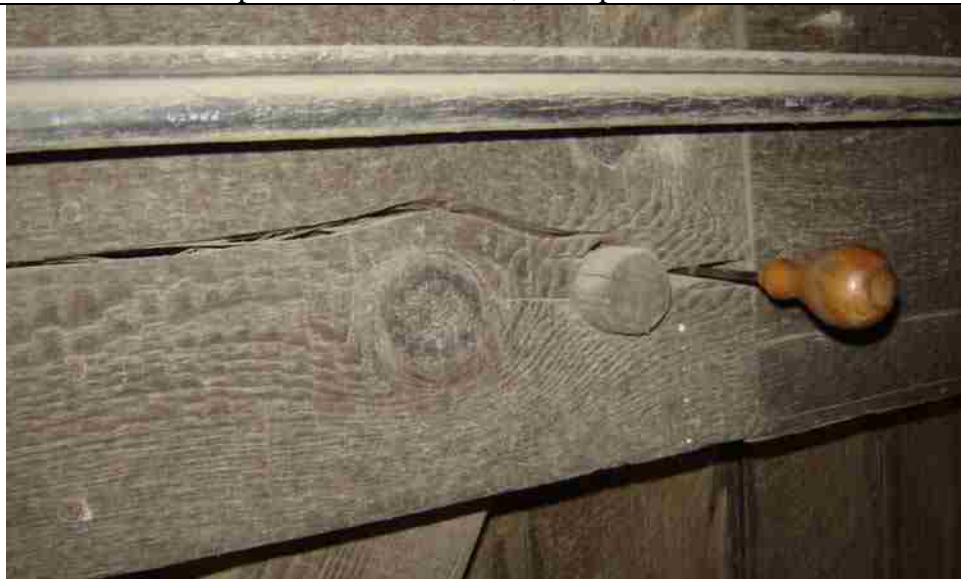
Photo No. 1-6 Top Chord S92 – S96 C, 24” Split at S92

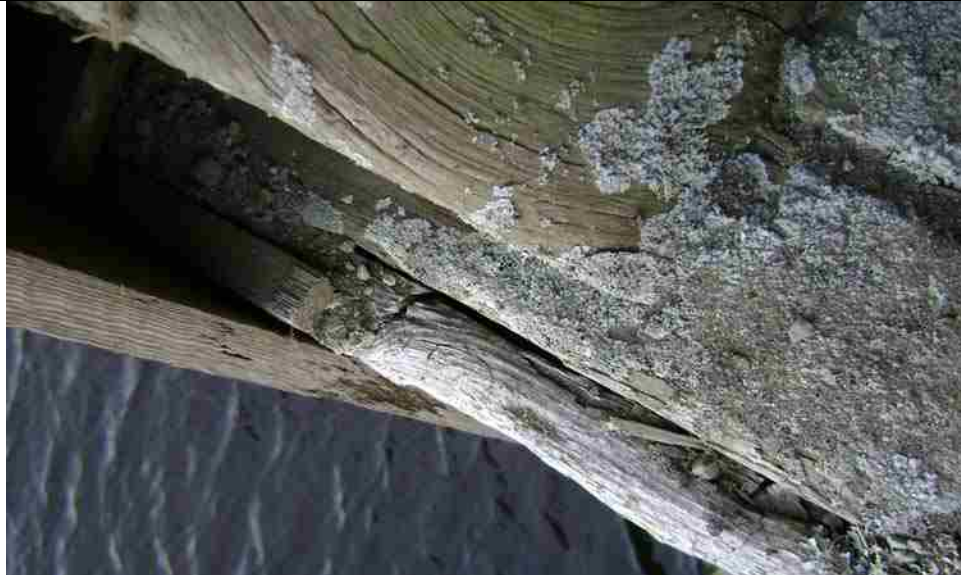
Photo No. 2-2 Bottom Chord N62 – N71 A, Rot near N63 & N70

Describe Work: Same as described for the upper chords: Existing bridge shall be jacked and braced as required to straighten, release stresses, plumb and re-align the trusses and arches (RS-3, Sheet 2). Special care shall be taken to avoid damage to members that are to remain and to avoid movement of the truss that could result in distortion or misalignment of the truss and its joints (GC-10, Sheet 2). All joints in replaced members shall match the existing joint, including all nails, bolts or screws required unless noted otherwise (GC-11, Sheet 2). All existing members shown to be replaced are to be replaced "in-kind" with new members identical in dimensions and configurations as the members originally used in the covered bridge (GC-12, Sheet 2).			
Project Need:			
The chords are primary structural members of the truss that carry the live and dead loads. The members to be replaced do not possess the required structural integrity.

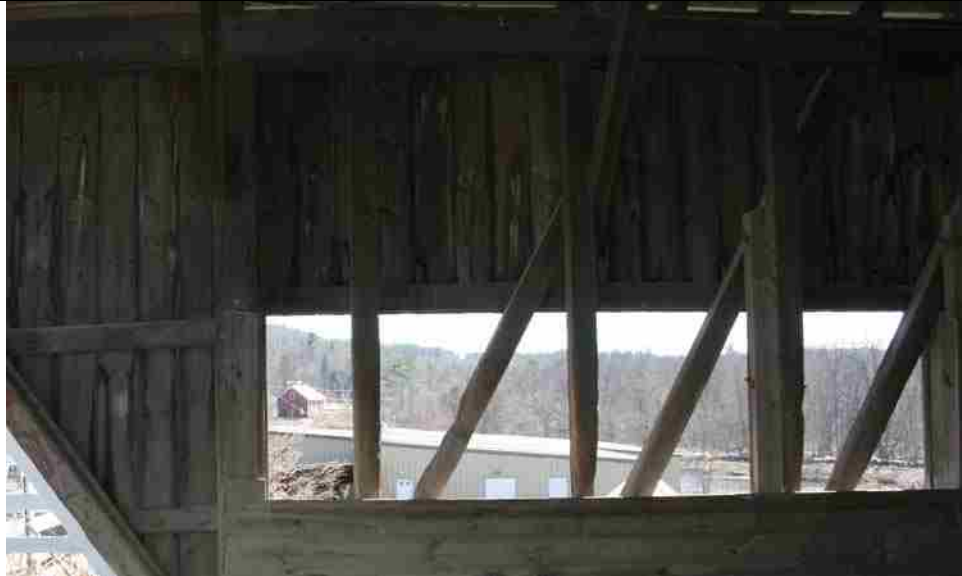
Photo No. 3-2 Vertical Truss Member S92, Section loss

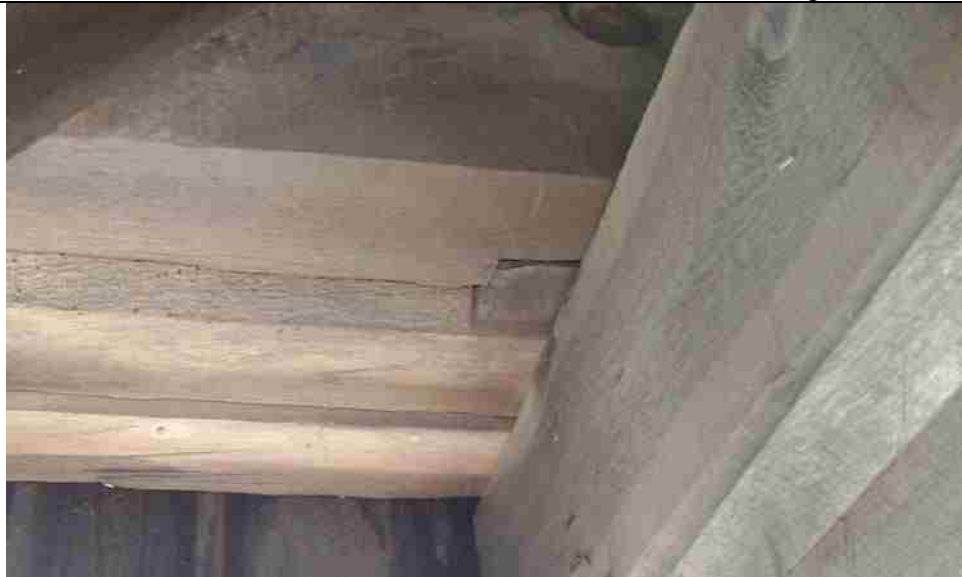
Photo No. 3-3 Vertical Truss Member S38, Lower Tail Missing

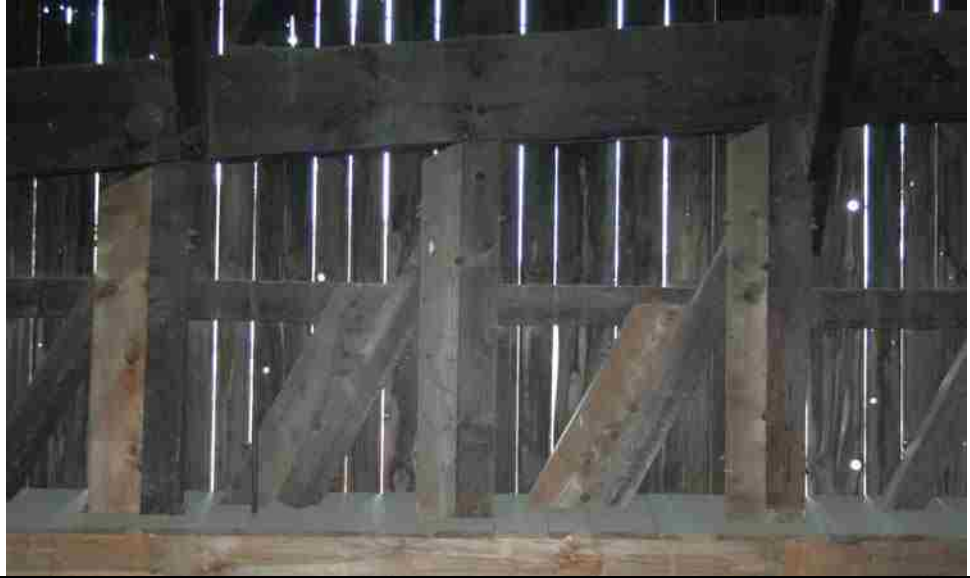
Photo No. 3-4 Vertical Truss Member N16, Spliced Members

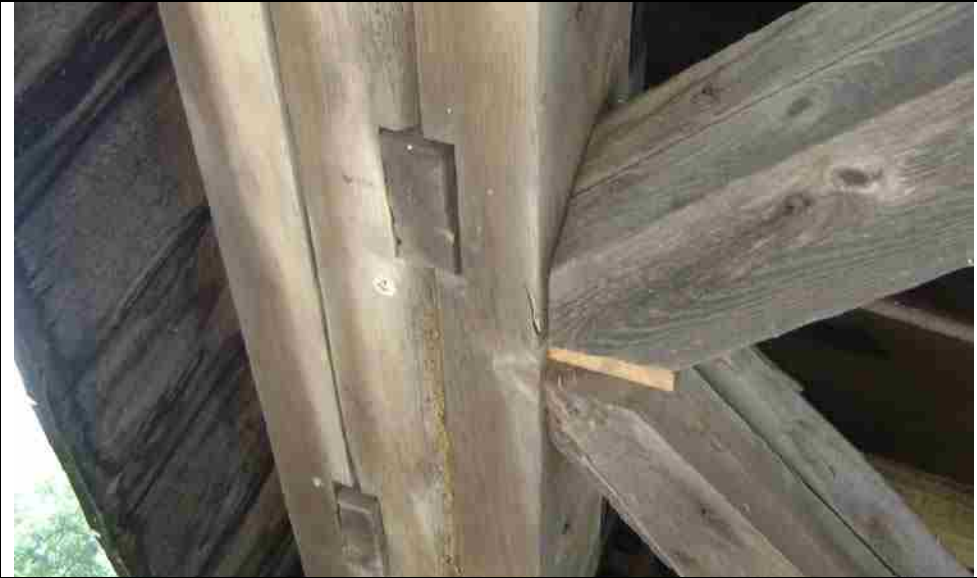
Photo No. 3-5 Vertical Truss Member S37, Lower Tail Missing

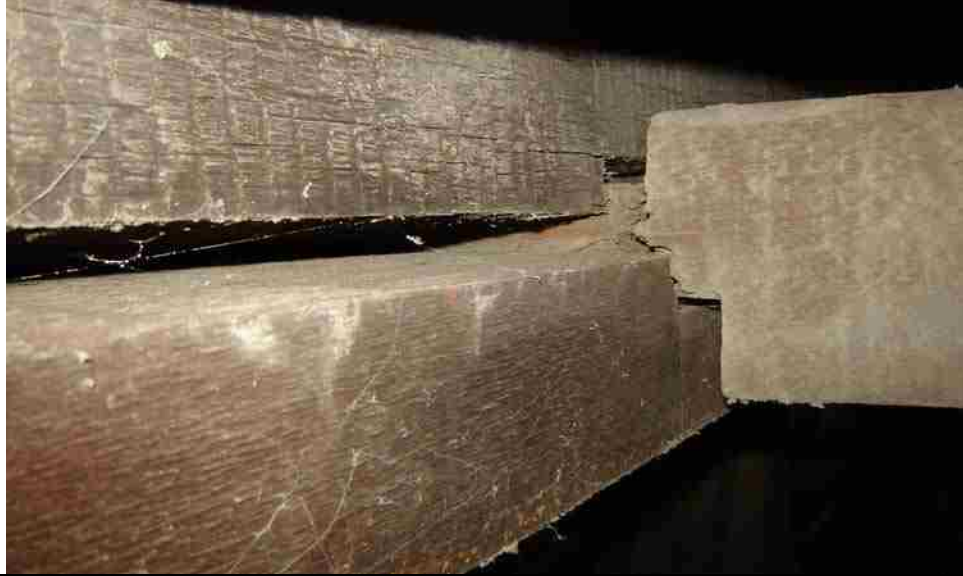
Photo No. 3-6 Vertical Truss Member S36, Broken Above Bottom Chord

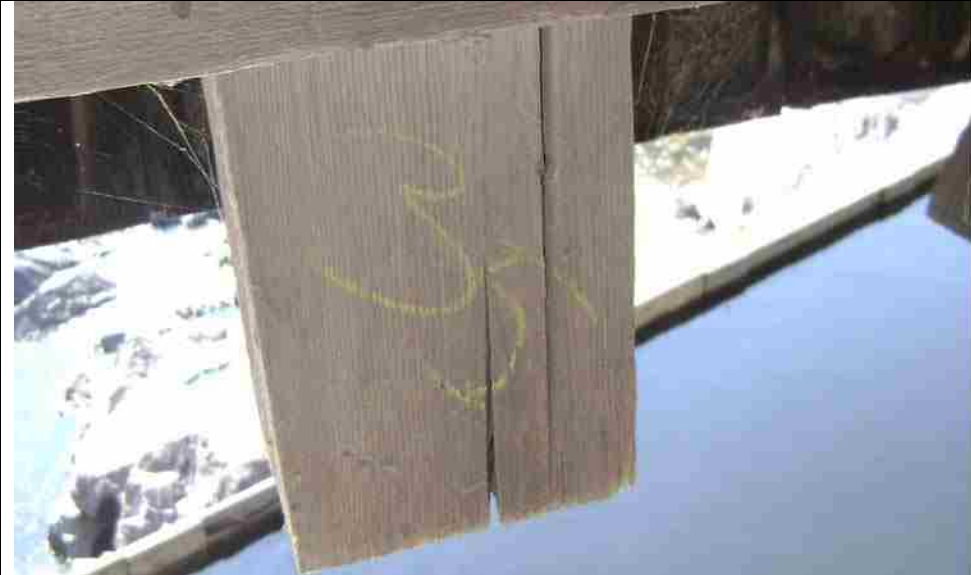
Photo No.3-7 Vertical Truss Member S35, Splits at Lower End

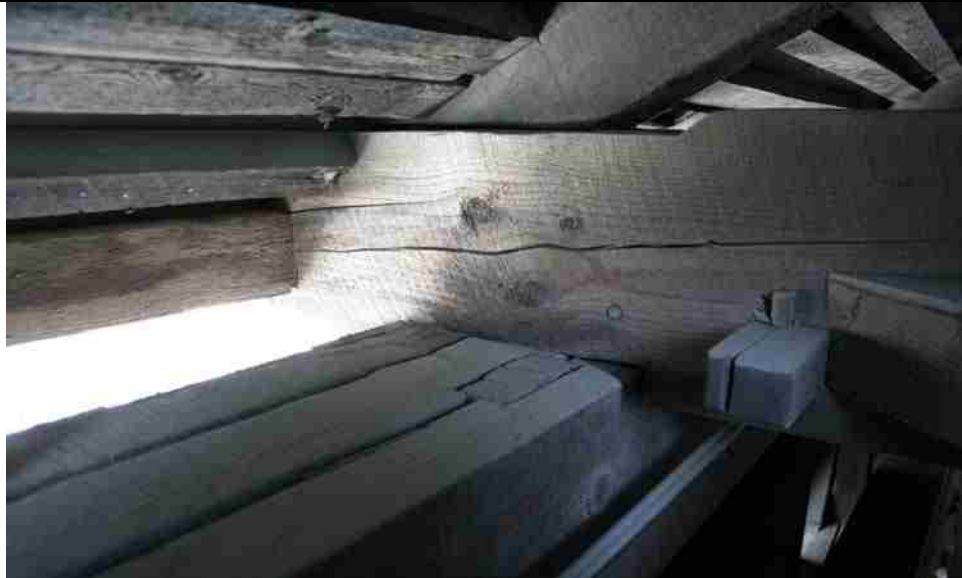
Photo No. 3-8 Vertical Truss Member S33, Missing Upper Tail

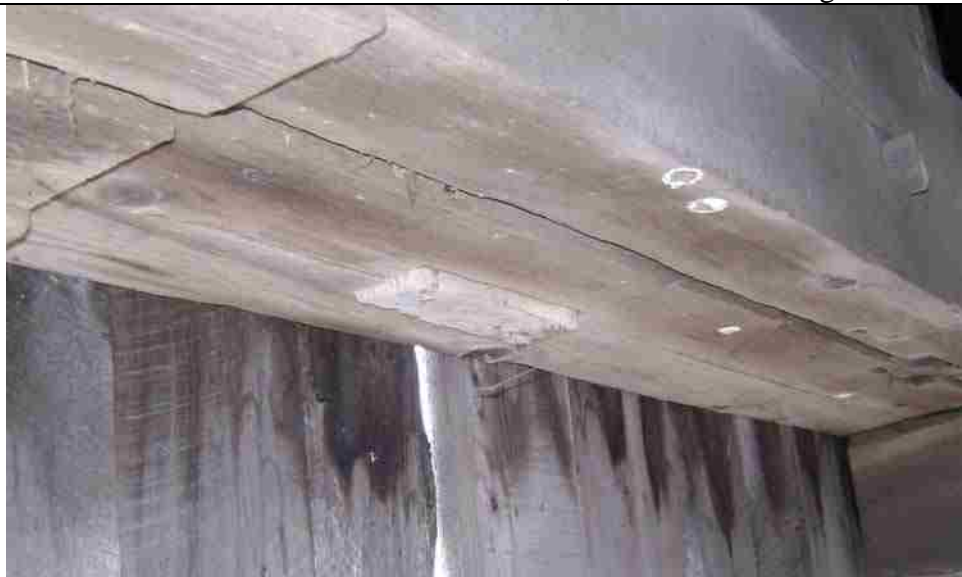
Photo No. 3-9 Vertical Truss Member N40, Lower Tail Missing

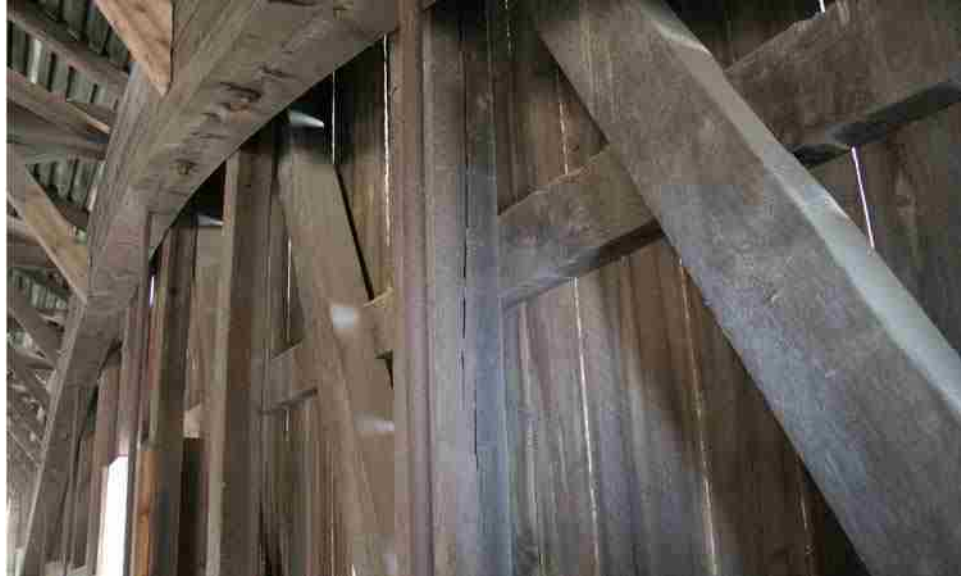
Photo No. 3-12 Vertical Truss Member N56, Split

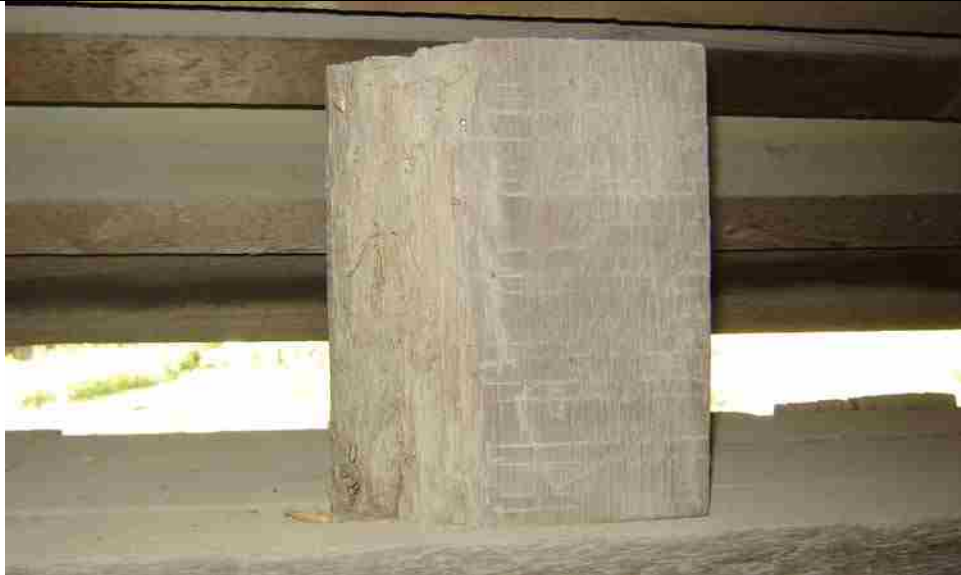
Photo No. 3-13 Vertical Truss Member N22, 2" Deep Rot into Upper Tai

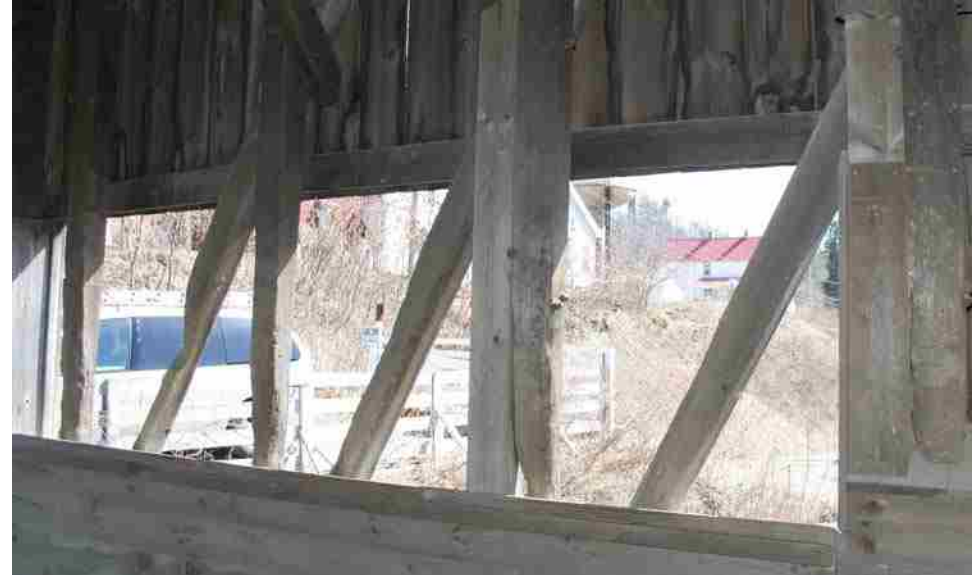
Photo No. 4-3 Diagonal S92L – S93U, Weathering

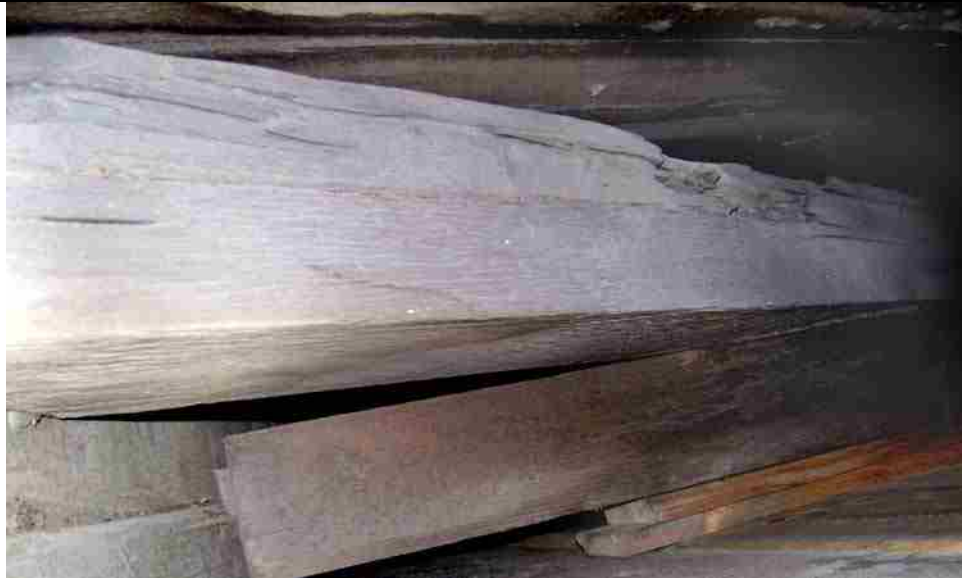
Photo No. 4-6 Diagonal S41L – S43U, Break, Splits, Rot

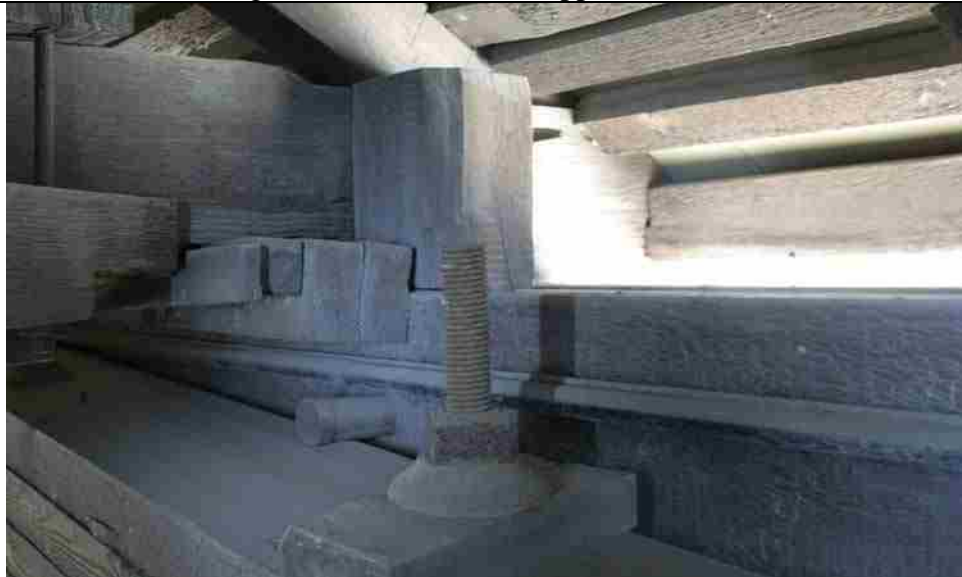
Photo No. 4-7 Diagonal S75L – S76U, Popped Trunnel @ S77

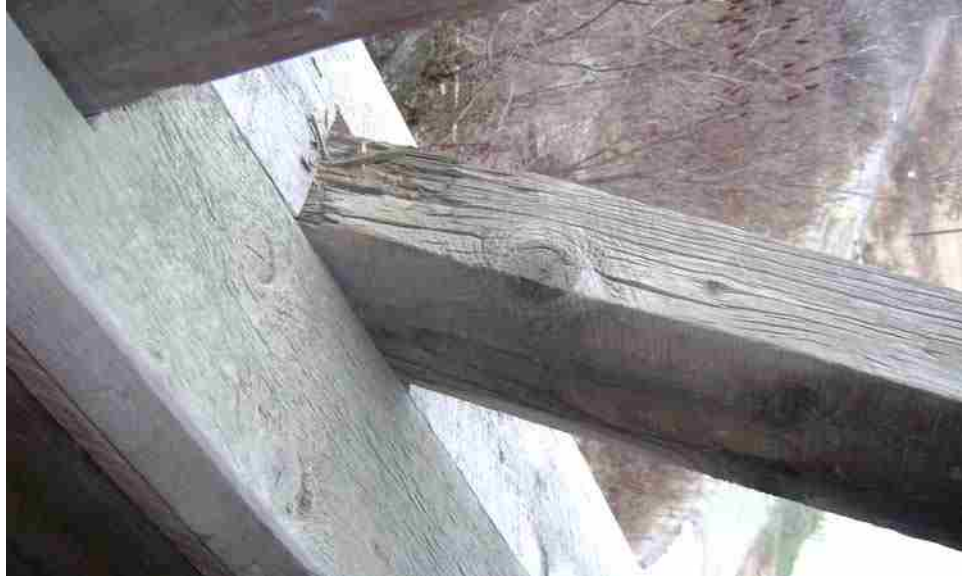
Photo No. 4-8 Diagonal N3L – N4U, Rot

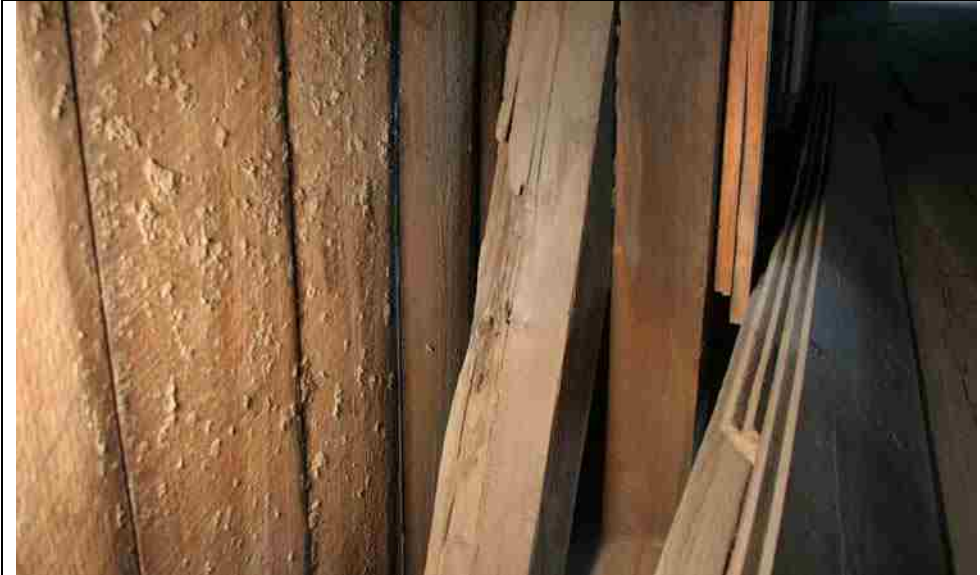
Photo No. 4-9 Diagonal S40L – S39U, Break, split at base, rot at middle

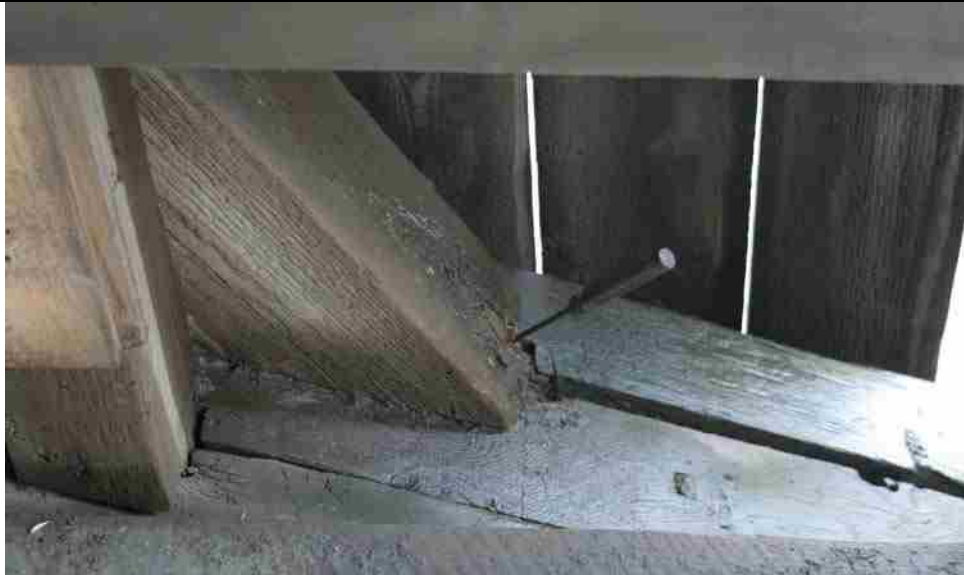
Photo No. 4-17 Diagonal N92L – N91U, Rot at base under window

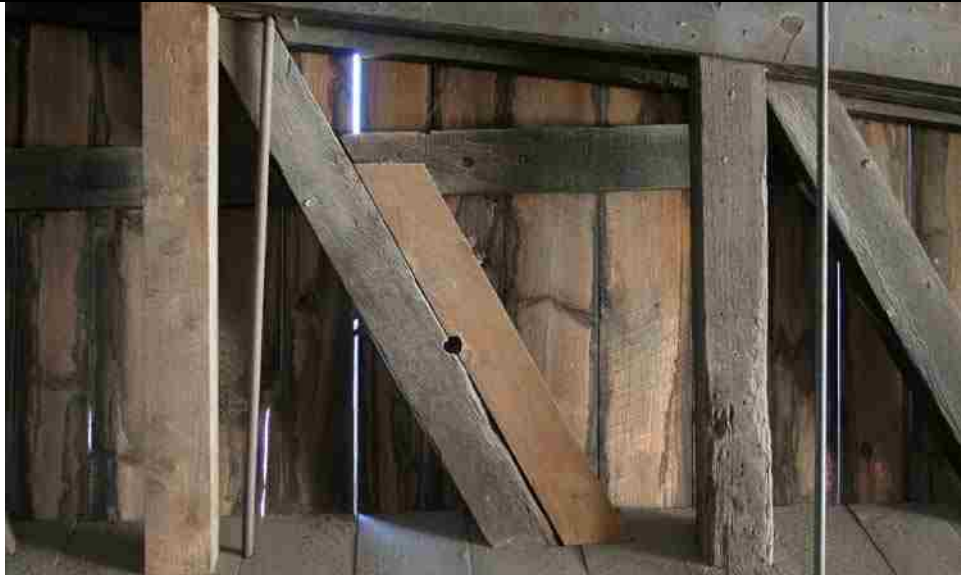
Photo No. 4-19 Diagonal S13L – S14U, Section loss; also Spliced Member

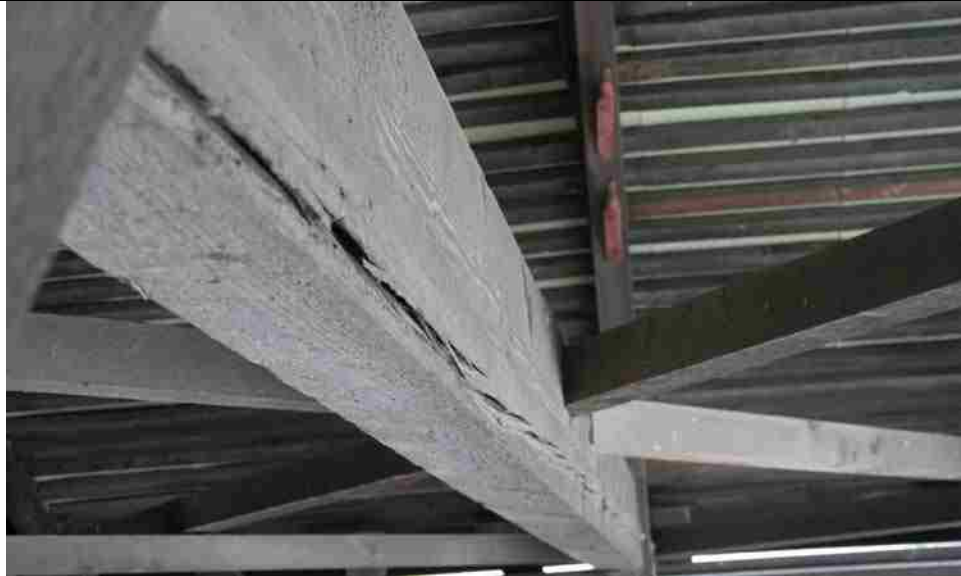
Photo No. 6-2 Cross Beam N93-S93, Split

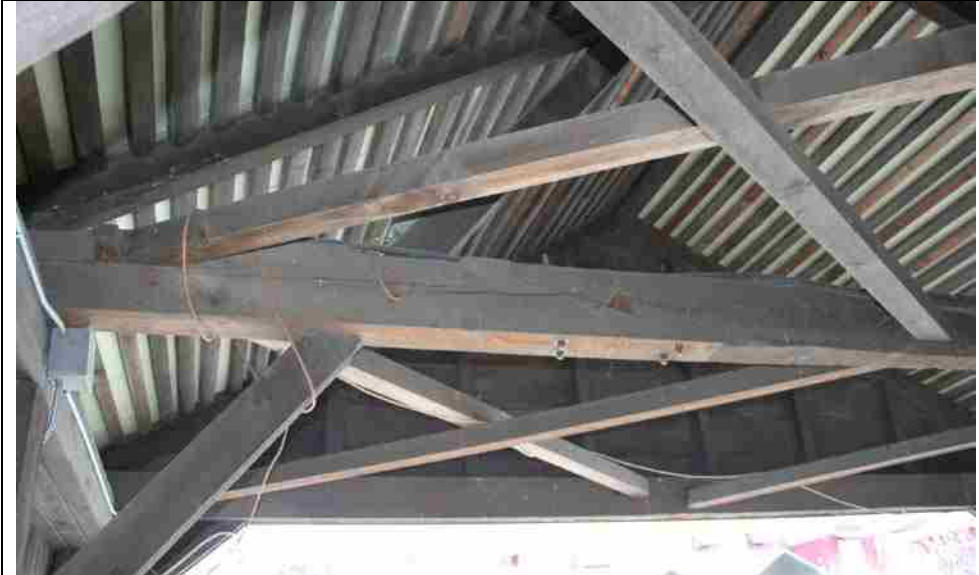
Photo No. 6-3 Cross Beam N95-S95 Split at scarf joint repair

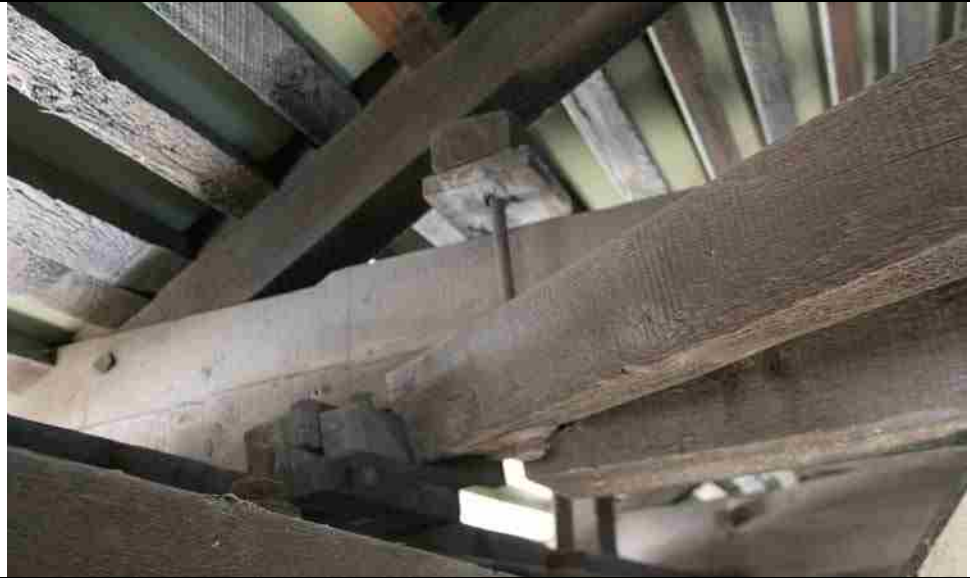
Photo No. 6-5 Cross Beam S77, Notched

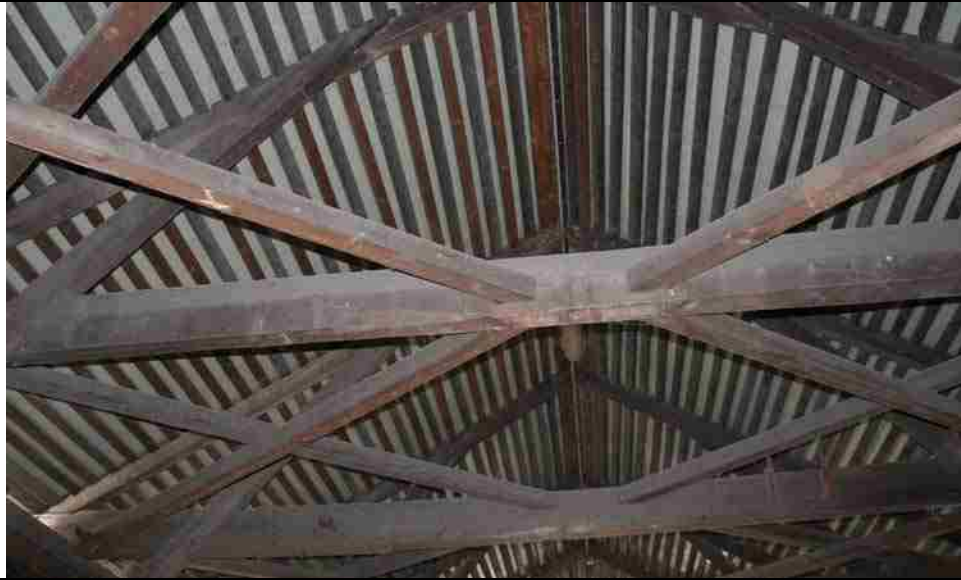
Photo No. 6-6 Cross Beam S27, Split, missing section

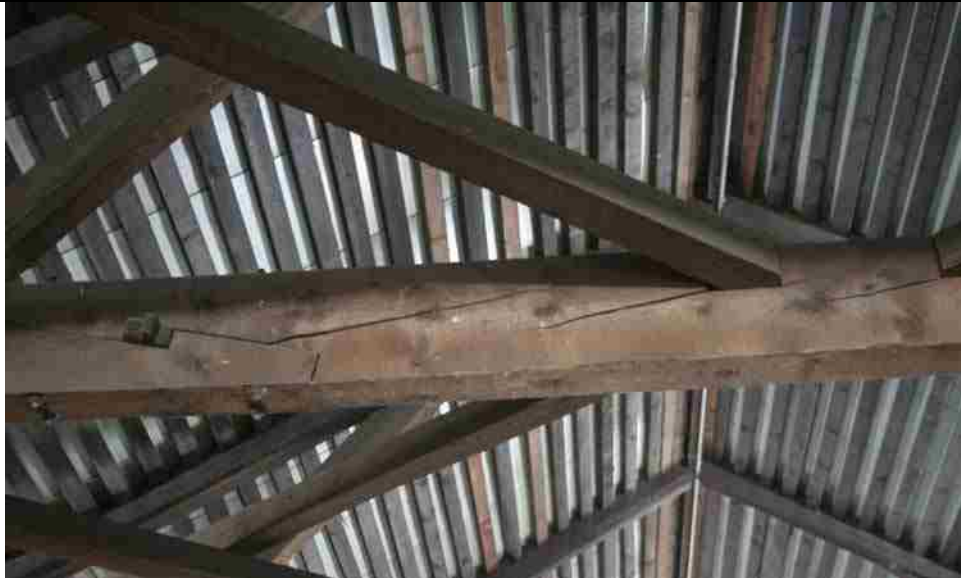
Photo No. 6-8 Cross Beam N33 – S33, stress splits

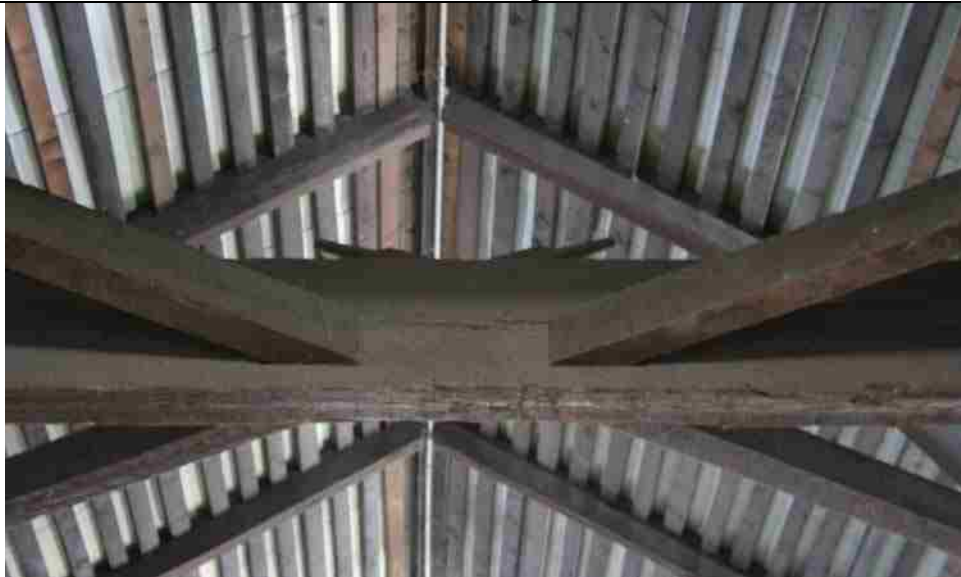
Photo No. 6-9 Cross Beam N37 – S37, split and rot

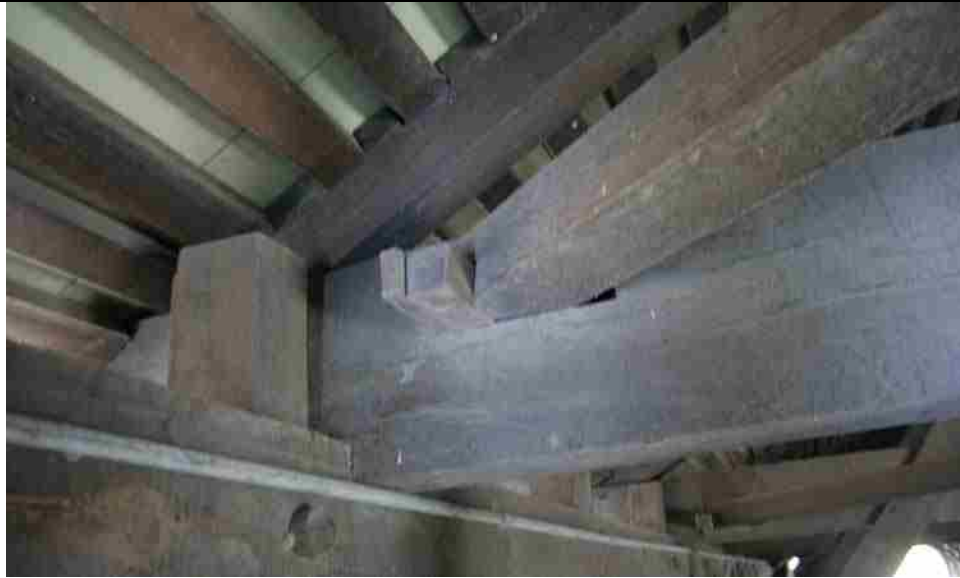
Photo No. 7-2 Upper Lateral N63 – N61, Split

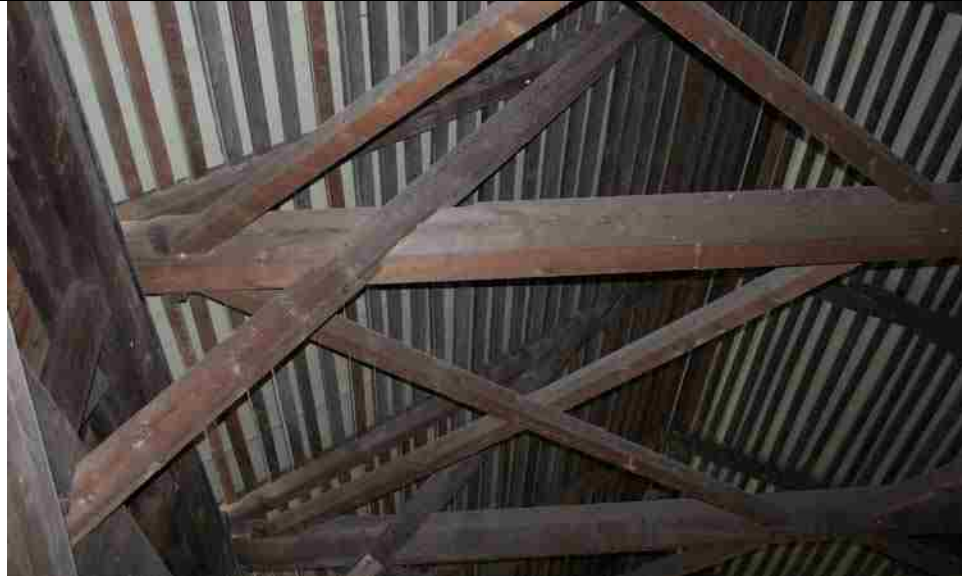
Photo No.8-2 Knee Brace S29, Split

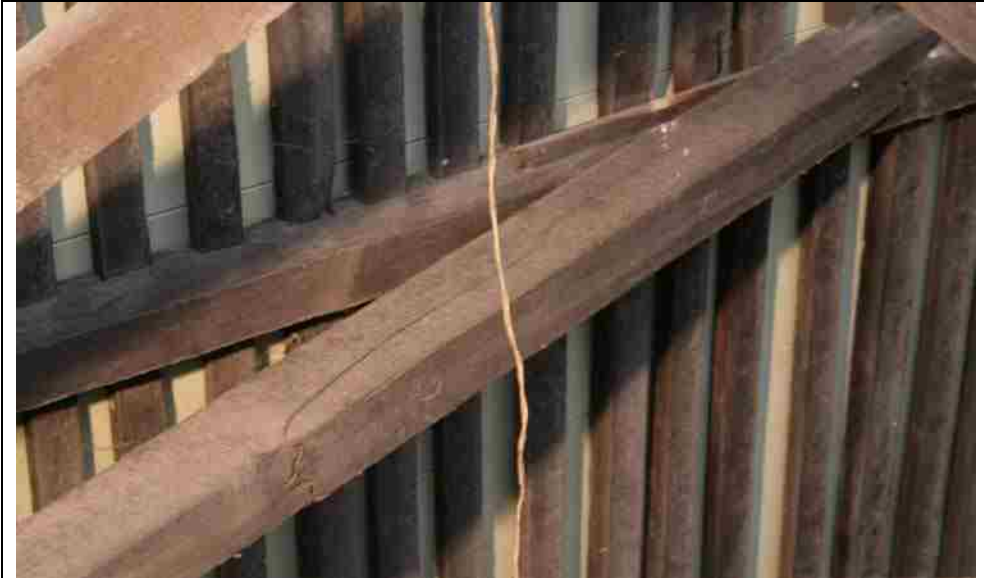
Photo No. 8-4 Knee Brace N5, Split

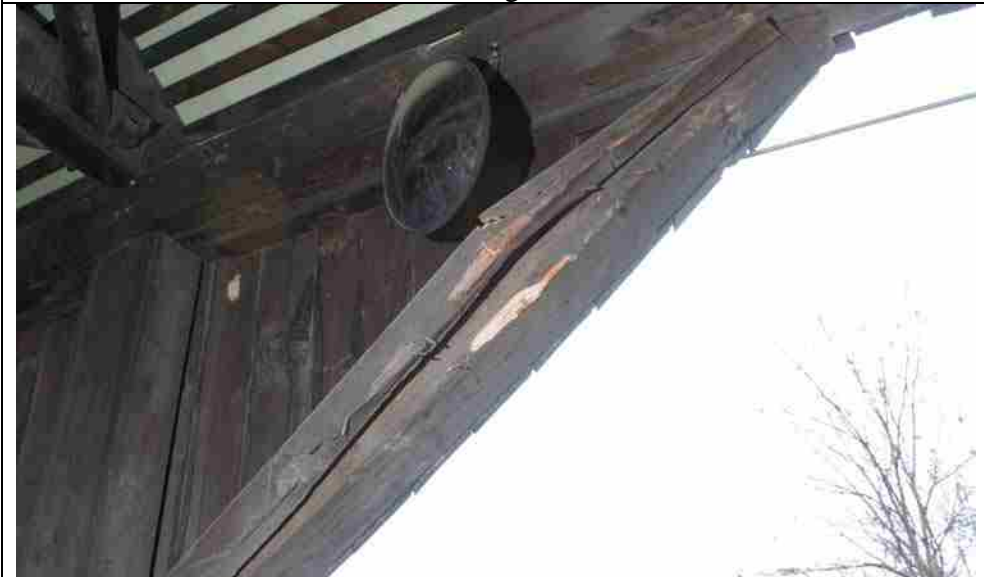
Photo No. 8-5 Knee Brace S0, Damage

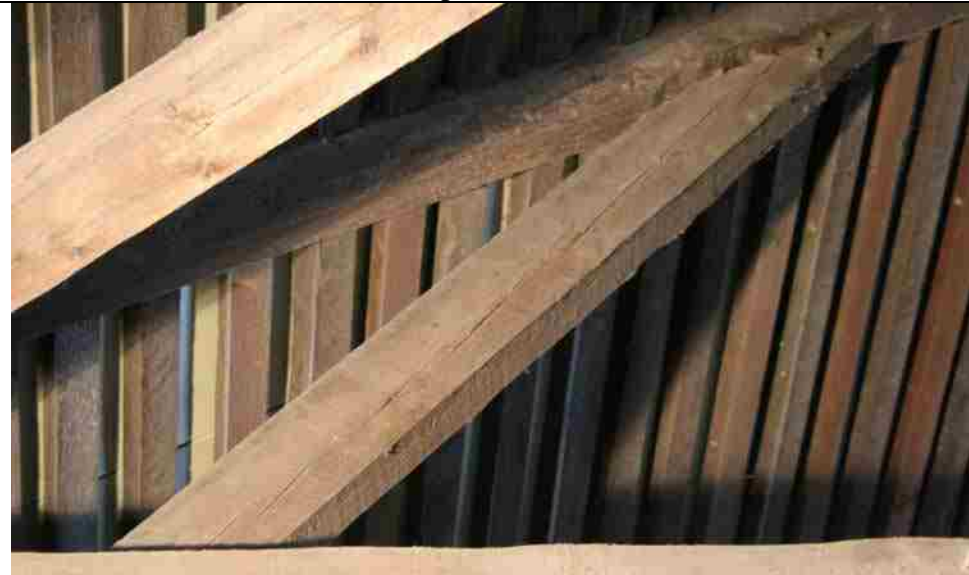
Photo No. 8-7 Knee Brace S49, Split

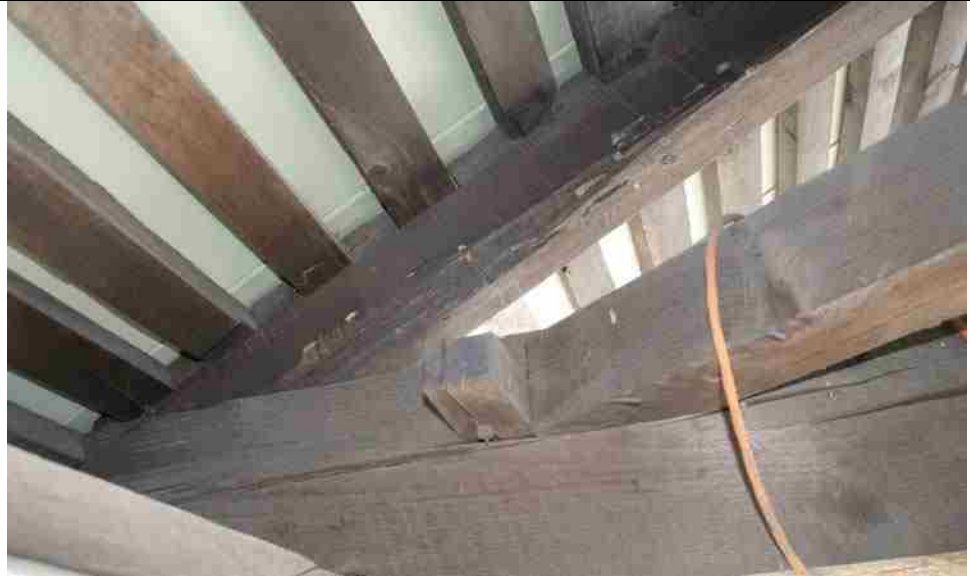
Photo No. 9-2 Rafter N95, Insect damage and rot

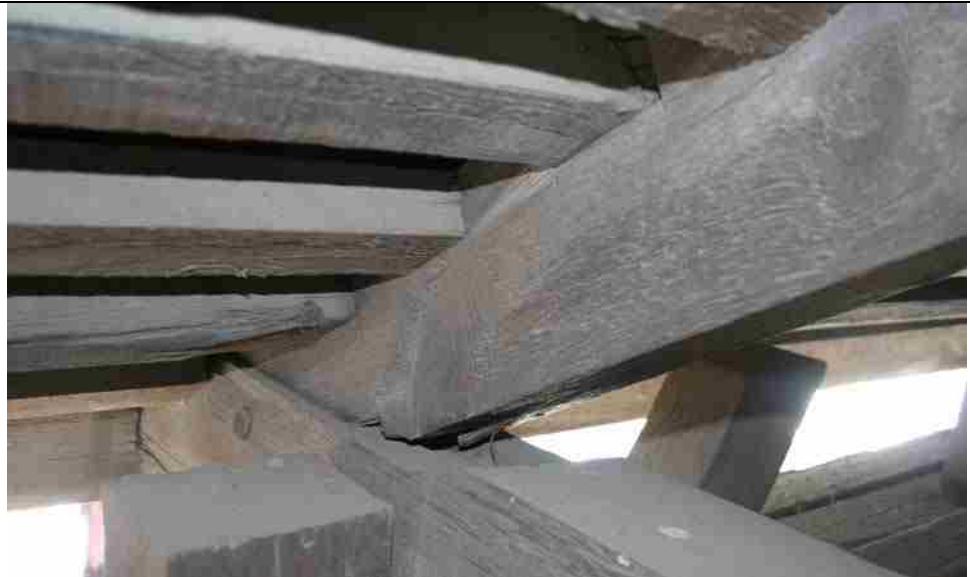
Photo No. 9-3 Rafter S89, Rot at rafter end

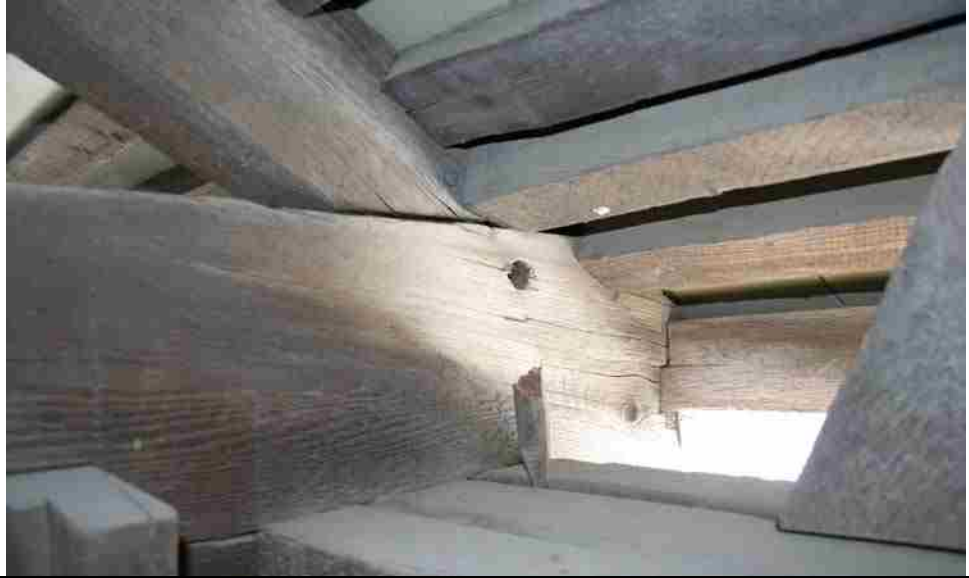
Photo No. 9-4 Rafter S85, Rot at rafter end, beetle damage

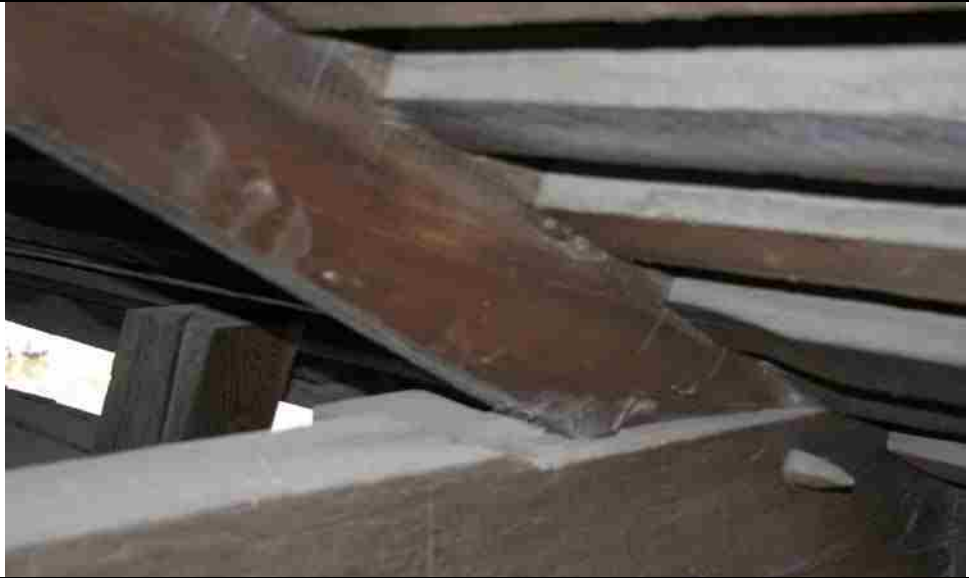
Photo No. 9-5 Rafter N77, Split off, proposed sister

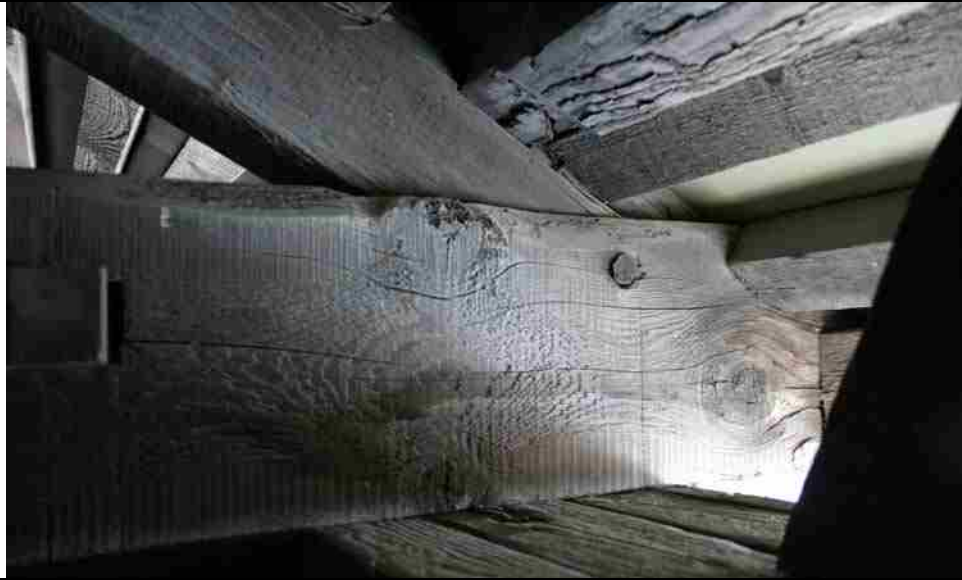
Photo No. 9-6 Rafter S31, Rot at rafter end

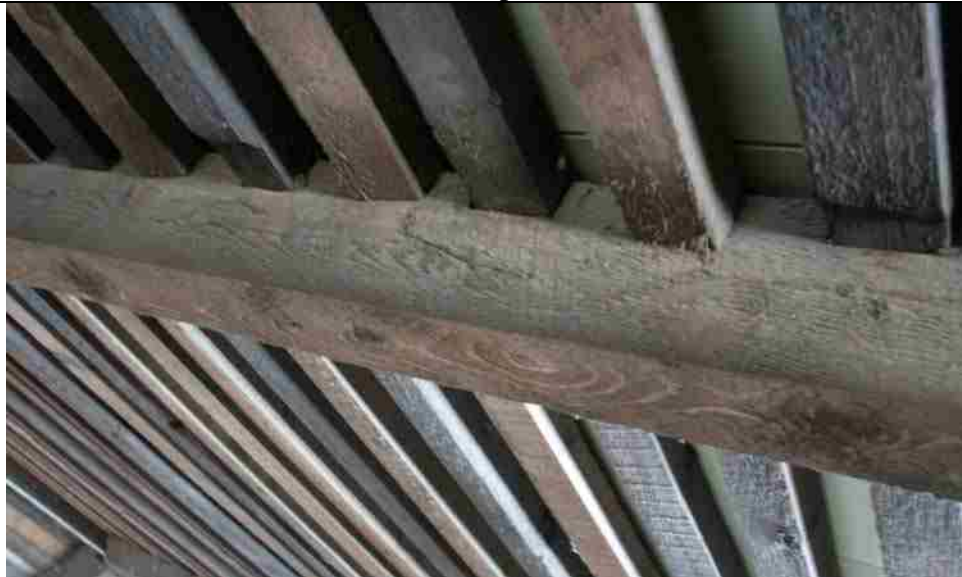
Photo No. 9-7 Rafter S19, Crack 3' up from end
