Bath Village Covered Bridge Bath, New Hampshire

Rehabilitation Project Report

November 2011

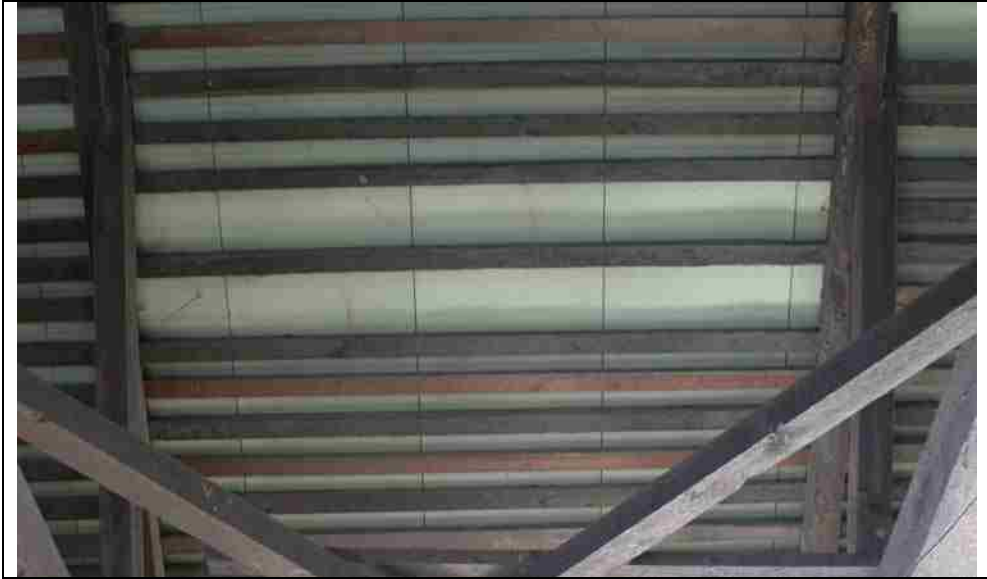
Photo No. 11-2 Purlin at node S63 – S61, Missing

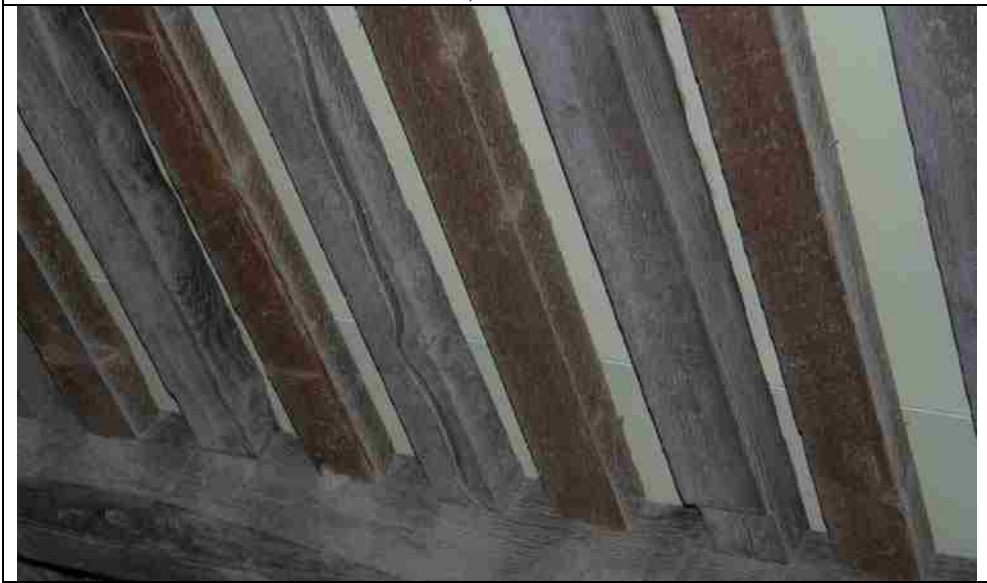
Photo No. 11-3 Purlin at node S85, Crack

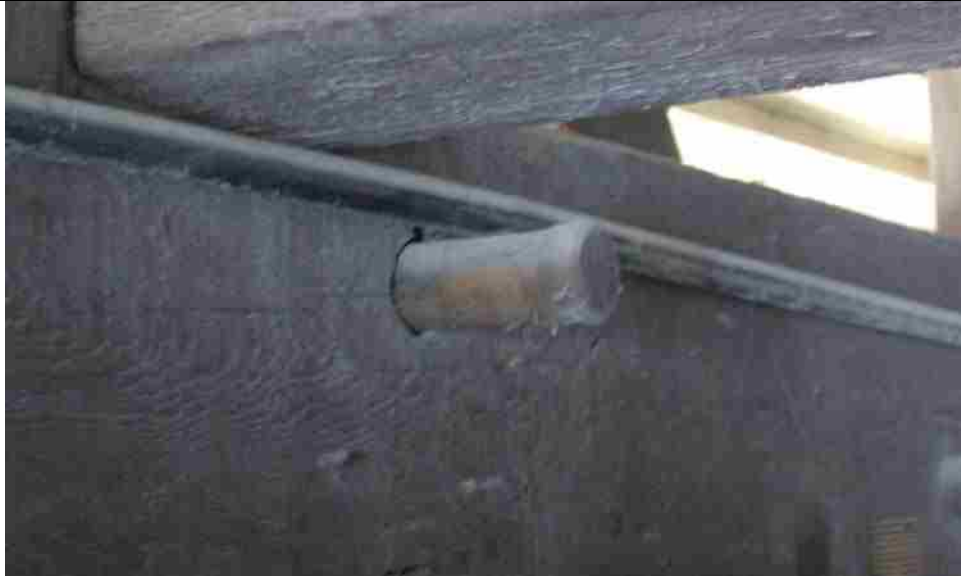
Photo No. 12-2 Trunnel S75, Popped out

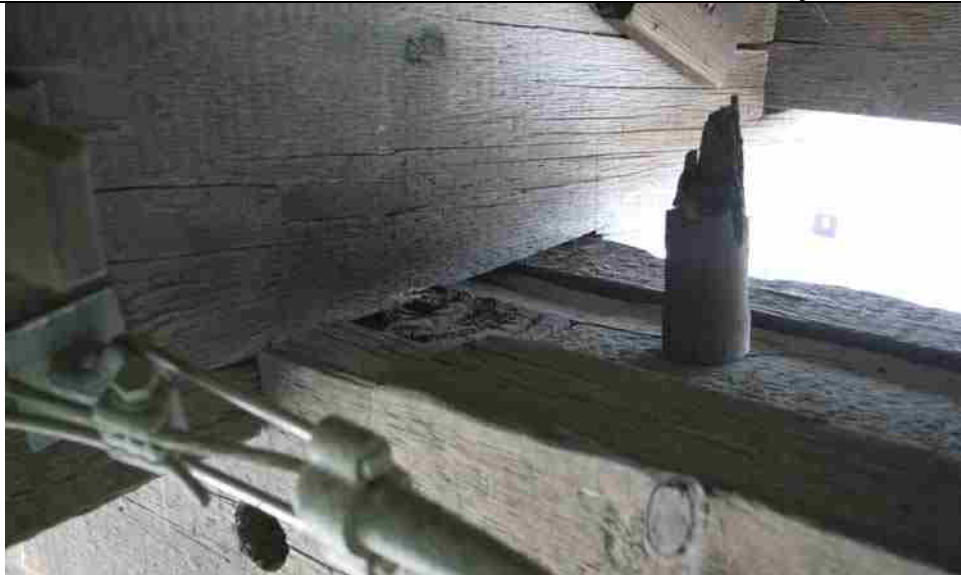
Photo No. 12-3 Trunnel S95, Rotted off; internal rot in rafter joint

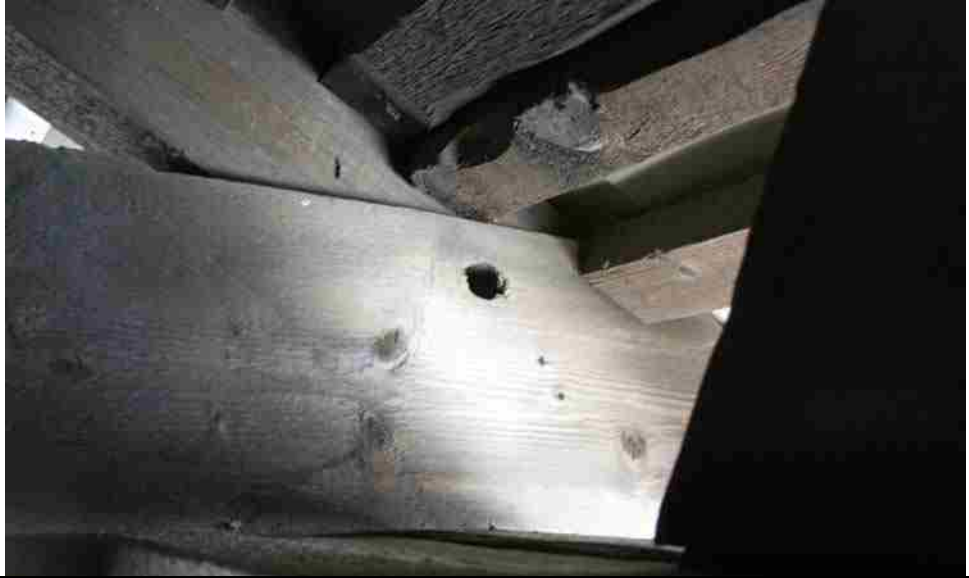
Photo No. 12-4 Trunnel S87, Missing

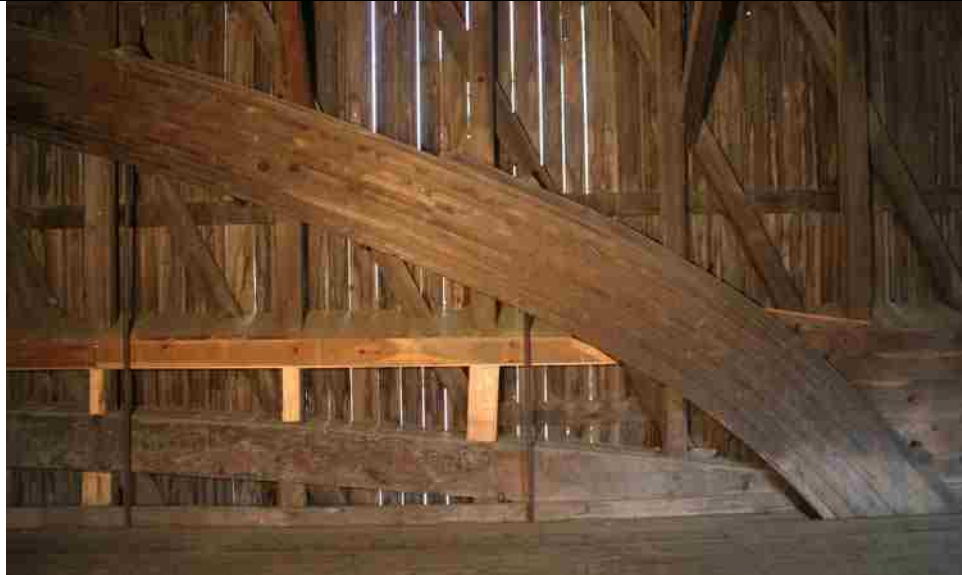
Photo No. 19- 7 Added Arch N61 – N56, arch raduis deformed

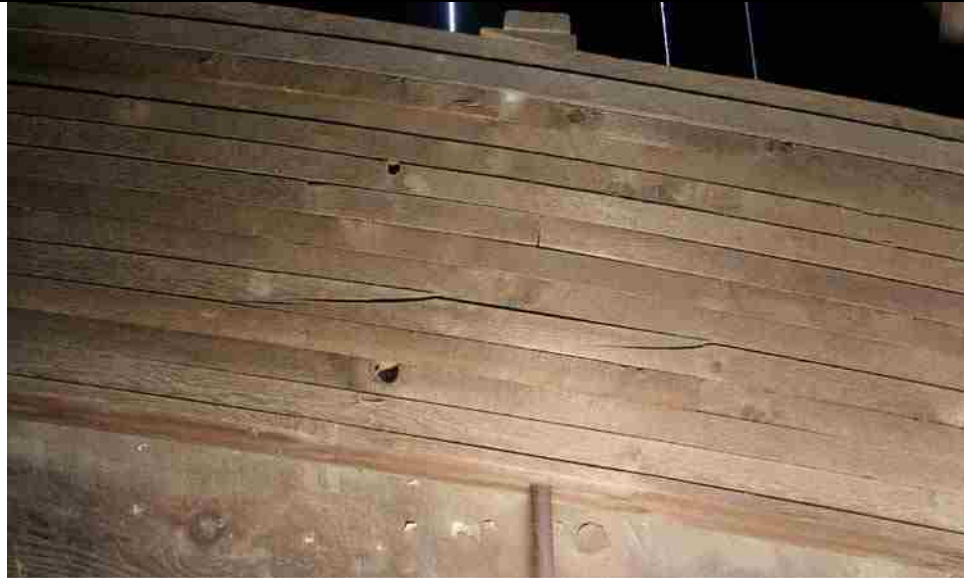
Photo No. 19-8 Added Arch N36, cracks in laminations

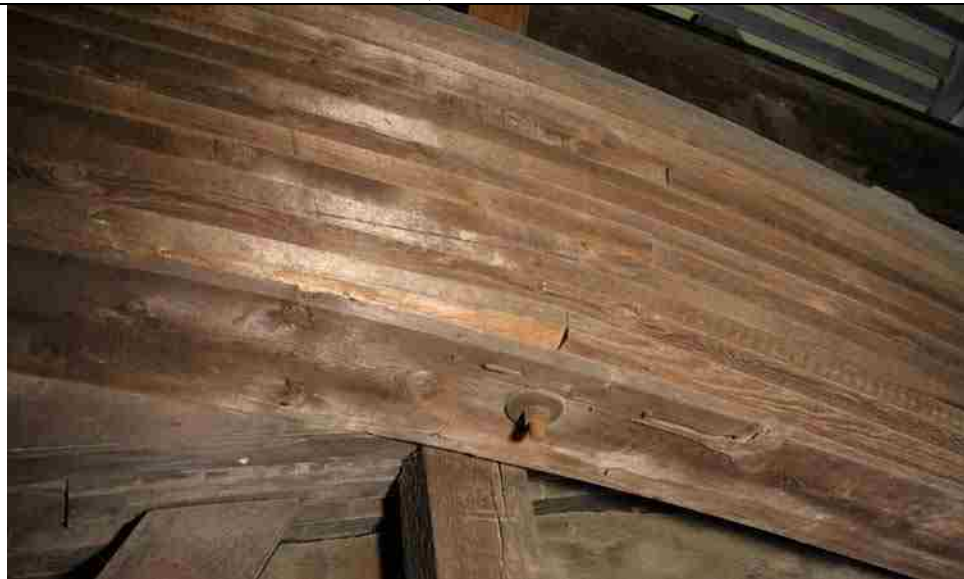
Photo No. 19-9 Added Arch S31, cracks in laminations

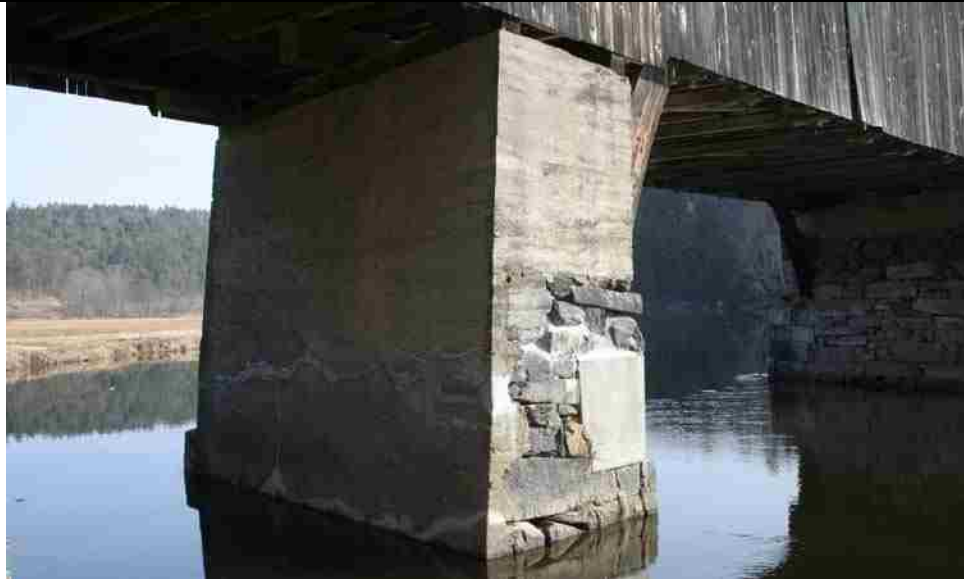
Photo No. 23-2 Pier 1 South (repaired 2007)
