Bement Covered Bridge, Bradford, New Hampshire Rehabilitation & Preservation Plan

Prepared by

Historic Documentation Company, Inc.
Portsmouth, Rhode Island

February 2018

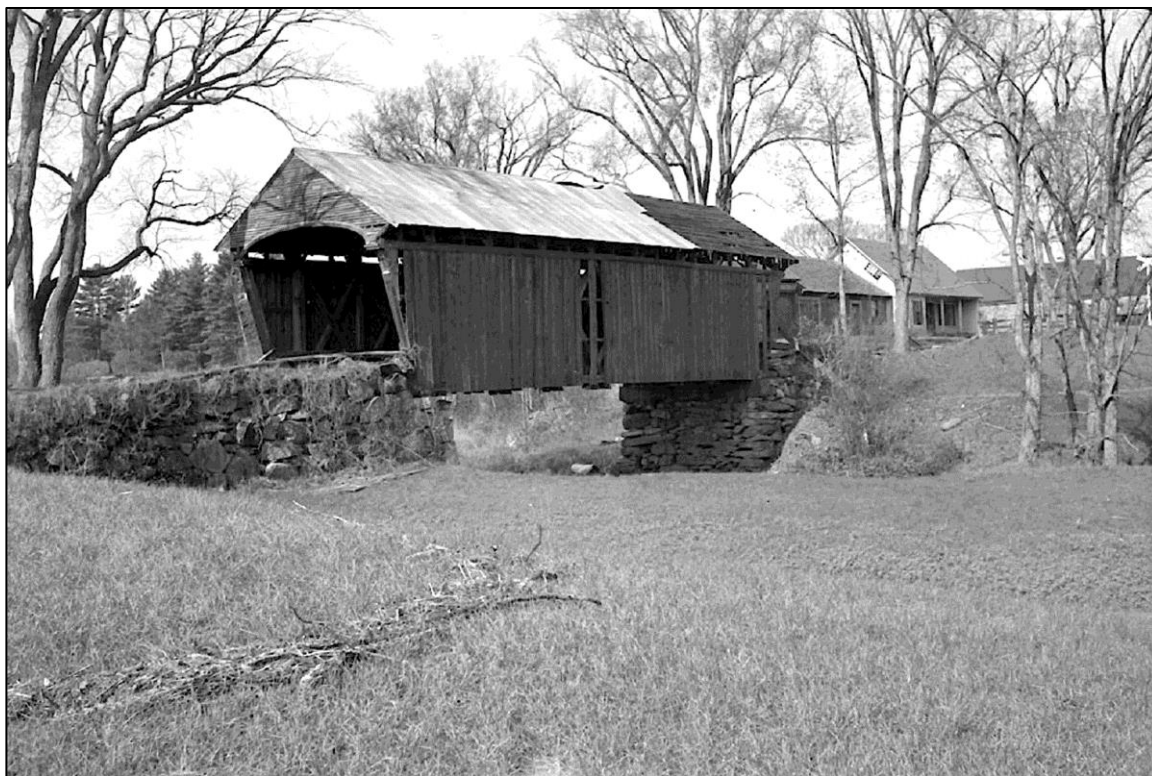
FIGURE 6: Bement Bridge, south portal and downstream (east) side, 1939, showing damage evidently from 1938 hurricane & flood. Note existing concrete repair to north abutment not present (source: Town of Bradford).

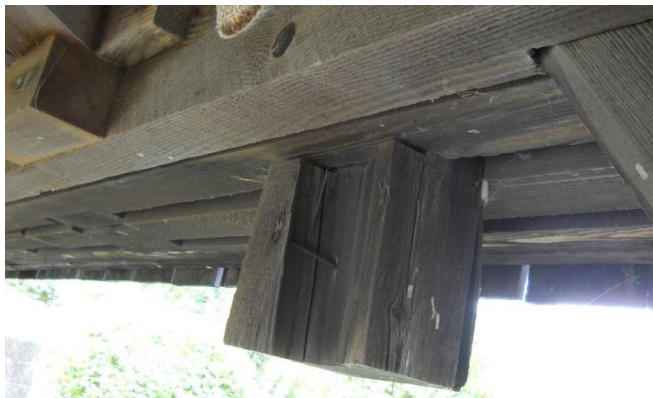
Post w/ broken tail at Node 6 to be replaced.

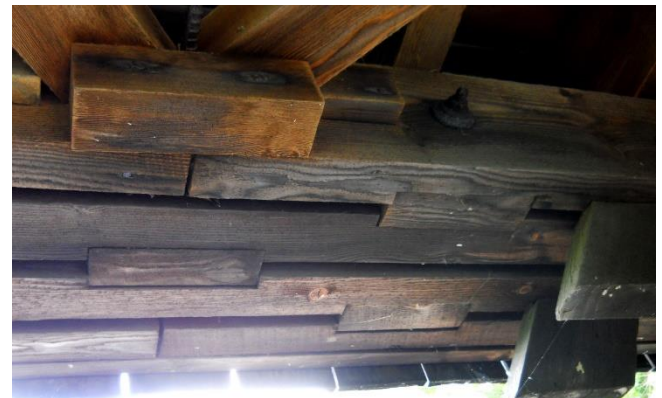
Critical lower chord splice joints adjacent to Node 6 post.

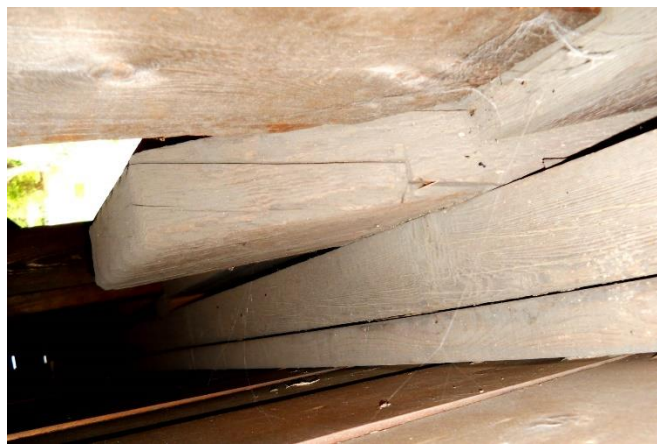
Counter brace with w/ structural split at Node 1 to be replaced.

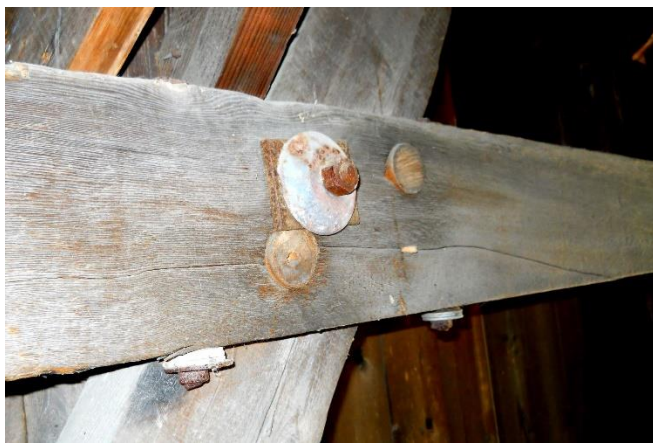
Crack in upper chord at Node 3. Note added vertical thru bolt reinforcement.

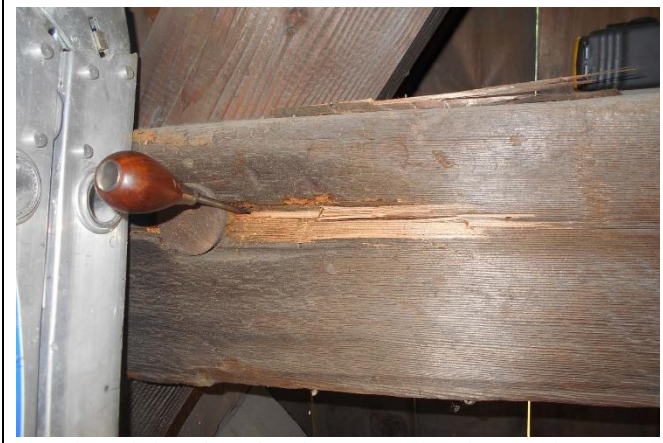
Crack and deterioration in upper chord at Node 6.

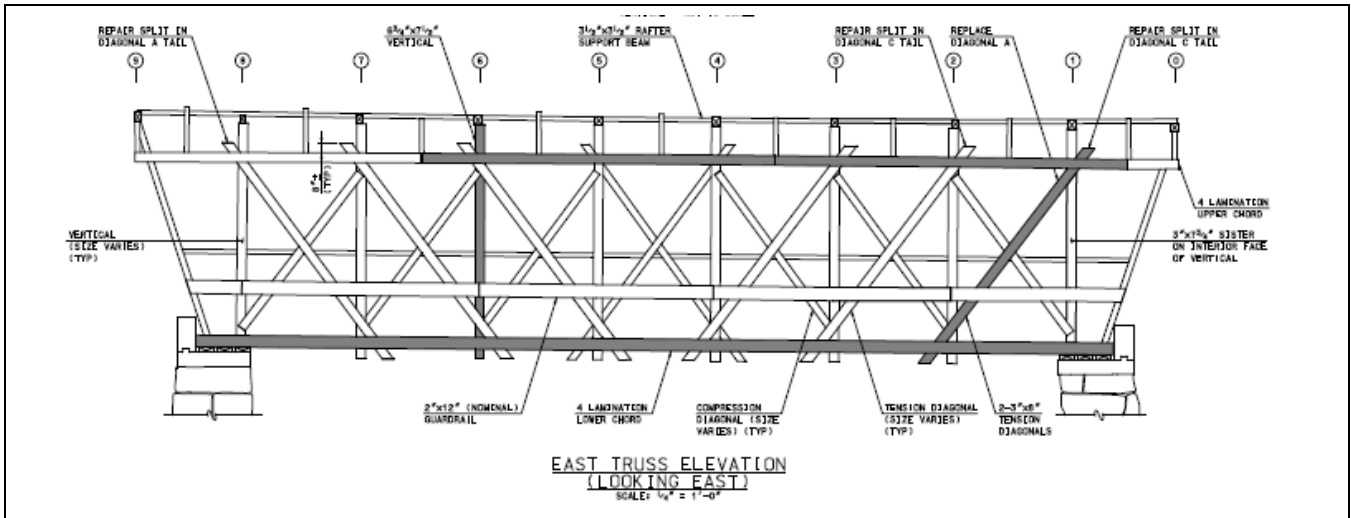
Plan Reference:
Sheet 30

Describe Work:	Bridge will be jacked and braced during rehabilitation as required to straighten, release stresses, plumb and re-align the trusses. Special care shall be taken to avoid damage to members that are to remain and to avoid movement of the truss that could result in distortion or misalignment of the truss and its joints. All joints in replaced members shall match the existing joint, including all nails, bolts or screws required unless noted otherwise. Members shown to be replaced are to be replaced "in-kind" with new members identical in dimensions and configurations as the members originally used in the bridge (see Plan Sheet 30 - East Truss Plan and Elevation, and Plan Sheet 31 - West Truss Plan and Elevation, with Upper Chord Plan details, shown in part below,		
Project Need:	The chords are primary structural members of the truss that carry the live and dead loads. The lower chord as constructed does not possess the required structural capacity.

Entire lower chord member (shaded) on East Truss to be replaced.

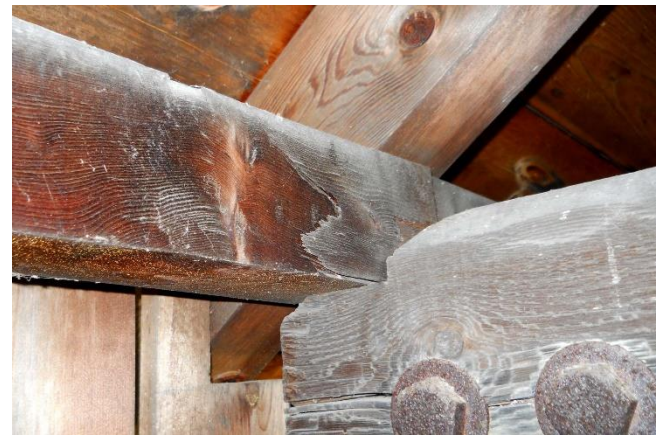
Detail of split in rafter support beams at Node 8.

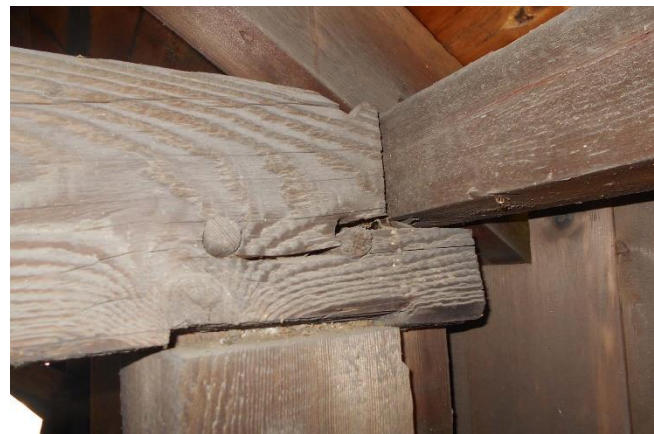
Cracked cross beam end at Node 7, west truss.

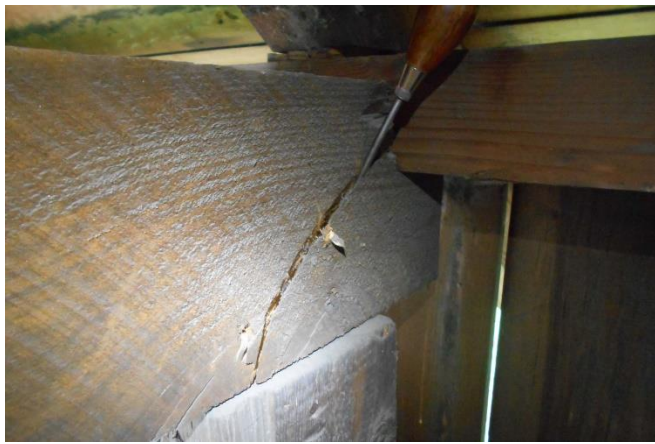
Cracked cross beam end at Node 1, west truss.

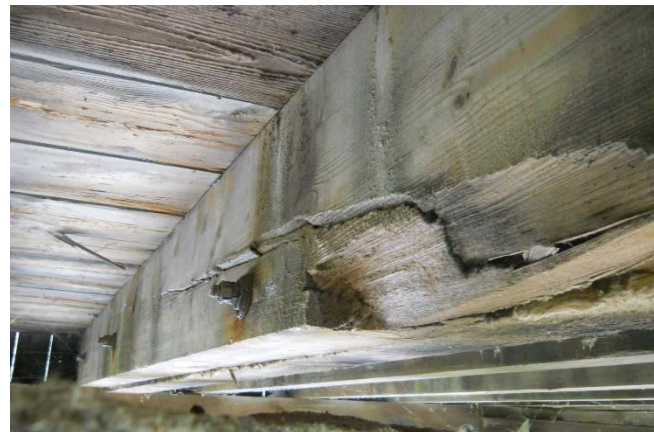
Broken Floor Beam between Node 3 and 4

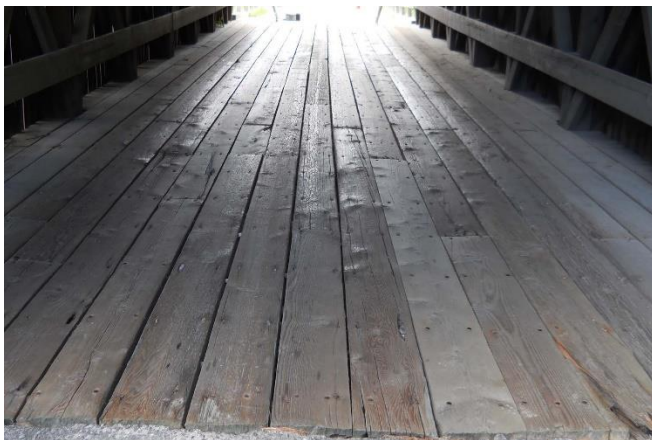
Decking is split, rotted and loose and has reached end of practical service life.

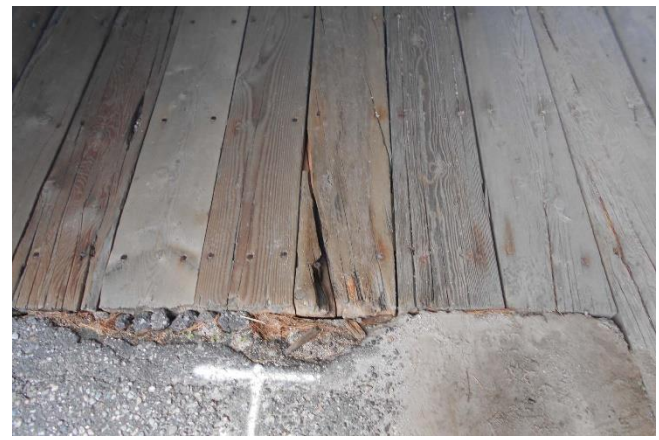
Detail of deck failure and deterioration.

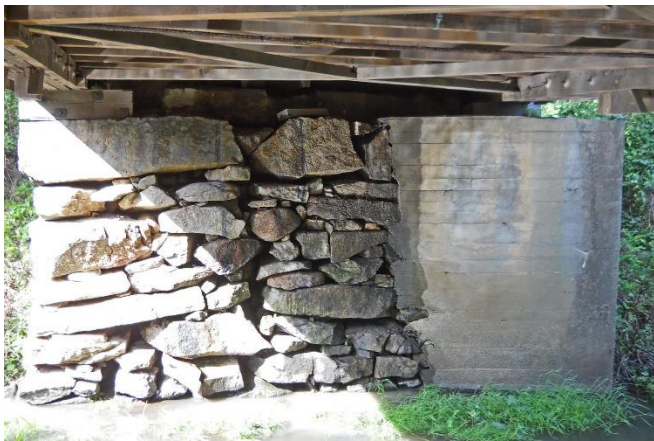
North Abutment showing loose stone work and concrete repair c.1939.

Describe Work:	<p><i>North Abutment:</i> Completely remove and replace the abutment and wingwalls dictated by observed deficient structural conditions and the deficiencies noted in the size and quality of existing stones.</p> <p><i>South Abutment:</i> Reconstruct portions of the east and west wingwalls to stabilize, remove bulges and prevent continued deterioration. Partially rethick and wedge abutment stemwall using compatible stonework. Construct a new concrete backwall and concrete cap to provide required structural bridge and approach foundation; concrete to be at ground level and largely concealed from the view. See Plan Sheets 20-27 – Substructure Modifications.</p>
Project Need:	Substructure is structurally deficient and in need of rehabilitation to provide a safe supporting structure for the bridge..
Impacts:	Work complies with Secretary's Standards for Rehabilitation, <i>Replacing Deteriorated Historic Materials and Features</i> .

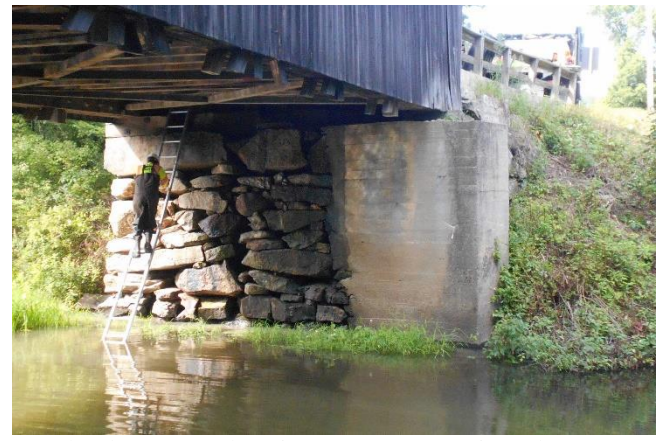
North Abutment, showing concrete repair and upstream side.

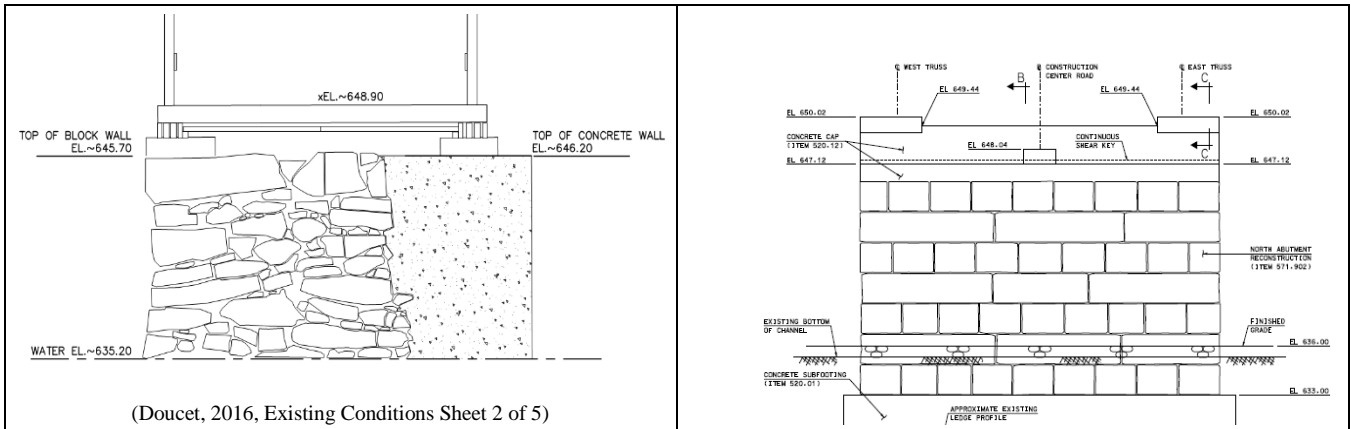
Plan Reference: Sheet 22 North abutment: Existing (left) showing loose and displaced collapsing stones (laser scan) and concrete repair; Proposed new dry laid cut stone abutment, (right).
