Stark Covered Bridge Stark, New Hampshire

Historic Structure Report

July 2012

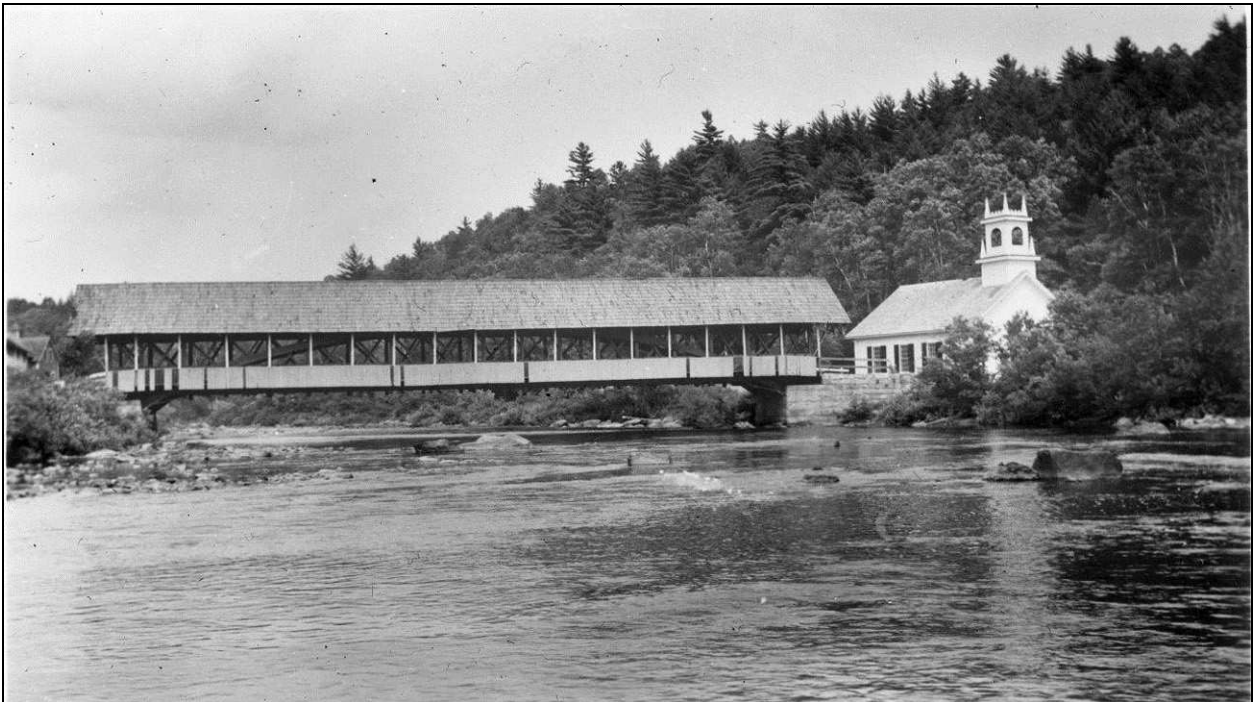
Figure 4: Early 20th century view (ca. 1925) of west elevation of Stark Bridge before bridge began sagging in the 1930s. Note missing siding boards. (Source: Collection of the National Society for the Preservation of Covered Bridges).

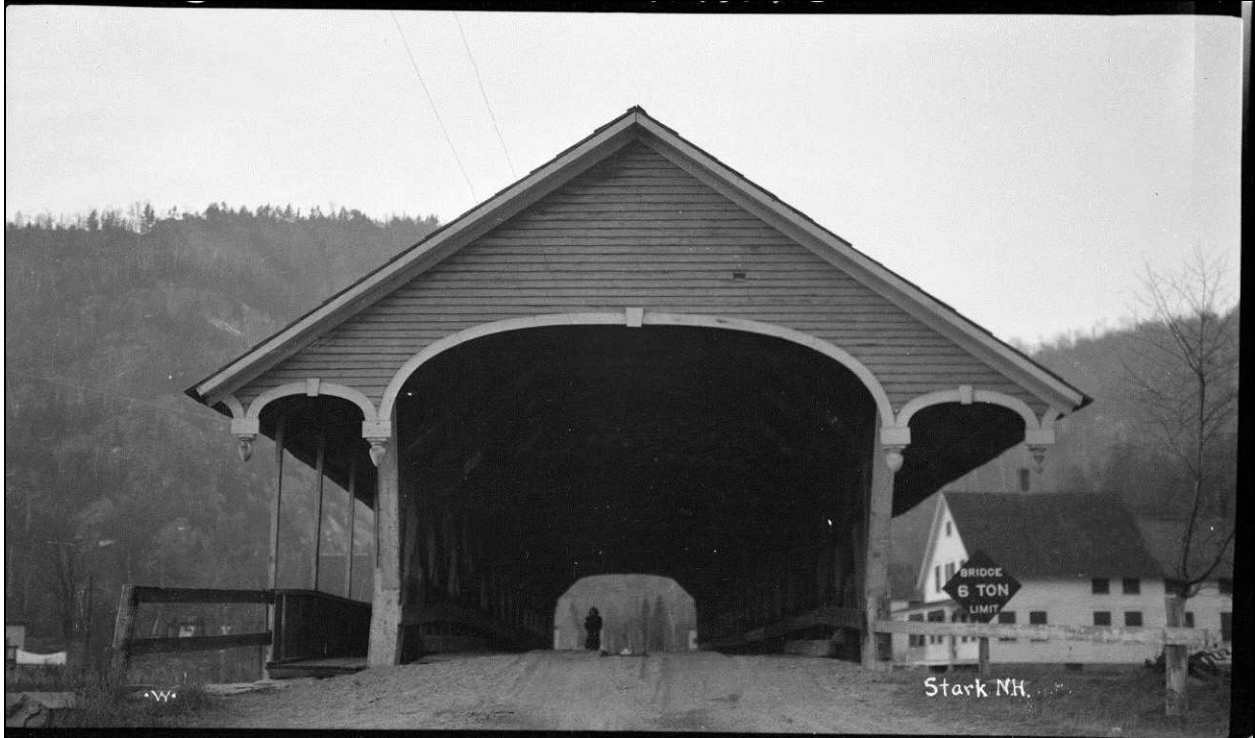
Figure 14: Photo of south end of bridge, 1938. Note missing sidewalk posts and railing on upstream side. (Source: Collection of the National Society for the Preservation of Covered Bridges).

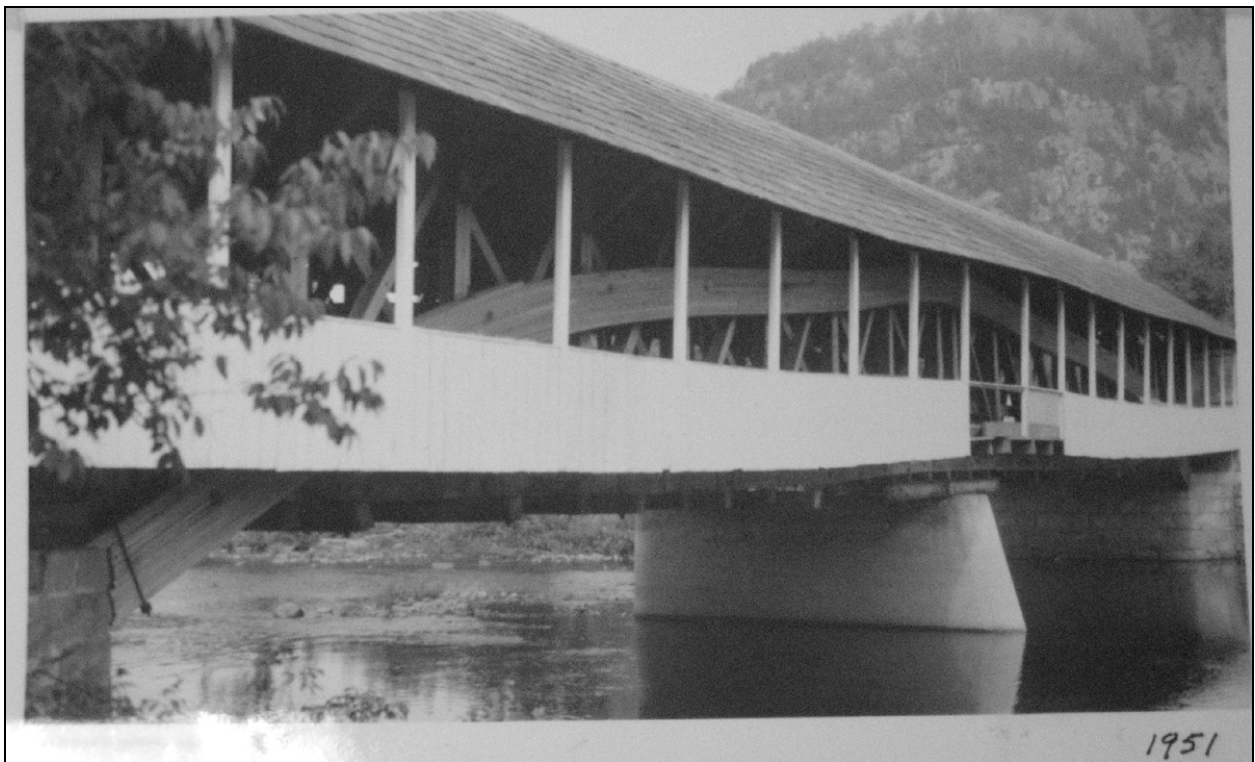
Figure 17: NHHD Bridge Inventory Card photo dated 1951 showing new pier built in 1948 and wood arch, lifted and slightly less deformed than seen in Figure 13.

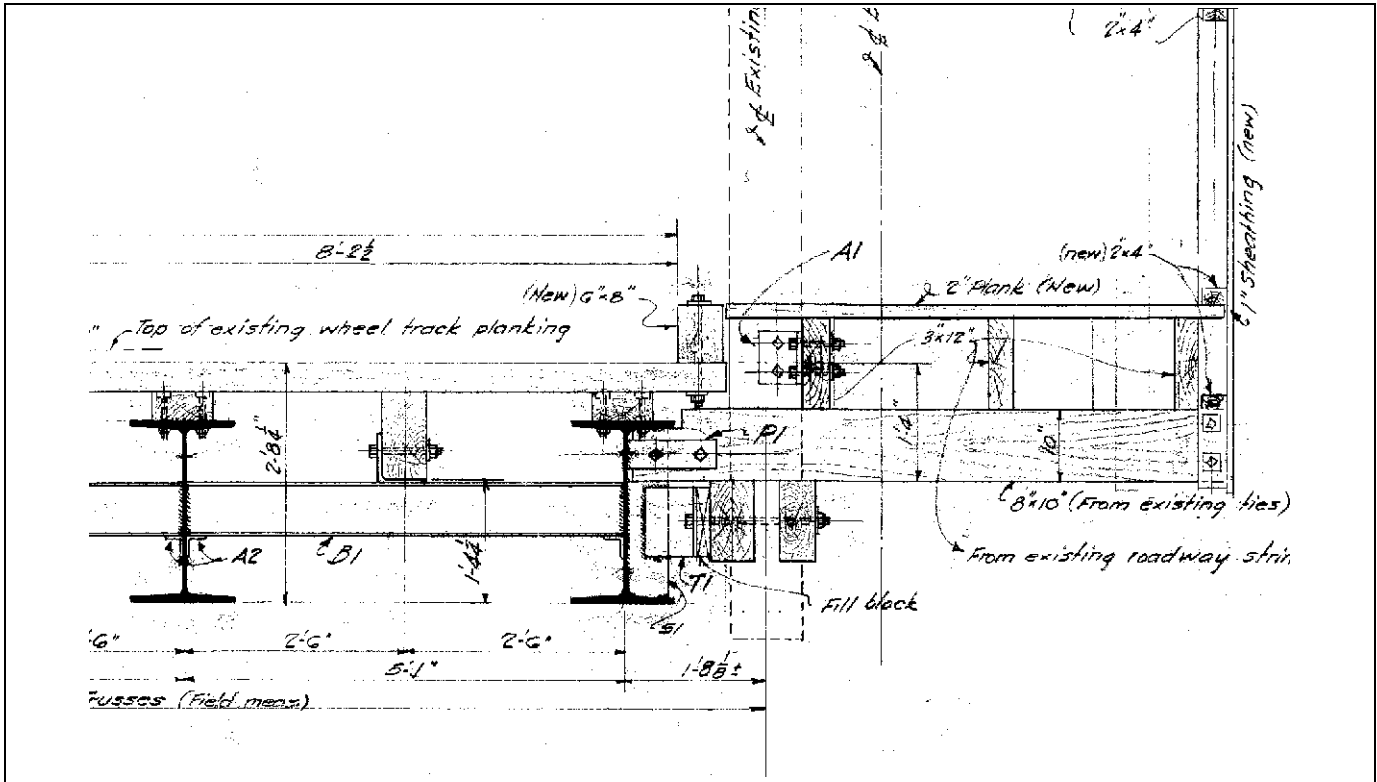
FIGURE: 4.3-3: Original design for lower chord from 1954 Repair Drawing does not show the use of the recycled deck planks.

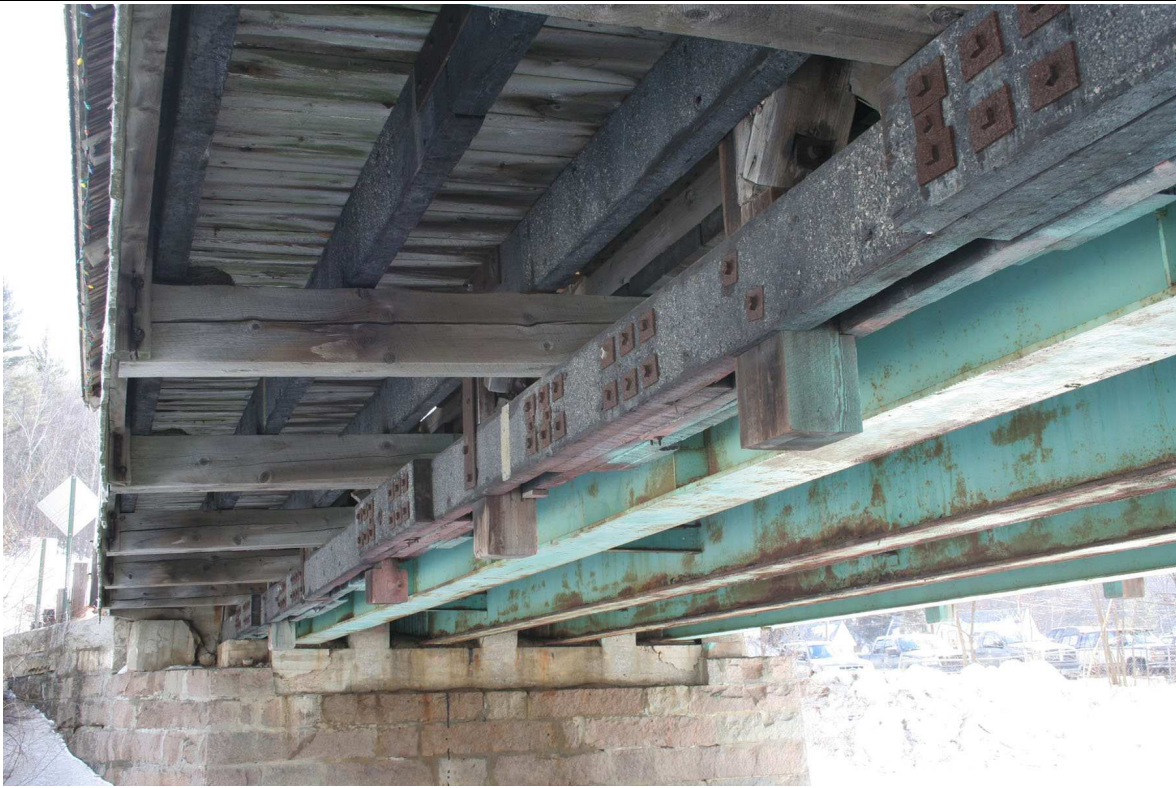
<p>Condition:</p> <p>The lower chords are in fair to good condition due to being treated against rot and coated with asphalt.</p>	
<p>Proposed Treatment:</p> <p>All lower chords will be replaced with new wood members compatible with existing original truss components.</p>	
<p>Project Need:</p> <p>The lower chords are primary structural members of the truss that carry the live and dead loads. The lower chord members and their thru-bolt connections are of insufficient strength and do not possess the required structural integrity to carry the required loads.</p>	
<p>Impacts:</p> <p>The existing chord members are not original to the bridge and are incompatible with the original design because they were salvaged deck timbers of different size, surfaced with asphalt pavement.</p>	
<p>Alternative Treatments Considered:</p> <p>None. There are no other repair alternatives that meet the Secretary of the Interior's Standards for Rehabilitation.</p>

FIGURE: 4.3-5: Lower chord members. Note splice blocks, asphalt road surface coating, yellow line stripe at center of photo.

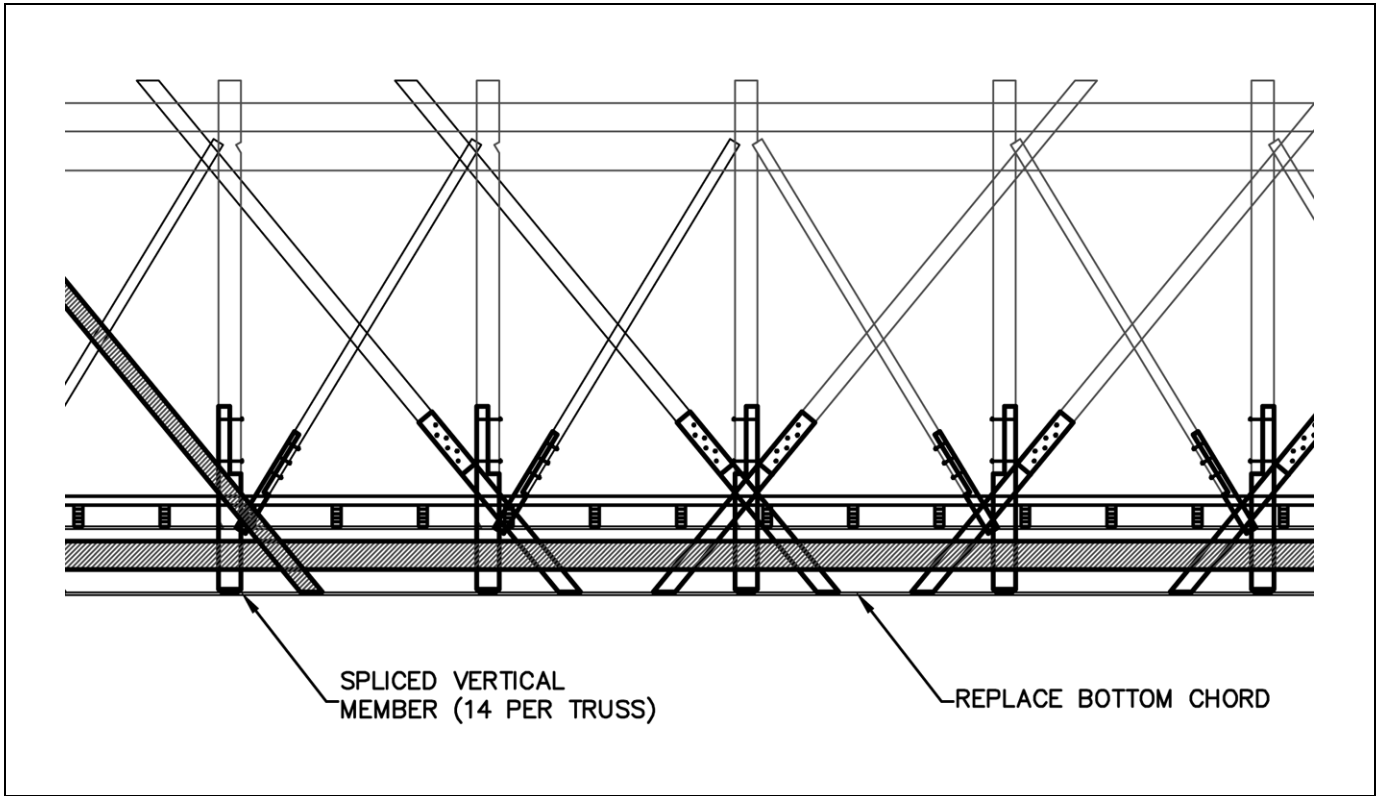
FIGURE: 4.4-3: Proposed repairs to vertical truss members (source: HEB 2012)

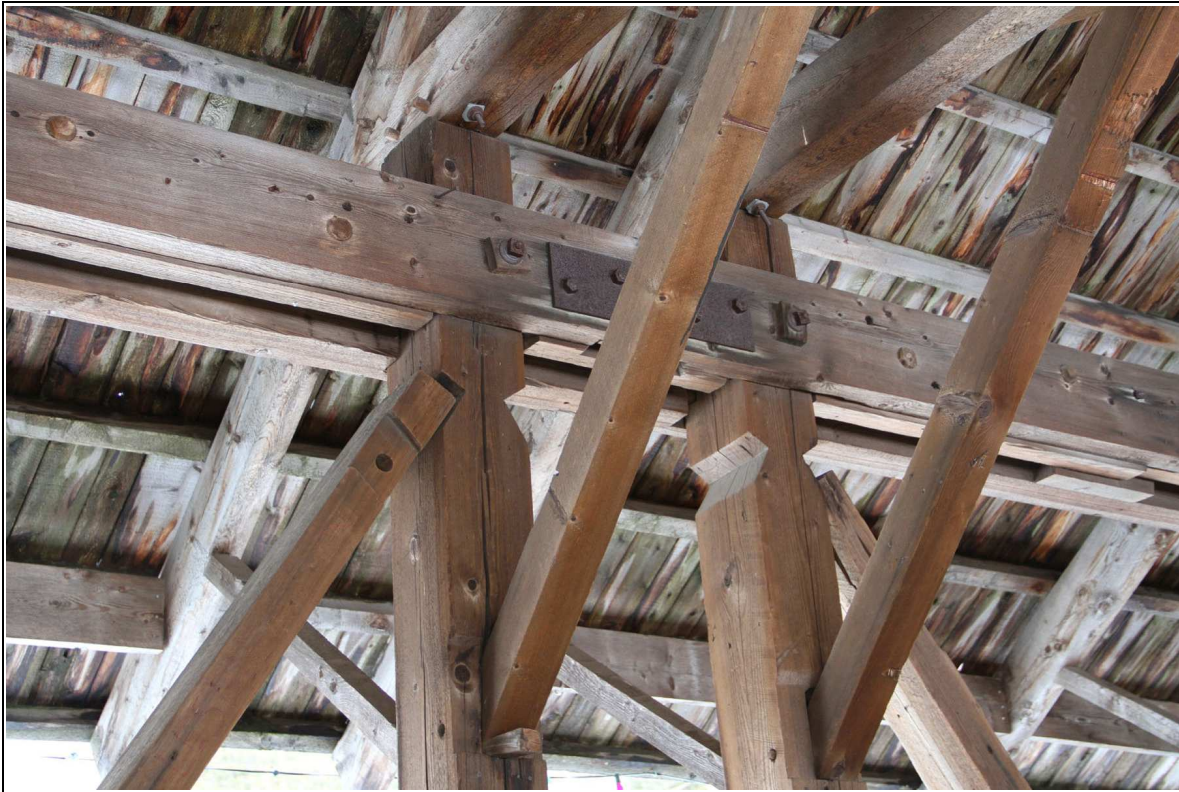
FIGURE: 4.4-7: Verticals at center of bridge moved from original location

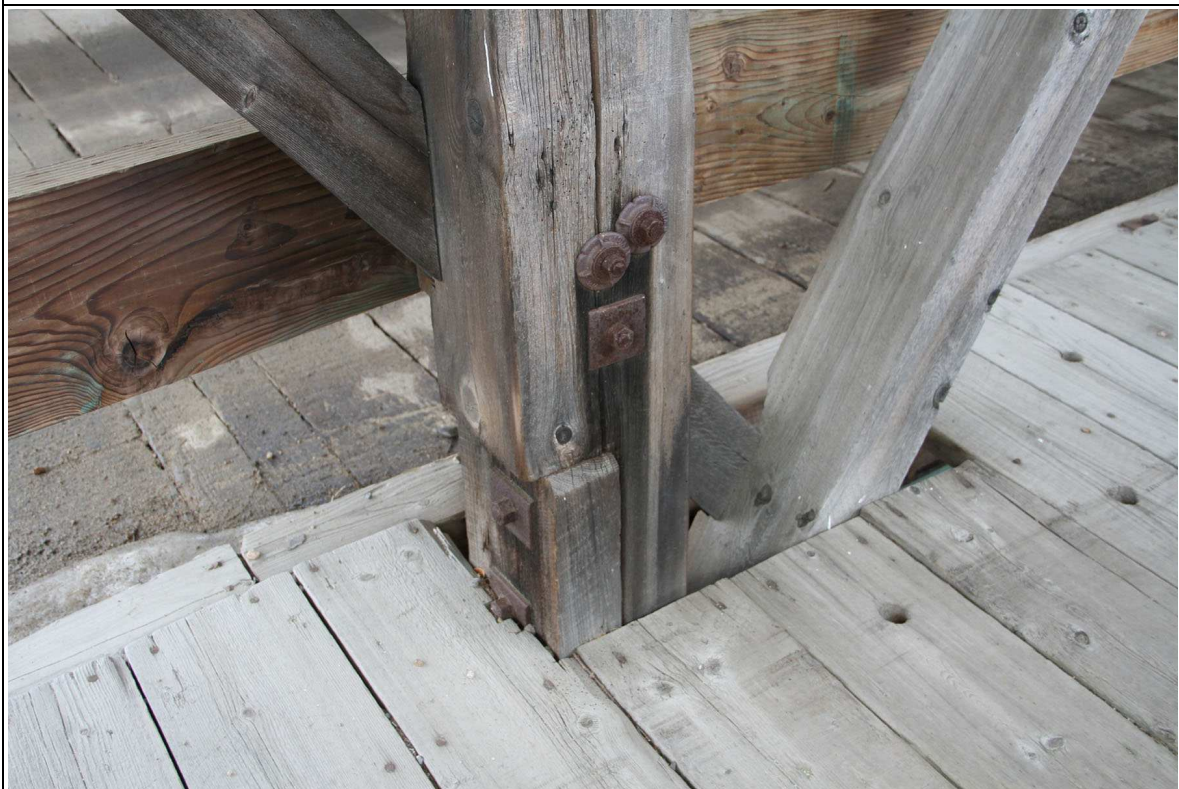
FIGURE: 4.4-8: Vertical with splice at bottom

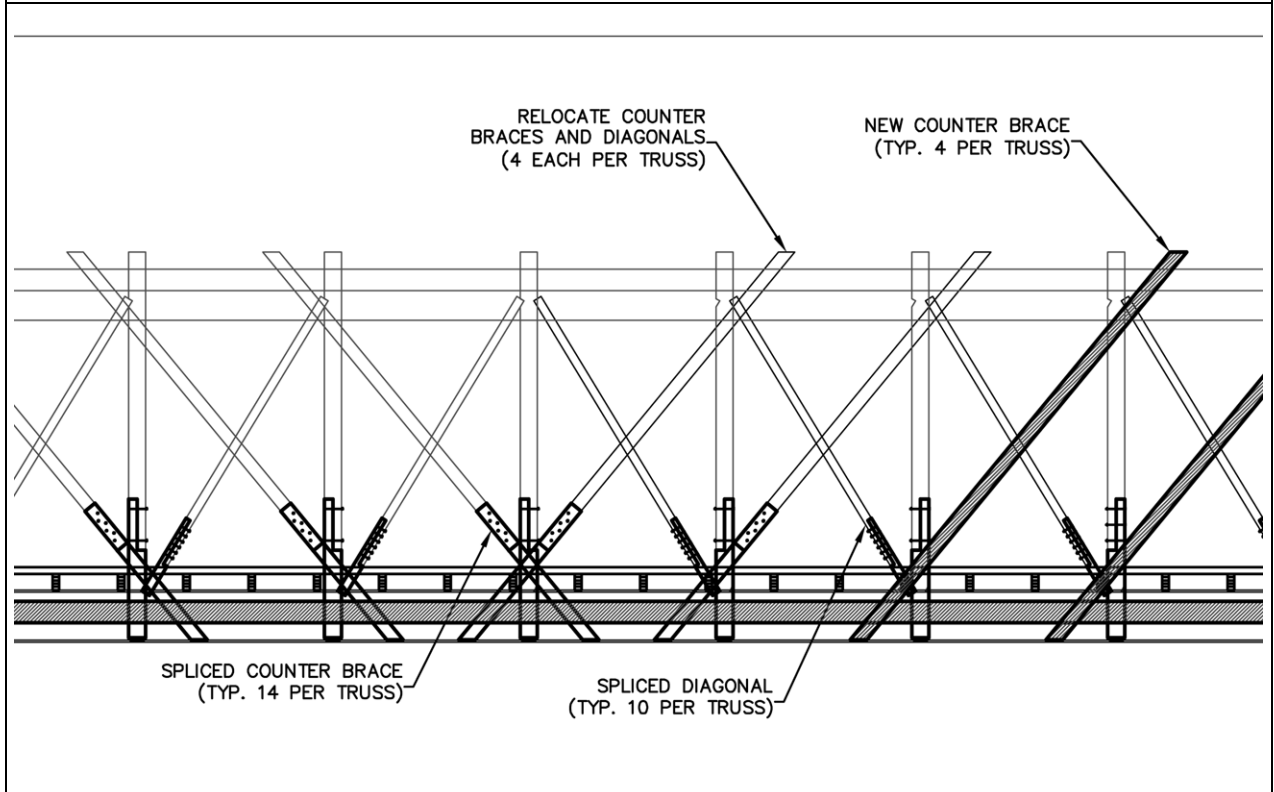
FIGURE: 4.5-2: Diagonal truss members, proposed repairs (source: HEB 2012)

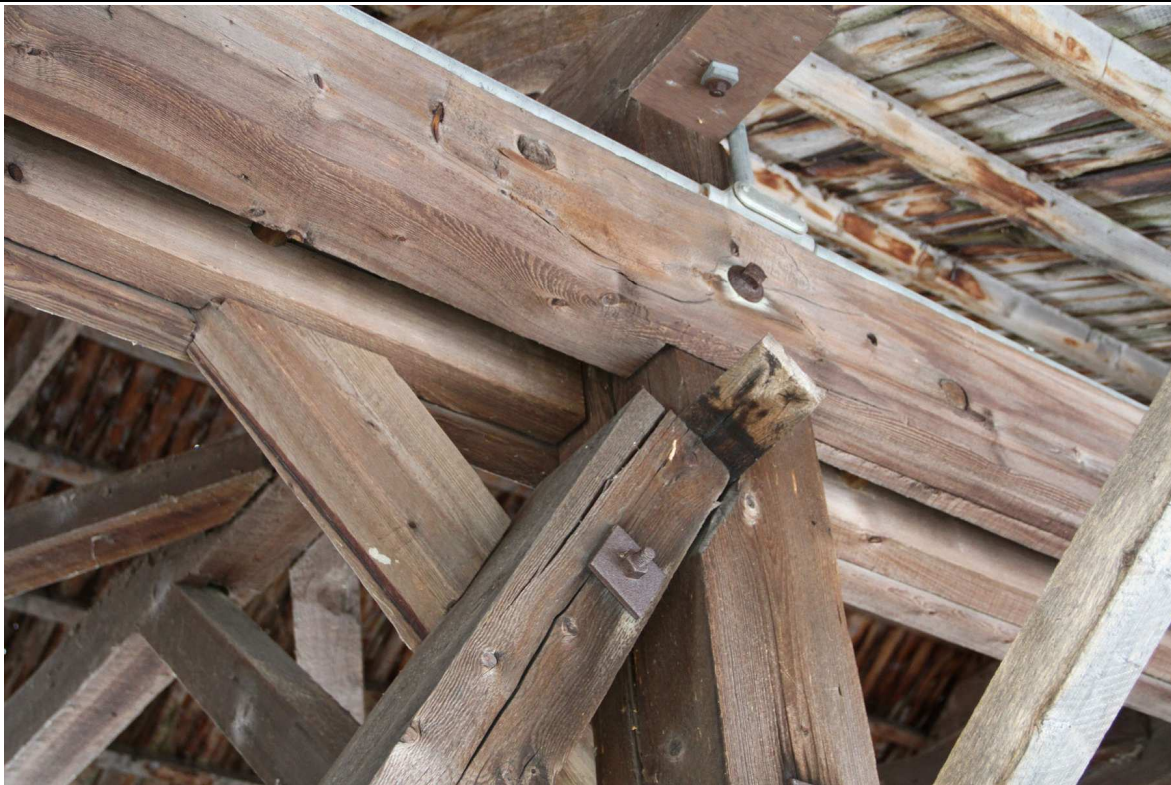
FIGURE: 4.5-4: Loose diagonal with spacer block inserted in open joint.

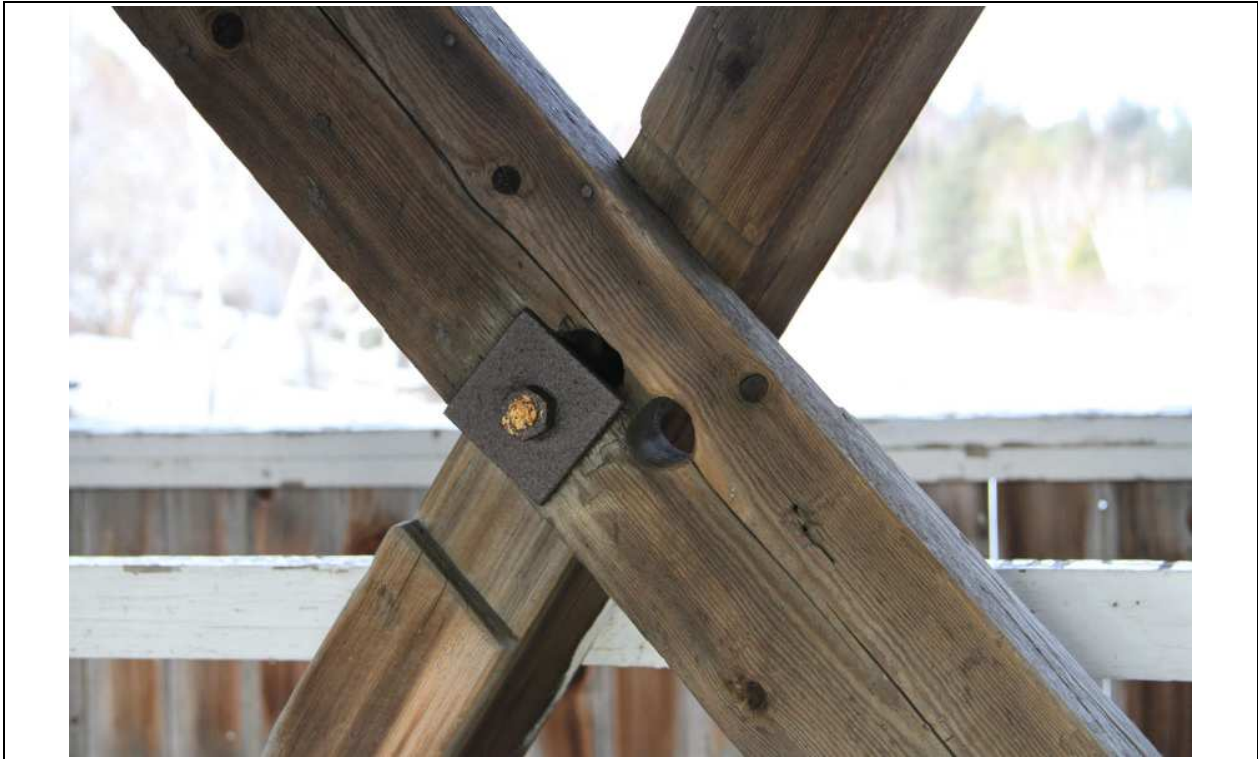
FIGURE: 4.5-5: Example of many diagonals that are bolted instead of pegged due to being misplaced and/or misaligned during previous reconstructions.

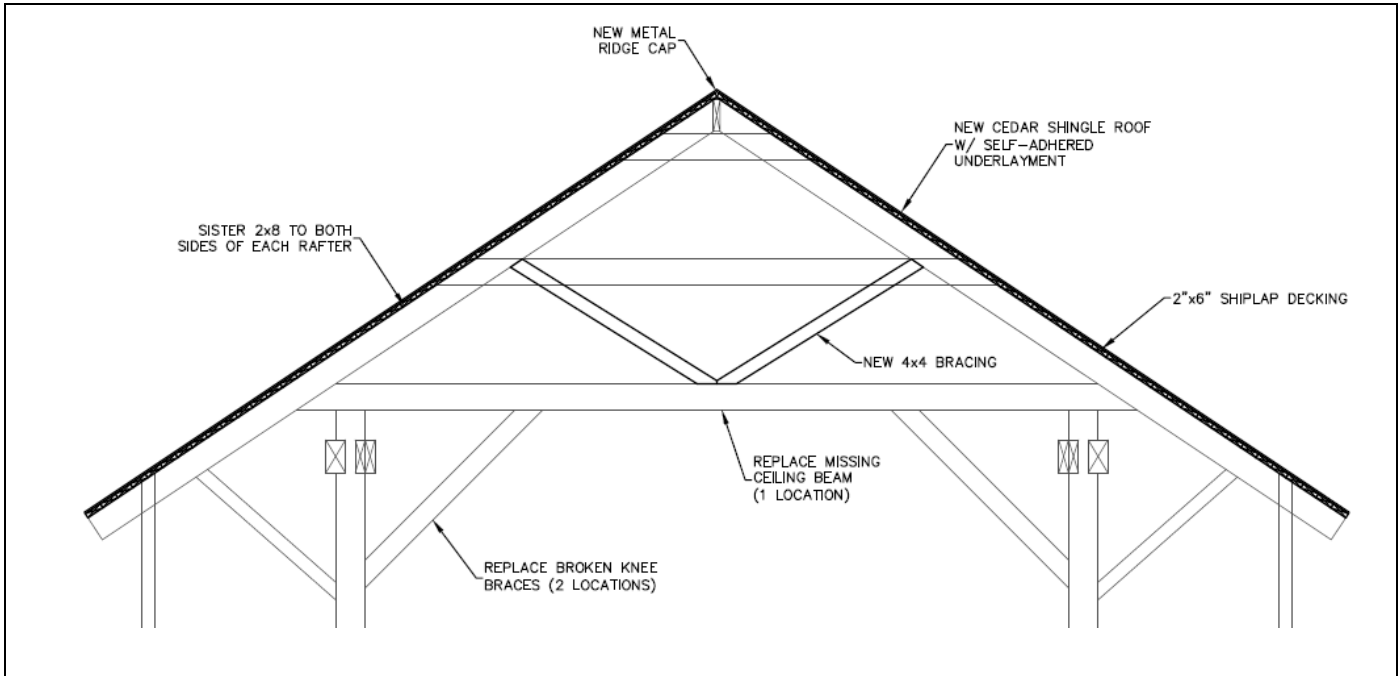
FIGURE: 4.7-2: Proposed repairs to roof system (source: HEB 2012)

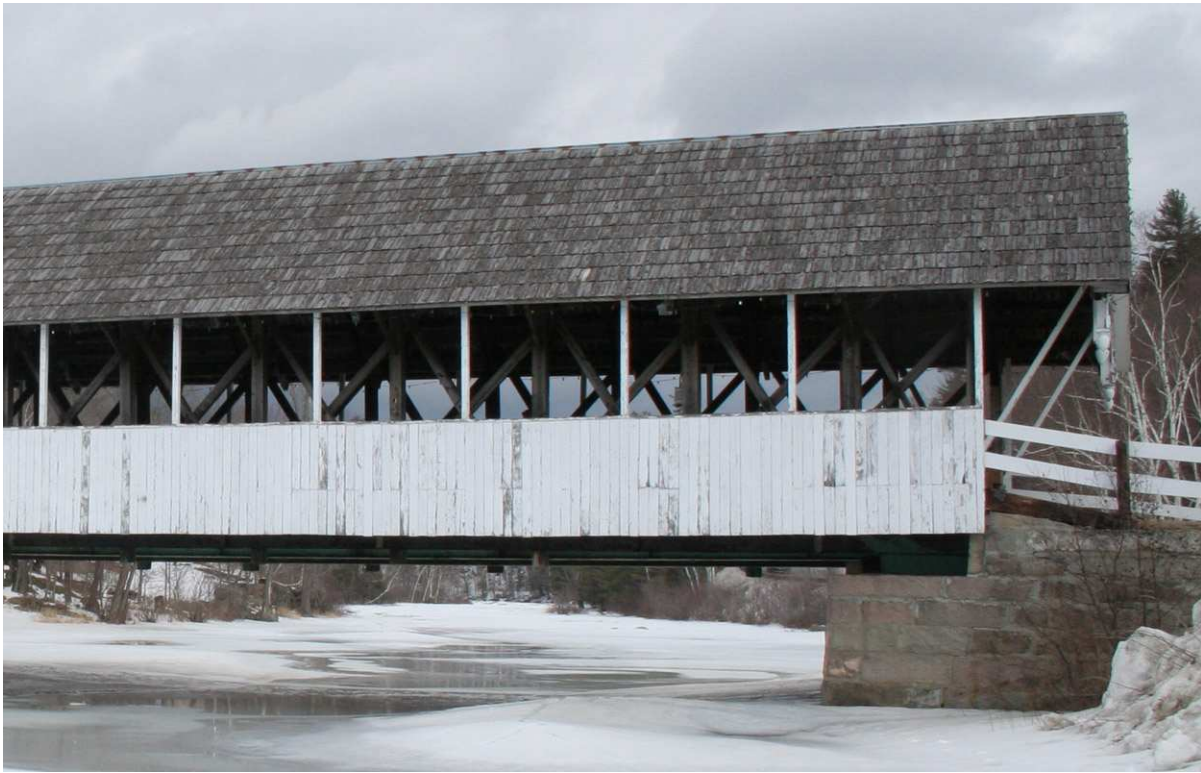
FIGURE: 4.7-5: Present wood shake roofing, installed 1981 and in poor condition.

- A. Remove and replace the existing wood shake roof
- B. Remove, replace, or strengthen deteriorated bridge members, including:
 - Replace roof rafters, as needed

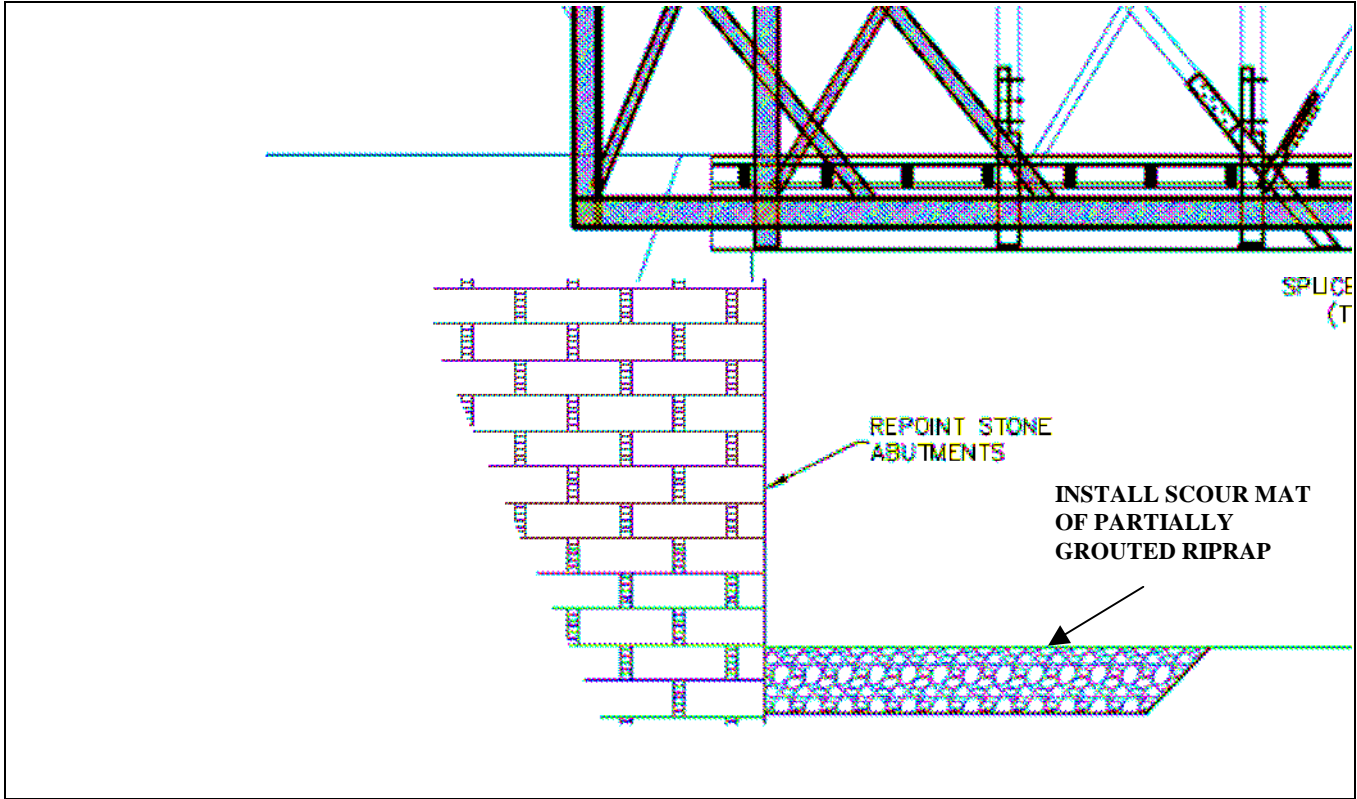
FIGURE: 4.10-1: Proposed rehab of stone abutments (source: HEB 2012).

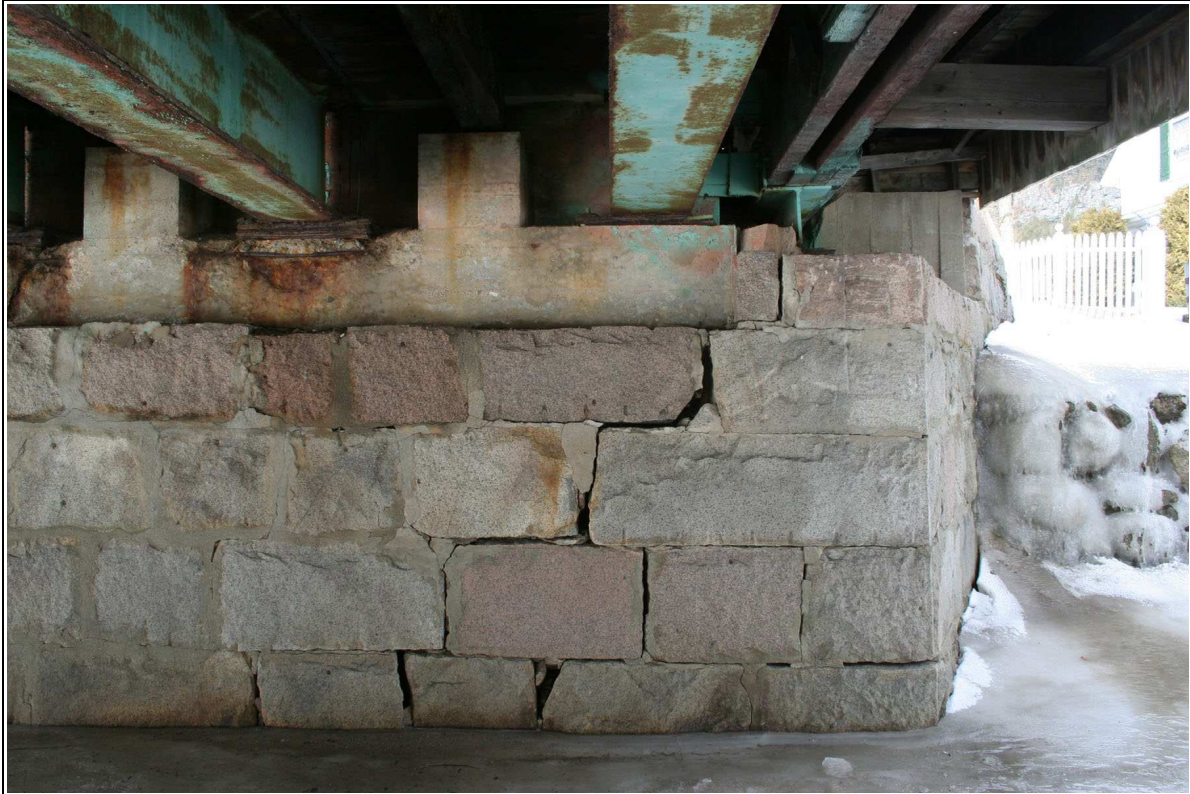
FIGURE: 4.10-3: North abutment, face showing opened joints at upstream corner.

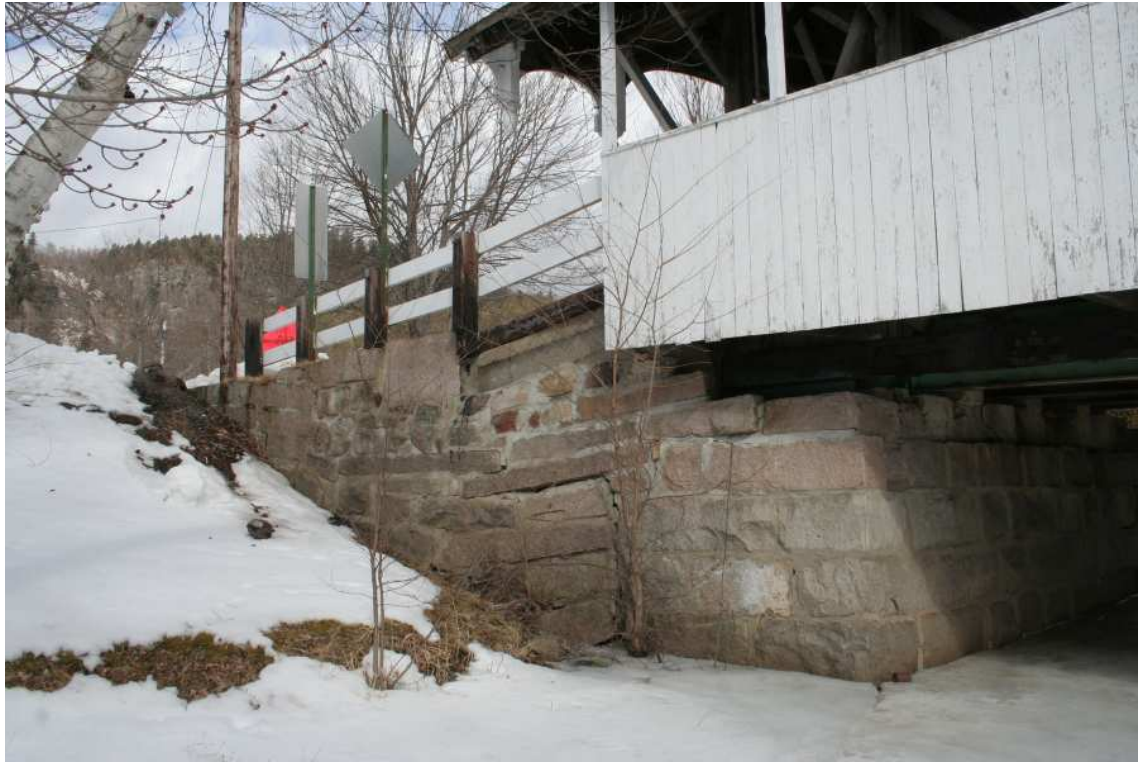
FIGURE: 4.10-5: North abutment, downstream corner and wingwall, showing settlement and fieldstone repairs.

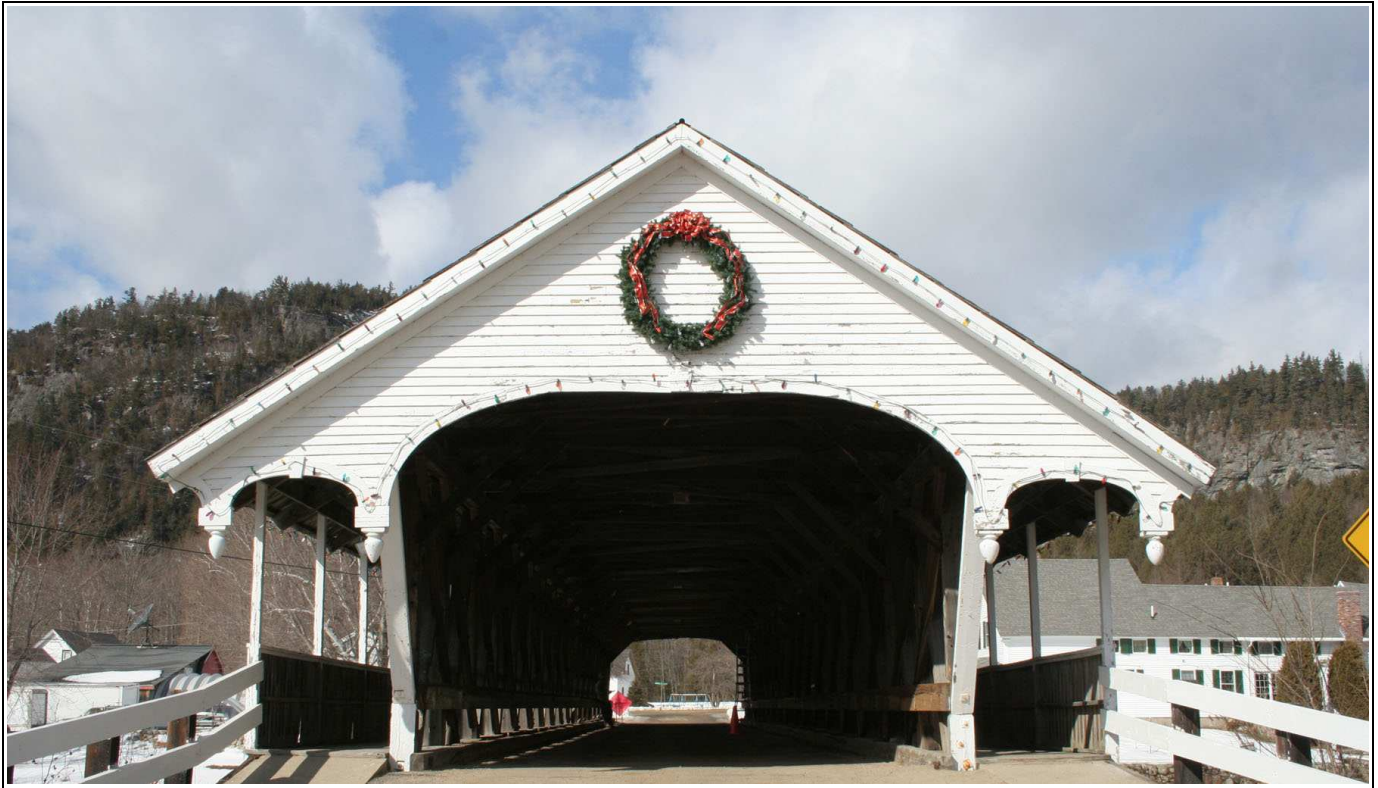
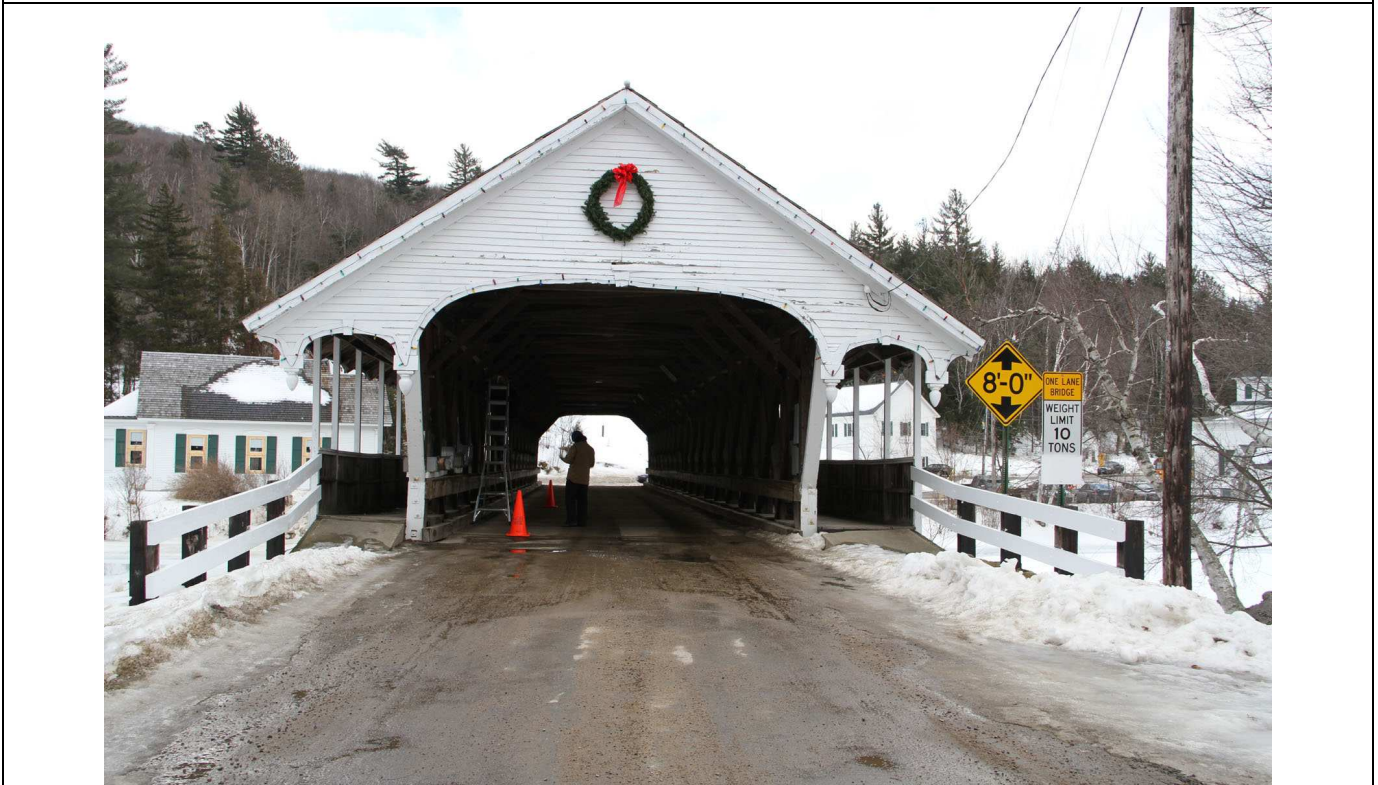
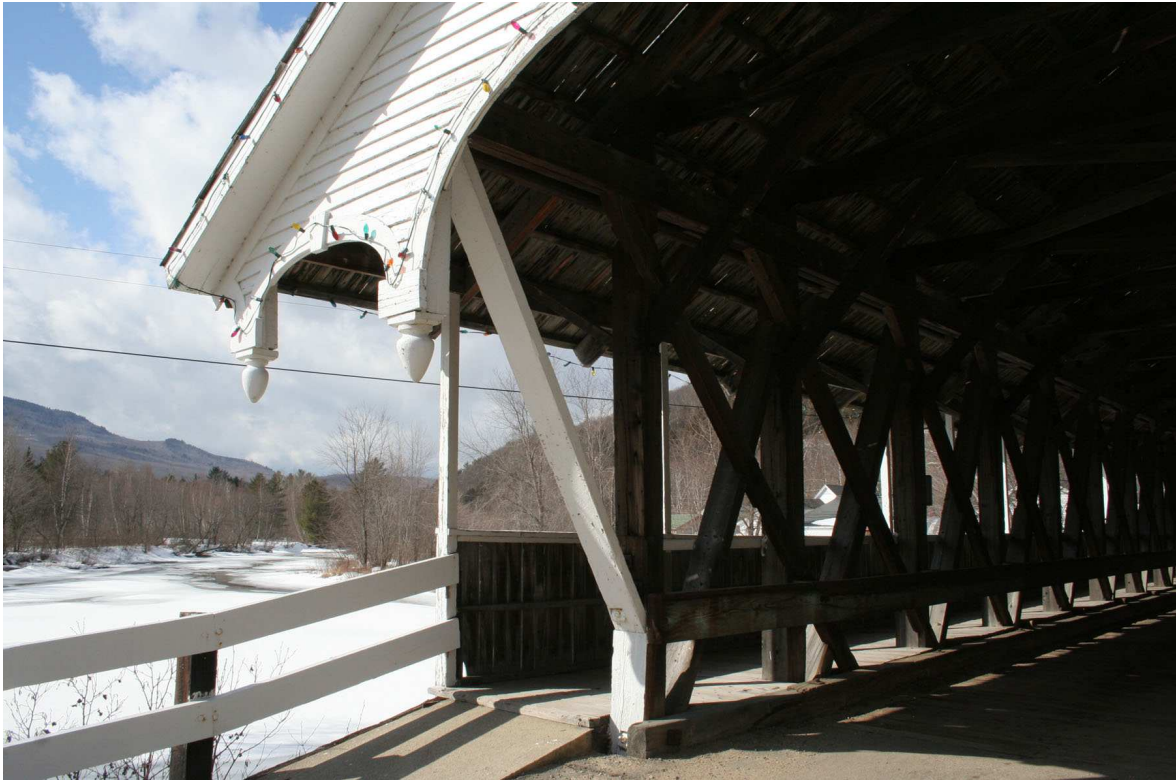
<p>Condition: The portal components are in good condition with the exception of peeling paint and several loose and cracked clapboards.</p>	
<p>Proposed Treatment: The portals will be stripped of paint, loose boards glued and refastened, and repainted.</p>	
<p>Project Need: The portals require the proposed maintenance to prevent further deterioration and extend service life.</p>	
<p>Impacts: The work impacts historic character-defining feature of the bridge. The proposed maintenance will be done in-kind and consistent with Secretary of the Interior's Standards for Rehabilitation (SOI Standards)</p>	
<p>Alternative Treatments Considered: None.</p>
