**TABLE OF OBSERVED FEATURES
 SURVEY AREA 1
 ORIGINAL MAIN LINE
 CONNECTICUT RIVER BRIDGE, WOODSVILLE TO
 LITTLETON
 (PHOTO KEYS FOLLOW TABLES)**

**PHOTOGRAPHS SURVEY AREA 1
ORIGINAL MAIN LINE
CONNECTICUT RIVER BRIDGE, WOODSVILLE TO
LITTLETON**

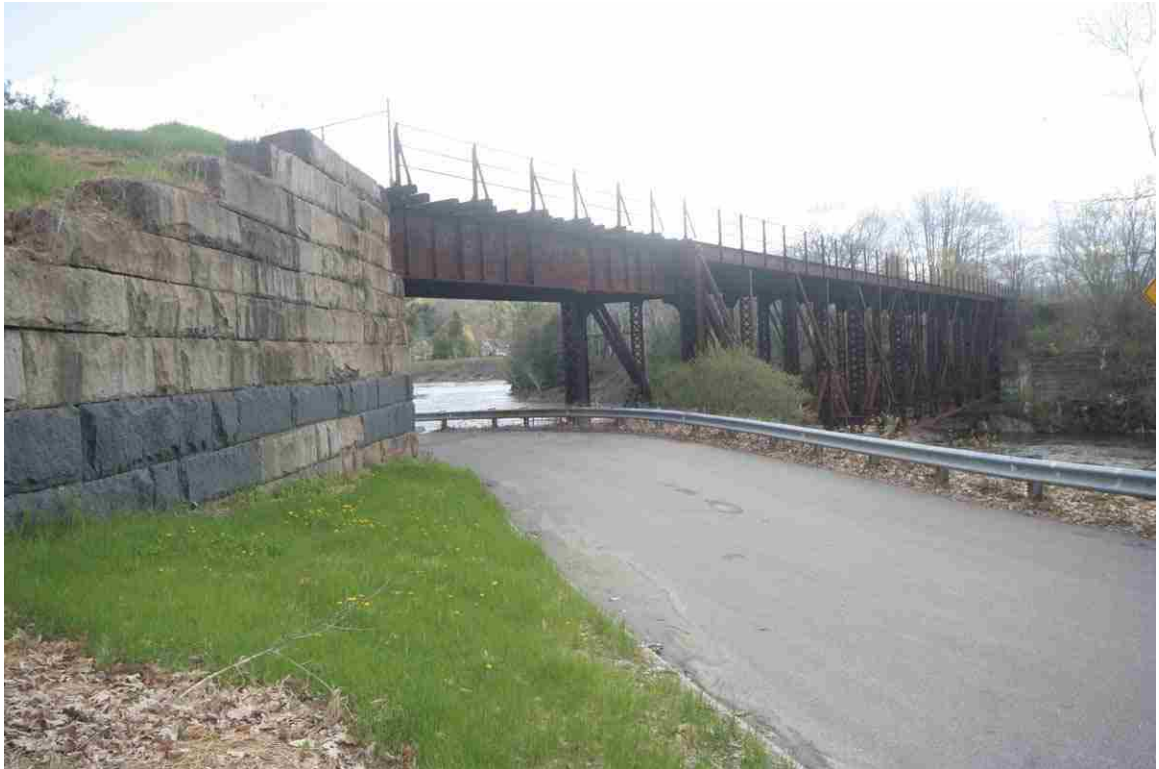
Photo # 1 description: Bridge 93.74 over Connecticut R. Bridge, Woodsville. Pin connected steel deck truss. Deck plate girder over Shaeffer Hill Rd. 1904.

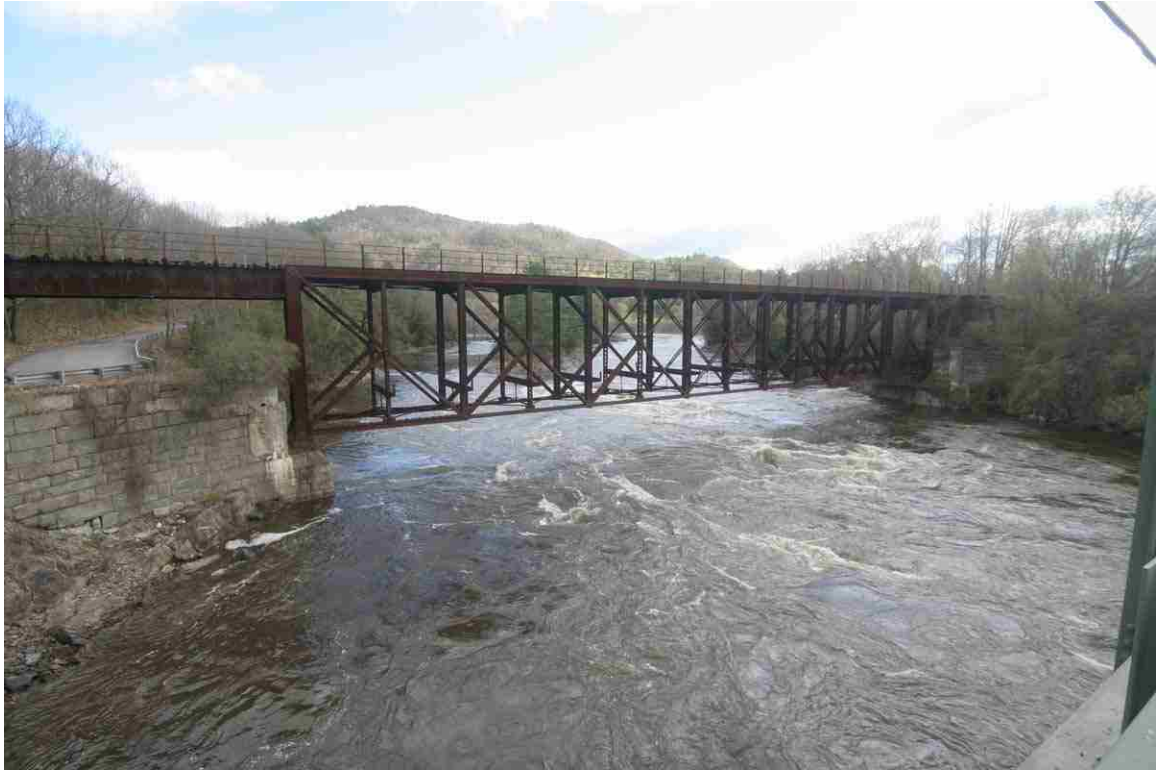
Photo # 2 description: Bridge 93.74 over Connecticut R. Bridge, Woodsville. Pin connected steel deck truss. Deck plate girder over Shaeffer Hill Rd. 1904.

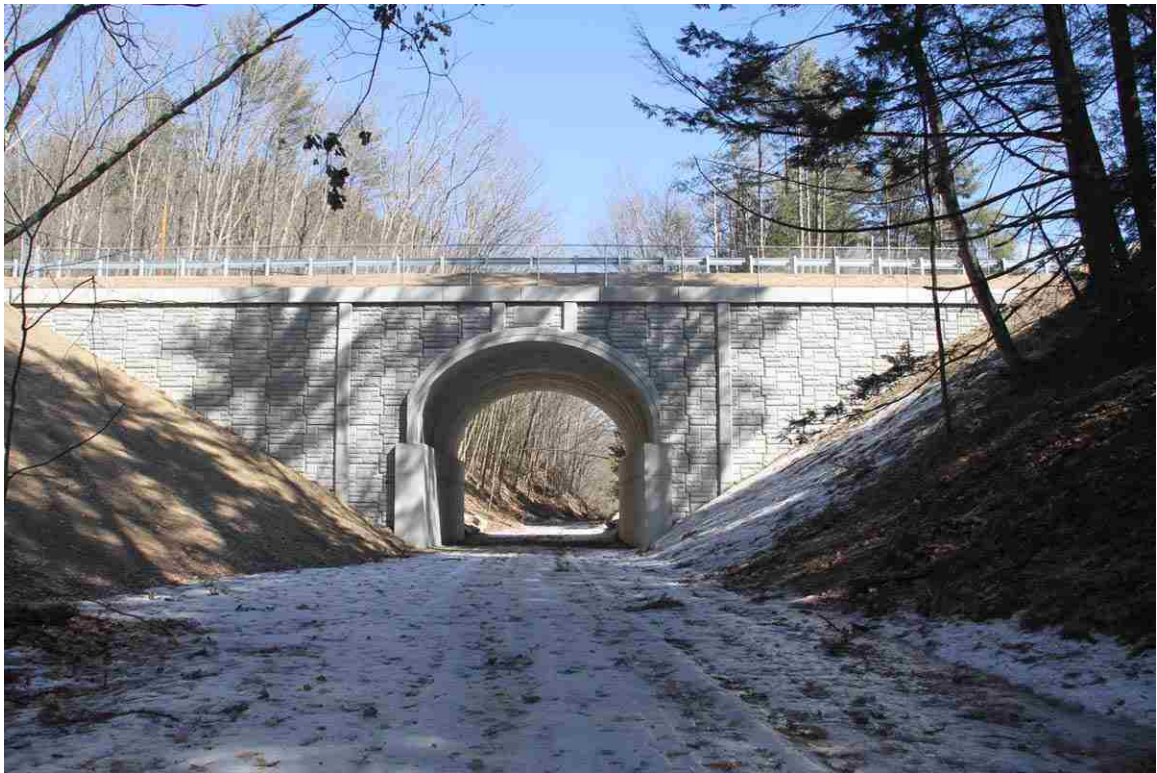
C. E. Randall Coal Pockets, Woodsville	93.70	Haverhill	N/C	12	c.1900	On Mill Street. Lack of integrity. Insufficient remaining features to identify the property type.
Mill Street underpass, Woodsville.	94.79	Haverhill	N/C	13	2018	New bridge. This report is part of the mitigation for the adverse effect of demolition of the prior Mill St. bridge.
Bridge No. 95.07 over Dartmouth College Rd., Woodsville.	95.07	Haverhill	C	14	1937	Steel deck plate girder on reinforced concrete abutments. B&M.
Culvert No. 95.57	95.57	Bath	C	15-16	?	Stone box.
Bridge No. 95.75	95.75	Bath	C	17-18	1930	Concrete slab. B&M
Mile marker No. 95.75	95.75	Bath	C	19	?	Concrete. Probably B&M, 1930.
Culvert No. 96.21	96.21	Bath	C	20	1924	Cast iron pipe, 18", concrete headwalls. B&M.
Culvert No. 96.27	96.27	Bath	C	21-22	1921	Railtop concrete slab, concrete encased stone walls. B&M
Bridge No. 96.52	96.52	Bath	C	23-24	1929	Precast concrete slab on stone walls. B&M

Photo # 12 description: C.E. Randall Coal Pockets, Mill St., Woodsville. Reinforced concrete. mp 93.70. c.1900.

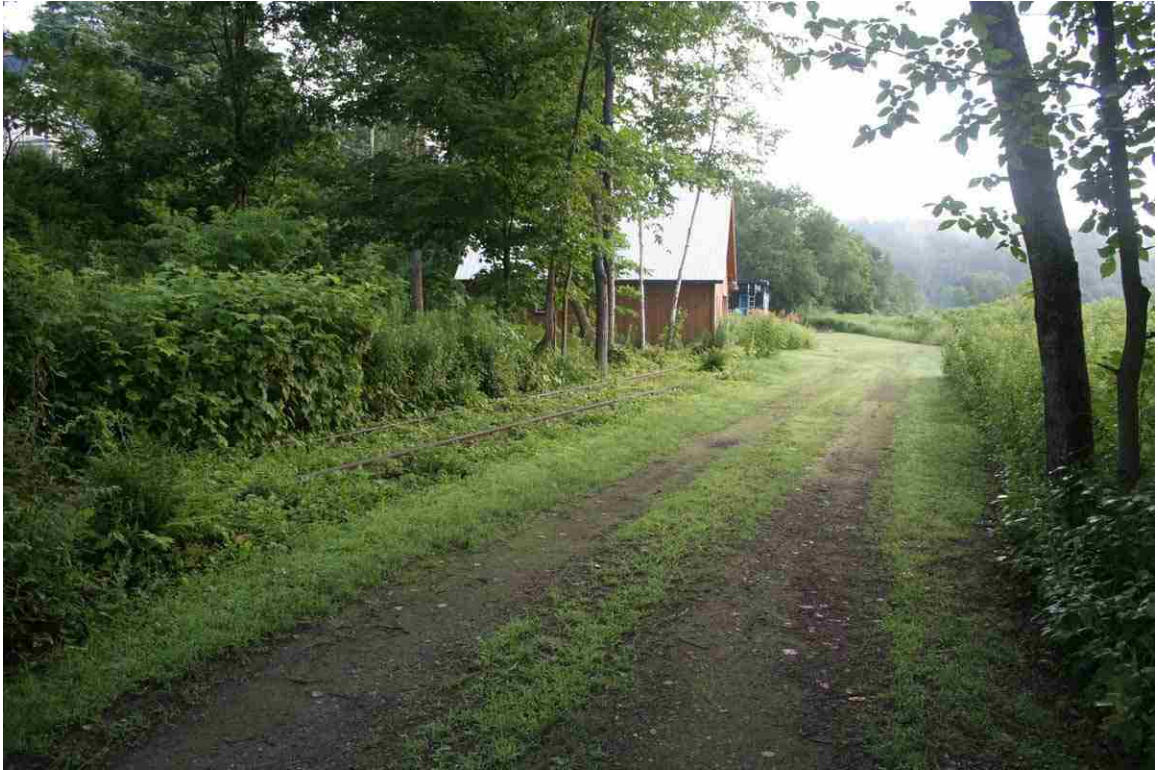
Photo # 32 description: Railbed passing under Bath Village Covered Bridge, showing timber bents added by railroad to lend additional structural support. mp 98.33. nd.

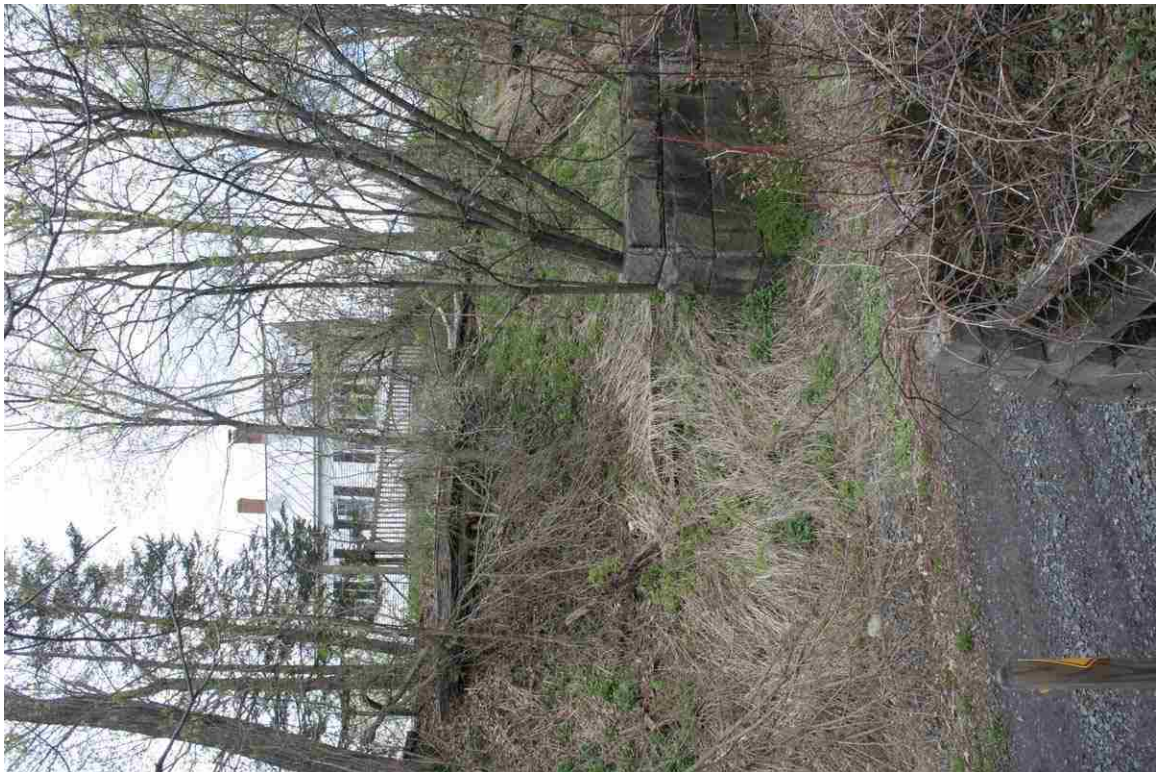
Photo # 41 description: Bridge 101.52, Bath. Granite pier footing and concrete cribbing remain from overhead framed wood trestle. 1899. Guardrail of US302/NH10 visible above. (1 of 3).

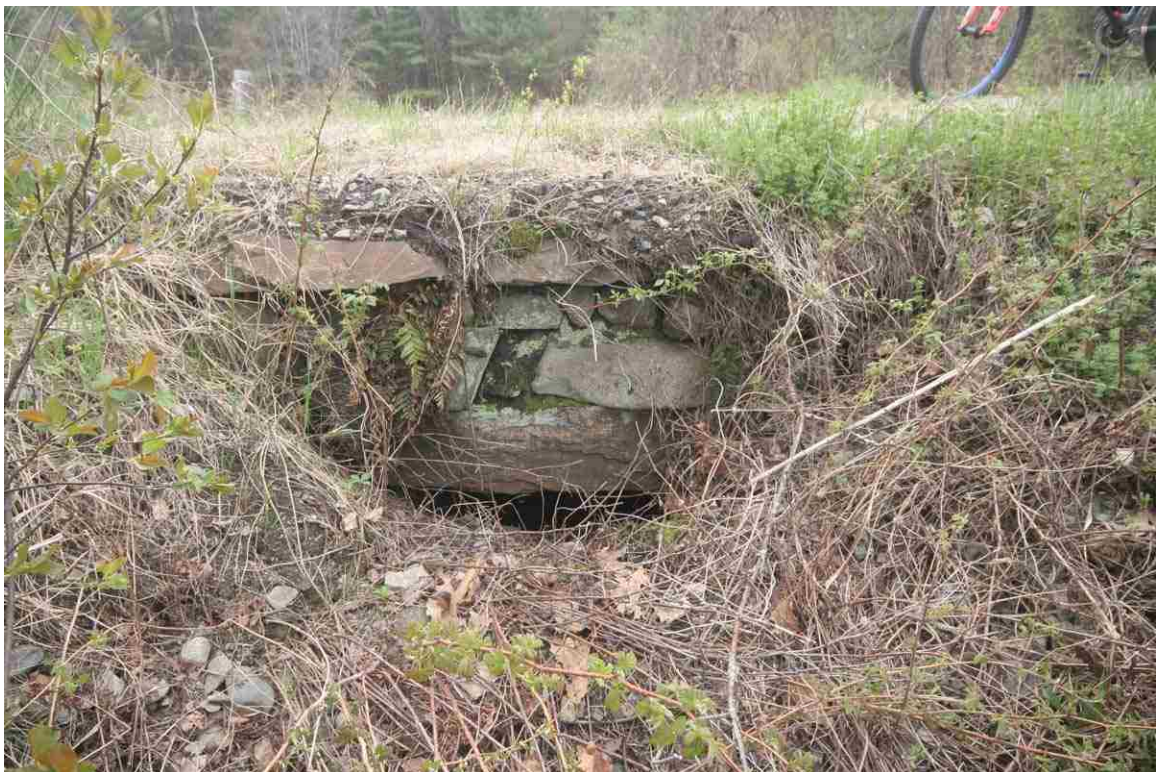
Photo # 71 description: Culvert No. 108.70, Lisbon. Concrete pipe, 5-6. nd. Concrete encased walls, probably replaced stone box. Outlet.

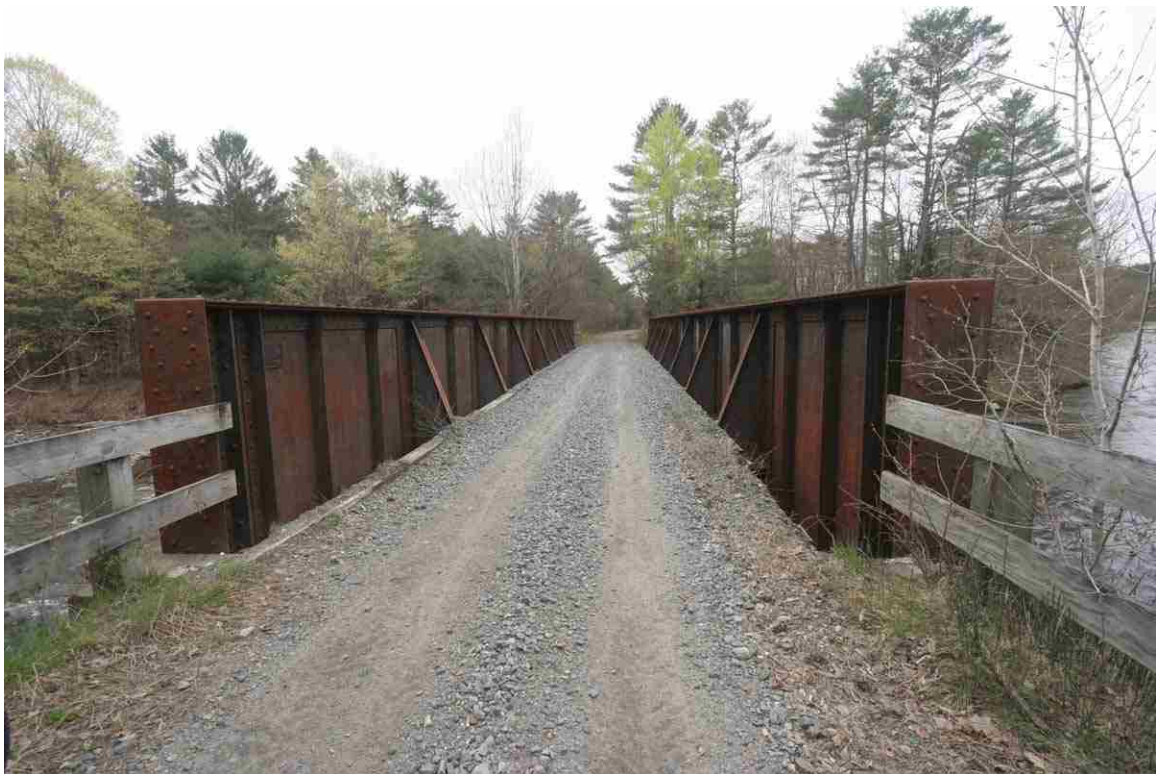
Photo # 75 description: Bridge 109.07, over Gale R., Lisbon. Steel thru plate girder, 92-10 span. 1929. (3 of 5).
Underside and new east concrete abutment joined to surviving stone abutment.
