**TABLE OF OBSERVED FEATURES  
 SURVEY AREA 4  
 WHITEFIELD-GROVETON LINE  
 PAGE ROAD, DALTON TO  
 SUMMER STREET, LANCASTER (COOS JUNCTION)**

**PHOTOGRAPHS  
SURVEY AREA 4  
PROFILE HOUSE BRANCH  
WHITEFIELD-GROVETON LINE  
PAGE ROAD, DALTON TO  
SUMMER STREET, LANCASTER (COOS JUNCTION)**

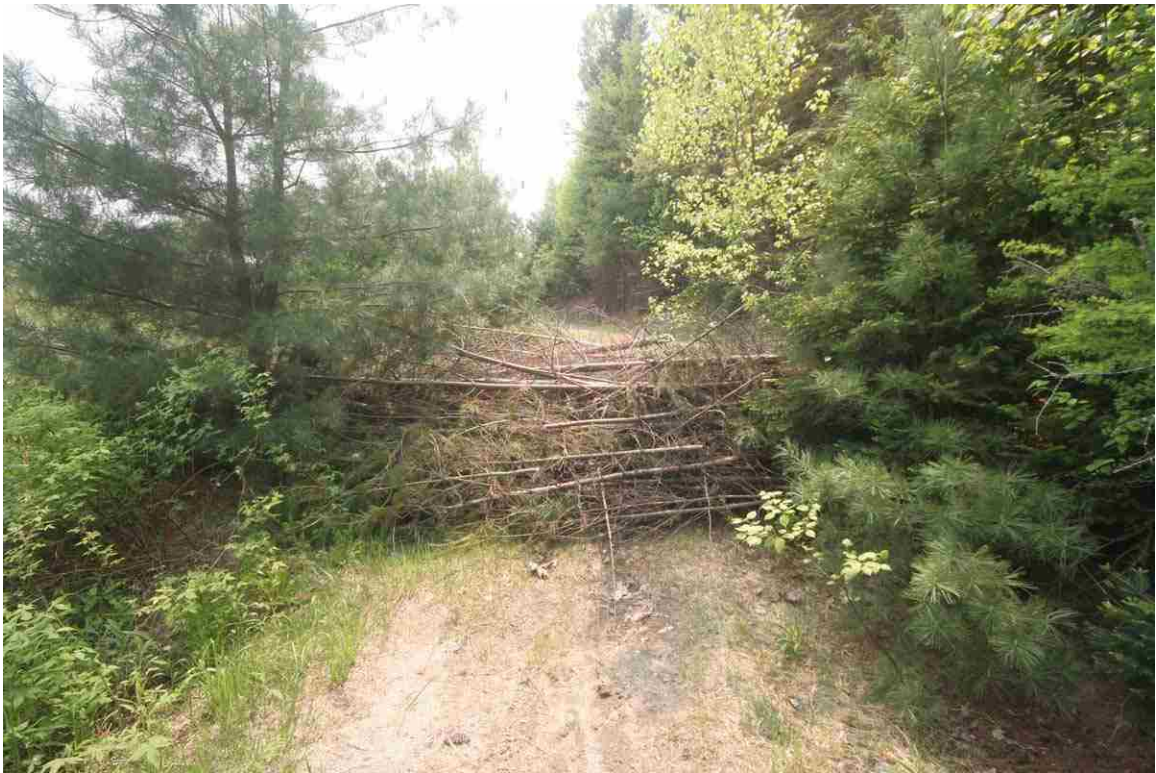
| Feature Name | Mile Post | Town | NR | Photo No. (s) | Date | Notes |
|---|---|---|---|---|---|---|
| South end of surveyed ROW at Page Road | ~126.70 | Dalton | N/C | 1 | ? | ROW barricaded. Page Rd. appears created from ROW |

Photo # 1 description: South end of surveyed ROW at Page Road, Dalton, mp~126.70. ROW ends with barricade of brush blocking access to Page Road, visible beyond. Page Rd. appears created from ROW.

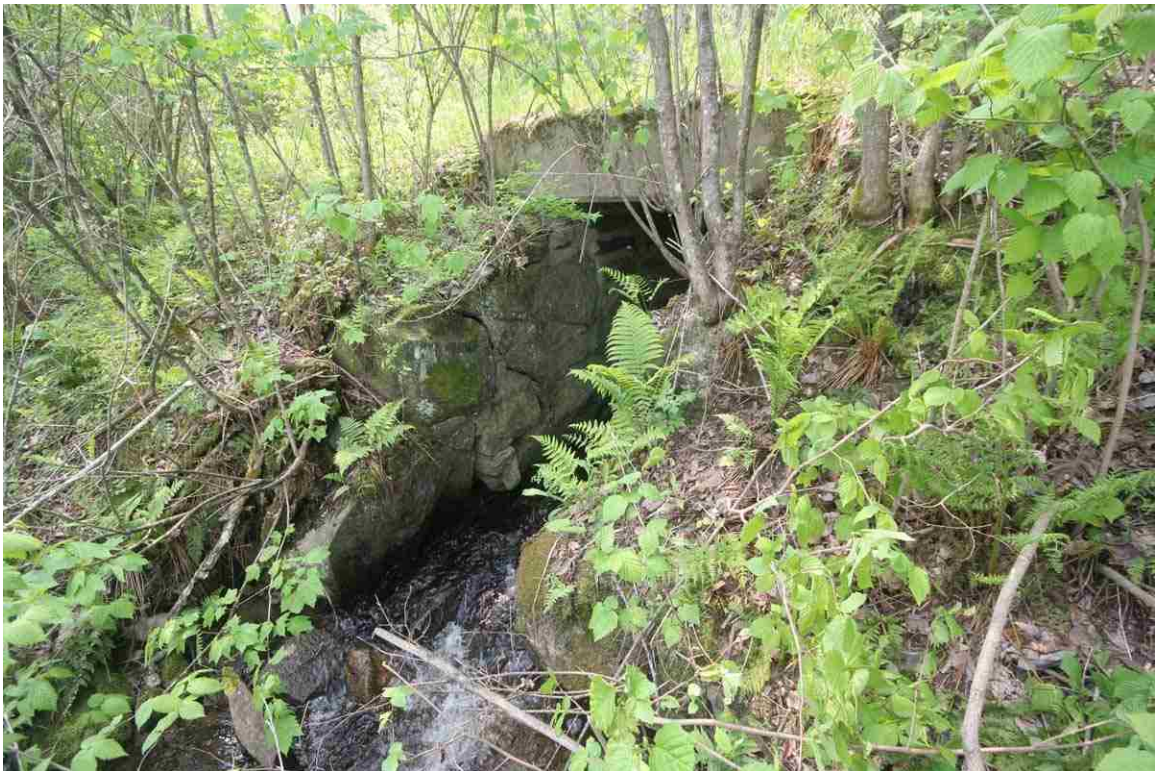
| Feature Name | Mile Post | Town | NR | Photo No. (s) | Date | Notes |
|---|---|---|---|---|---|---|
| Bridge No. 126.81, over unnamed stream | 126.81 | Dalton | C | 2-3 | ? | Concrete slab, 4' span, on split fieldstone abutments. |

Photo # 2 description: Bridge 126.81, over unnamed stream, Dalton. Concrete slab, 4' span, on split fieldstone abutments. nd. Downstream side. (1 of 2).

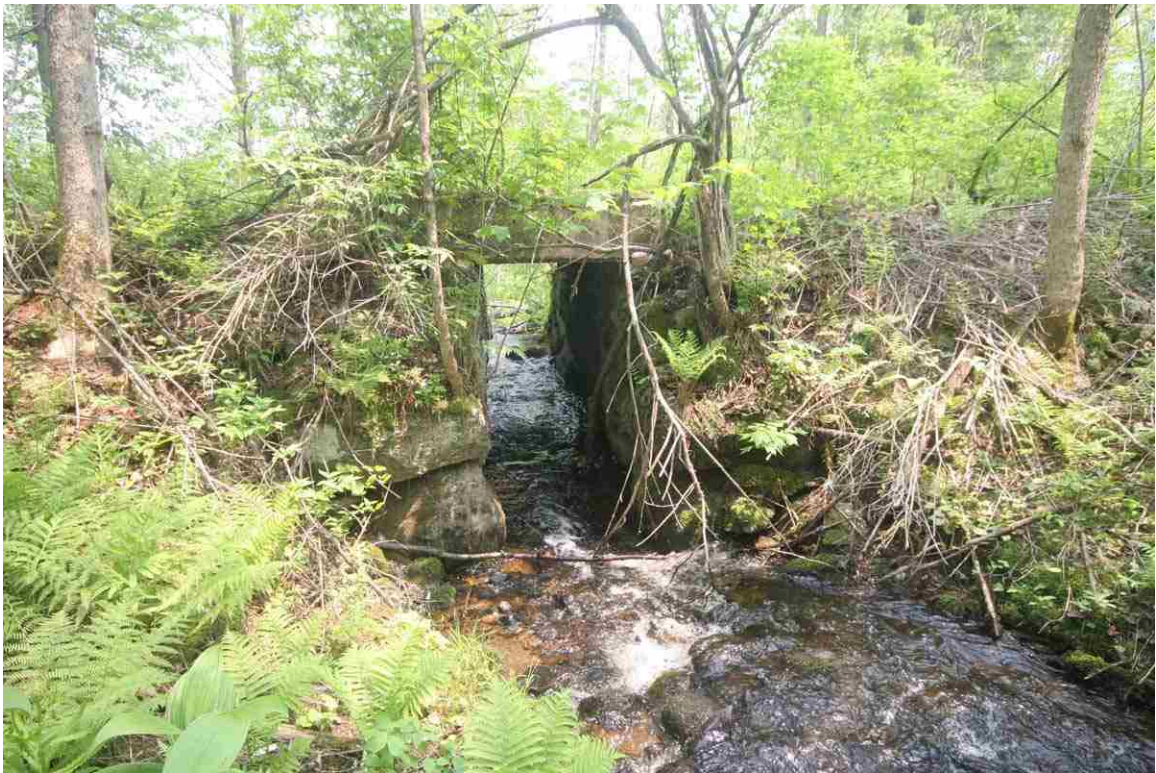
Photo # 3 description: Bridge 126.81. Upstream side. (2 of 2).

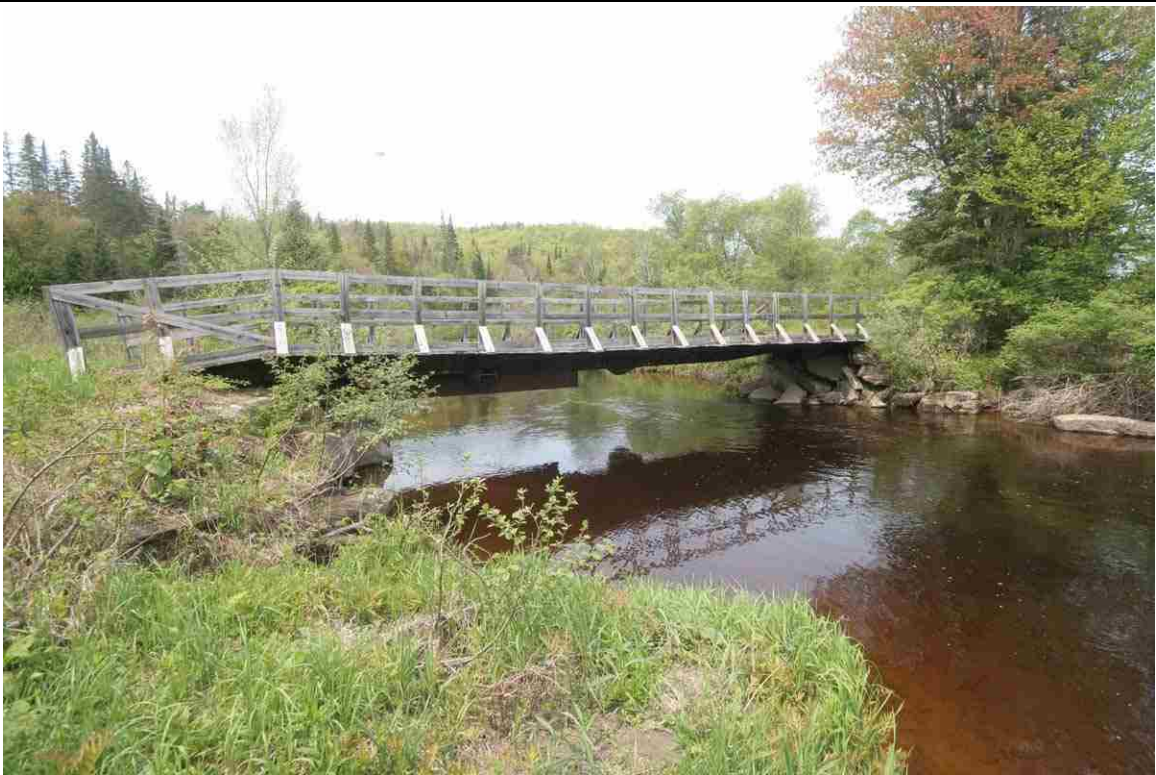
| Feature Name | Mile Post | Town | NR | Photo No. (s) | Date | Notes |
|---|---|---|---|---|---|---|
| Snowmobile Bridge over Johns River | 127.45 | Dalton | N/C | 6 | ? | Modern steel I-beam trail bridge replaced covered wood truss. Repaired & reconstructed stone abutments. |

Photo # 6 description: Snowmobile Bridge over Johns R., Dalton. mp 127.45. Modern improvised steel I-beam stringer for trail use replaced covered wood truss. Repaired/reconstructed stone abutments. nd.

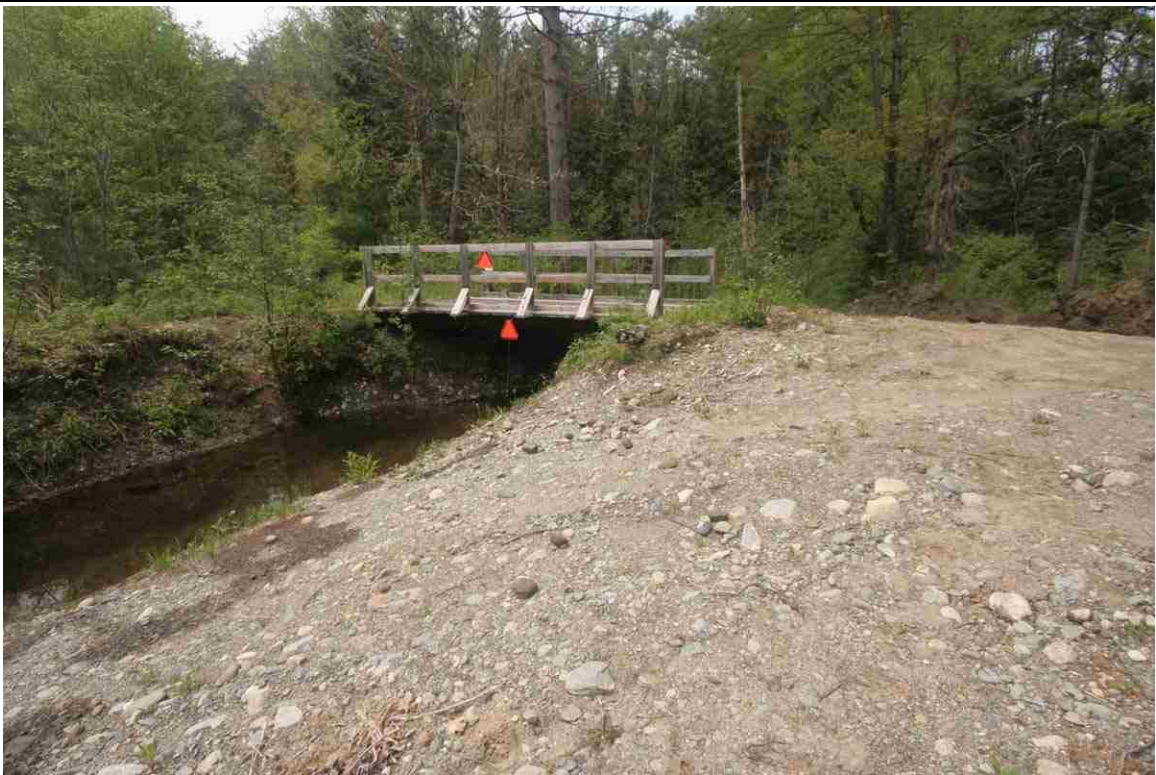
| Feature Name | Mile Post | Town | NR | Photo No. (s) | Date | Notes |
|---|---|---|---|---|---|---|
| Snowmobile Bridge, over unnamed stream. | 127.78 | Dalton | N/C | 8 | ? | Modern steel stringer on treated wood bearings. Replaced 12' pipe culvert. |

Photo # 8 description: Snowmobile Bridge, over unnamed stream, mp 127.78, Dalton. Modern steel stringer on treated wood bearings. Apparently replaced 12" pipe culvert formerly at this location.

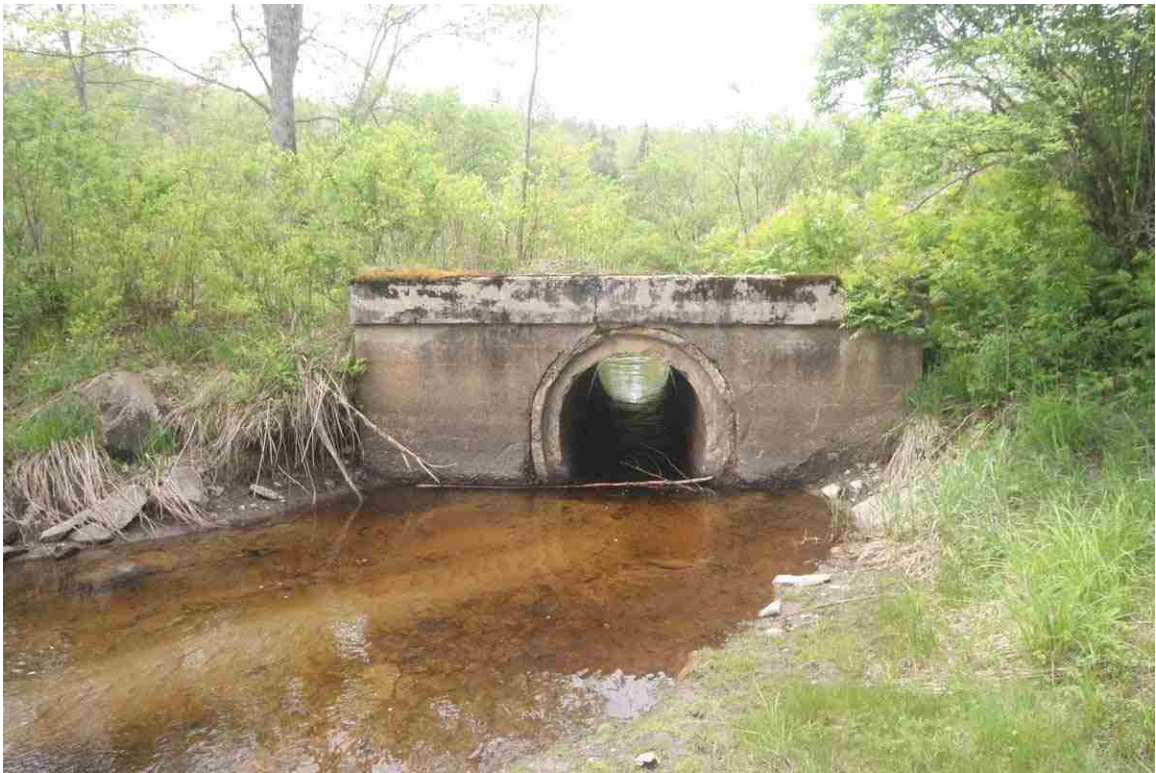
| Feature Name | Mile Post | Town | NR | Photo No. (s) | Date | Notes |
|---|---|---|---|---|---|---|
| Culvert No. 128.38 | 128.38 | Dalton | C | 11 | 1914 | Concrete pipe, 36", concrete headwalls. Good dated example of type. Replaced wood stringer span. |

Photo # 11 description: Culvert 128.38, Dalton. Concrete pipe, 36" with concrete headwalls. nd. Present in 1914; replaced a wood stringer span.

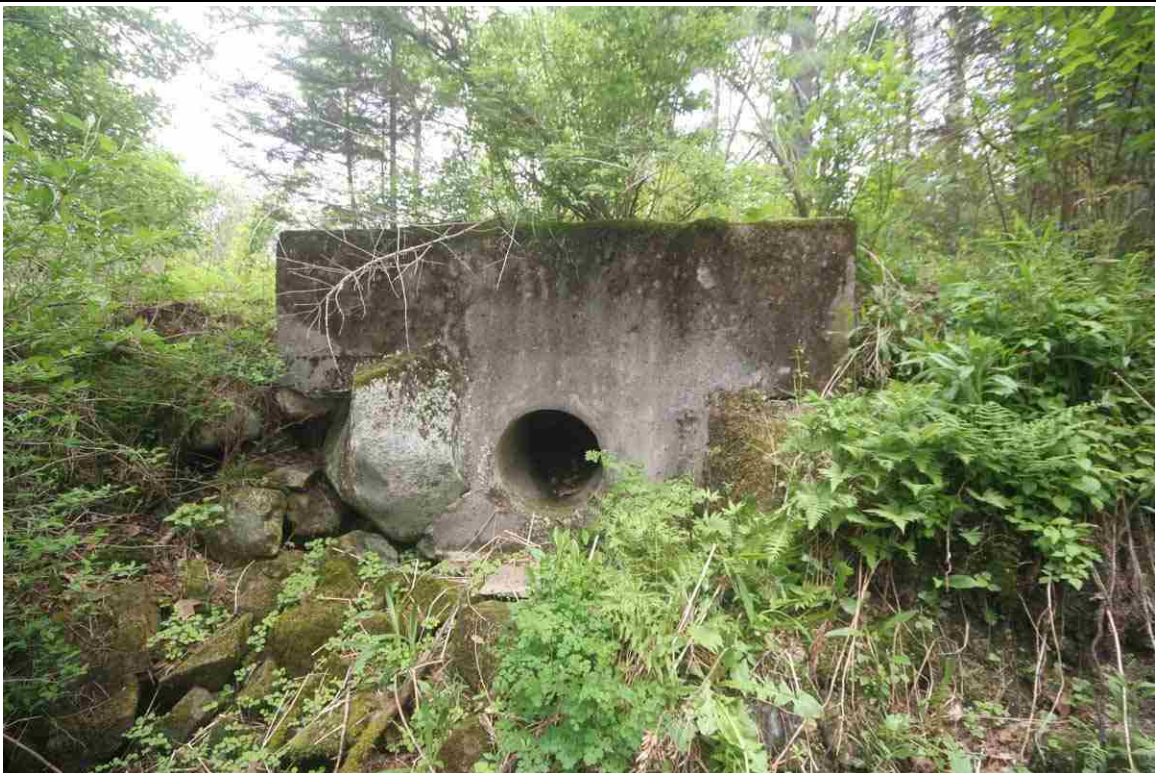
| Feature Name | Mile Post | Town | NR | Photo No. (s) | Date | Notes |
|---|---|---|---|---|---|---|
| Pipe Culvert | ~128.45 | Dalton | C | 14 | ? | Cast iron pipe, concrete headwalls. |

Photo # 14 description: Culvert 128.45, Dalton. Cast iron pipe, 18" with concrete headwalls. nd. Appears to have replaced a stone box culvert previously at this location.

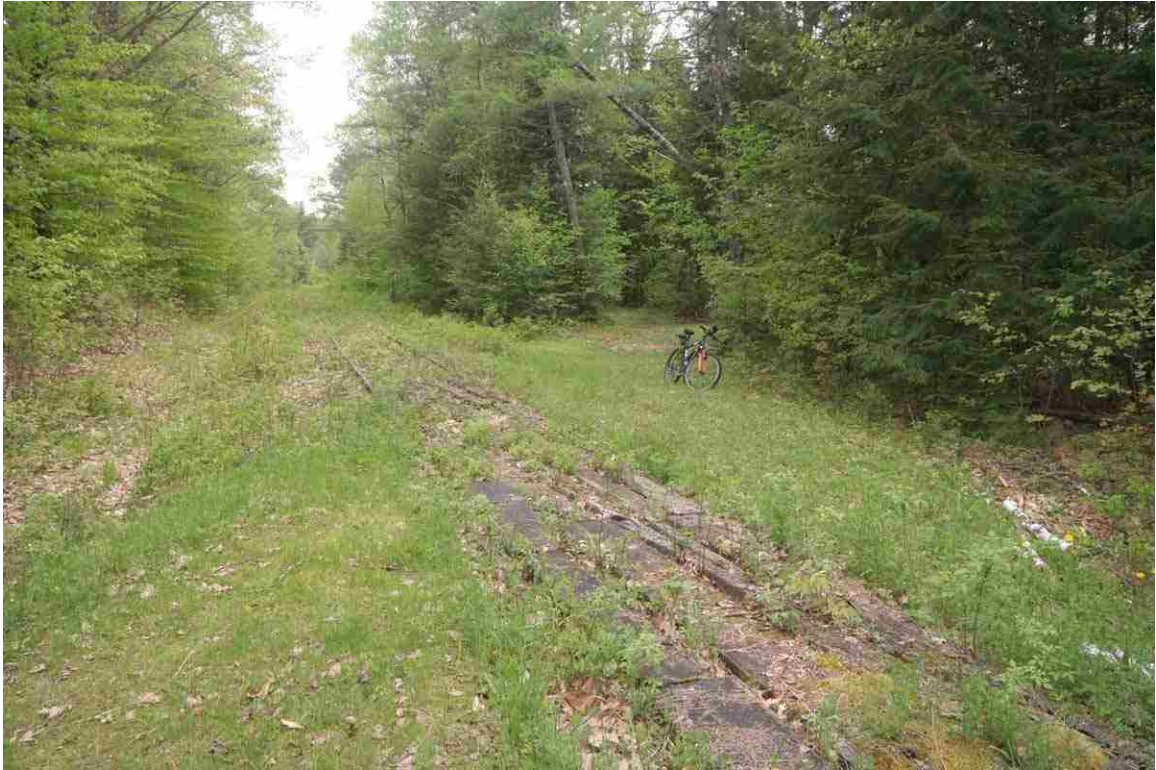
| Feature Name | Mile Post | Town | NR | Photo No. (s) | Date | Notes |
|---|---|---|---|---|---|---|
| Scotts Junction | 128.55 | Dalton | C | 15-16 | ? | B&M crossing MC. Track remnants remain. |

Photo # 15 description: Scotts Junction, 128.55, Dalton. Junction/crossover of MC line (tracks extant) and B&M, ROW running north into woods (past bicycle) to Lancaster. (1 of 2).

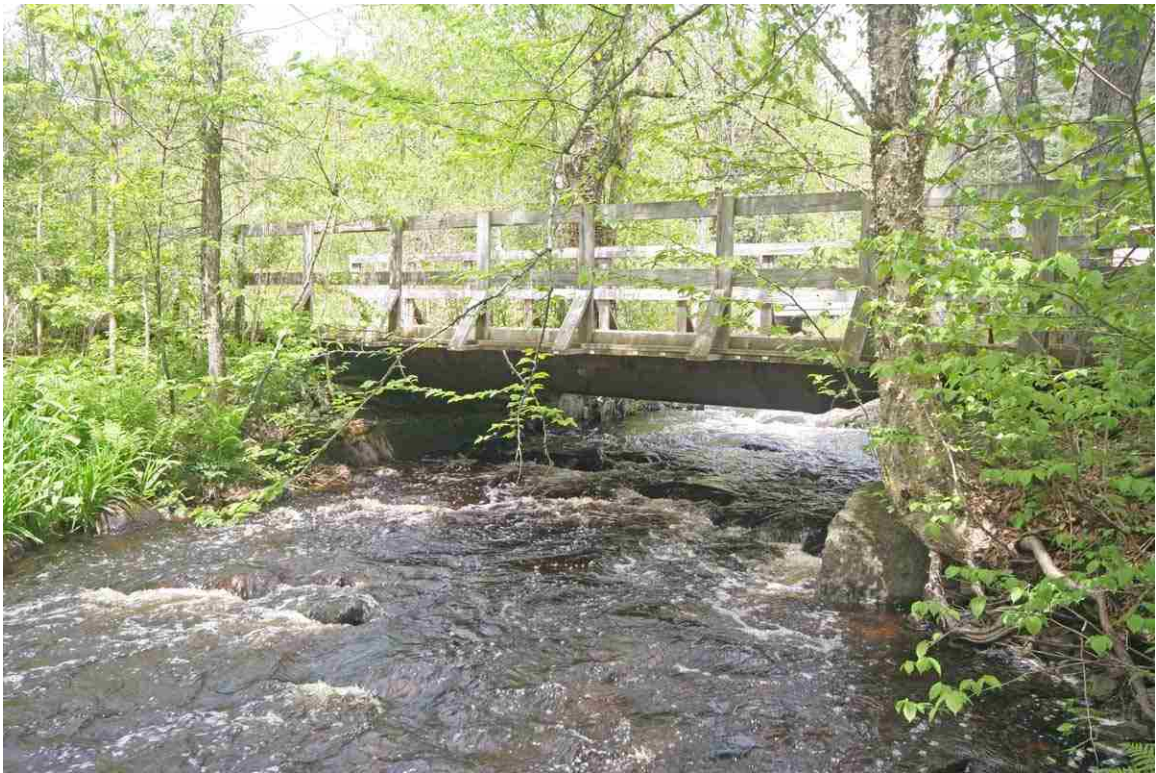
| Feature Name | Mile Post | Town | NR | Photo No. (s) | Date | Notes |
|---|---|---|---|---|---|---|
| Snowmobile Bridge, over unnamed stream | ~128.75 | Dalton | N/C | 19 | ? | Improvised steel stringer on split fieldstone abutments. |

Photo # 19 description: Snowmobile Bridge over unnamed stream, mp~128.75, Dalton. Improvised steel stringer bridge on split fieldstone abutments. nd.

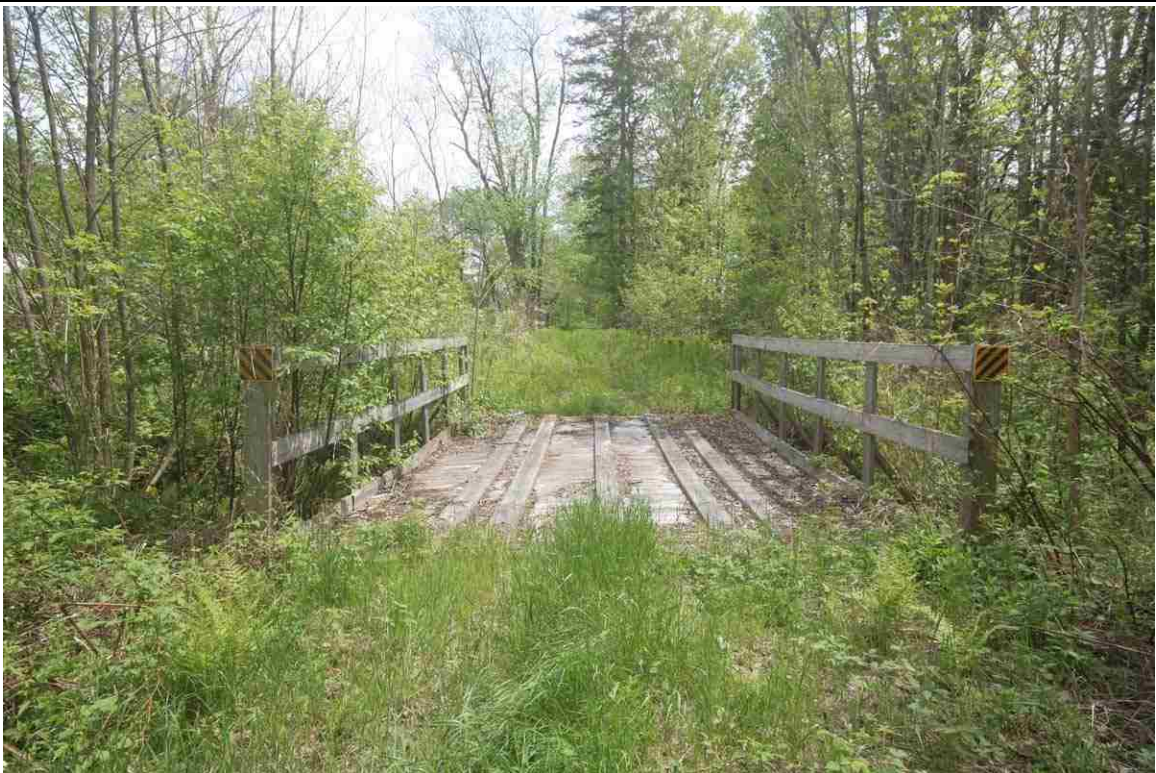
| Feature Name | Mile Post | Town | NR | Photo No. (s) | Date | Notes |
|---|---|---|---|---|---|---|
| Snowmobile Bridge, over unnamed stream | ~128.76 | Dalton | N/C | 20 | ? | Improvised steel stringer on split fieldstone abutments. |

Photo # 20 description: Snowmobile Bridge over unnamed stream, mp~128.76, Dalton. Improvised steel stringer on split fieldstone abutments. nd.

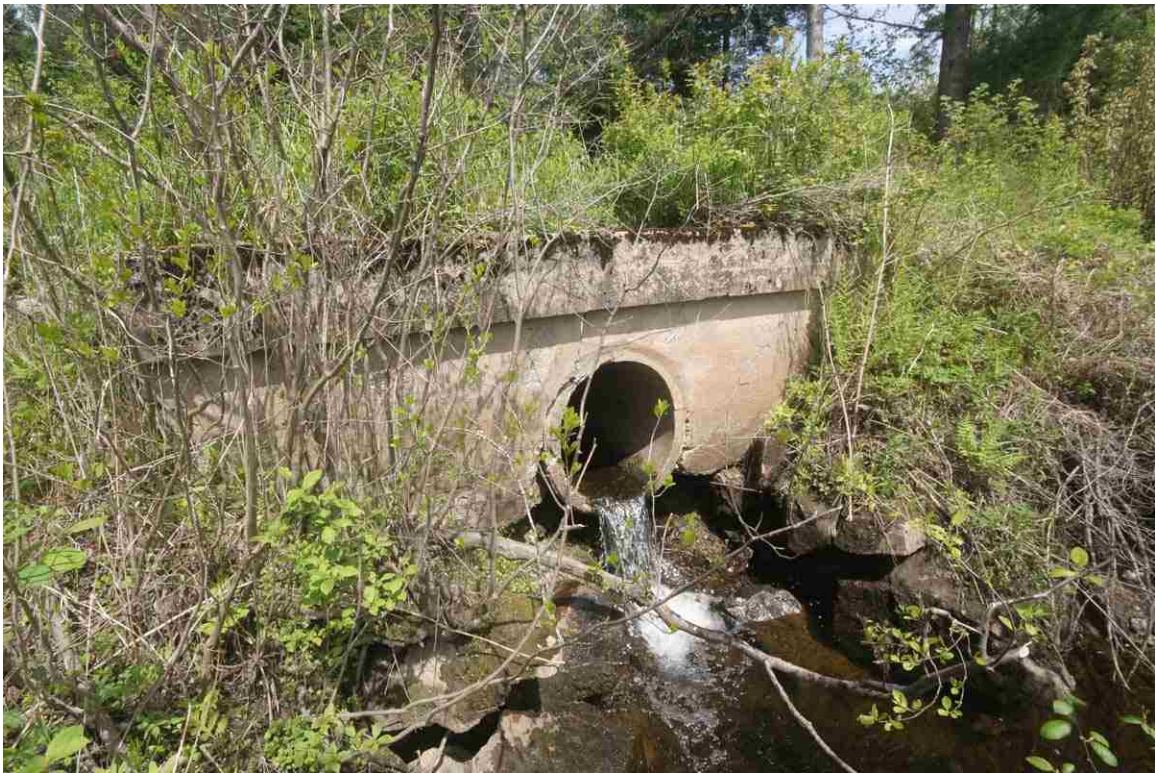
| Feature Name | Mile Post | Town | NR | Photo No. (s) | Date | Notes |
|---|---|---|---|---|---|---|
| Culvert No. 128.90 | 128.90 | Dalton | C | 21 | ? | Akron pipe, 30" with concrete headwalls. |

Photo # 21 description: Culvert 128.90, Dalton. Akron pipe, 30" with concrete headwalls. nd.

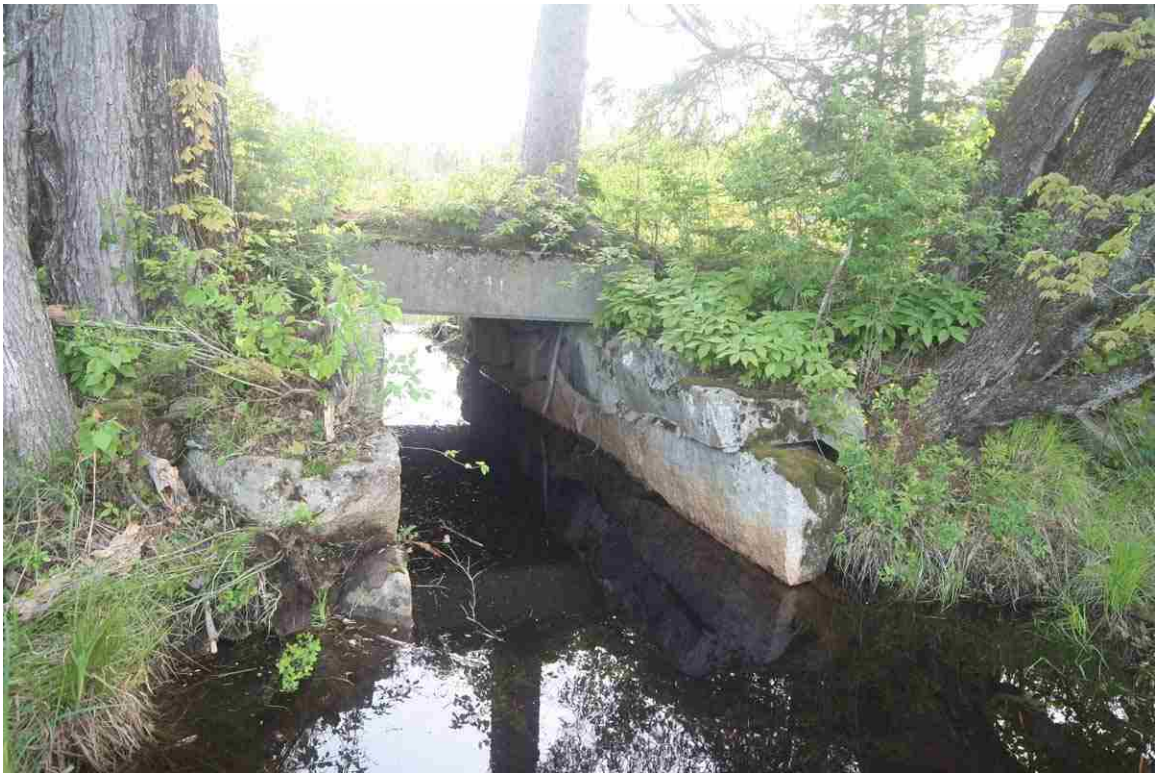
| Feature Name | Mile Post | Town | NR | Photo No. (s) | Date | Notes |
|---|---|---|---|---|---|---|
| Bridge No. 129.13 over unnamed stream. | 129.13 | Dalton | C | 23 | ? | Concrete slab, ~5' span, split quarry and fieldstone abutments. |

Photo # 23 description: Bridge 129.13 over unnamed stream, Dalton. Concrete slab, ~5' span, on split quarry and fieldstone abutments. nd.

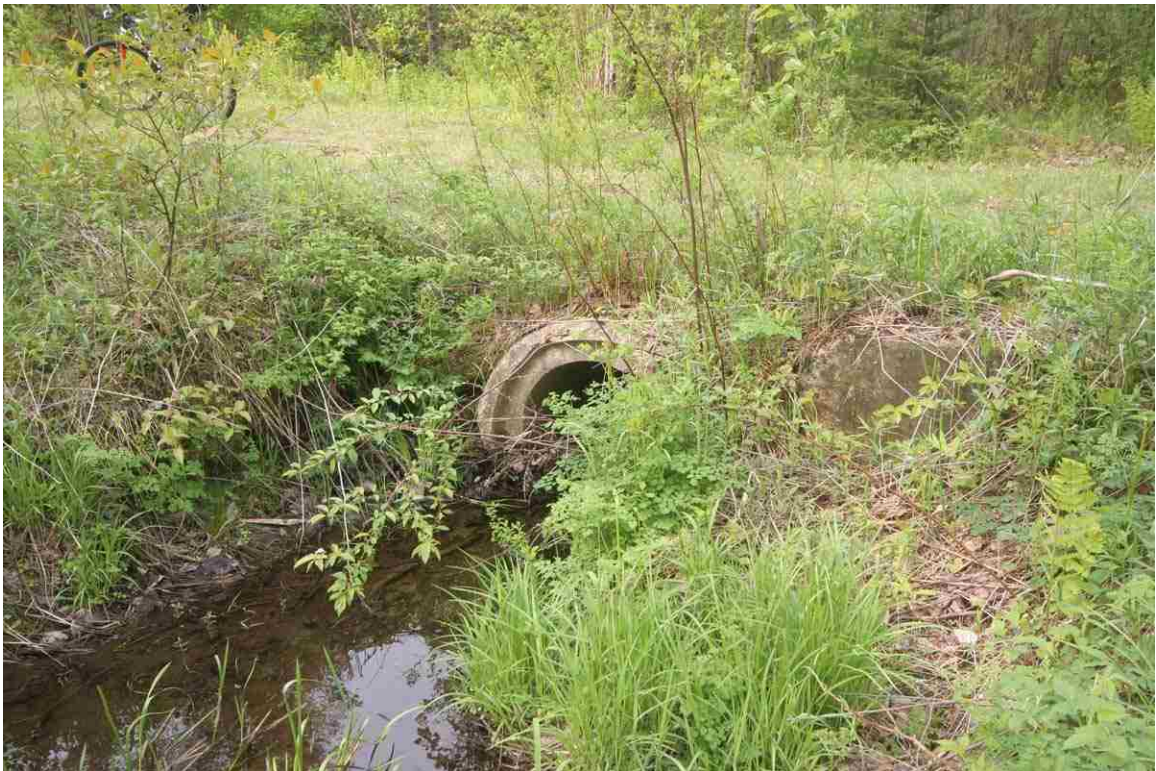
| Feature Name | Mile Post | Town | NR | Photo No. (s) | Date | Notes |
|---|---|---|---|---|---|---|
| Pipe Culvert | ~129.50 | Dalton | C | 24 | ? | Akron pipe, 38". Small section of concrete headwall visible. |

Photo # 24 description: Culvert, mp~129.50, Dalton. Akron pipe, 38". Small section of presumed concrete headwall is visible; remaining wall missing or buried. nd.

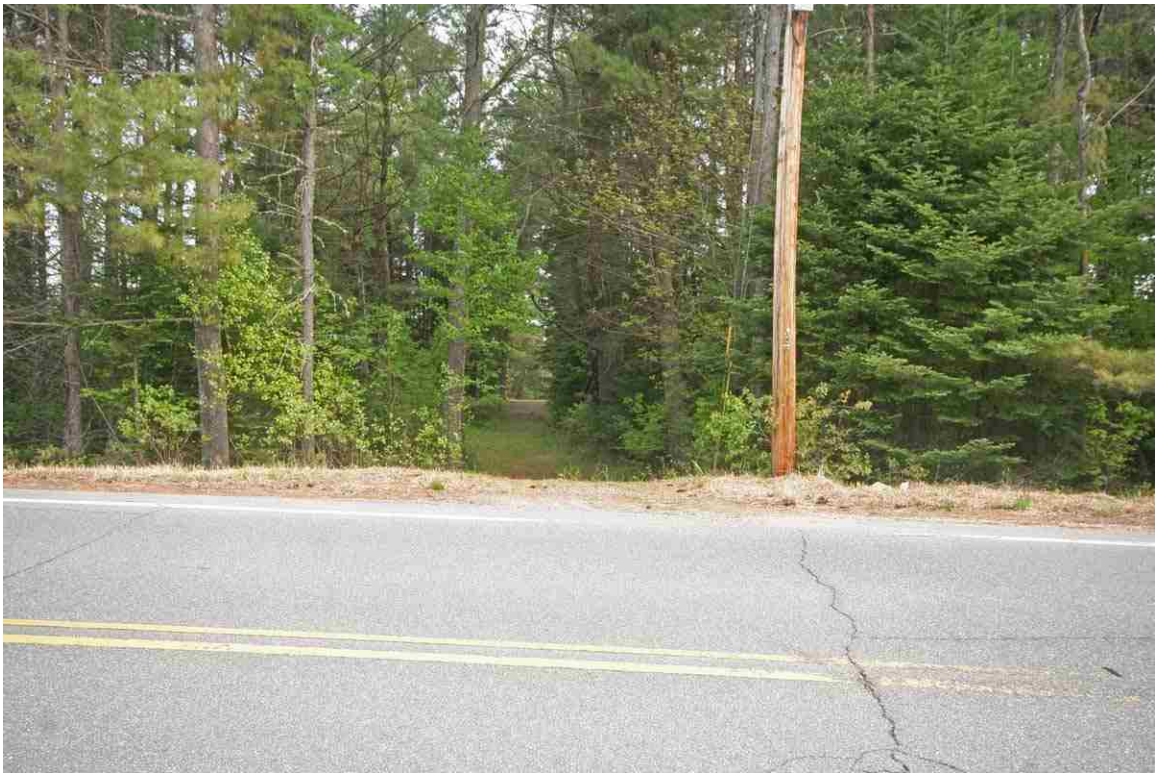
Photo # 27 description: ROW/Trail looking north at Whitefield Road, NH142, Dalton, mp~130.1. ROW ends, becomes private property but trail continues in rough condition.

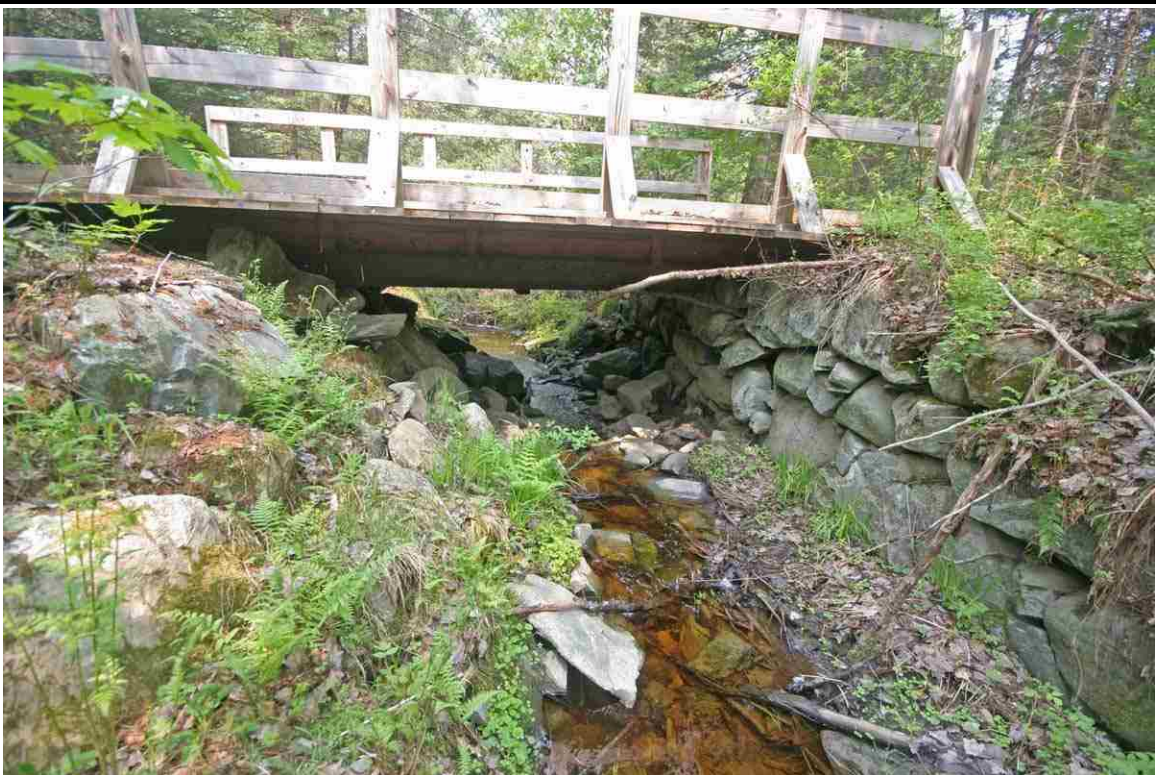
| Feature Name | Mile Post | Town | NR | Photo No. (s) | Date | Notes |
|---|---|---|---|---|---|---|
| Snowmobile Bridge over unnamed stream. | ~130.45 | Dalton | N/C | 28 | ? | Treated timber stringer on reconstructed fieldstone abutments. |

Photo # 28 description: Snowmobile Bridge over unnamed stream, mp~130.45, Dalton. Treated timber stringer on reconstructed fieldstone abutments.

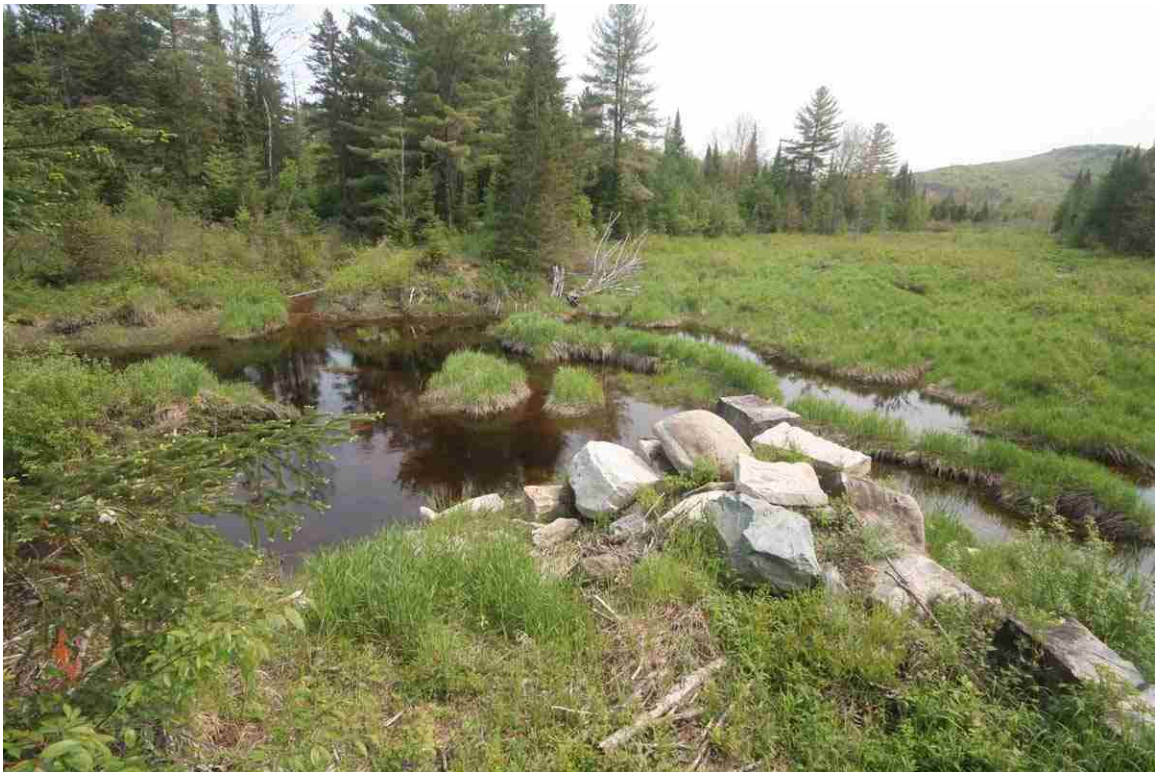
| Feature Name | Mile Post | Town | NR | Photo No. (s) | Date | Notes |
|--|---|---|---|---|---|---|
| ROW washed out & rerouted | ~131.01 | Lancaster | N/C | 30 | ? | Former location of 48" pipe culvert |

Photo # 30 description: Character of ROW/Trail at mp~131.01, Lancaster. Location of 48" concrete pipe culvert, washed out. Trail detours west over snowmobile bridge and rejoins ROW 500' north.

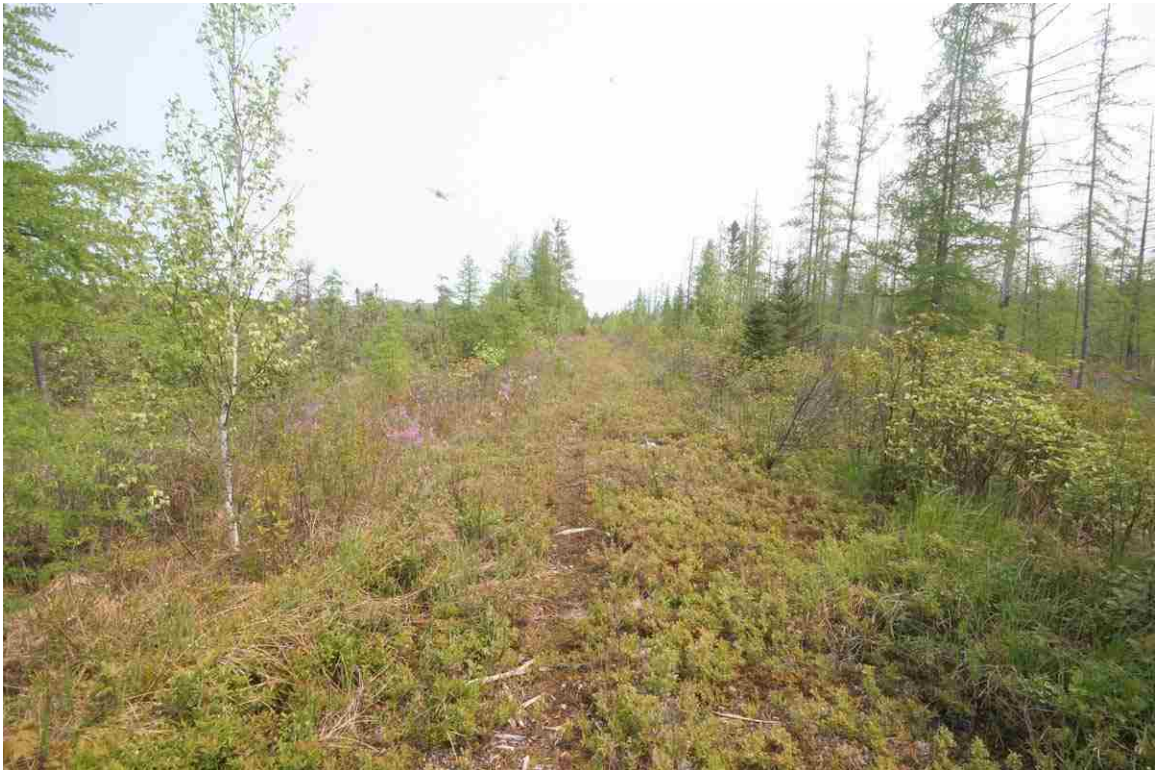
Photo # 32 description: Character of ROW at mp~131.26, Lancaster, looking north (2 of 2). Tough going on foot; no biking.

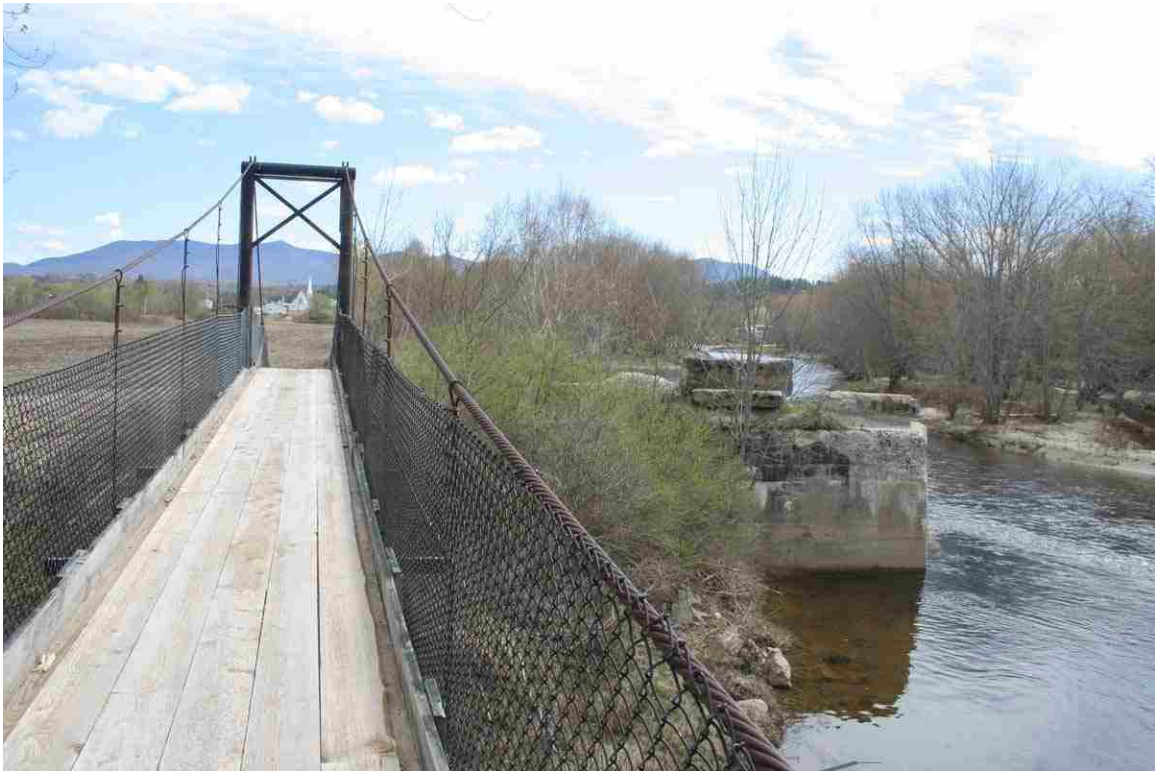
Photo # 39 description: Israel R. snowmobile suspension bridge at foot of of Heath St. Lancaster. North abutment of B&M Bridge 136.01, concrete, at right.

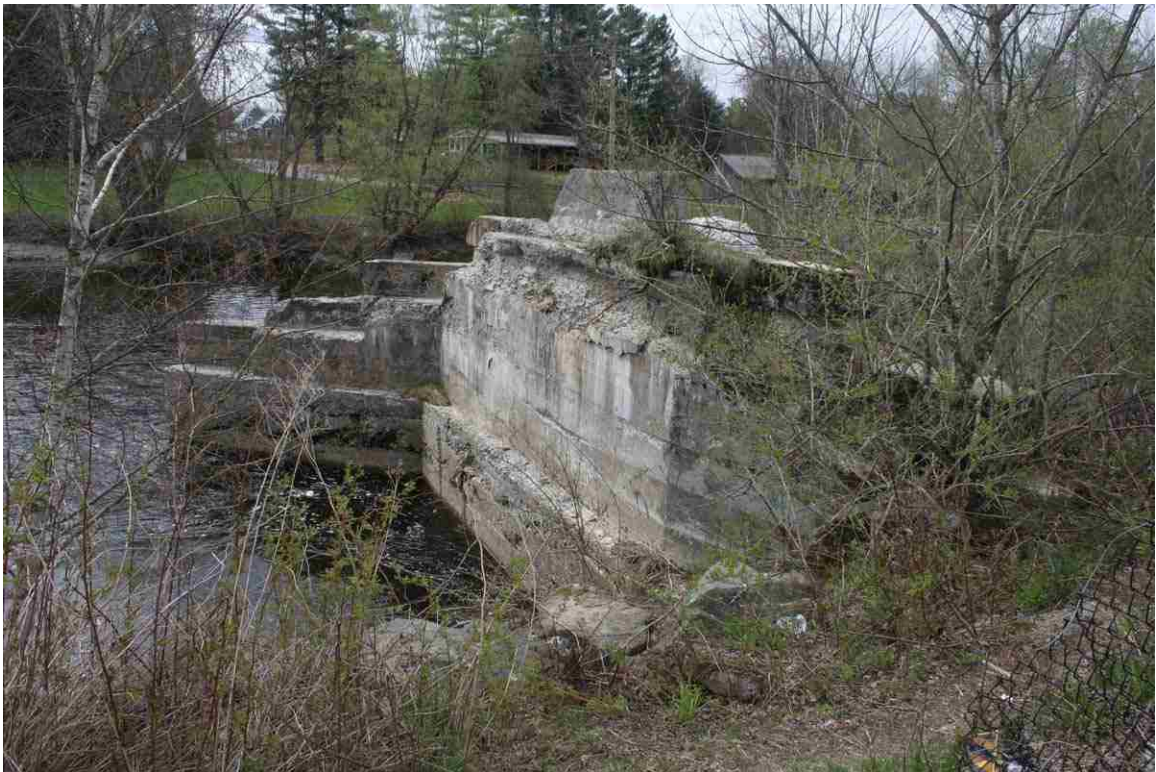
| Feature Name | Mile Post | Town | NR | Photo No. (s) | Date | Notes |
|--|---|---|---|---|---|---|
| North abutment of B&M Bridge No. 136.01 | 136.01 | Lancaster | N/C | 40 | ? | Concrete bevel wing abutment remains with backfill washed out. |

Photo # 40 description: North abutment of B&M Bridge 136.01, showing exposed back side, the railbed fill completely washed out. Provides interesting look at construction methods.

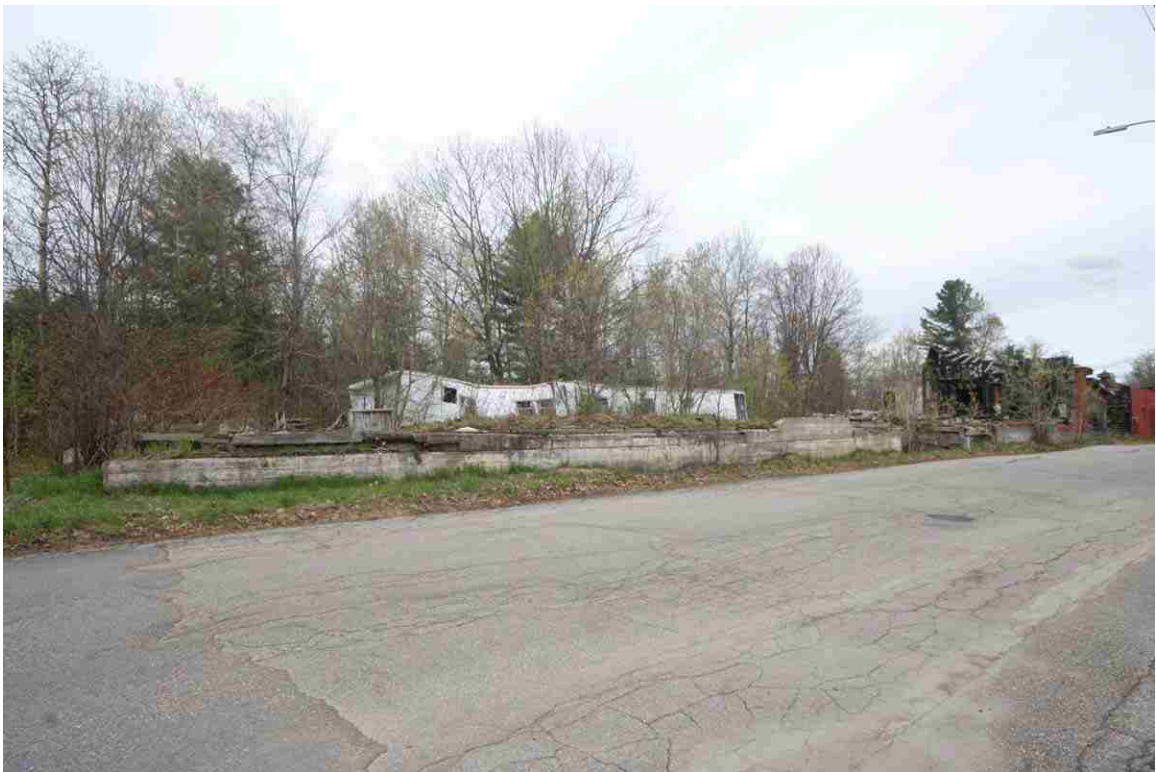
| Feature Name | Mile Post | Town | NR | Photo No. (s) | Date | Notes |
|--|---|---|---|---|---|---|
| Railroad associated building foundation. | ~136.75 | Lancaster | N/C | 50 | ? | Possibly remains of B&M Depot? More research needed. No integrity. |

Photo # 50 description: Concrete block foundation of demolished railroad associated building on Depot St., Lancaster. ~mp 136.75. Possibly remains of B&M Depot? More research needed.

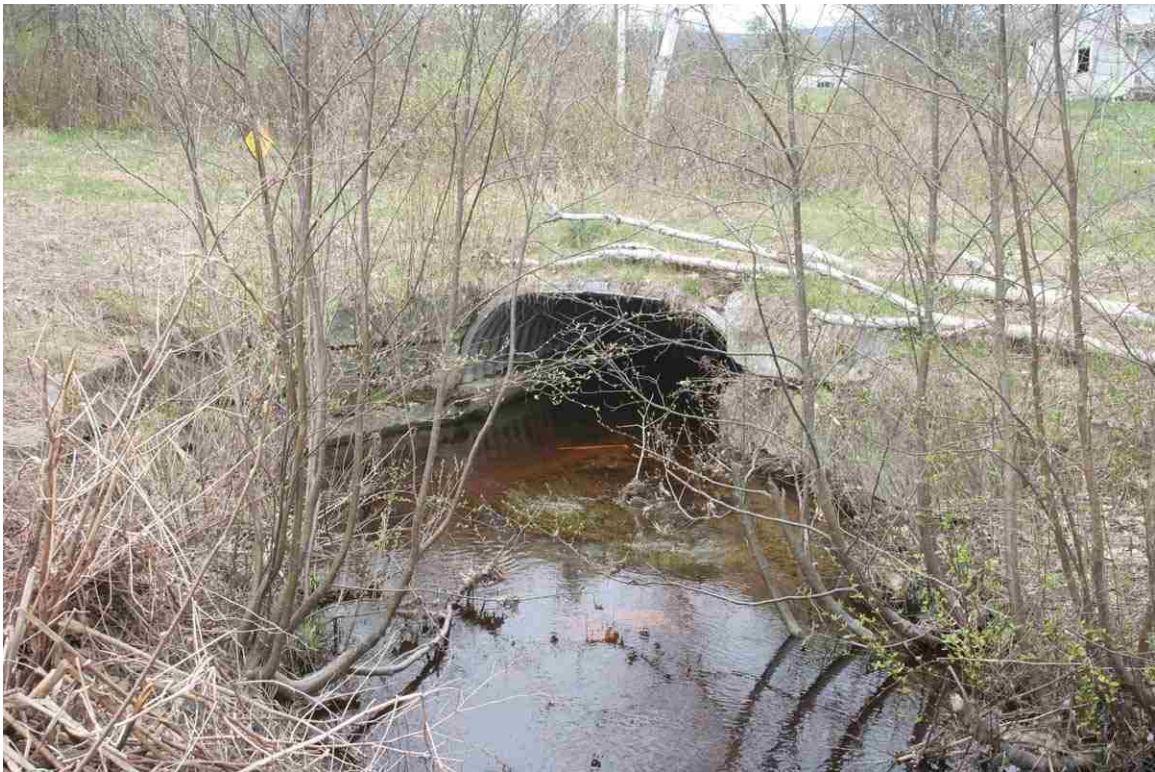
| Feature Name | Mile Post | Town | NR | Photo No. (s) | Date | Notes |
|--|---|---|---|---|---|---|
| Culvert | ~136.84 | Lancaster | N/C | 56 | ? | Metal arch culvert carrying ROW over unnamed stream. Stone wall remains. |

Photo # 56 description: Metal arch culvert carrying ROW over unnamed stream near Kilkenny St., Lancaster. ~mp 136.84. Stone walls possible remains of box culvert.
