Blair Bridge, Campton, NH Covered Bridge Project Report

Phase 1 - Research and Inspection Findings

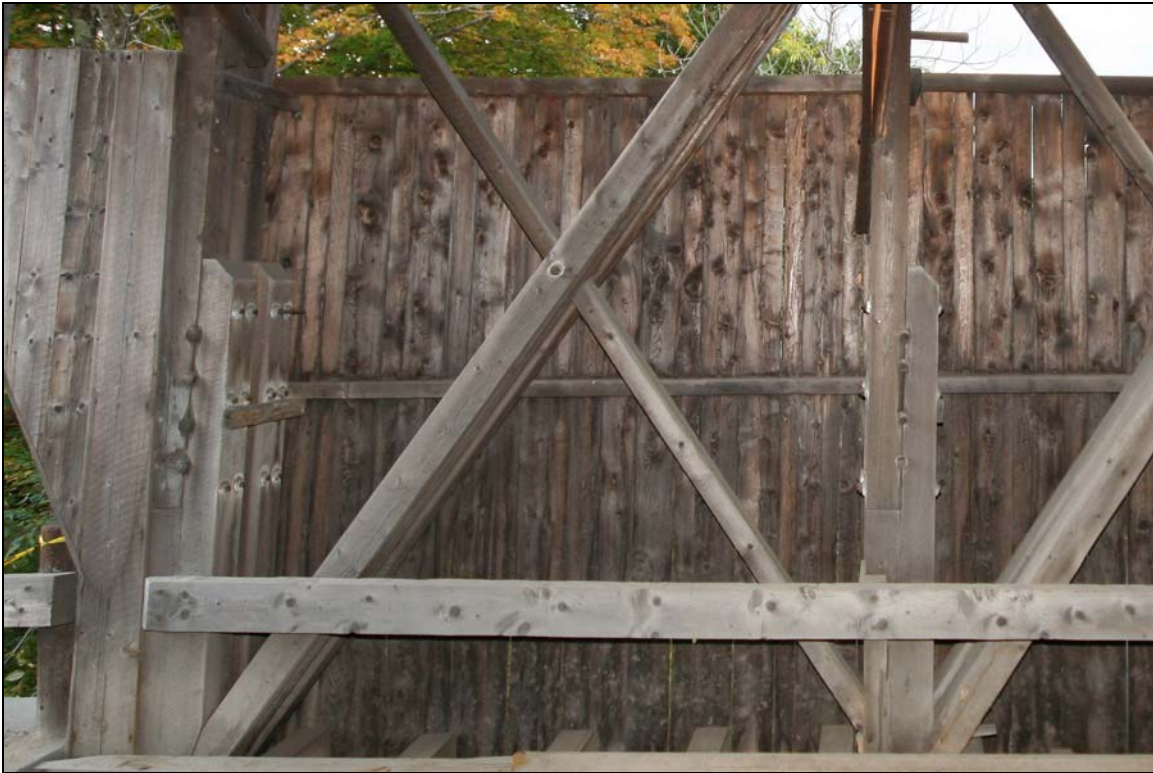
Photo No. 2: Post repair at SE corner done in 1977 showing bolted splices and shear dowels. View S.

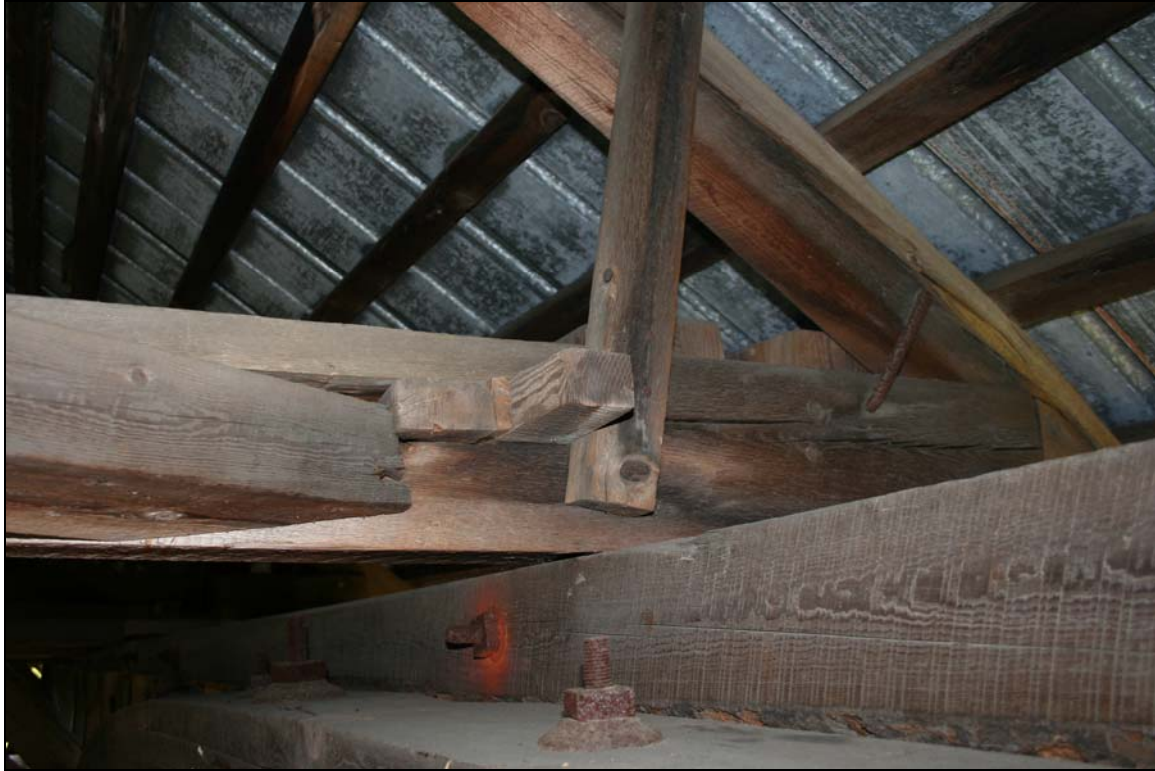
Photo No. 3: Top chord of south truss (right); top of arch (bottom); cross beam (center) showing wedges against lateral brace (left); rafter attached to tie beam with cramp iron or "dog." View SE.

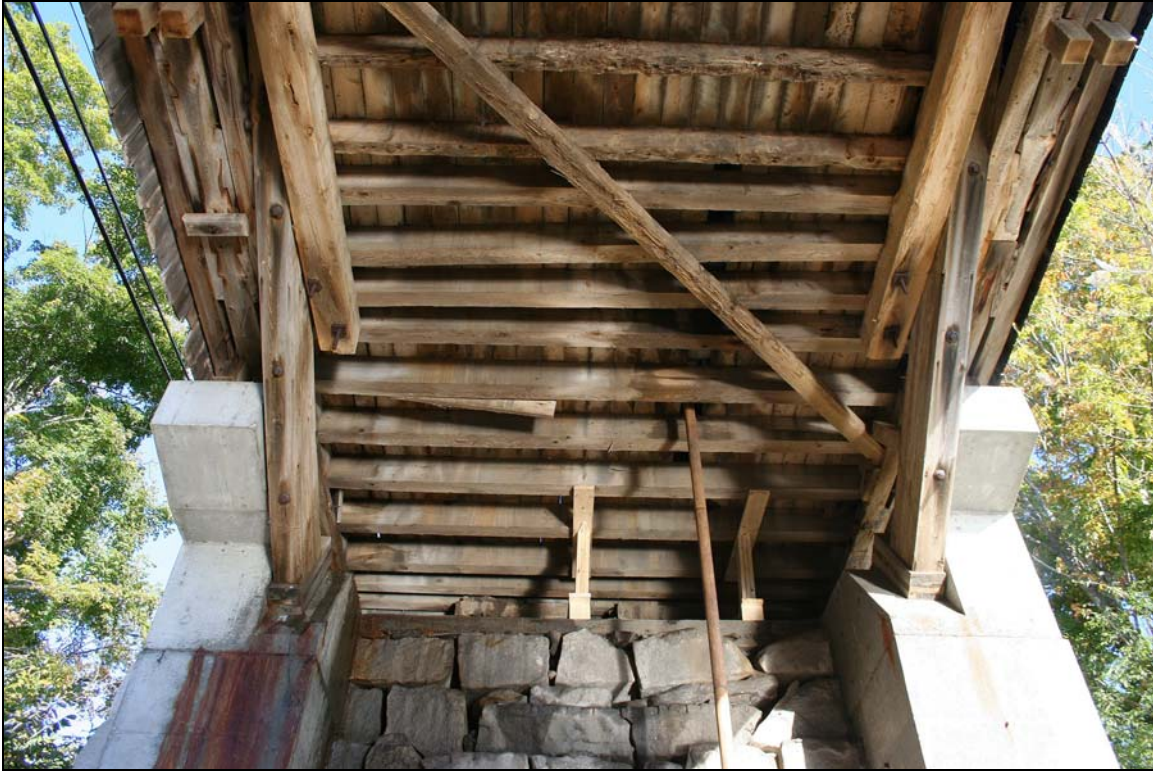
Photo No. 5: East abutment and underside of bridge, showing 1977 concrete reinforcement, and assortment of floor system repairs and problems; note deteriorated floor beams at top of photo. View E.

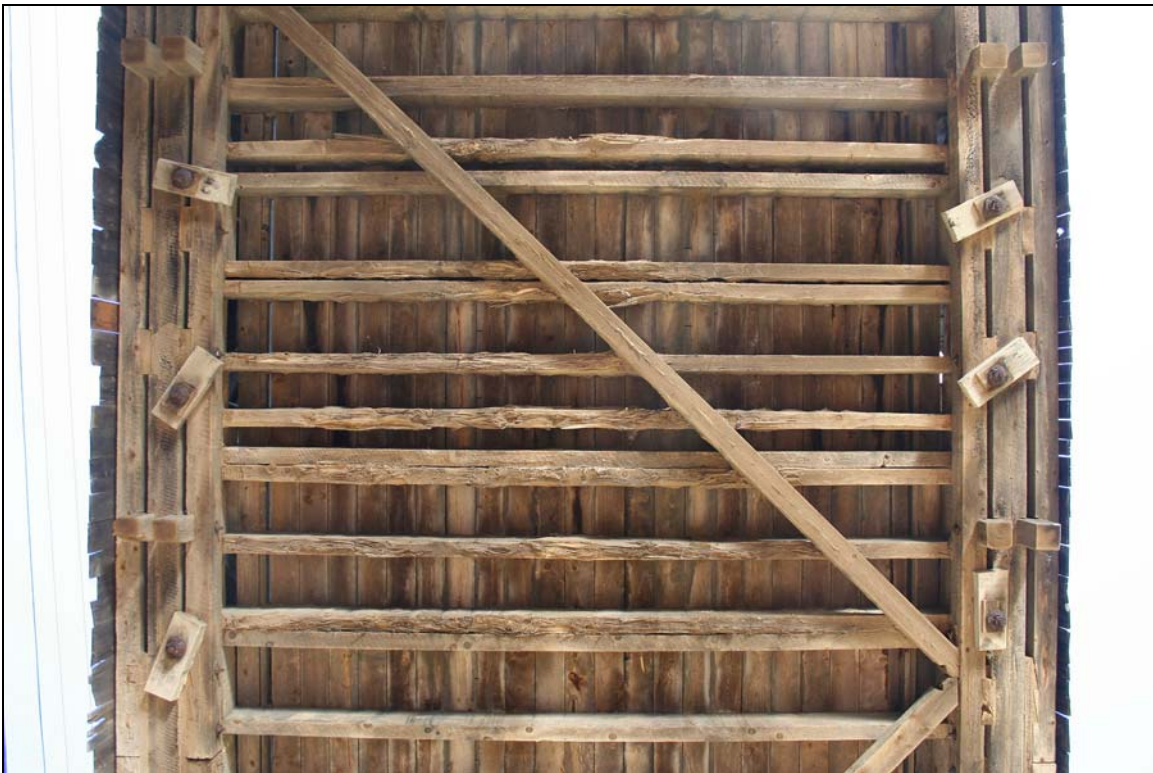
Photo No. 6: Underside of east span, showing floorbeams, triple lower chords and arch hangar rod support blocks. View up.
