**TABLE OF OBSERVED FEATURES  
 SURVEY AREA 2  
 HAZEN'S CROSSING, WHITEFIELD TO  
 BERLIN STATION**

| Feature Name | Mile Post | Town | NR | Photo No. (s) | Date | Notes |

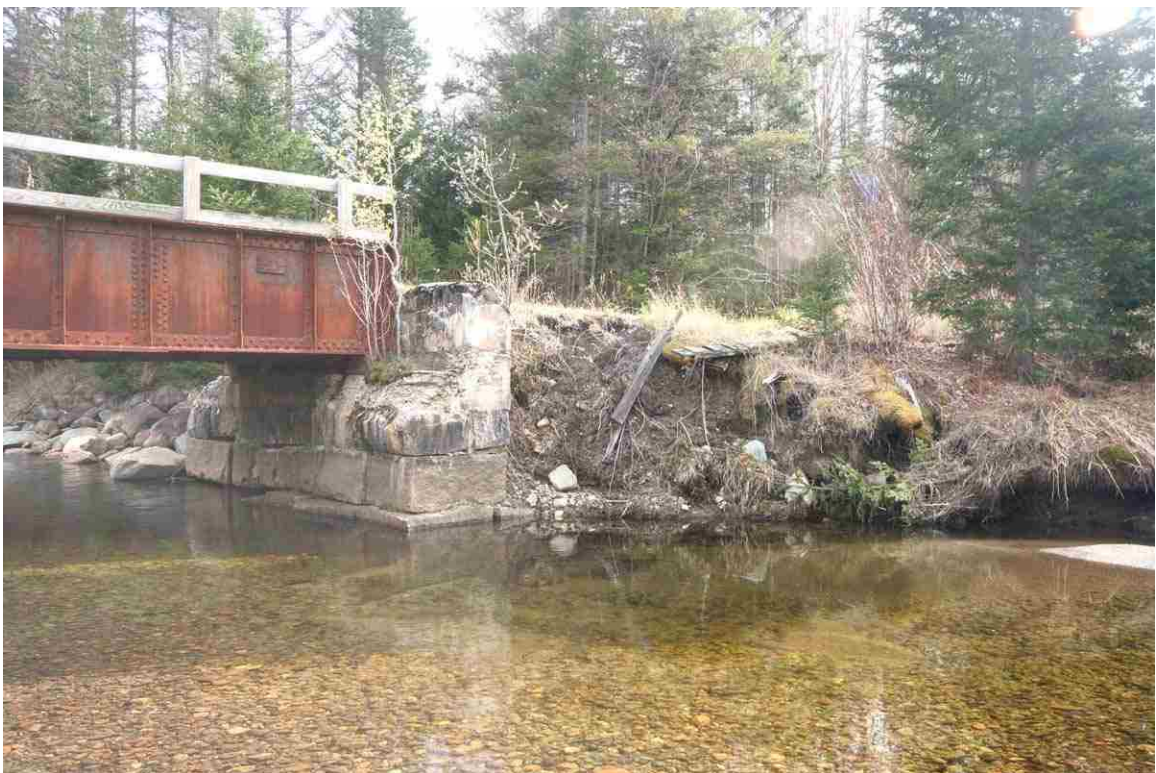
Photo # 46 description: Bridge 138.75 over Israel's R., Randolph. Washout of west abutment, north end. Condition critical. (4 of 4).

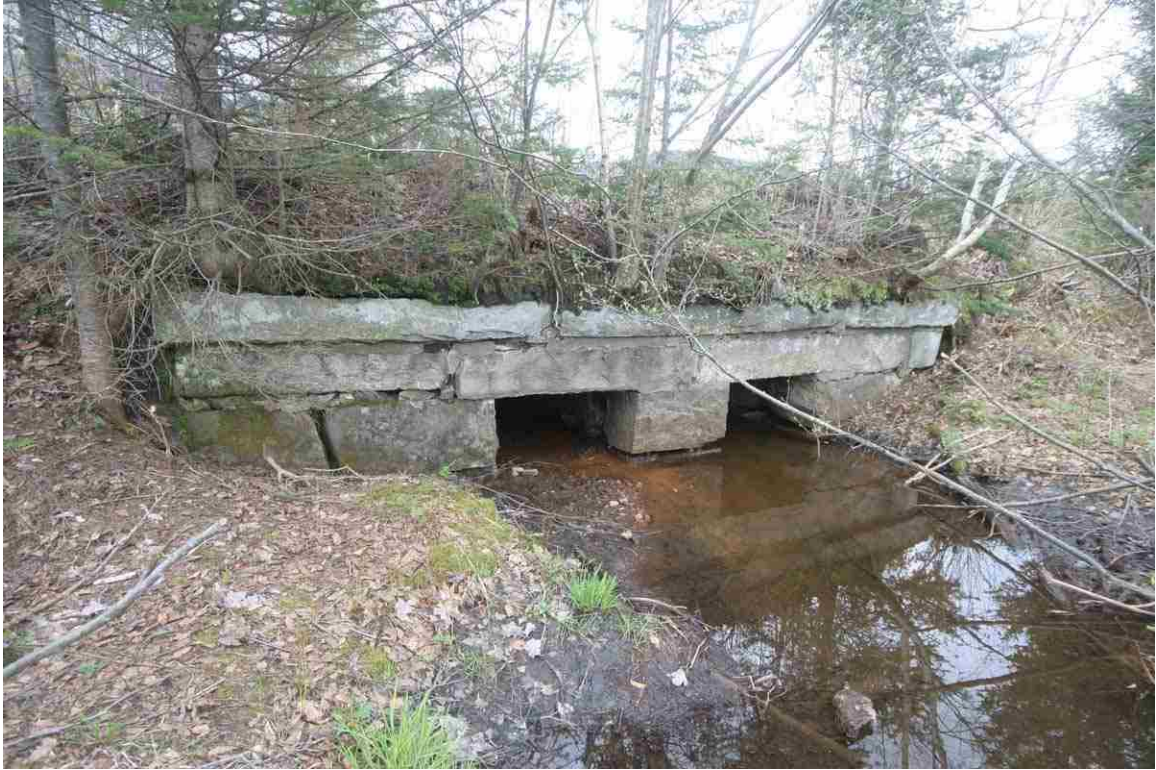
Photo # 47 description: Culvert 140.21, Randolph. Double stone box, 48", quarry-split stone. nd. Rare and outstanding example of double box. Outlet. (1 of 2).

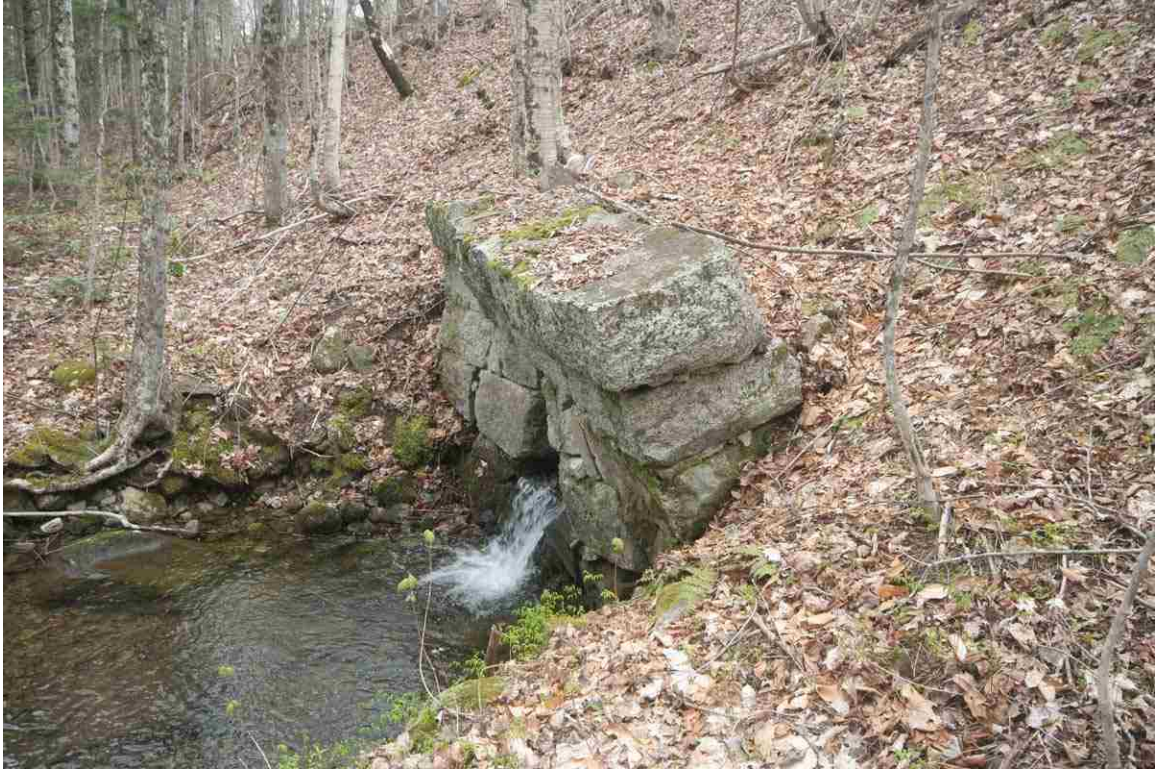
Photo # 57 description: Culvert 142.19, Randolph. (2 of 2). Critical condition; collapse imminent.

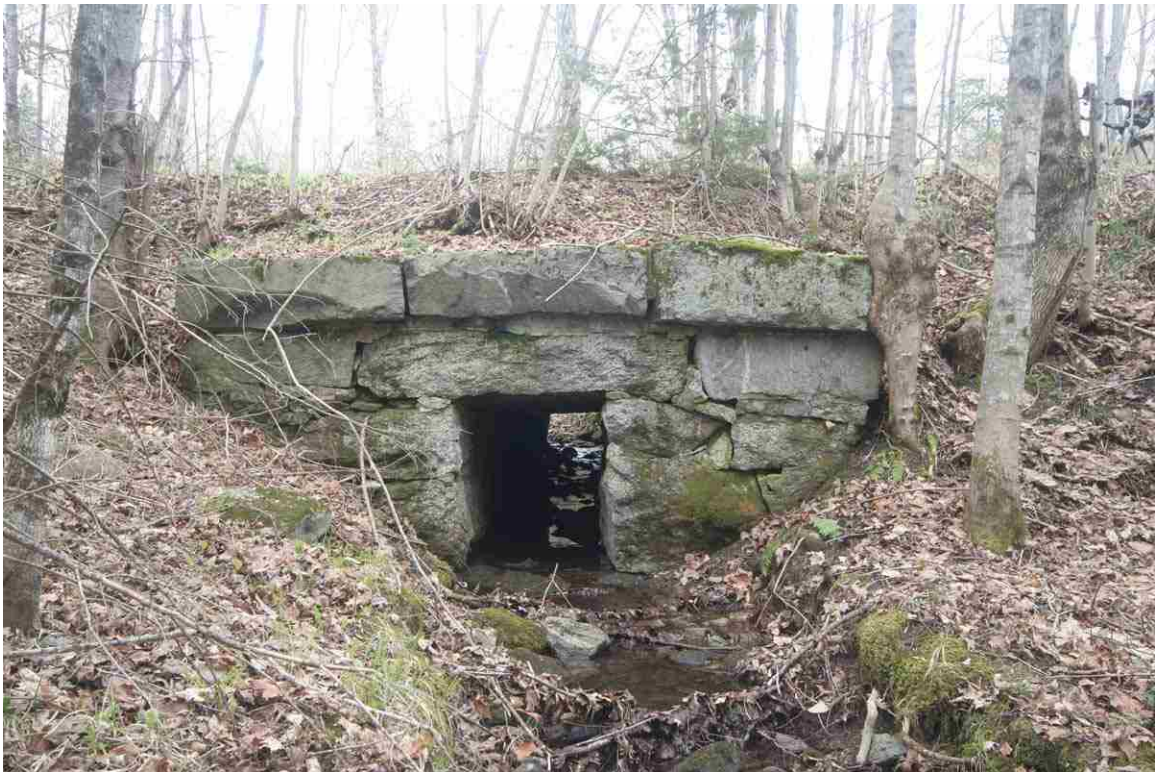
Photo # 58 description: Culvert 142.24, Randolph. Stone box, 36" x 48", mixed split quarry & fieldstone. nd. .

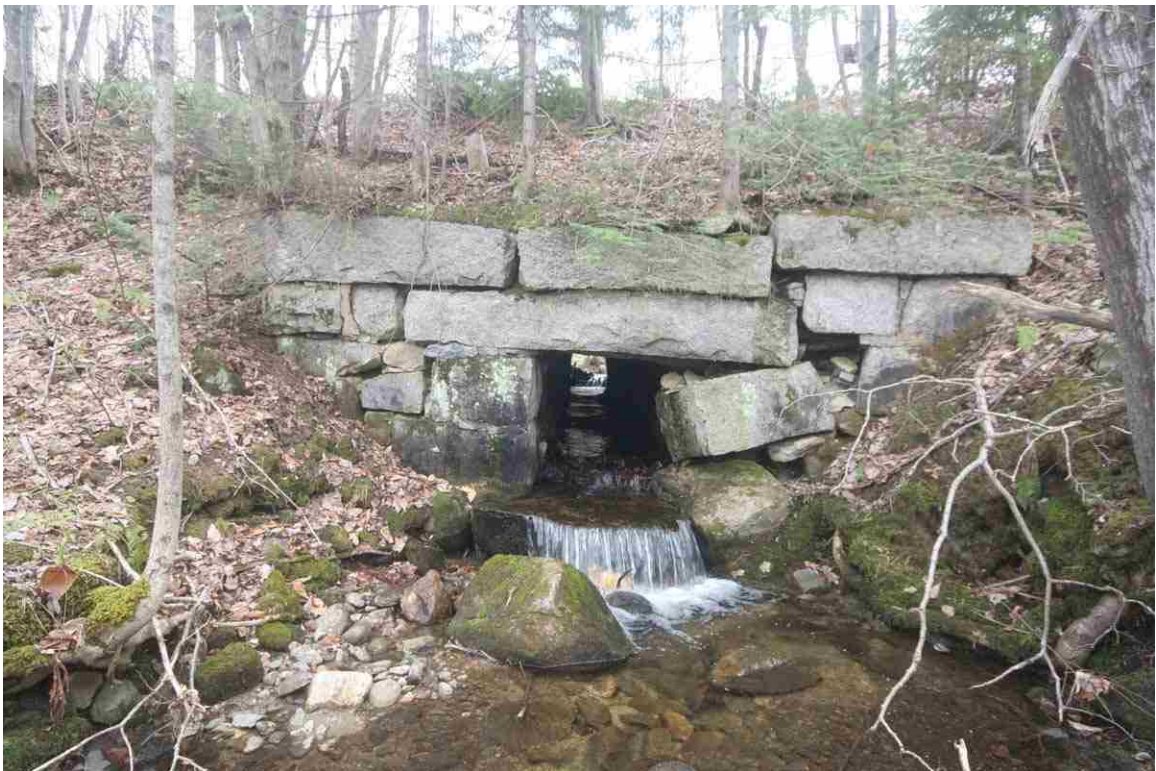
Photo # 64 description: Culvert 142.59, Randolph. Stone box, 54", mixed split quarry & fieldstone. nd. Note outlet headwall collapsing, condition critical.

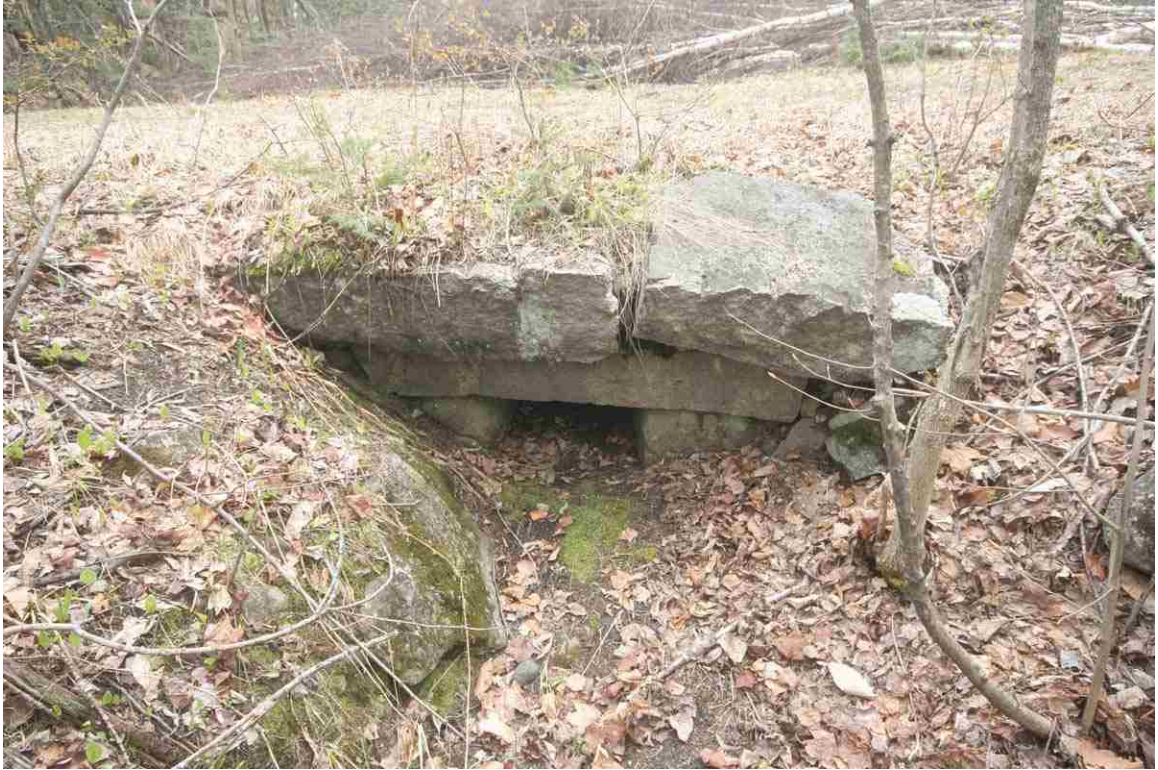
Photo # 65 description: Culvert 142.70, Randolph. Stone box, 36", split quarry stone. nd..

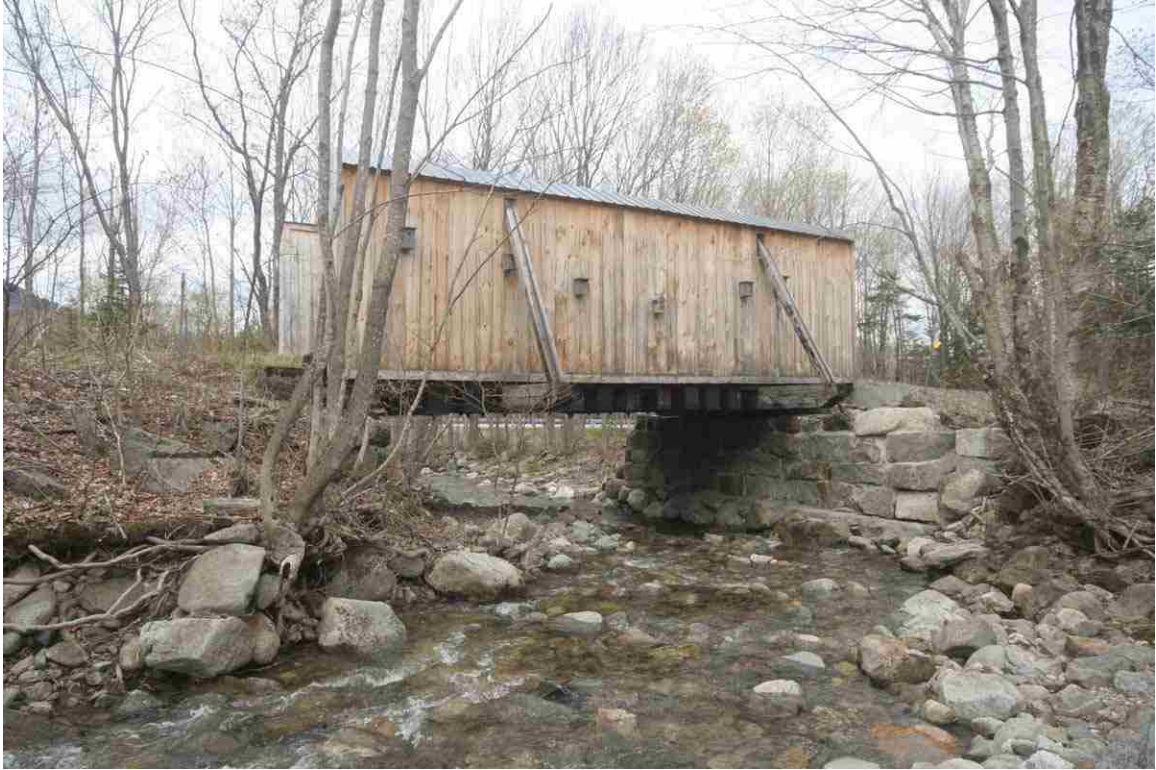
Photo # 67 description: Bridge 143.06 over Snyder Brook, Randolph. Upstream side. Note siding recently replaced. US2 paralleling RR ROW 150' north, just visible under bridge. (2 of 3).

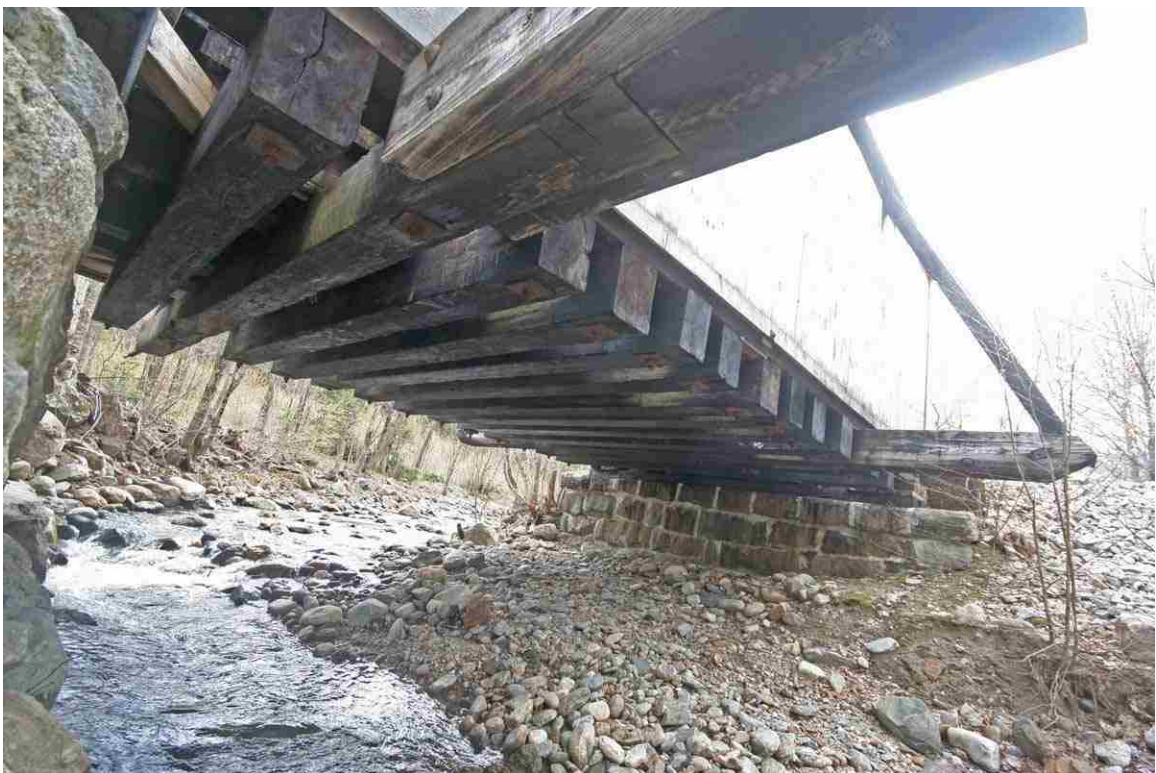
Photo # 68 description: Bridge 143.06 over Snyder Brook, Randolph. Underside and repaired west abutment. (3 of 3).

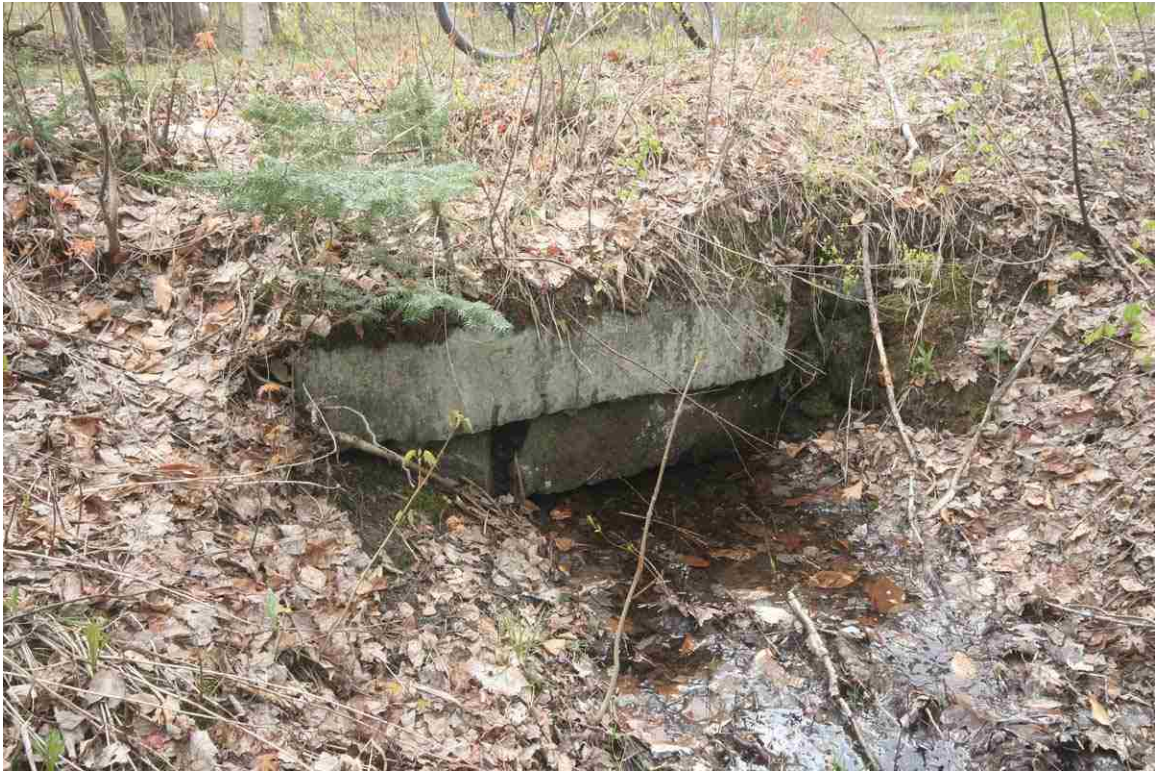
Photo # 69 description: Culvert 143.28, Randolph. Stone box, 30", mixed split quarry & fieldstone. nd.

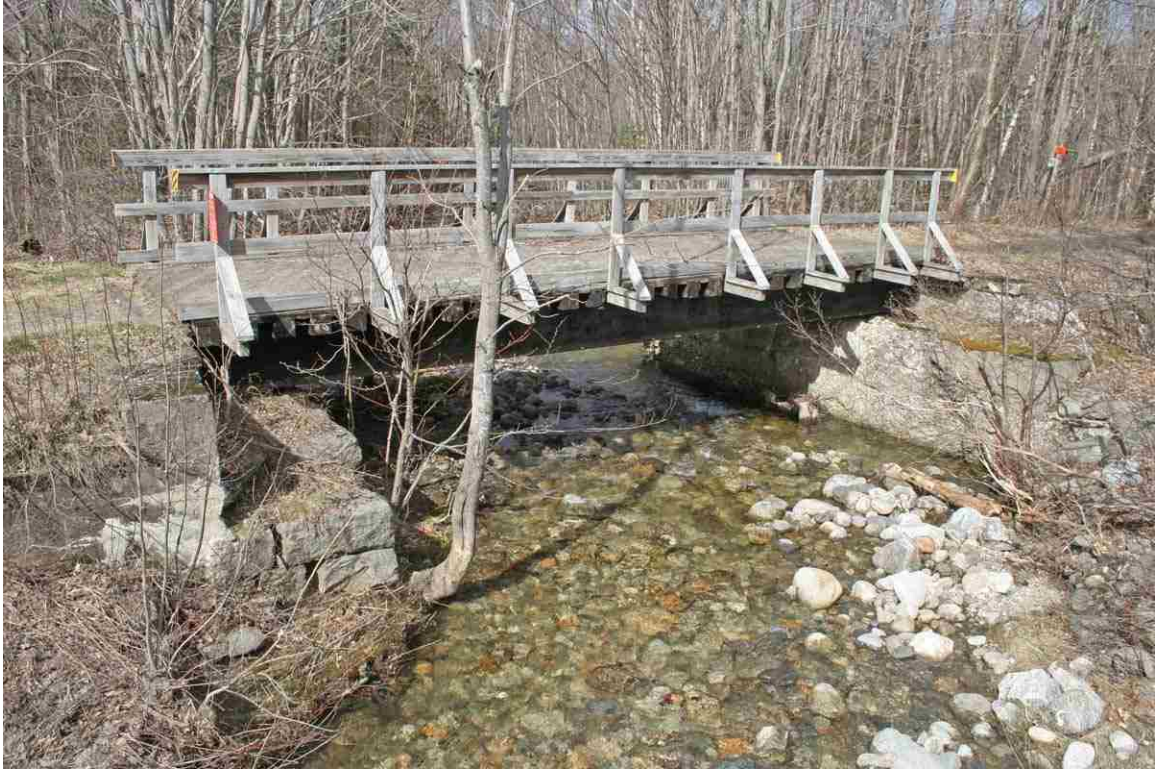
Photo # 75 description: Bridge 144.13 over Bumpus Brook, Randolph. Steel I-beam stringer, 28' span, on one stone, one concrete abutment. nd. Replaced pony Howe truss dated 1918. Upstream side. (1 of 2).

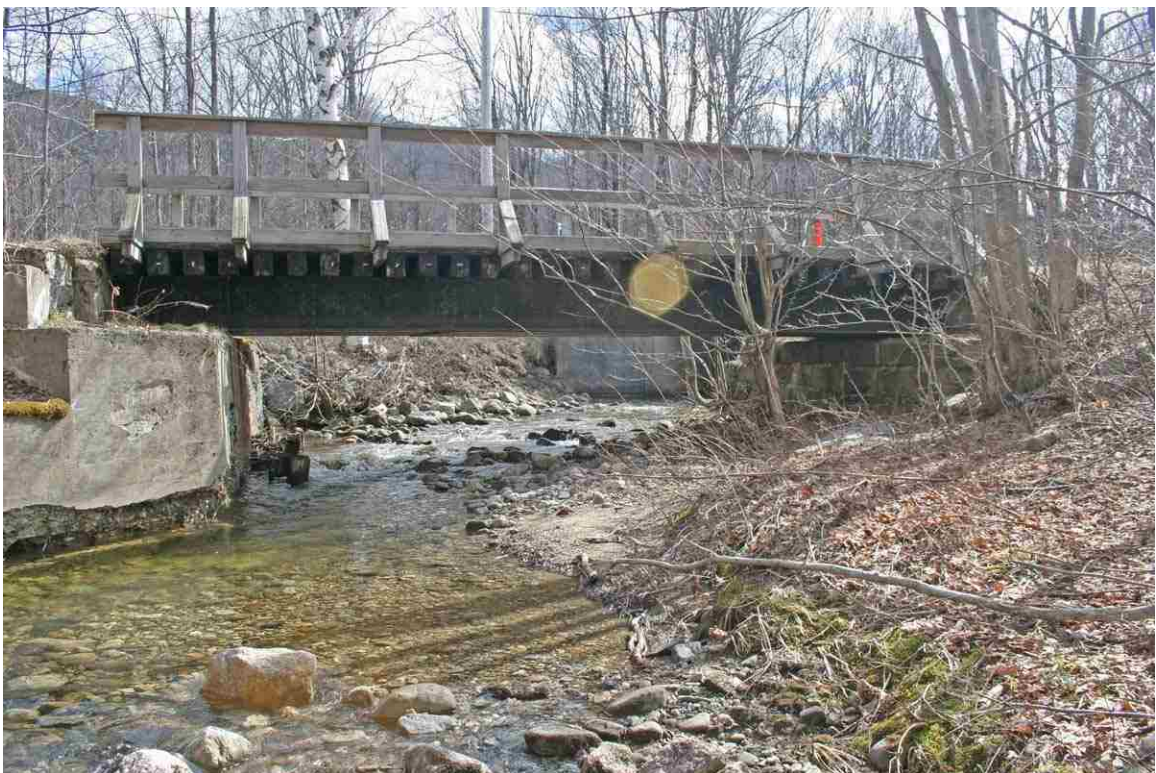
Photo # 76 description: Bridge 144.13 over Bumpus Brook, Randolph. Downstream side showing concrete east abutment. (2 of 2).

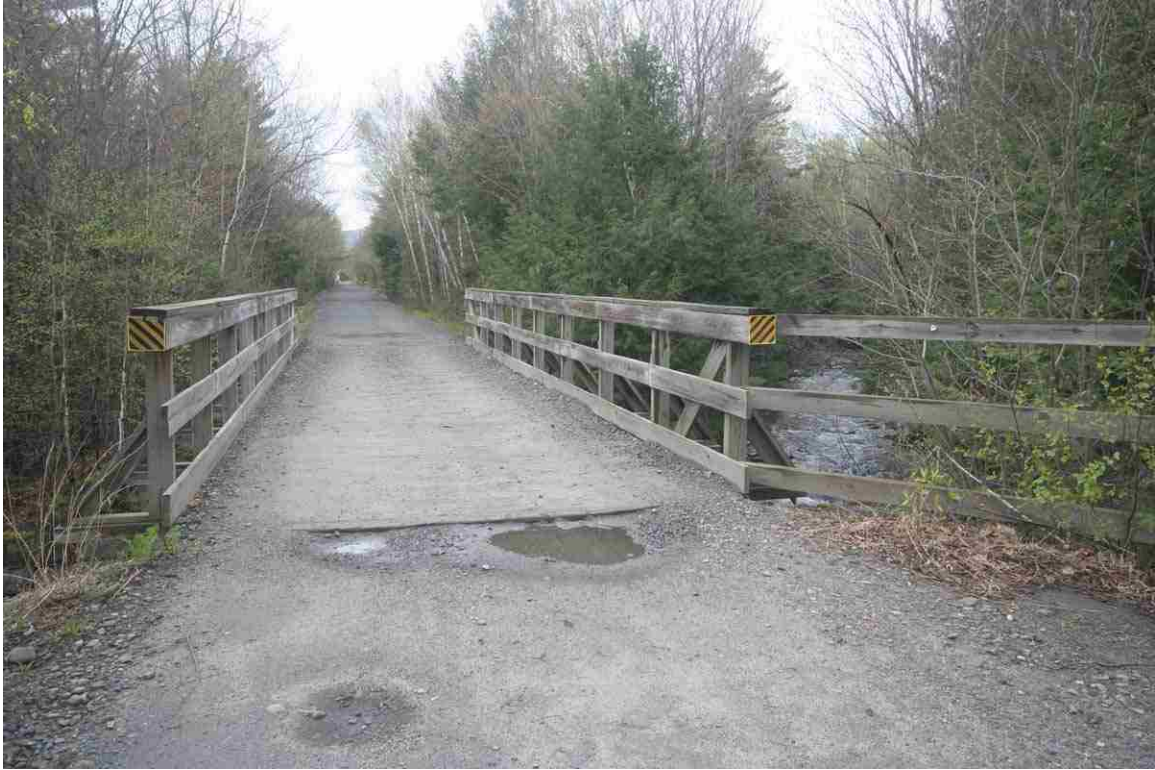
Photo # 111 description: Bridge 148.81, over Moose Brook, Gorham. I-beam stringers on stone (1) and concrete (1) abutments. nd. Stringers replaced 40' span wood pony Howe truss built 1918. (1 of 4).

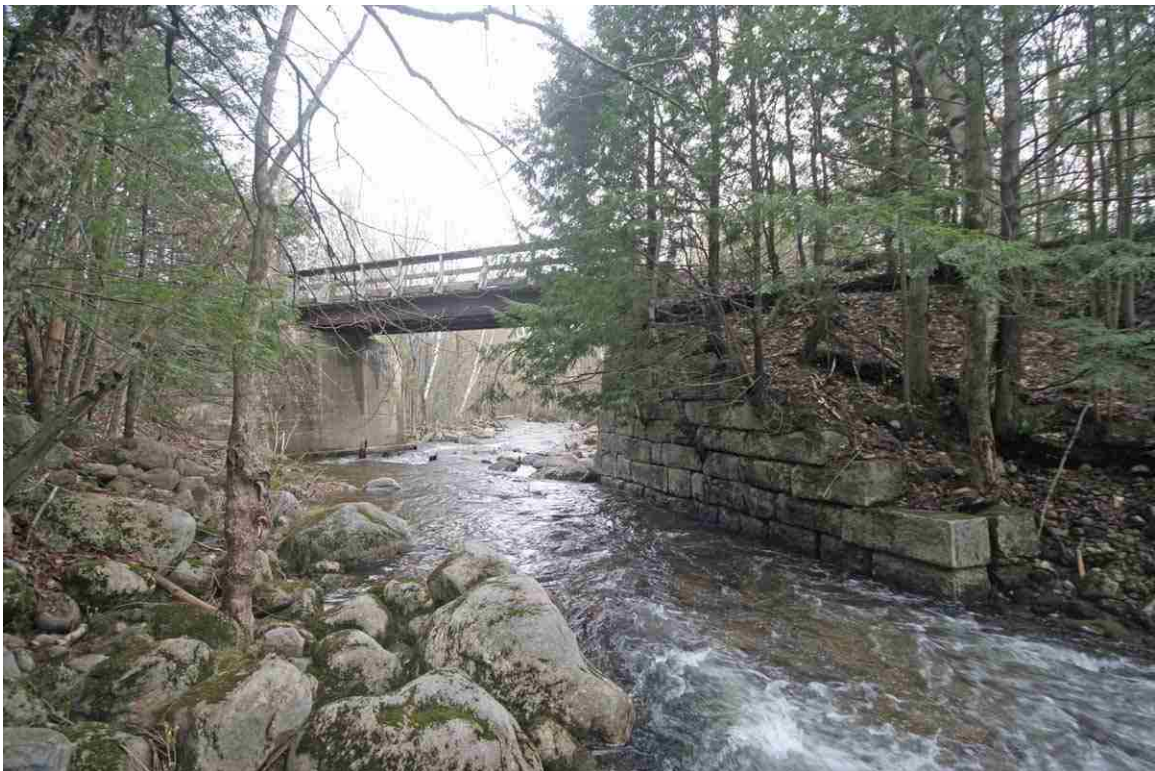
Photo # 112 description: Bridge 148.81, over Moose Brook, Gorham. Upstream side. (2 of 4).

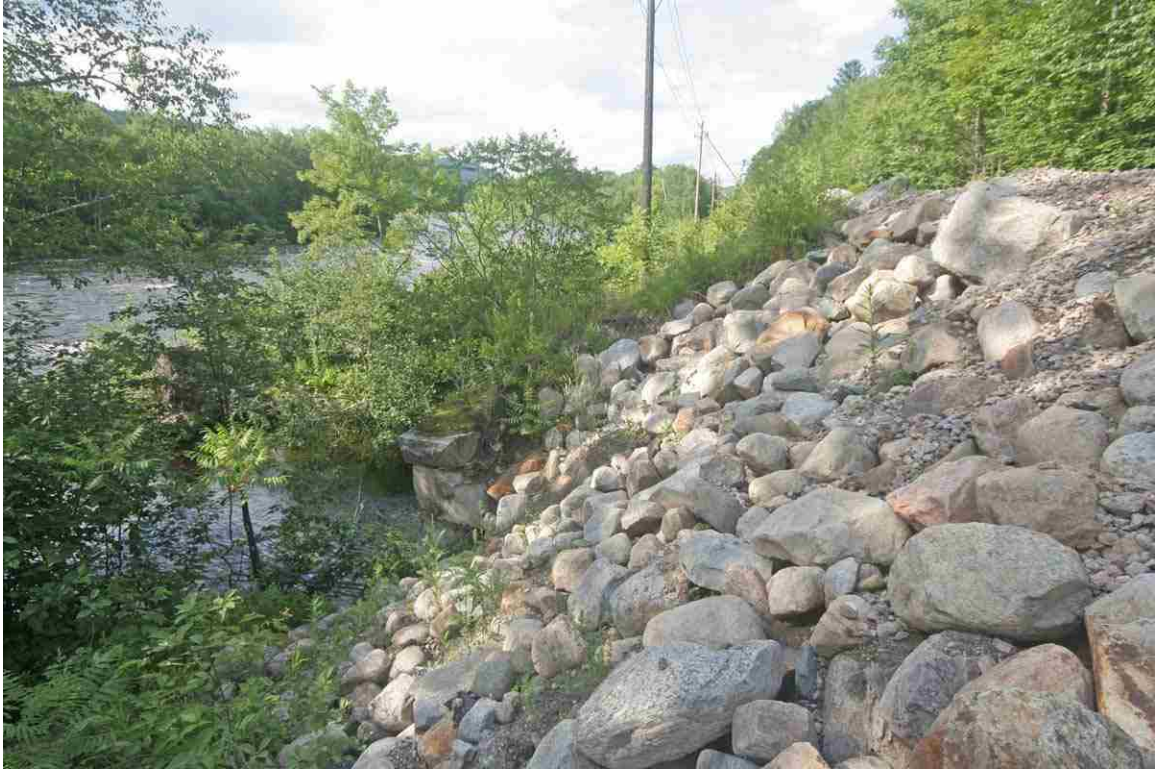
Photo # 125 description: Culvert 150.95, Gorham. Showing extensive fill and rip rap repair to wash out on south side of culvert, visible at center. (2 of 2).

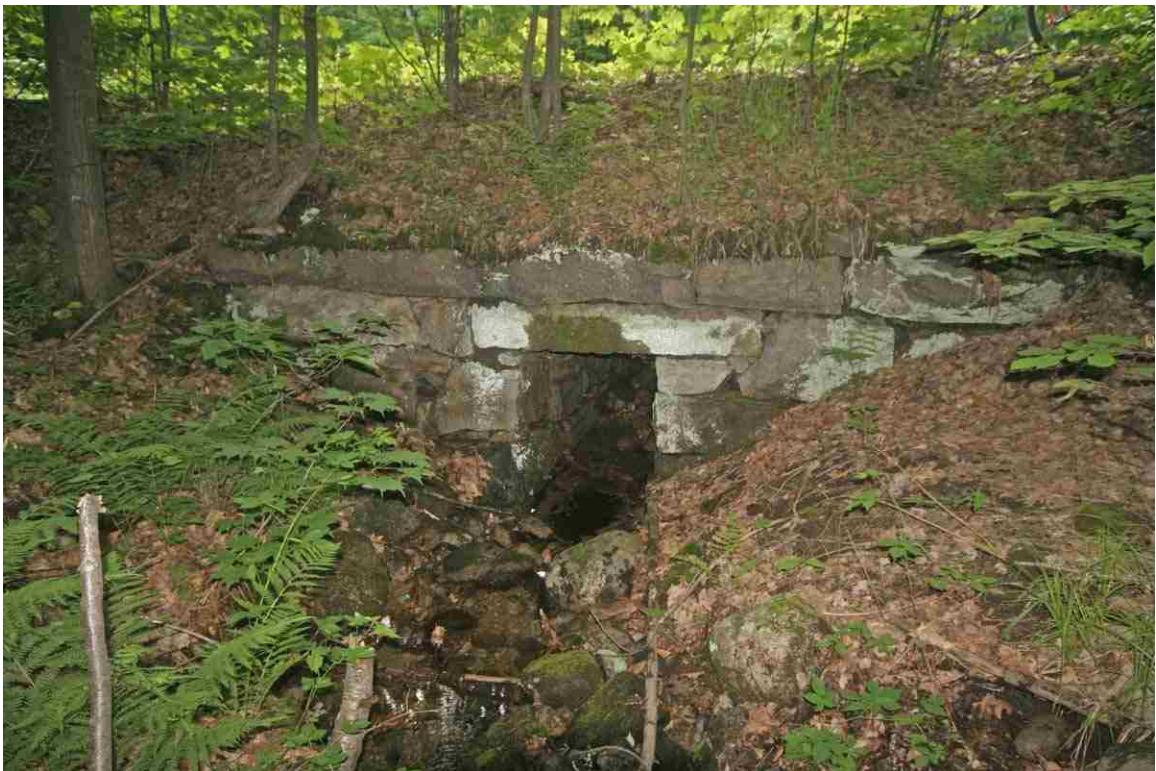
Photo # 126 description: Culvert 151.21, Gorham. Stone box, 4' x 6', mixed split quarry & fieldstone. nd.

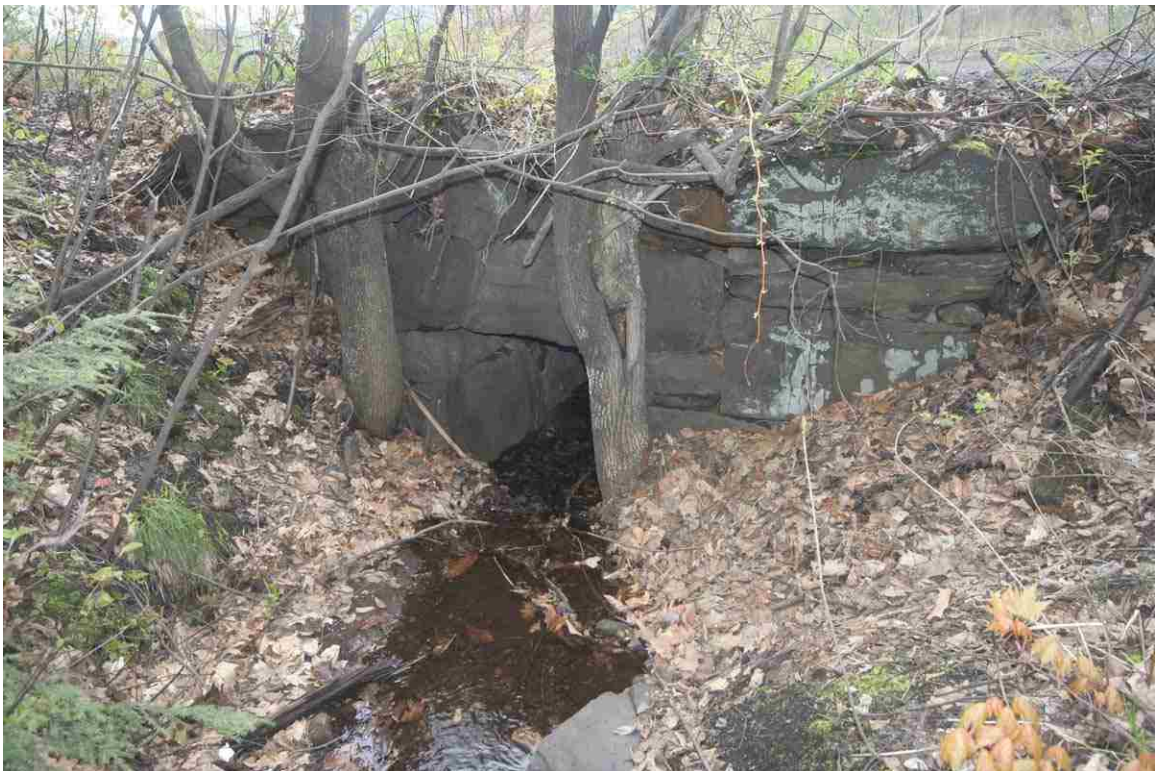
Photo # 128 description: Culvert 152.99, Berlin. Stone box, 36", mixed split quarry and field stone. Inlet. nd. Outlet repaired/extended with CMP.

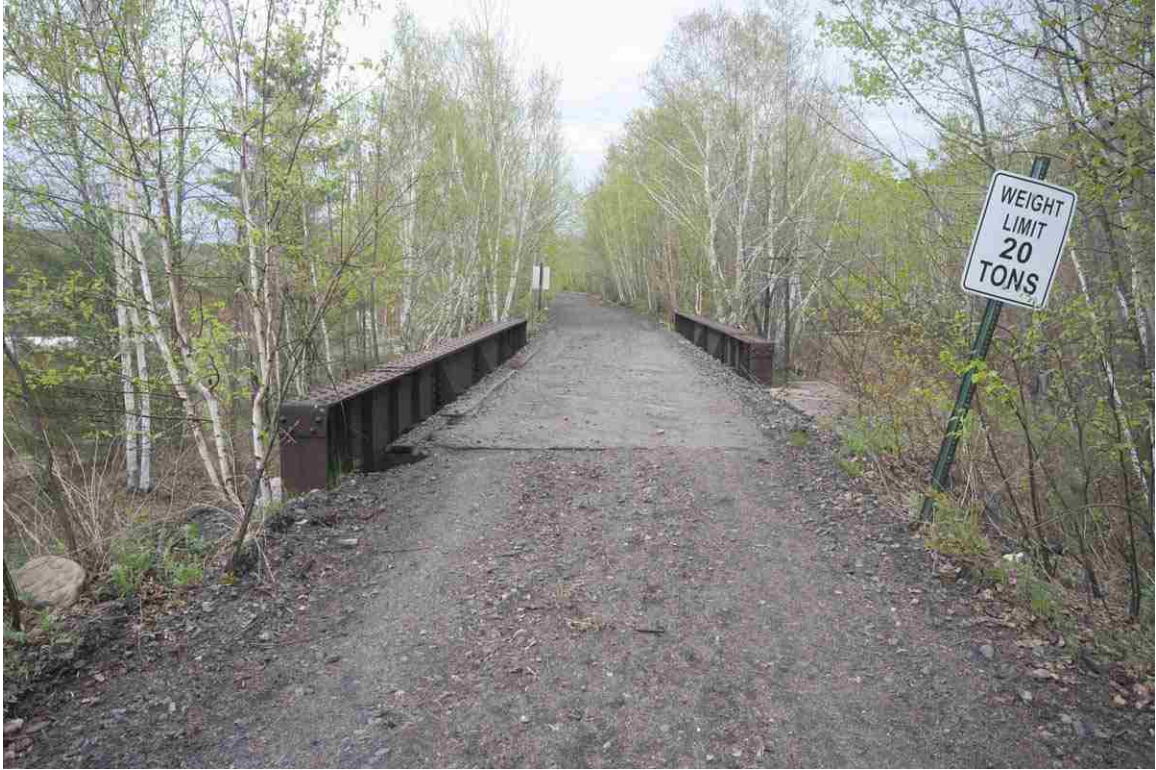
Photo # 129 description: Bridge 153.14 over A&SLRR at Berlin Mills Station, Berlin. Thru plate girder, 35' span, sharply skewed, on concrete abutments. 1940. South approach. (1 of 4).

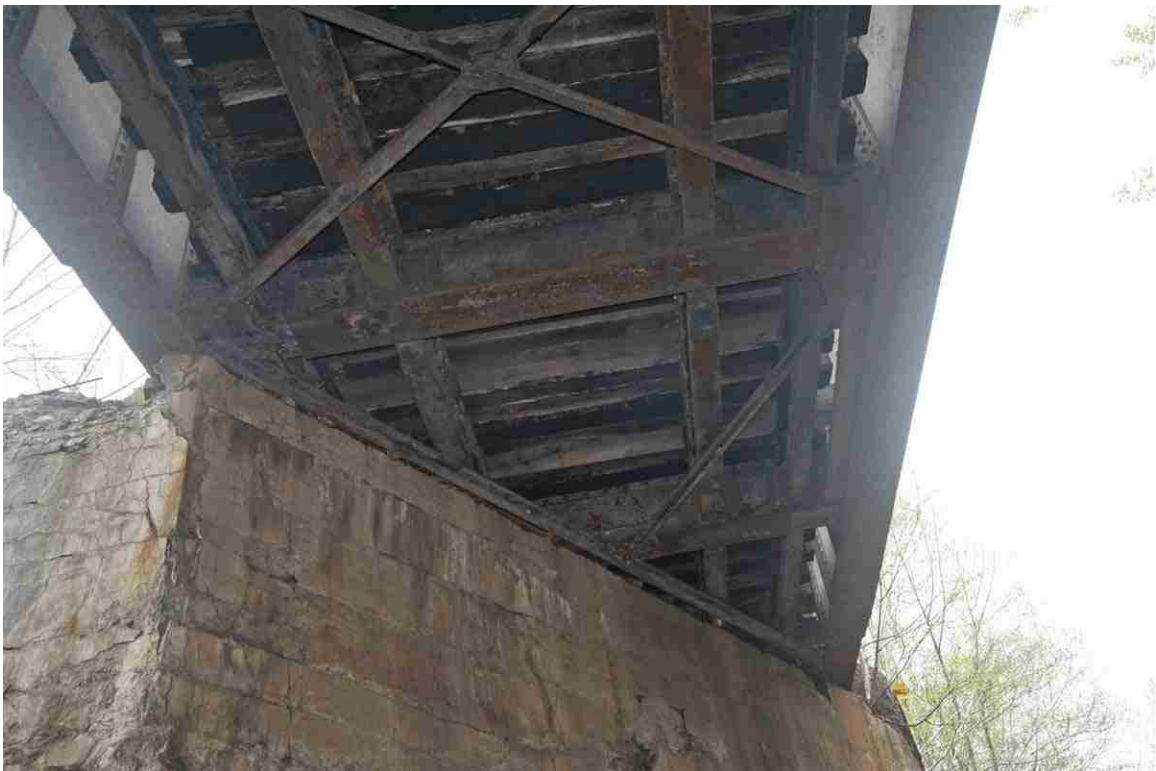
Photo # 132 description: Bridge 153.14 over A&SLRR at Berlin Mills Station, Berlin. Underside showing framing and ties still in place under new deck and gravel fill. Both abutments deteriorating.

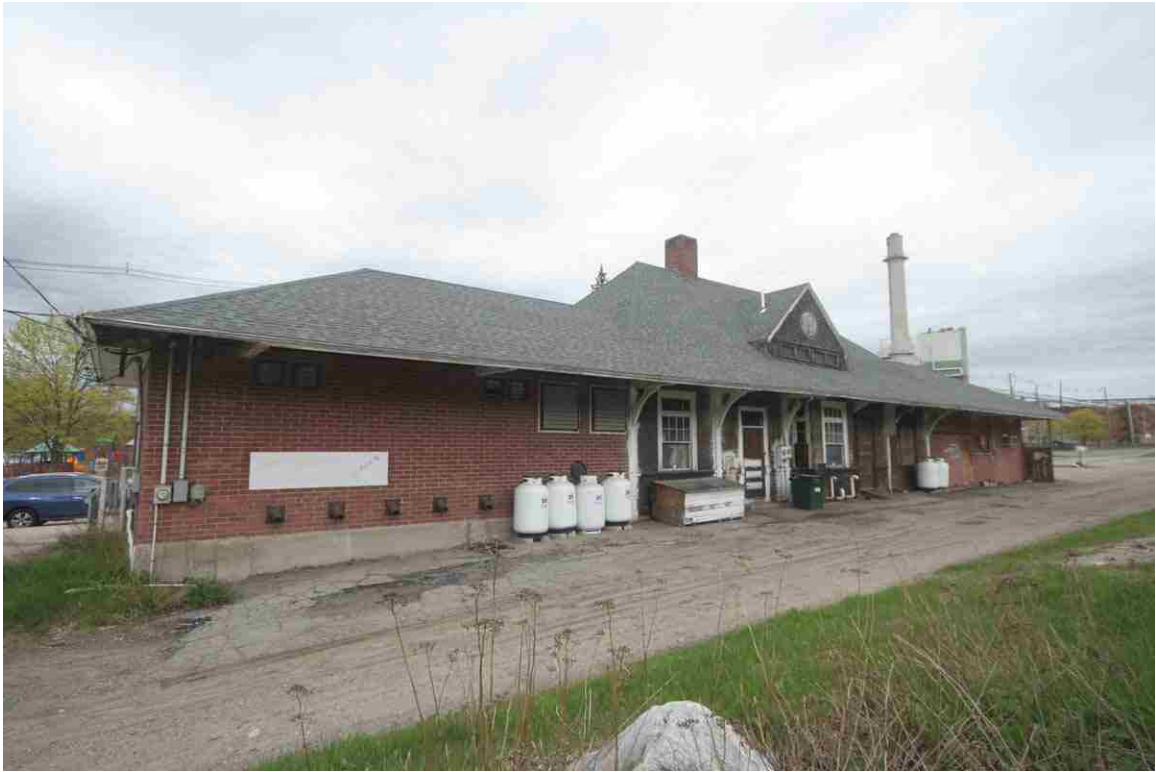
Photo # 133 description: B&M Berlin Station, mp 154.25. Track (east) side. Tracks remain partially exposed. nd. Occupied by commercial tenants. (1 of 2).
