**TABLE OF OBSERVED FEATURES
 SURVEY AREA 3
 MT. WASHINGTON BRANCH
 WING ROAD, BETHLEHEM TO
 MT. WASHINGTON BASE STATION**

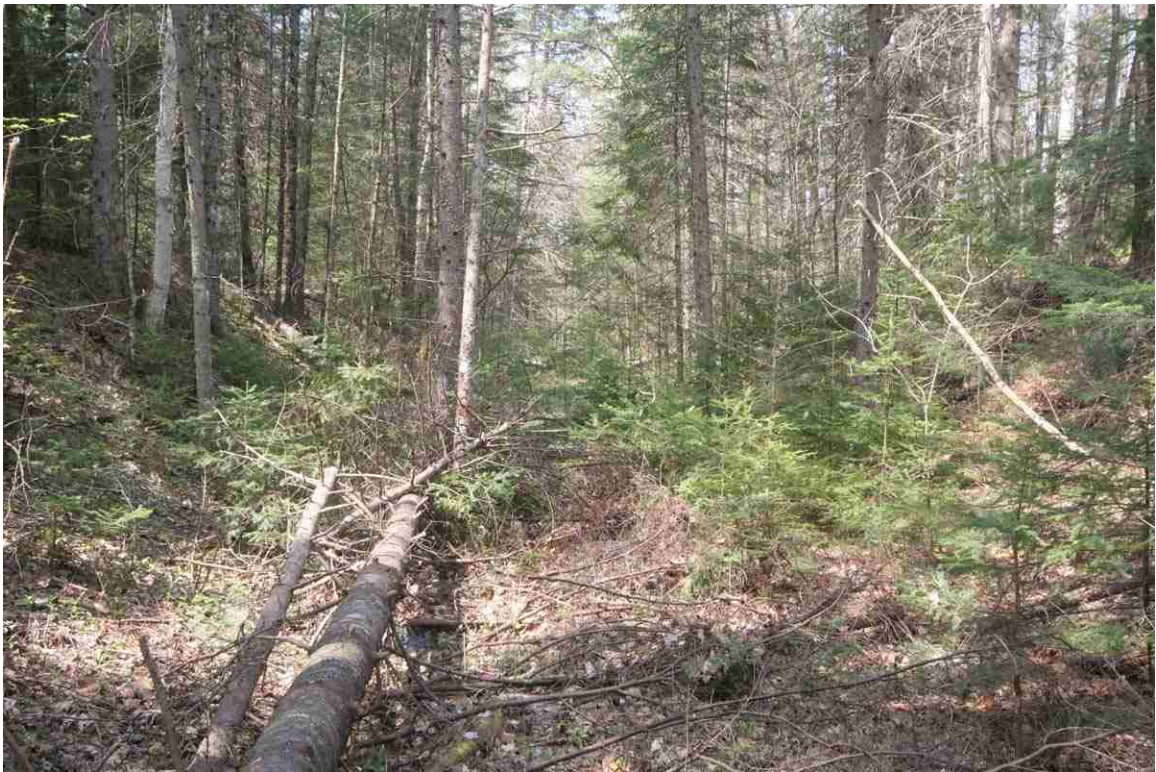
Photo # 10 description: Abandoned ROW, Bethlehem. mp~121.34. Typical condition, reclaimed by nature.

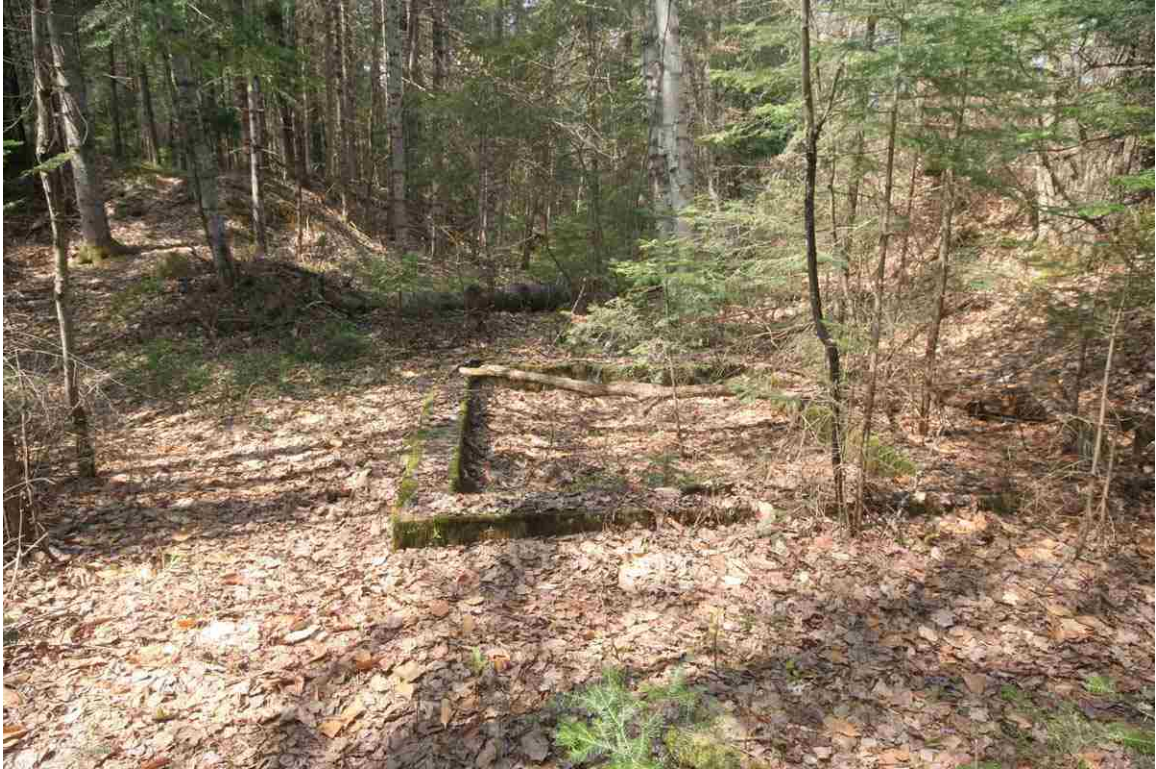
Photo # 11 description: Abandoned ROW. mp~121.36, Bethlehem. Concrete foundation alongside ROW.

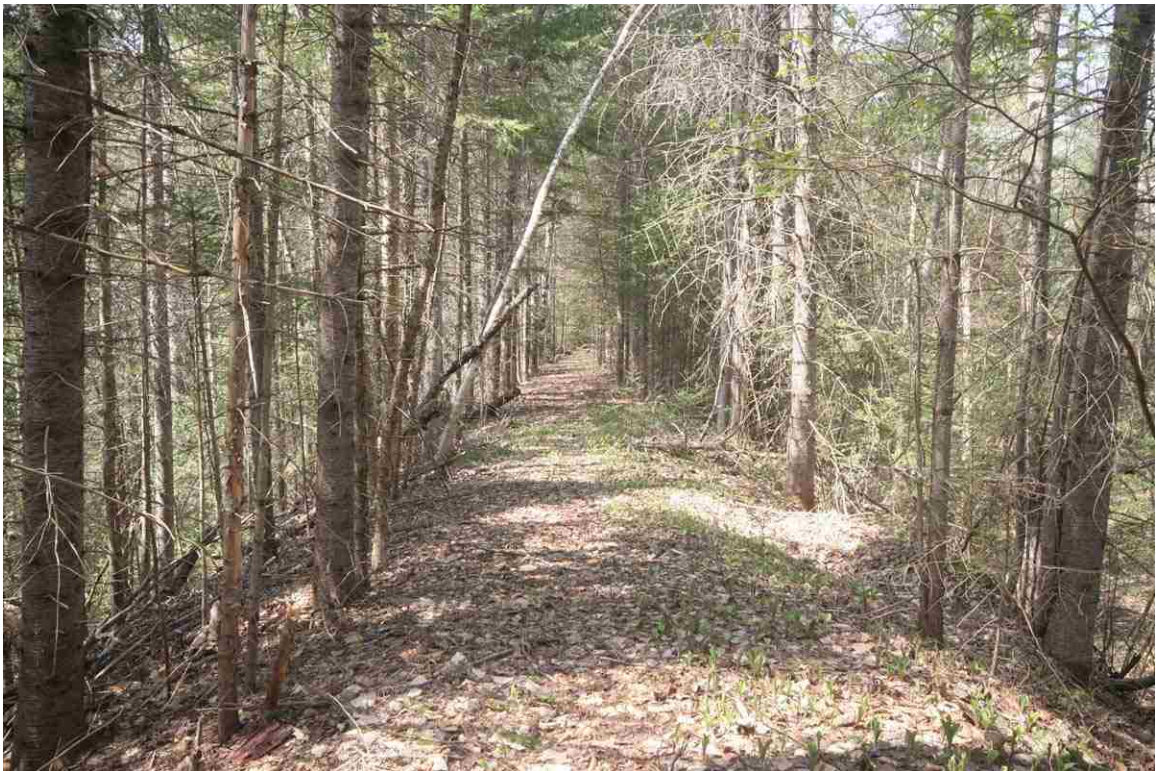
Photo # 12 description: Abandoned ROW. mp~121.39, Bethlehem. Short section north of Maple Street evidently maintained as private snowmobile path.

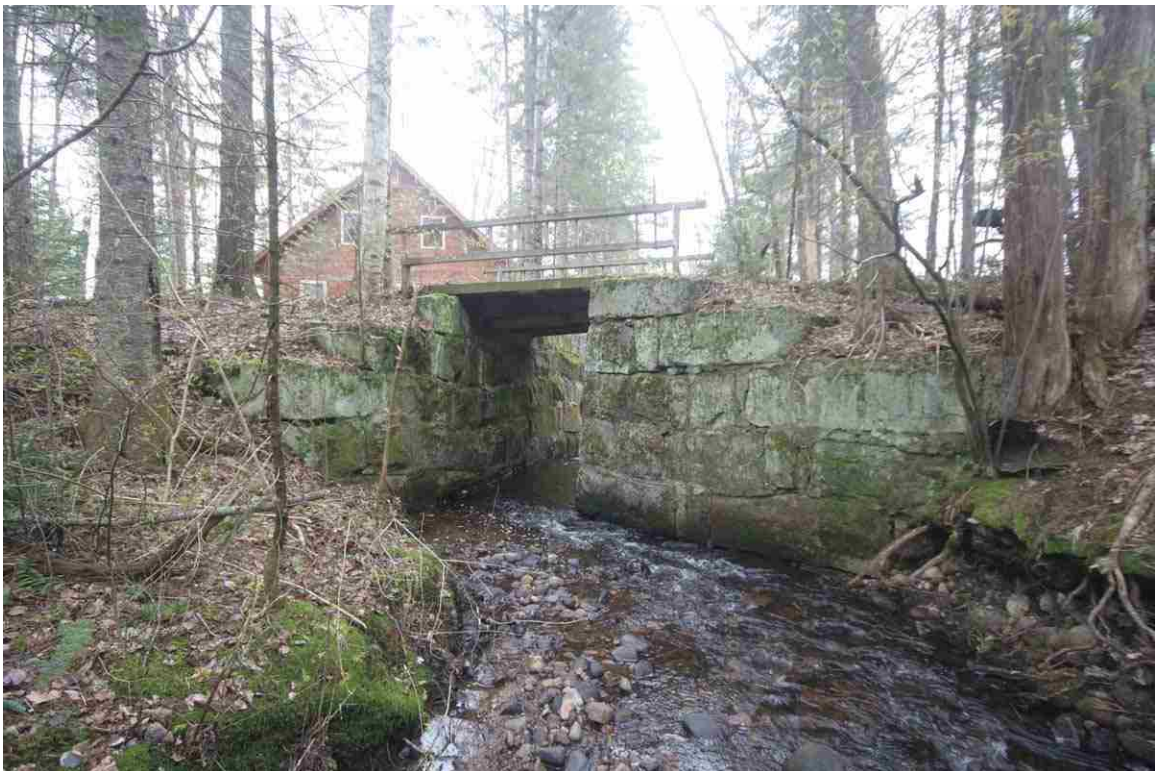
Photo # 44 description: Bridge 128.93 over unnamed stream, Carroll. Steel stringer replacement snowmobile bridge, was wood stringer. On high split quarry stone abutments. Upstream side. (1 of 2).

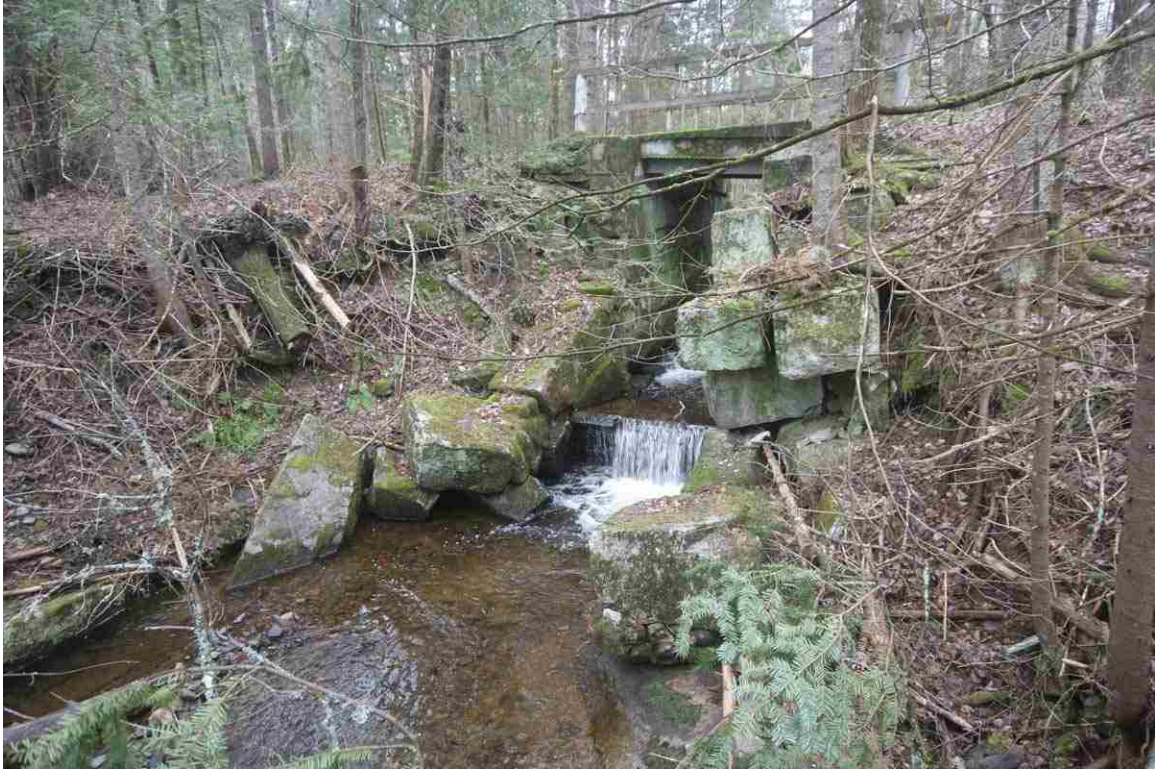
Photo # 45 description: Bridge 128.93 over unnamed stream, Carroll. Downstream side. Collapsing. (2 of 2).

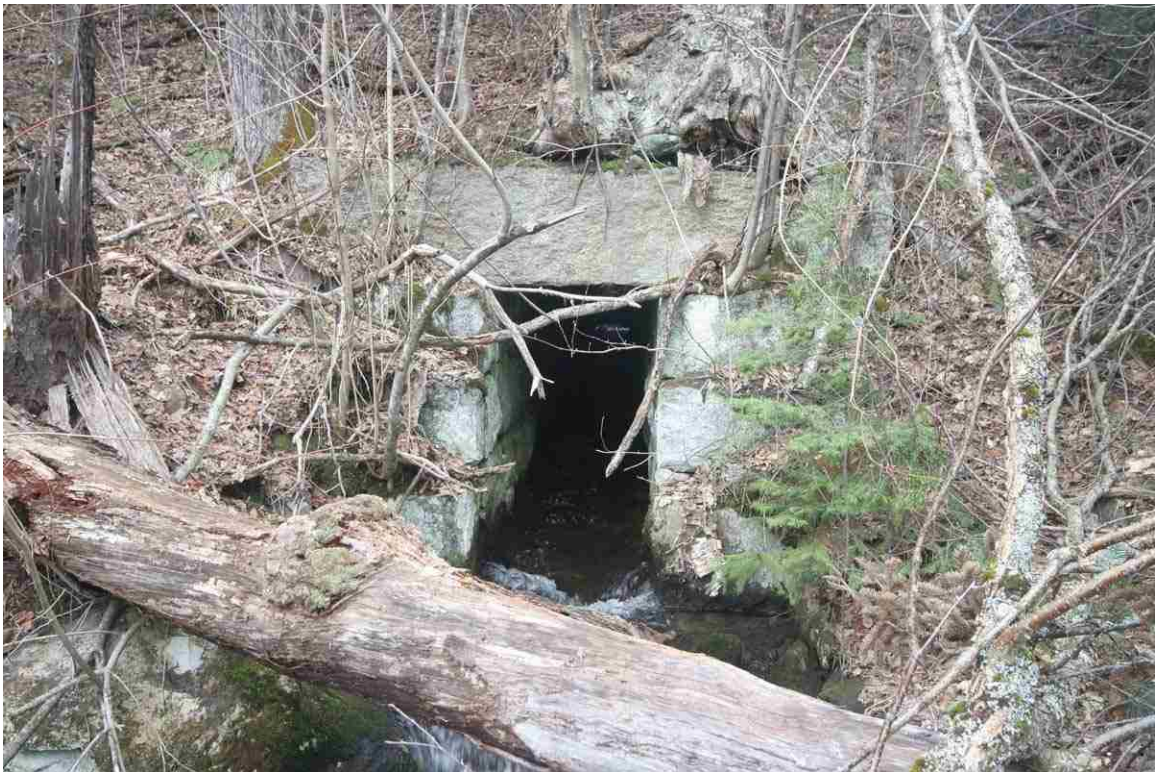
Photo # 60 description: Culvert 133.07, Carroll. Stone box, 6' x 8'. Impressive size with deep cover, in good condition. nd.

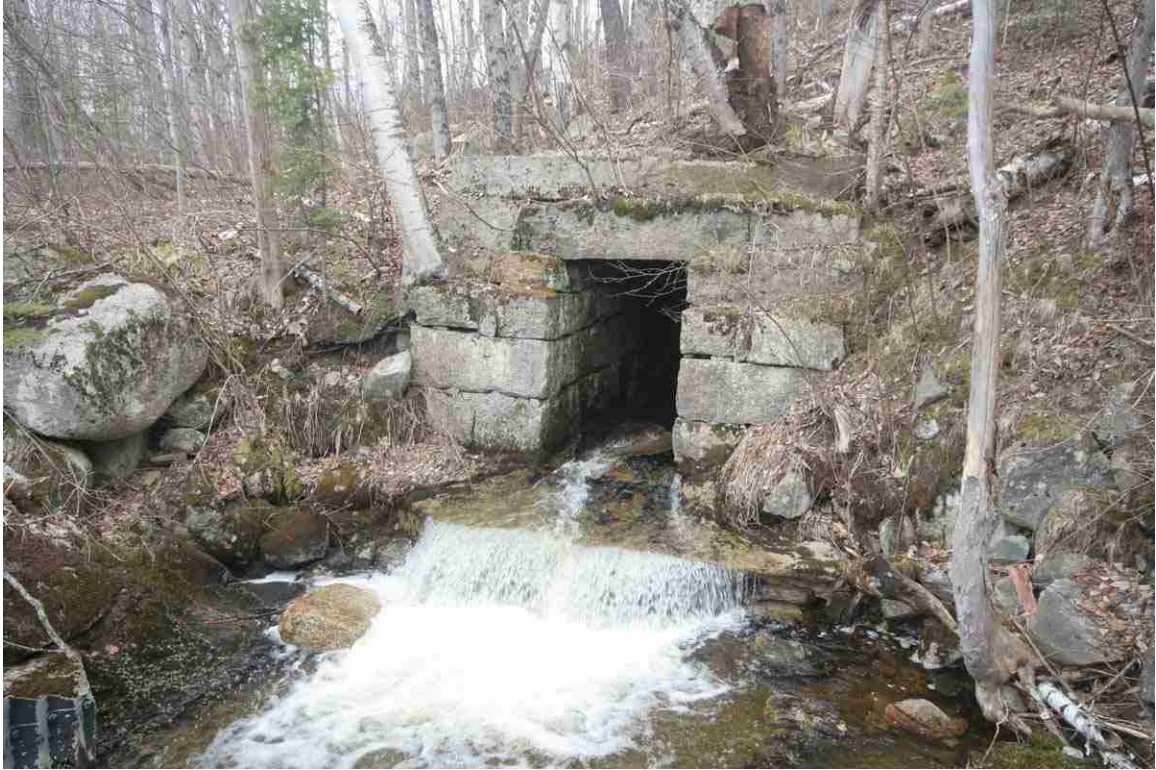
Photo # 61 description: Culvert 133.13, Black Brook, Carroll. Stone box, 3' x 6'. Quarry split squared granite. nd

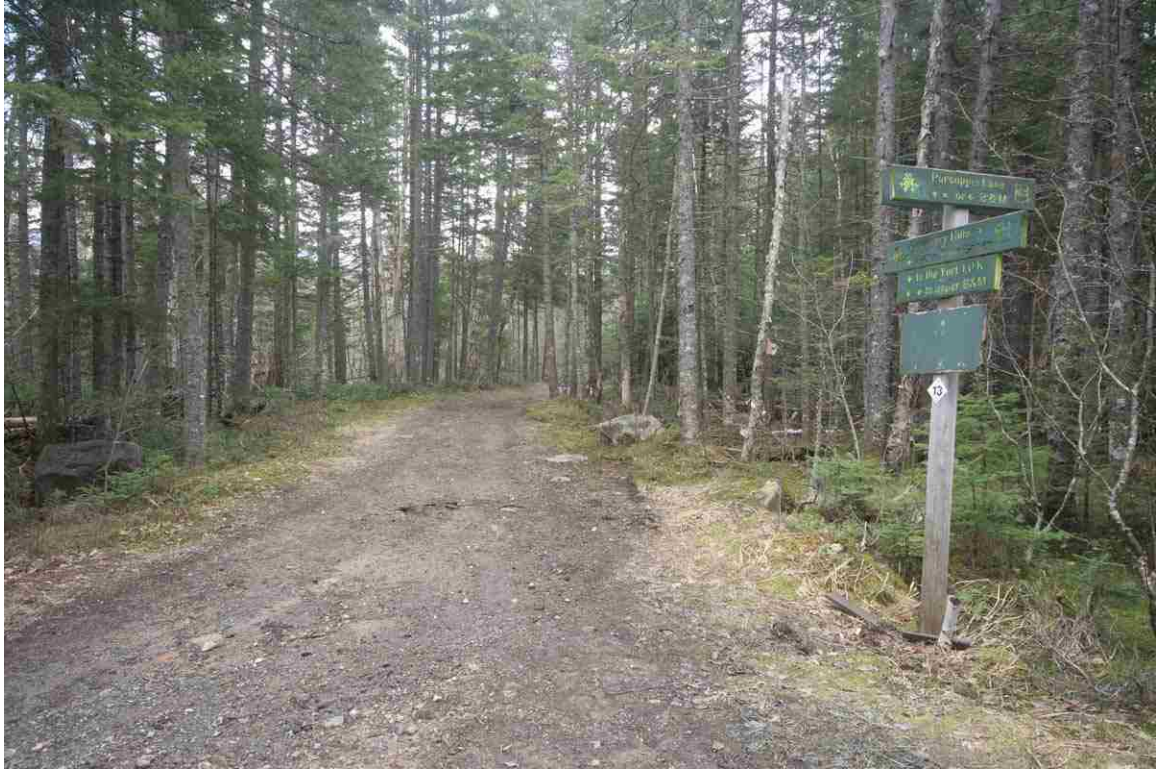
Photo # 83 description: Condition of ROW, maintained as trail by NFS, vicinity of mp~136.00, Crawfords Purchase. Junction with other foot trails.

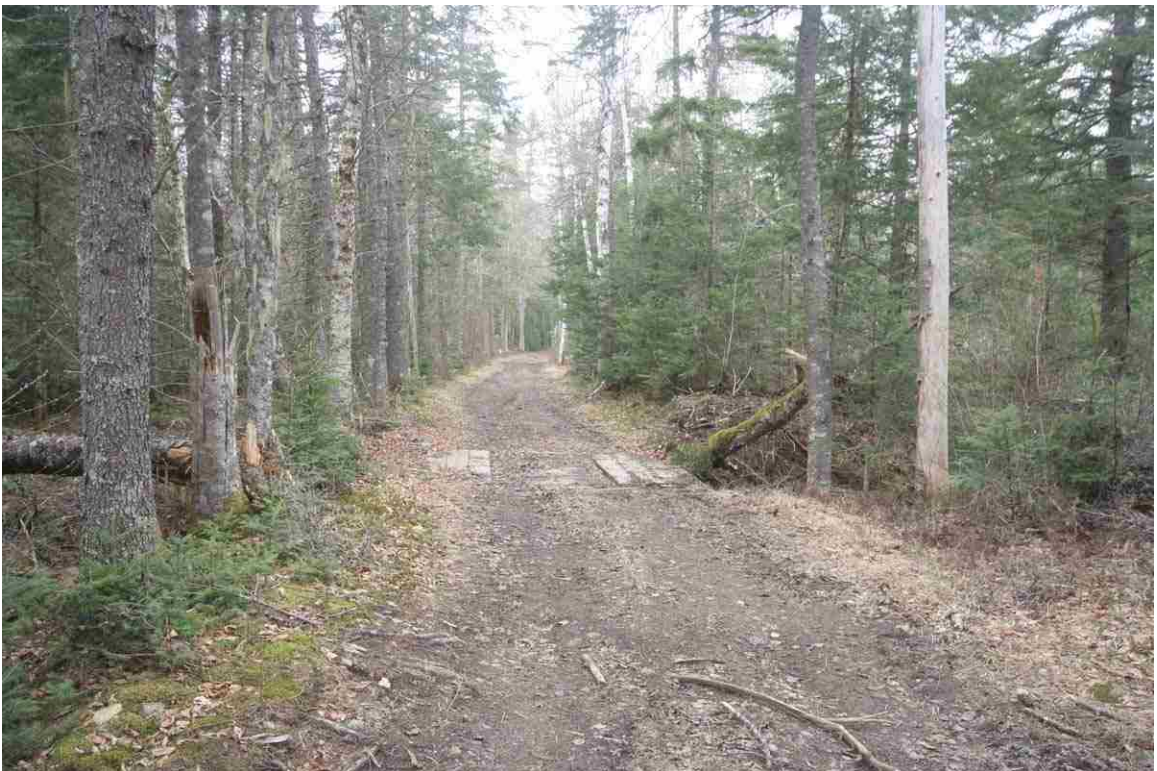
Photo # 84 description: Condition of ROW, maintained as trail. New plank span possibly replaced pipe culvert, vicinity of mp~136.02, Crawfords Purchase.

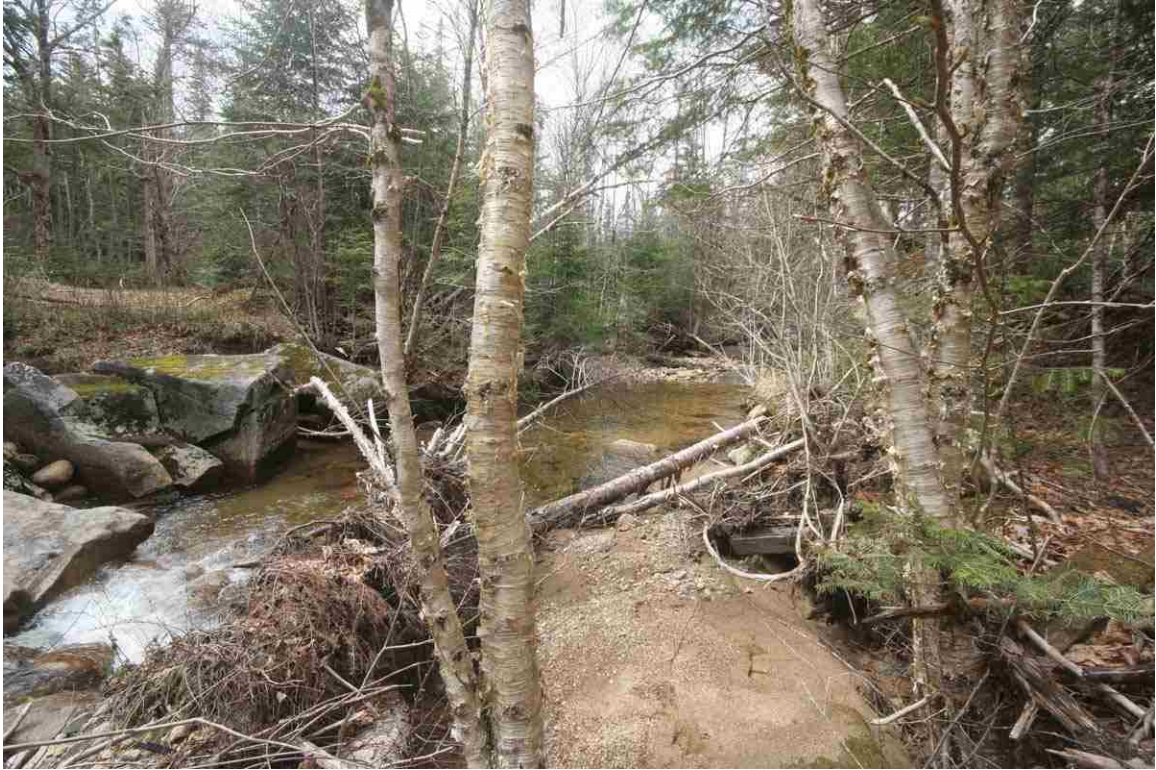
Photo # 85 description: Location of washed out bridge or culvert over unnamed stream crossing, vicinity of mp~137.90, Crawfords Purchase. Random quarried stones are strewn along stream banks.

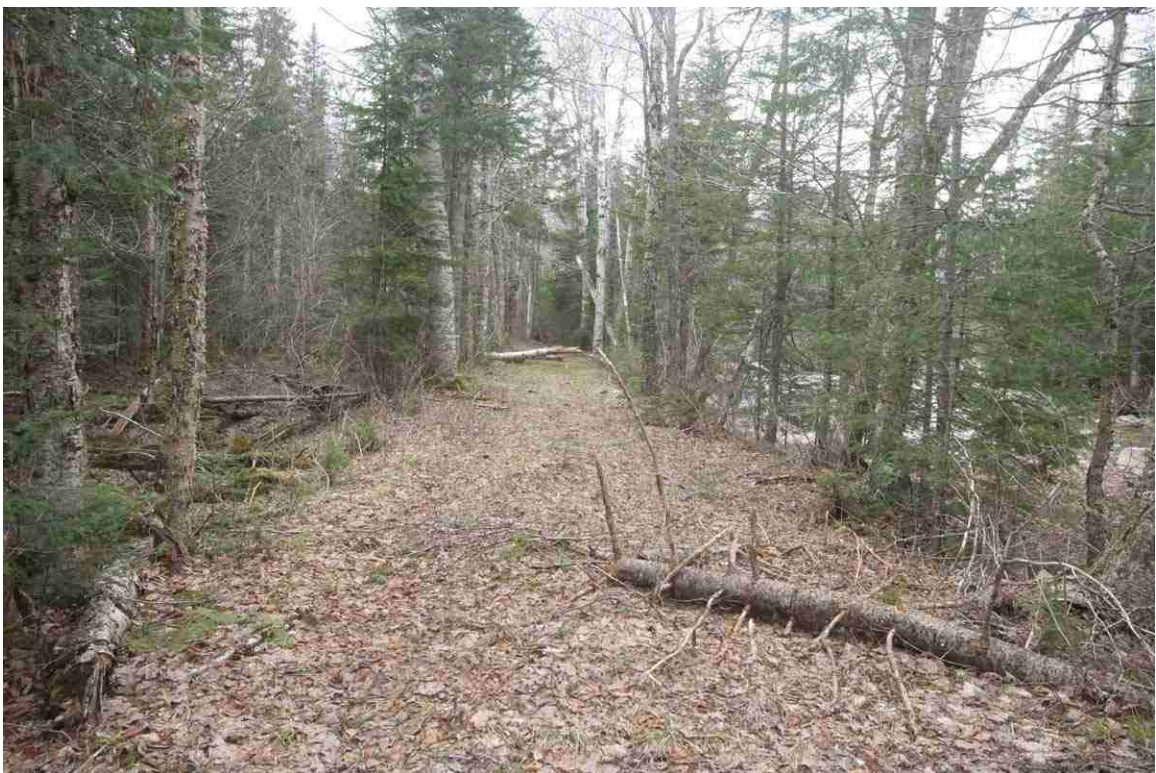
Photo # 86 description: Condition of ROW, no longer maintained as trail, vicinity of mp~138.10, Crawfords Purchase.

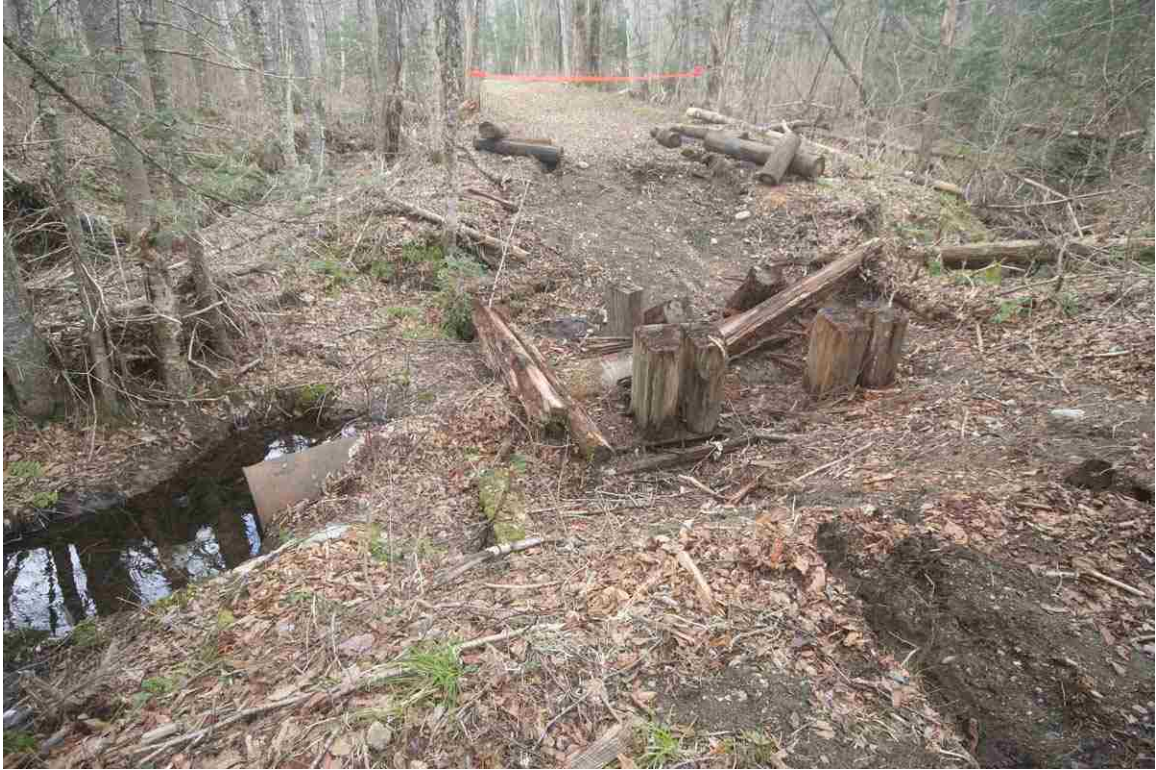
Photo # 87 description: Culvert 138.23, Crawfords Purchase. 24" cast iron pipe on timber frame. Note reliving piles that carried stringer span over solid fill. Washed out. nd. (1 of 3).
