**CONNECTICUT RIVER BRIDGE
06 WALPOLE – BELLOWS FALLS**

NH Bridge ID: Walpole 058/053

CARRYING: Church Street
PRESENT NAME: Church Street Bridge
DATE BUILT: 1983
LAT/LONG: 43.138213,-72.448225

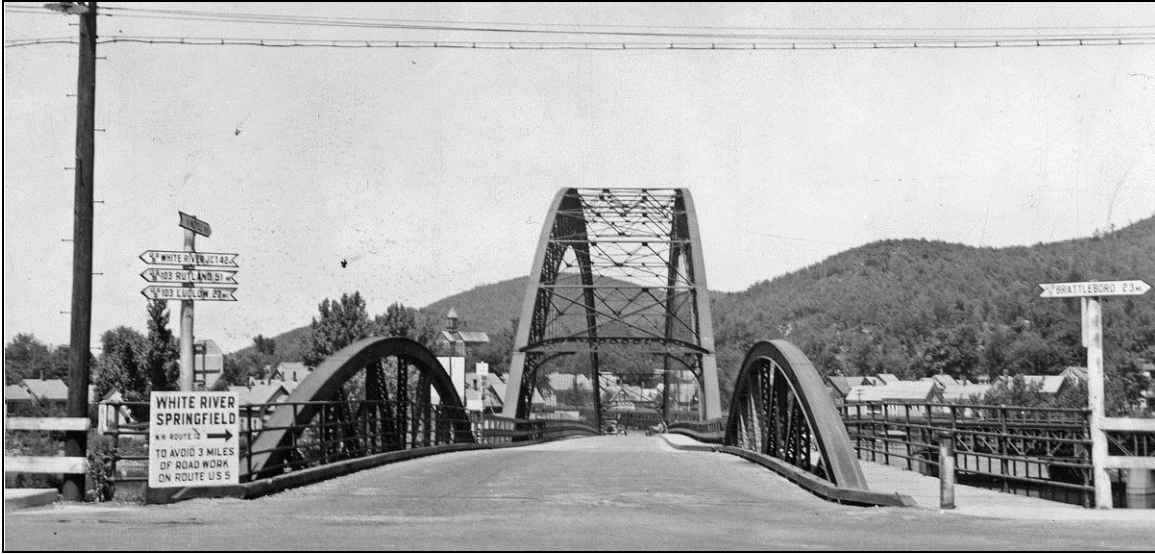
FIGURE 4: Arch Bridge, Bellows Falls end, showing bowstring truss span over the tracks of the former Rutland Railroad (NHDOT 1941).

bowstring bridge over the tracks with a steel girder bridge. In 1971, consulting engineers recommended to New Hampshire that the major arch bridge be closed to vehicle use due to its deteriorated condition, which recommendation was accepted. The historic bridge, a symbol of innovation in American bridge engineering, remained in pedestrian use until 1982 when it was demolished despite national public protest. The “unsound” bridge required five attempts at explosive demolition to bring it down.

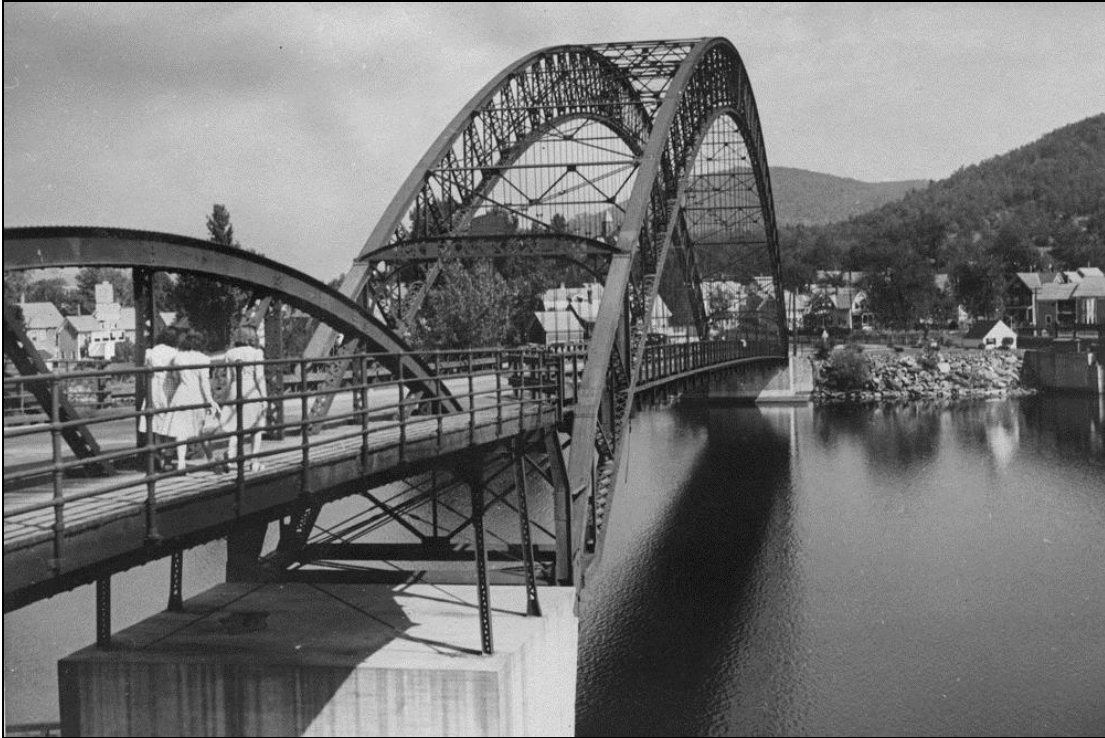
FIGURE 7: Arch Bridge, downstream side, from Vermont, c.1945, showing bowstring truss approach span (at left), replaced in 1961 with steel stringer span (Cheshire County Historical Society).
