MILL STREET BRIDGE

Spanning Ammonoosuc Rail Trail (former Boston & Maine Railroad)

HAER No. NH-55

HISTORIC AMERICAN ENGINEERING RECORD

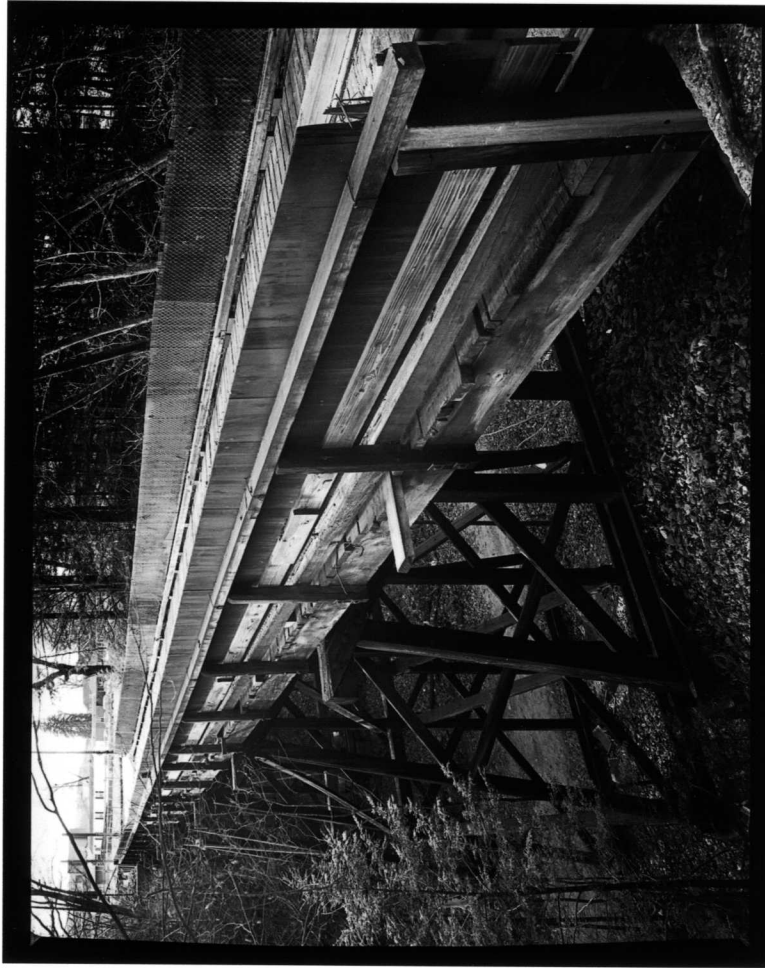
HAER No. NH - 55 - 3

- NH-55-1 APPROACH TO BRIDGE FROM NORTH. VIEW LOOKING SOUTH.
- NH-55-2 APPROACH TO BRIDGE FROM SOUTH. VIEW LOOKING NORTH.
- NH-55-3 OBLIQUE VIEW OF EAST ELEVATION, SHOWING RAILING ASSEMBLY,
FLOORING, BENT ATTACHMENTS. VIEW LOOKING SOUTHWEST.

There are nine 8" x 14" timber stringers spaced on 2'-2" centers. The road deck consists of 3-1/2" x 8" pressure treated planks laid flat and perpendicular to the stringers. The plastic identification labels that come attached to the ends of pressure treated lumber are still attached to many of the planks, indicating their fairly recent installation. The roadway is 16'-5" wide, edged with heavy timber curbs. There are no sidewalks. The solid wood railings are roughly 48" high, consisting of solid vertical wood planking nailed to horizontal timbers nailed to timber posts that are bolted to the outside stringers. Continuous chain link fencing has been attached to the inside face of the railings. Standard W-section steel guardrail on wood posts has been installed along the approaches.

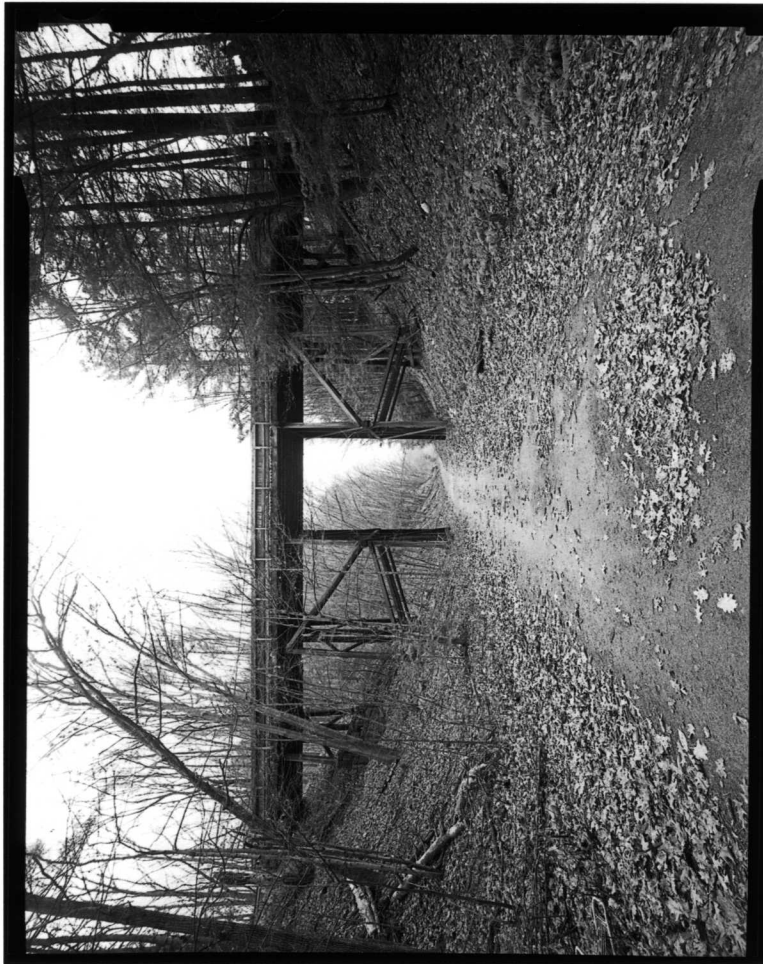
HAER No. NH - 55 - 4

- NH-55-4 WEST ELEVATION FROM FORMER RAILROAD BED. VIEW LOOKING EAST.
- NH-55-5 EAST ELEVATION FROM FORMER RAILROAD BED. VIEW LOOKING WEST.
- NH-55-6 OBLIQUE VIEW OF SOUTH BENTS. VIEW LOOKING
SOUTHEAST.

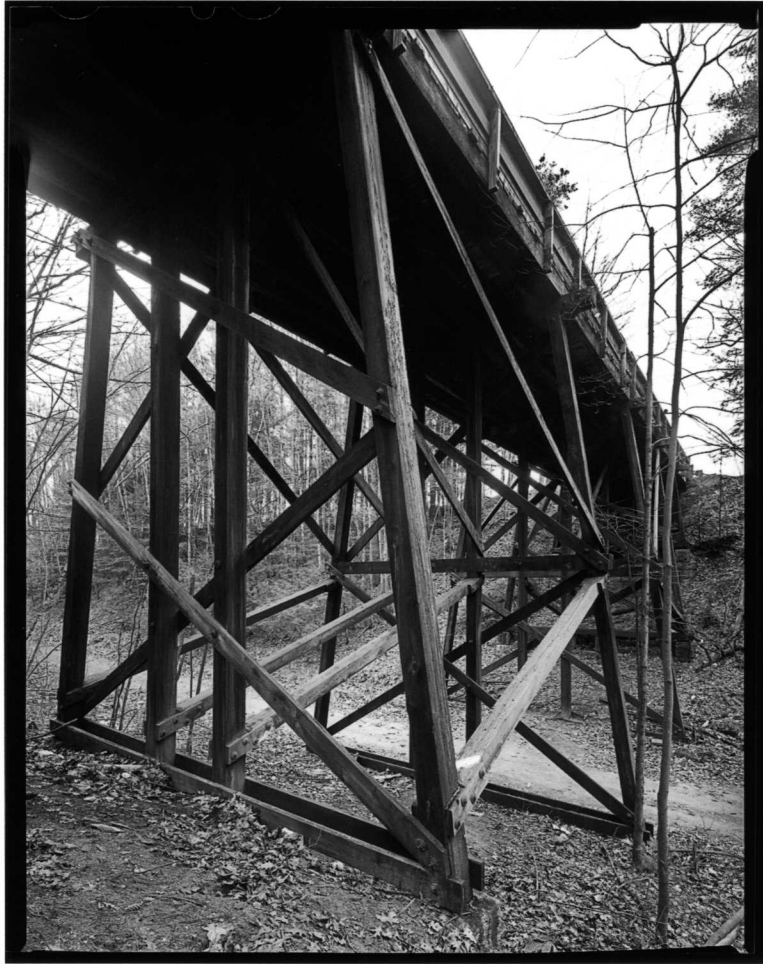
HAER No. NH - 55 - 7

- NH-55-7 DETAIL OF NORTH INTERMEDIATE BENT SHOWING CROSS BRACING
CONNECTIONS AND LATERAL BRACING OF INTERIOR TWO-STORY BENT.
VIEW LOOKING SOUTHEAST.
- NH-55-8 ELEVATION OF NORTH INTERIOR TWO-STORY BENT. VIEW LOOKING
NORTH.

The inside bents (4 & 5) with a height of 34' are constructed as two-story frames, meaning a second complete upper frame consisting of four columns, a cap beam and two cross braces is stacked atop an identical lower frame. The method of attaching and bolting the bracing to the columns and the ends of the cap beams unifies the connections of the upper and lower frames. The cap beams are extended past the columns about 6" to accept the bracing end bolt. Each column bears on a 24" square granite block footing extending above grade about 4" and to an unknown depth below grade. Additional diagonal bracing, referred to on the drawings as tower bracing, connects the columns of the two-story bent at a point just above and below the first-story cap beam, with the top and bottoms of the columns of the adjacent bent. Because the adjacent bent is single-story, built on a slope and shorter by about 6', the two bents together do not form a typical symmetrical timber trestle tower with two equal multi-story bents with each story fully cross-braced in both directions.

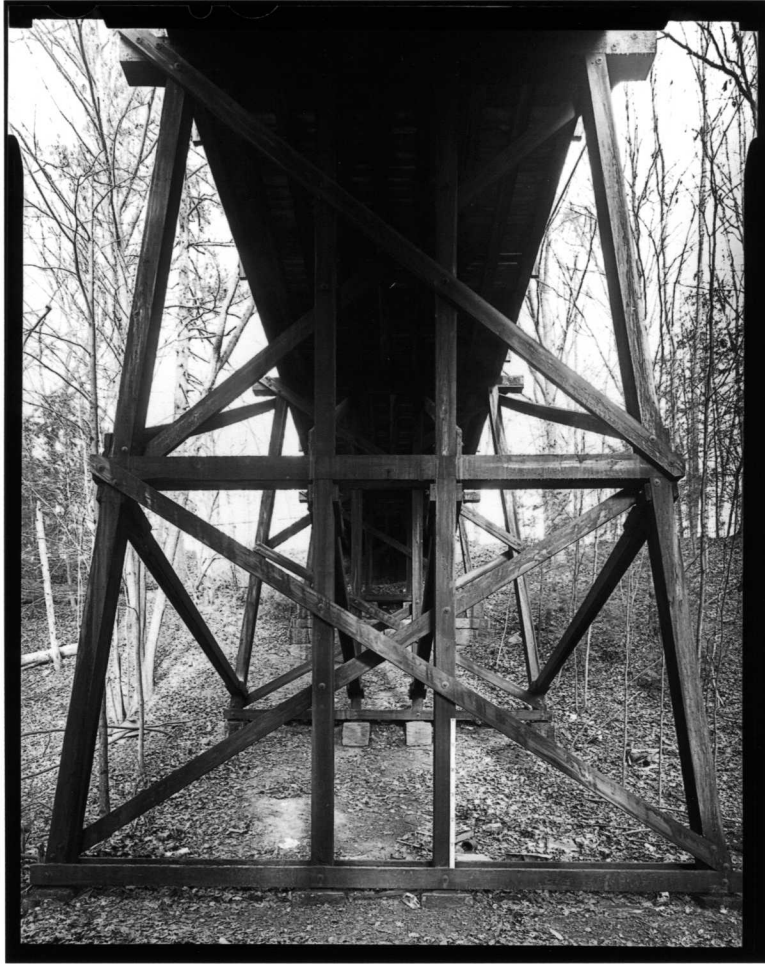
HAER No. NH - 55 - 9

- NH-55-9 ELEVATION OF SOUTH INTERIOR TWO-STORY BENT, WITH SCALE. VIEW
LOOKING SOUTH.
- NH-55-10 NORTH INTERMEDIATE BENT AND FOOTINGS SHOWING LATERAL
BRACING CONNECTION. VIEW LOOKING NORTH.

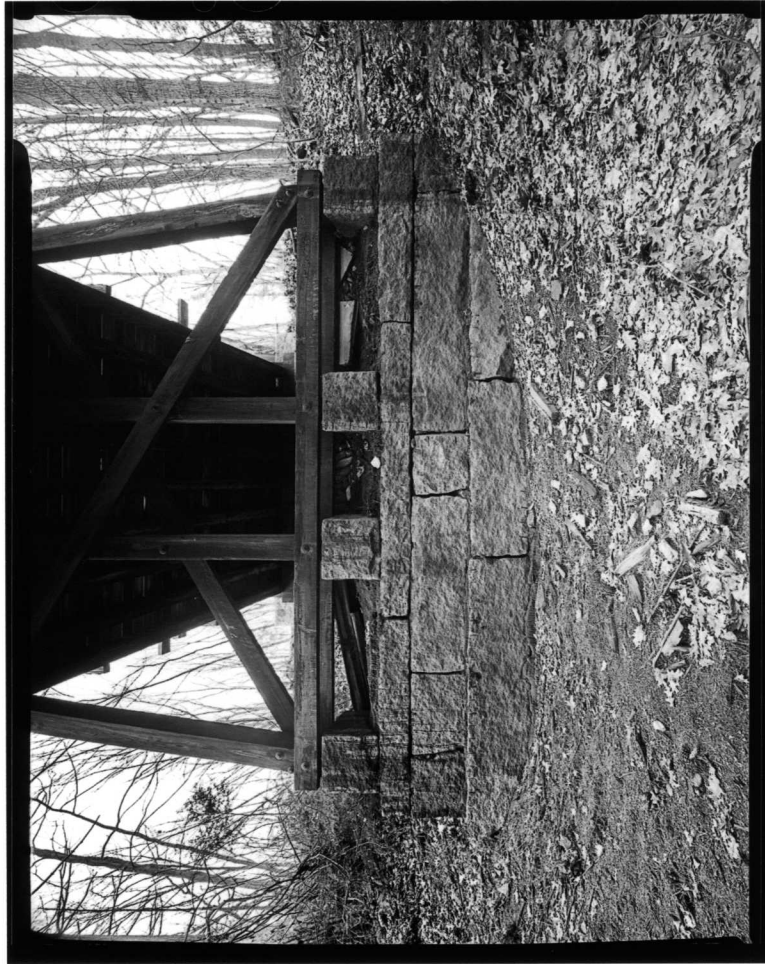
HAER No. NH - 55 - 11

- NH-55-11 NORTH INSIDE BENT AND GRANITE FOOTING. VIEW LOOKING NORTH.
- NH-55-12 SOUTH INSIDE BENT AND GRANITE FOOTING WITH SCALE. VIEW LOOKING
SOUTH.
- NH-55-13 NORTH ABUTMENT. VIEW LOOKING NORTH.

The intermediate bents (3 & 6) and outside bents (2 & 7) are single story bents differing only in height, bracing and footing detail. The intermediate bents are about 28' tall, requiring two sets of cross bracing to brace the one-piece columns. The columns bear on the same type of individual granite footings like those carrying the inside bents. The outside bents are roughly 18' tall with one set of cross bracing. They bear on granite blocks that in-turn bear on a granite retaining wall, three courses of which is exposed on the down-slope face.

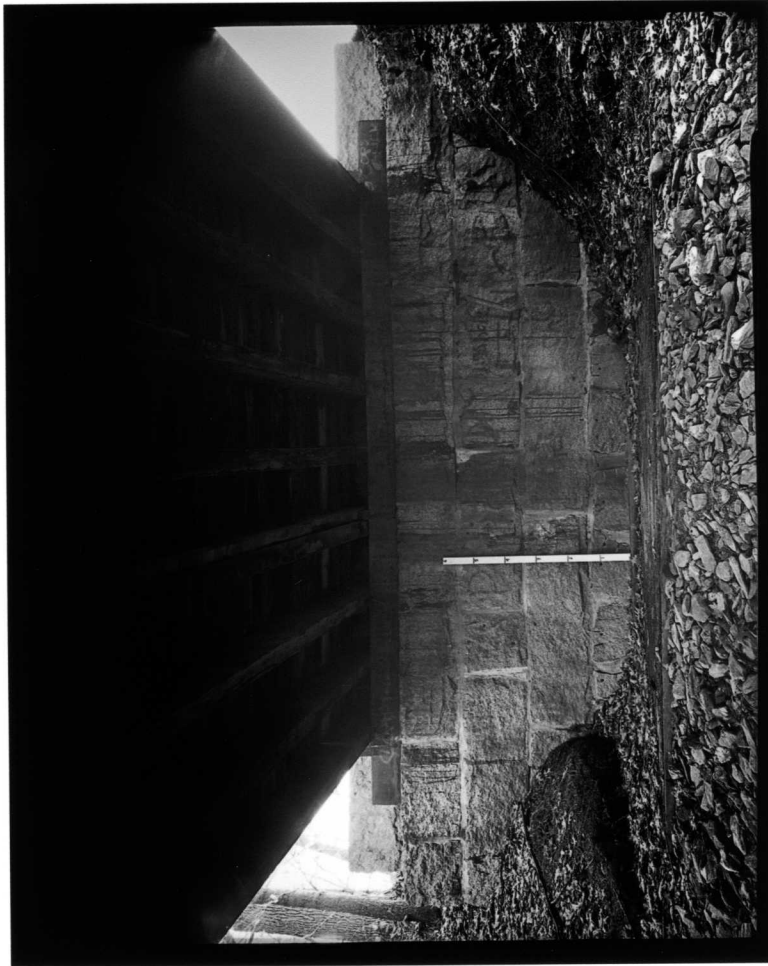
HAER No. NH - 55 - 14

- NH-55-14 SOUTH ABUTMENT, WITH SCALE. VIEW LOOKING SOUTH.

The abutments are constructed of coursed, split-face granite blocks laid in mortar. The blocks and mortar joints are not as finely squared and fitted as those of the bent footings but still meet the definition of ashlar masonry. On the face of the abutments, originally just two courses of stone were exposed but erosion has since exposed three or four courses and the concrete footings on which they were built. The abutments have a 16" seat and granite back walls 27" high. On top of the granite abutment is a 10" x 12" timber sill on which the stringers bear. A retaining wall consisting of pressure treated planks has been recently installed in front of the south abutment to check erosion.
