**NEW HAMPSHIRE HISTORIC PROPERTY DOCUMENTATION**  
**POWER CANAL**  
**NASHUA MANUFACTURING COMPANY, NASHUA, NH**

**NH State No. 538-G**

**LOCATION:** Nashua River at Mine Falls Dam to Pine Street Extension, passing through Mine Falls Park, Nashua, Hillsborough County, New Hampshire  
USGS Nashua North NH Quadrangle  
UTM Coordinates: 19.297615.4737120

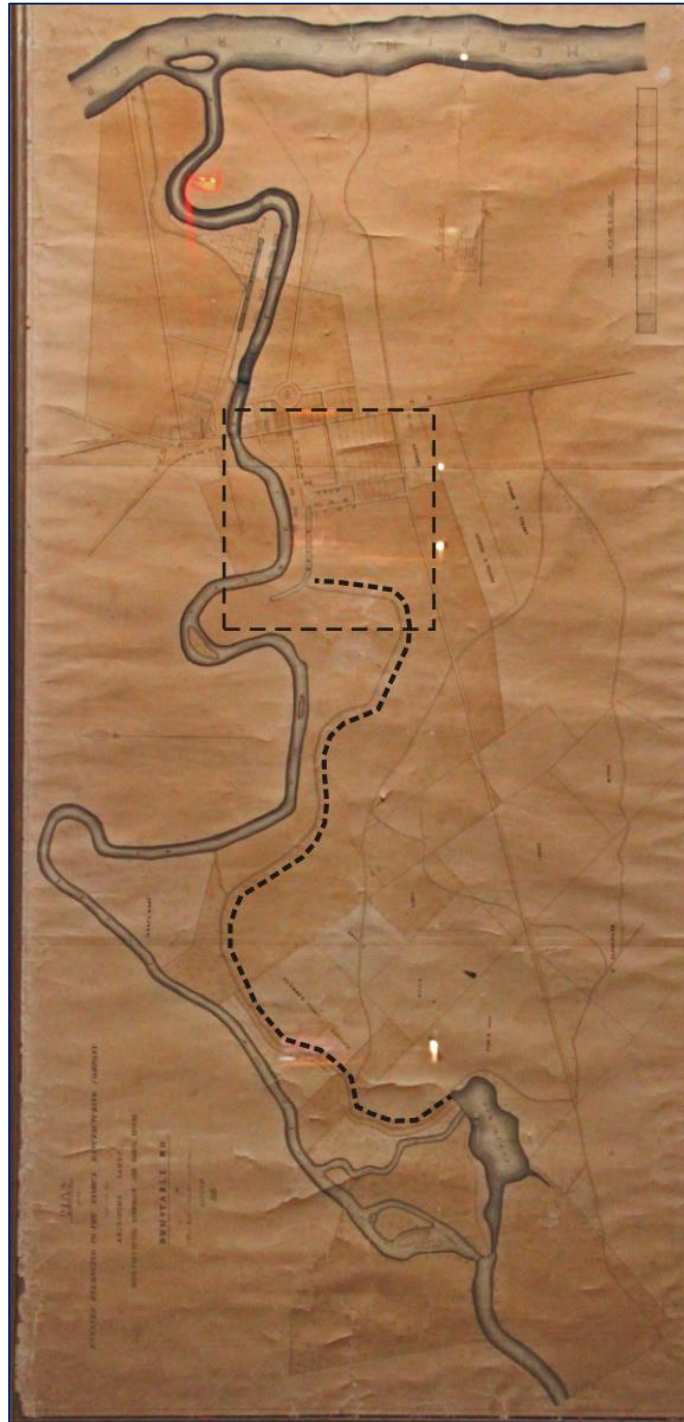
**FIGURE 4:** 1825 Map of Nashua Manufacturing Company property, showing Power Canal (beside dashed line) and mill development at Canal Basin at eastern terminus of canal (map oriented with east at top) in area of dashed box, detail of which shown below in Figure 4. (Source: Rust, 1825. Nashua Historical Society map collection).

The Nashua Manufacturing Company Power Canal (Canal) is an artificial water course approximately 14,010 feet in length, 60' wide on average and perhaps as much as 8 feet deep in places. It is located in the geographical center of the City of Nashua and follows a winding course, roughly paralleling the Nashua River in its course west to east to the Merrimack River (see Figures 1 and 2). Along most of the course of the Canal the setting is a natural undeveloped wooded environment that is now a City park with improved trails. At its eastern end the Canal runs alongside Ledge Street for nearly 1000 feet before turning north and running another 1000 feet parallel to Pine Street, through the historic industrial district of the Nashua Manufacturing Company to its terminus at Pine Street Extension (see Figure 3). The Canal was completed in 1824 along with a dam, gates and mill pond to provide water to the water wheels powering the company textile mill located 1.75 miles east of the dam (see Figure 4).

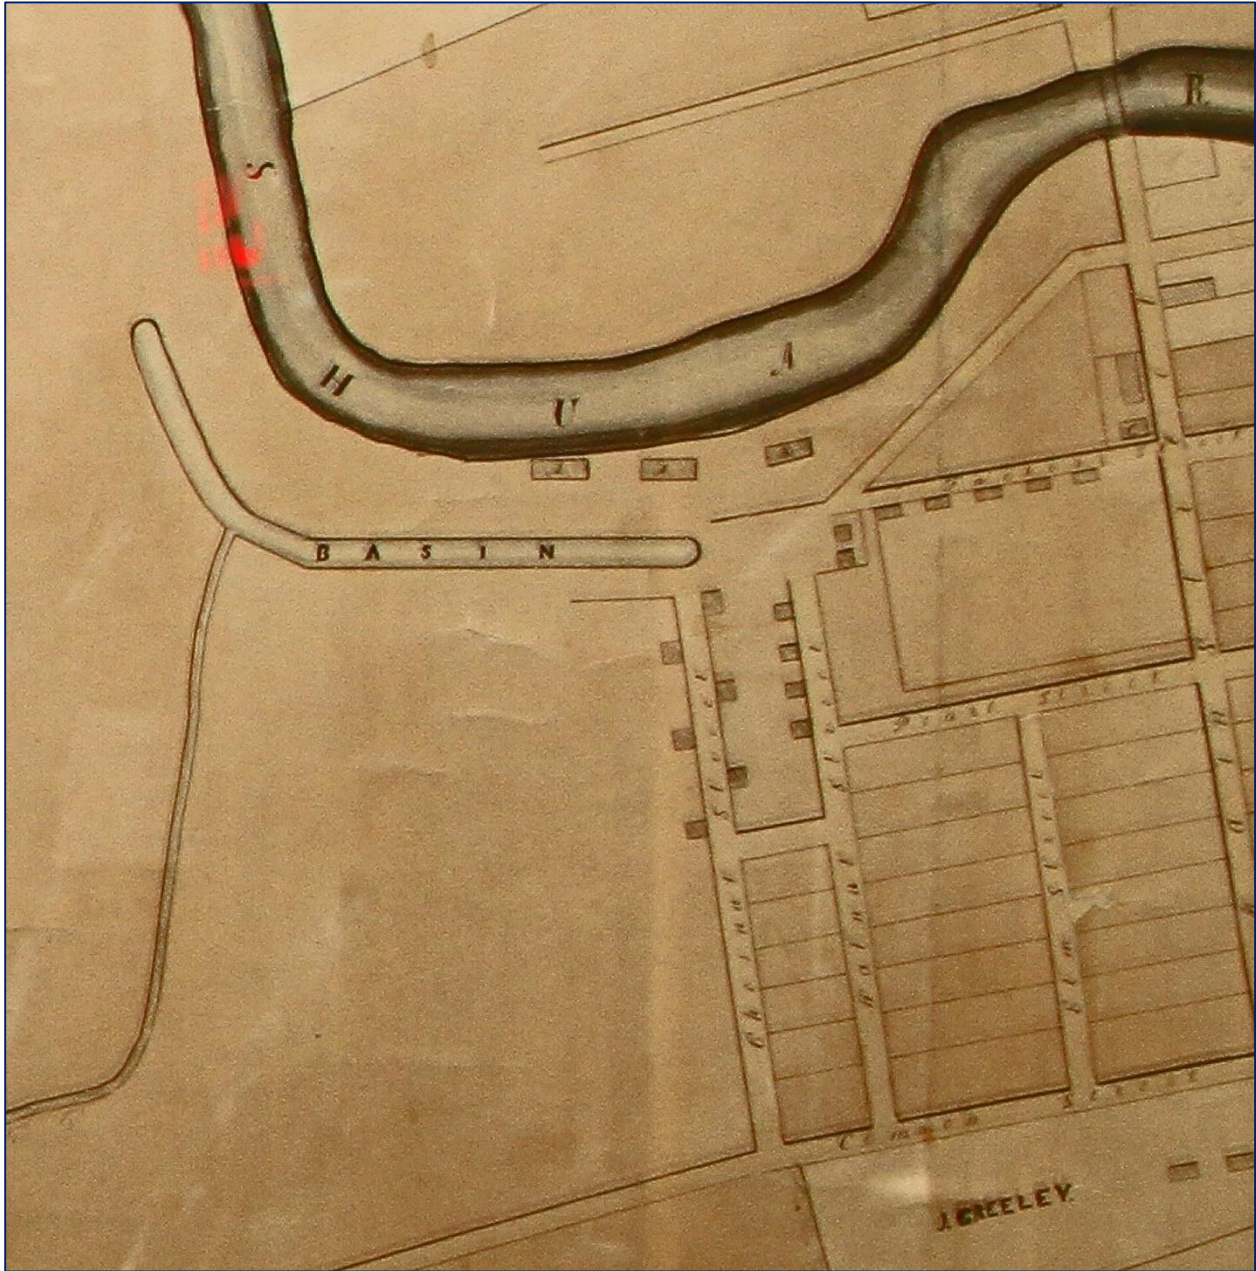
**FIGURE 5:** Detail of 1825 map of Nashua Manufacturing Company property by Thos. Rust, (area within dashed box on complete map, Figure 4) showing Canal Basin, three mill buildings, mill worker housing and other buildings along Walnut, Chestnut and Factory Streets. (Source: Rust, 1825. Nashua Historical Society map collection).

The status of development of the Canal, Canal Basin and mill complex as of 1842 is shown on the map of Nashua prepared that year by J. Hoar and F. Mead (see Figure 6). The west end of the Basin depicted on the 1825 map as originally extending northwest of the canal outlet (see Figure 5), is not shown on the 1842 map, apparently having been filled in. The 1842 map shows the Basin as having been widened and two bridges added, one at the west end of Basin Street carrying it over the north end of the Canal where it enters the Basin, and the second spanning the Basin between Ash and Vine streets.

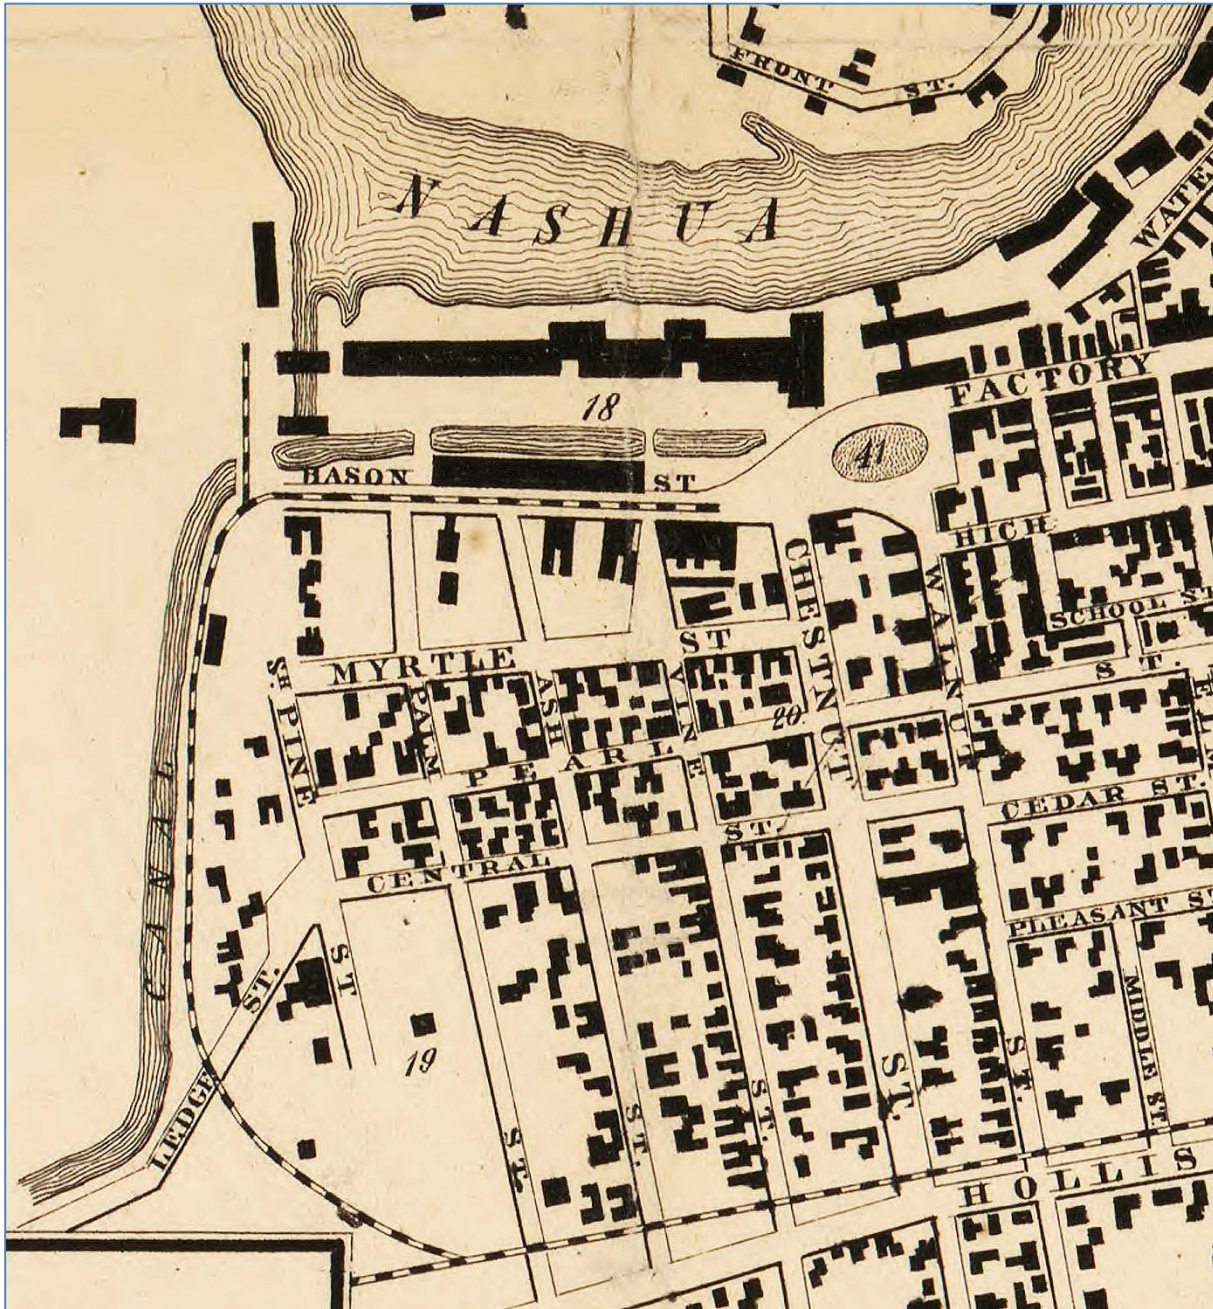
**FIGURE 7:** 1858 map of Nashua, showing further development of Nashua Manufacturing Company mill complex, most importantly the addition of the Worcester & Nashua Railroad serving the mill with a line that runs north along the canal after branching off the main line along Hollis Street. A low stone retaining wall was built along the east side of the canal to support the bank alongside the railroad tracks. Based on a comparison to the 1842 map (Figure 6) the canal appears to have been realigned more due-north, but the difference may be a mapping inaccuracy. The tracks then extend over the Canal Basin on a new bridge (see Figure 8) and east along Basin Street. Three bridges now span the Canal Basin. (Source: Chase 1858).

By 1858, as show on the map of Nashua by J. Chase, the mill complex and particularly the neighborhood around it had undergone dramatic development, largely due to the opening of the

Worcester and Nashua Railroad in 1848 (see Figure 7). A branch line to serve the mill complex was extended north off the main line running west to east along Hollis Street to the Worcester Depot at Main Street and the rail yards beyond. The Nashua Manufacturing Company branch line ran north along the east side of the canal and then over the Canal Basin on a new bridge (see Figure 8) to serve a Boiler House and other future developments planned for the northwest corner of the mill complex property. The tracks were also extended east along Basin Street and a third bridge spanning the Canal Basin has been added.

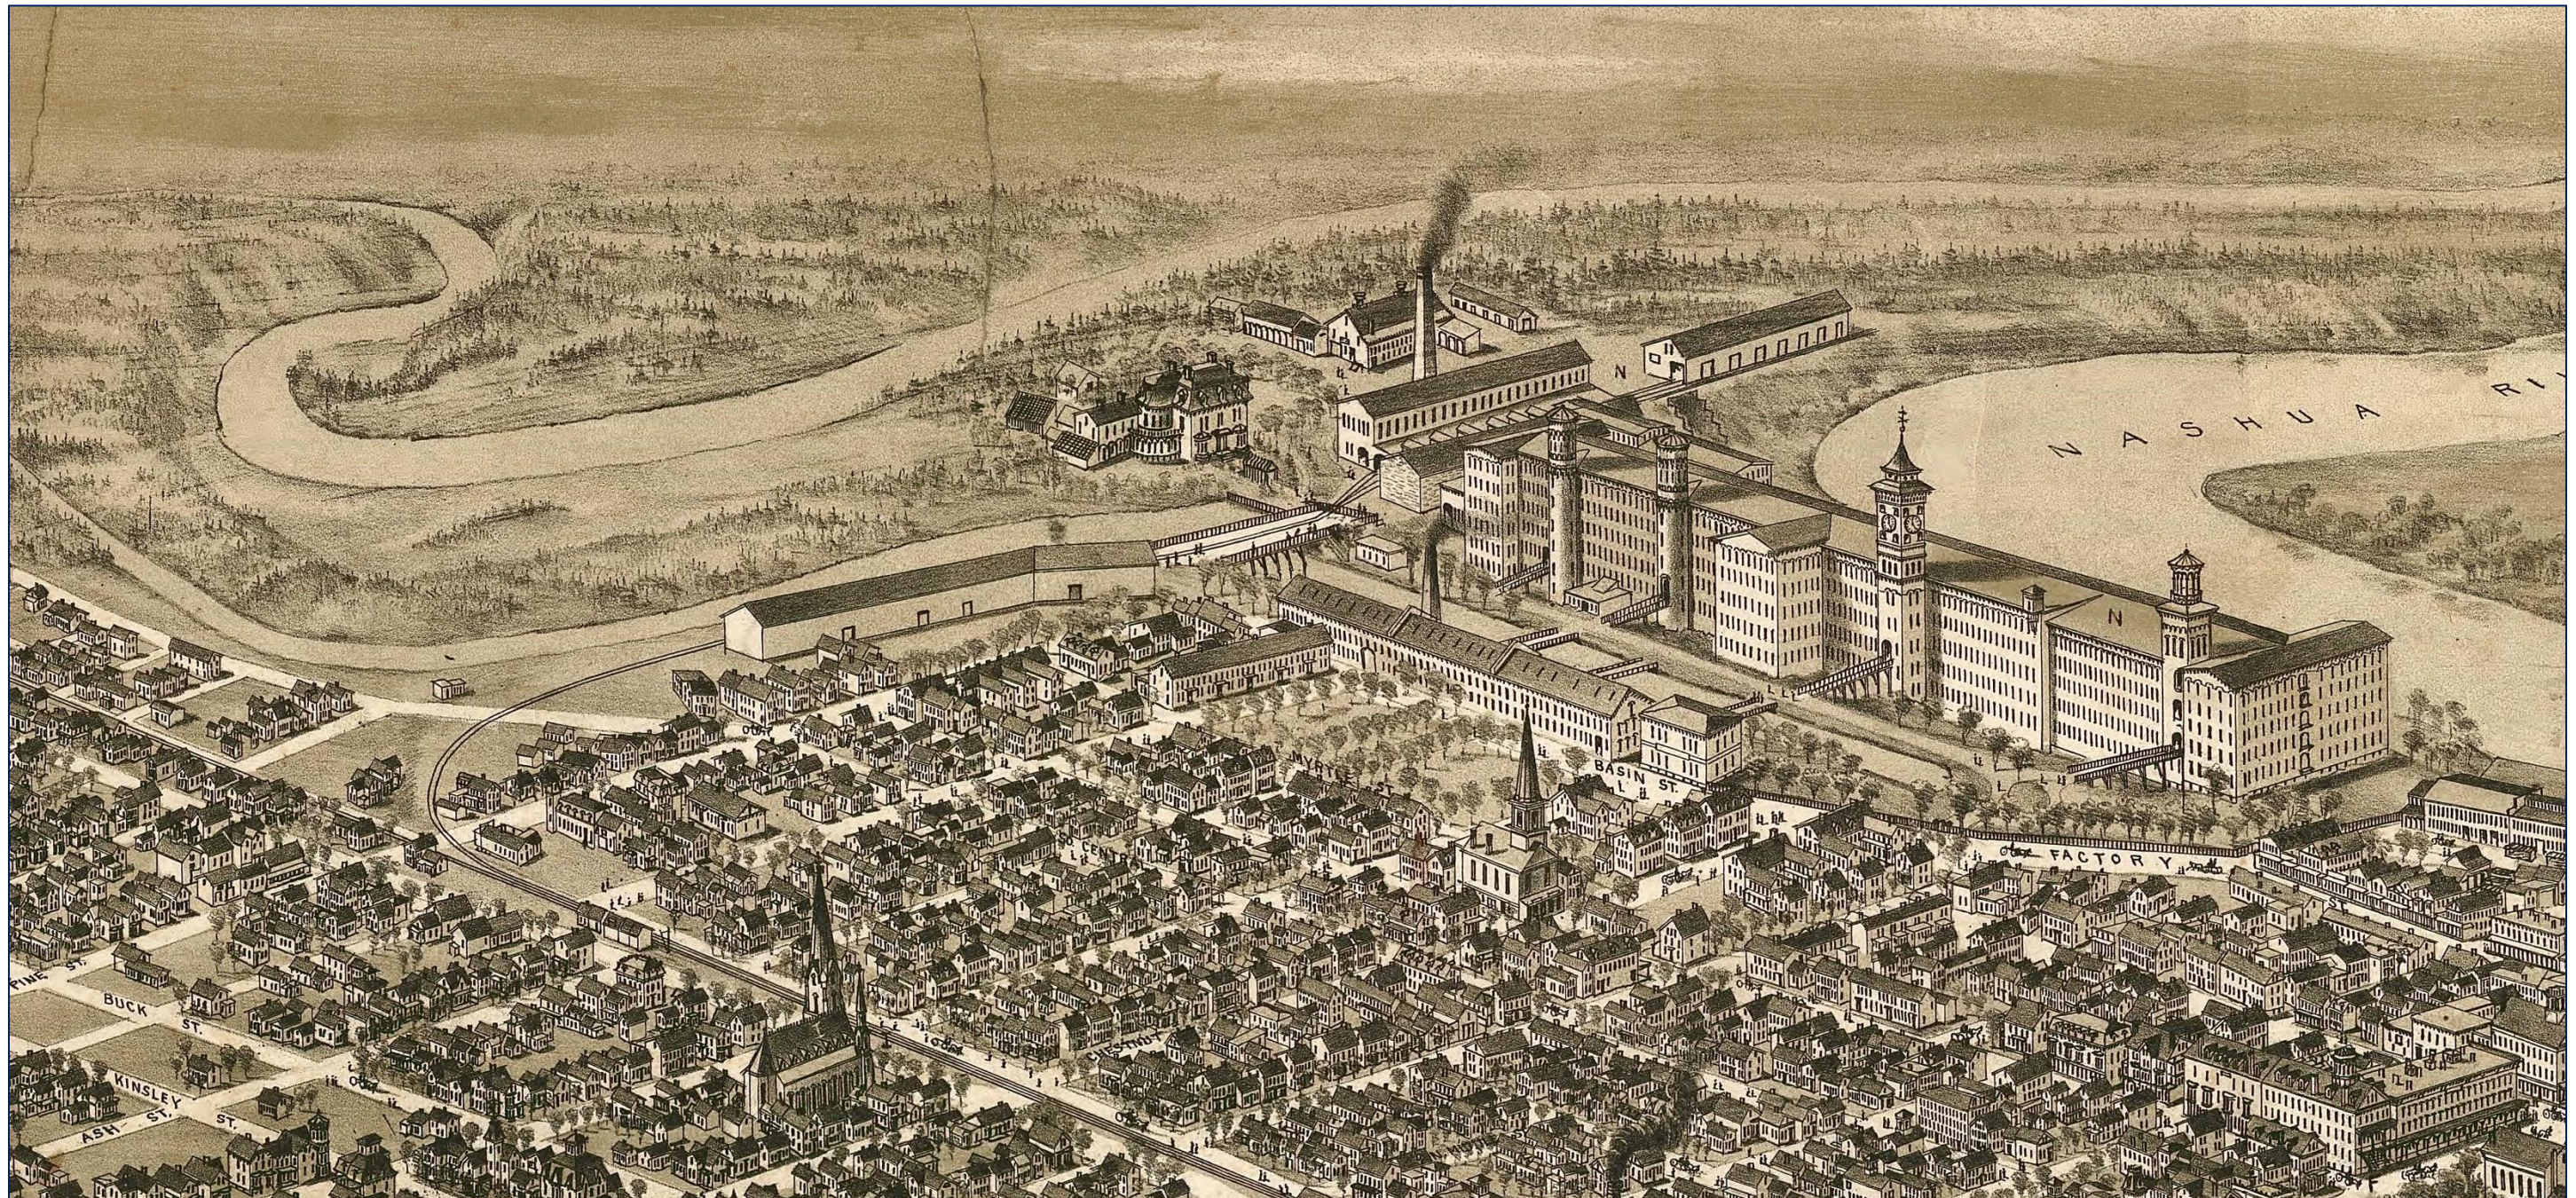
**FIGURE 8:** 1883 Bird's-eye view map of Nashua, showing location of Canal, railroad tracks alongside canal and Storehouse No. 2 crossing canal basin on pile bent bridge to serve Boiler House. Note bridges over Canal Basin appear as thru-girder or parallel-chord trusses, as opposed to iron bowstring trusses shown in later photographs. (Source: O.H. Bailey & Co., 1883).

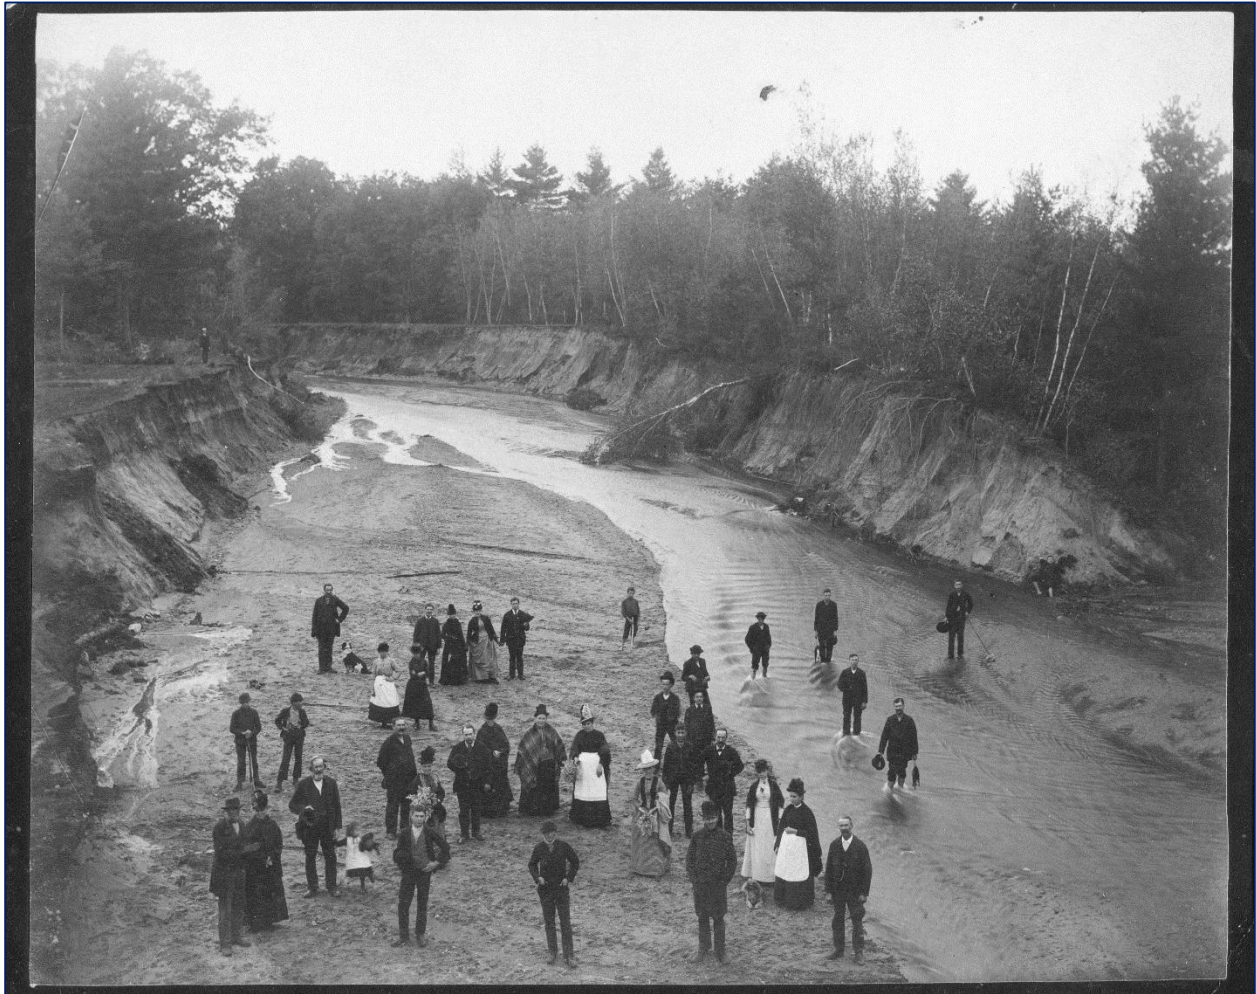
**FIGURE 9:** Photograph of canal break of 6 October 1887, showing hole in canal wall visible at far right, and curious folks posed in nearly dry canal bed. (Source: Nashua Historical Society photograph collection).

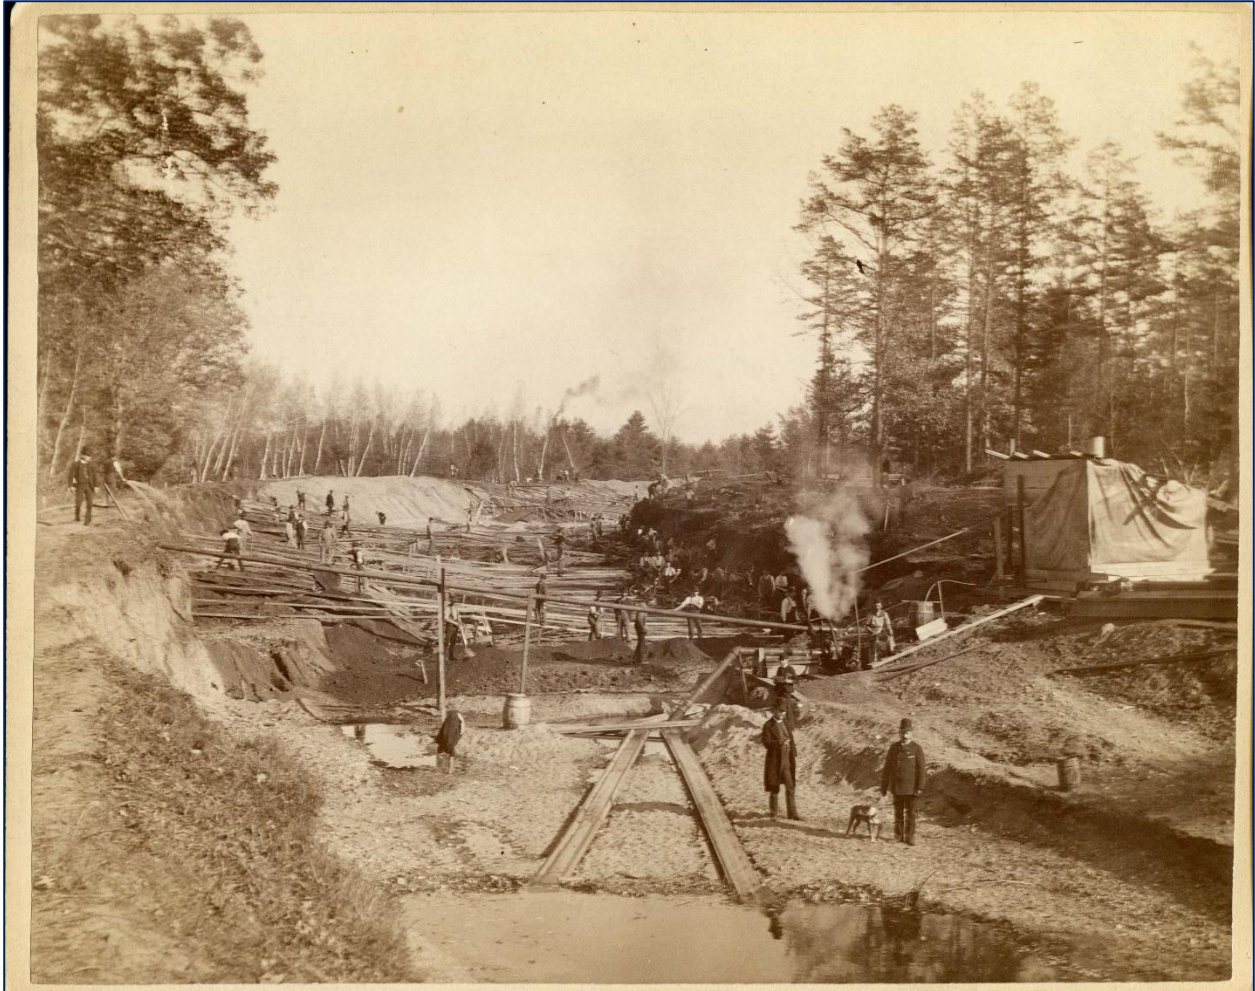
**FIGURE 10:** Photograph of repair work to canal following break of 6 October 1887, showing: work realigning canal, here reducing curvature by cutting fill from bank on inside of curve (on right) and filling opposite bank; use of steam engine (in tent) to power water pump (under steam plume) used to dewater canal and provide water to compact fill. (Source: Nashua Historical Society photograph collection).

The work to repair the canal involved a hundred or more laborers and was carried on day and night through November. Hundreds of feet of the canal bank along the curve at the location of the break, although standing, were severely undermined so it was decided to dig them down and rebuild them on a straighter alignment (see Figures 10-12).<sup>6</sup>

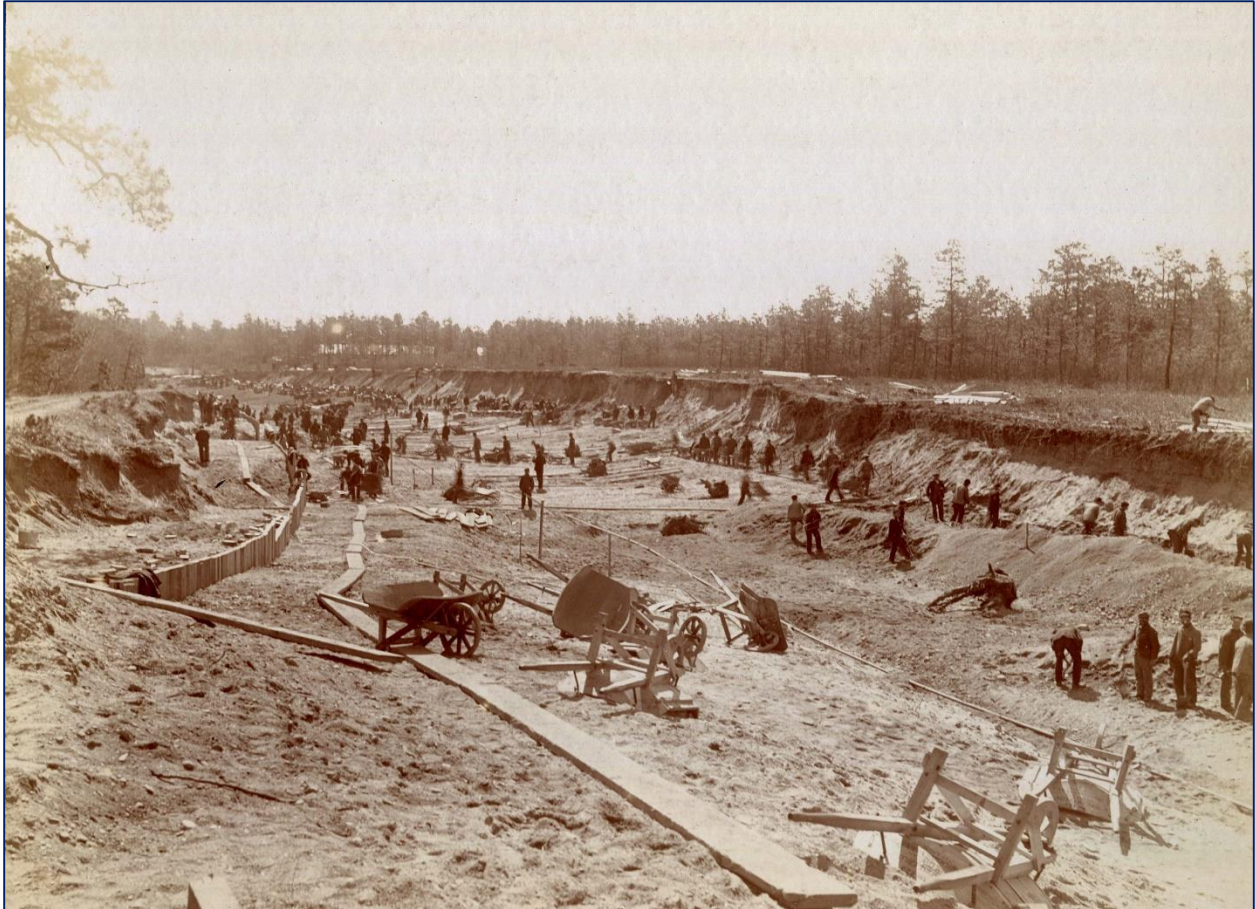
**FIGURE 11:** Photograph of repair work to canal following break of 6 October 1887, showing: work realigning canal by cutting fill from bank on right and filling opposite bank. Note vertical timber plank retaining wall (at left) forming toe of new embankment. (Source: Nashua Historical Society photograph collection).

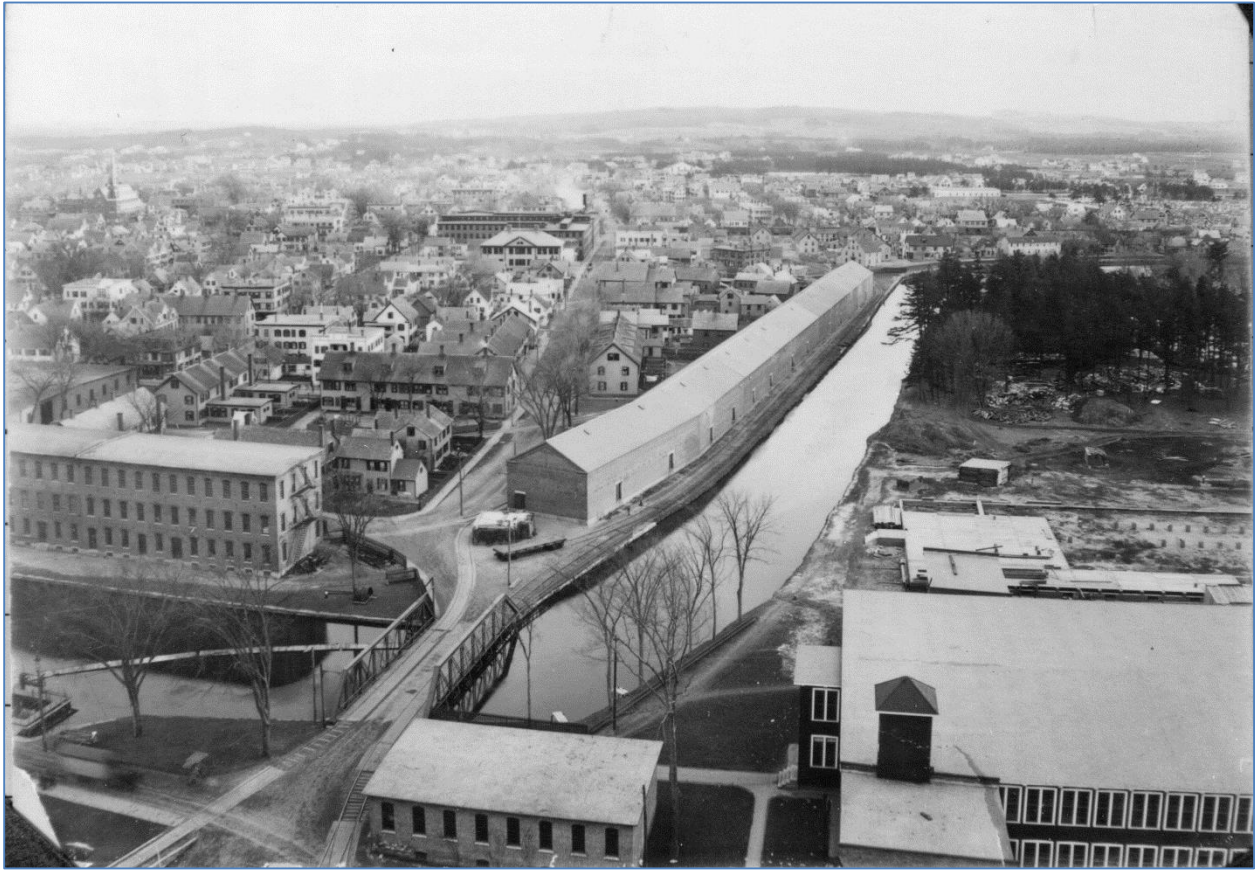
**FIGURE 14:** Photograph of Nashua Manufacturing Co. circa 1898, evidently taken from scaffolding for Boiler House chimney construction, looking south and showing: Canal alongside Storehouse No. 2; Pine Street spanning canal on pony truss bridge (replacing earlier pile bent bridge) and Waste House, in foreground; portion of original Waste Way overflow structure, located on north side of Canal Basin at west end, just visible in lower left. (Source: Frank Ingalls, Photographer; Ingalls Photograph Collection, Nashua Historical Society).

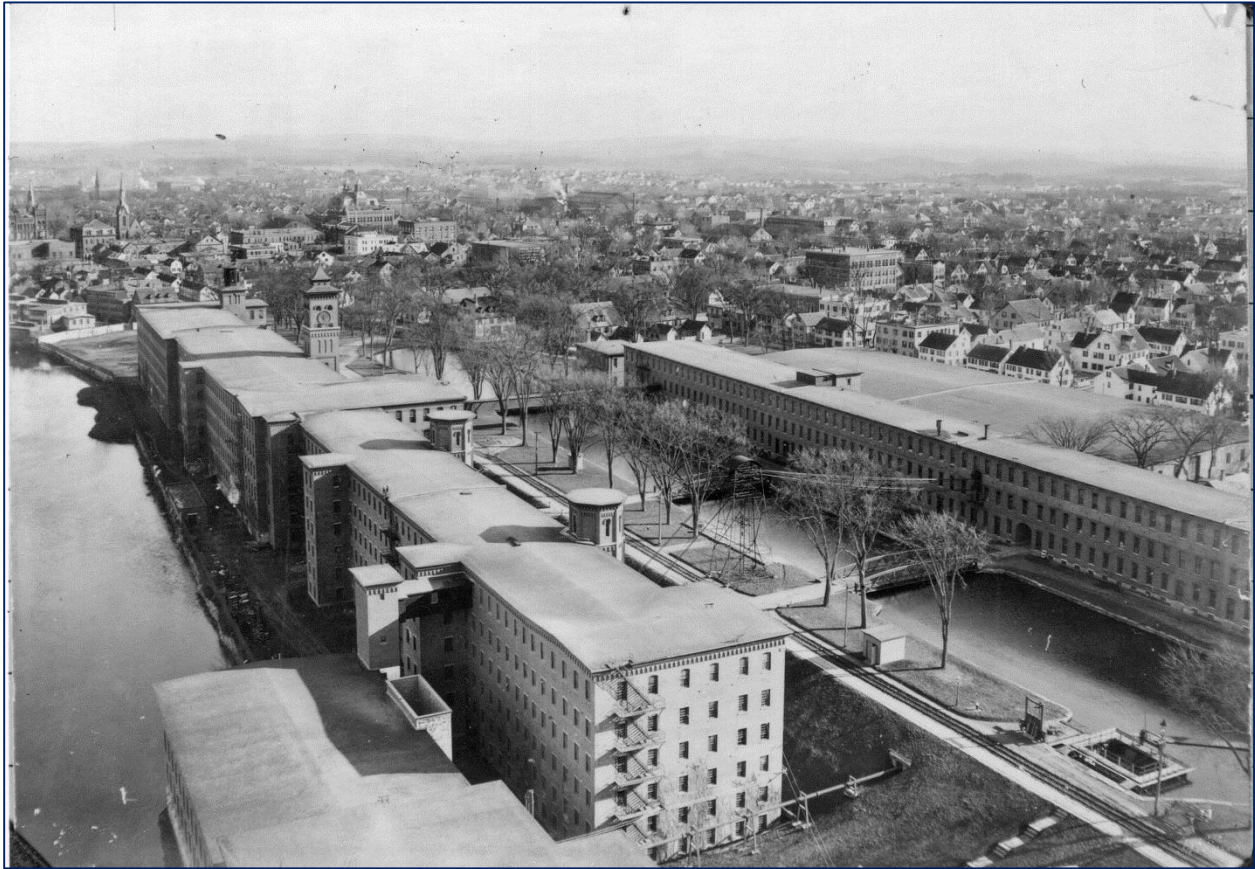
**FIGURE 15:** Photograph of Nashua Manufacturing Co. circa 1898, evidently taken from scaffolding for Boiler House chimney construction, looking east and showing: Canal Basin extending east in front of main mill buildings along Basin Street; bowstring truss bridges spanning Basin; original Waste Way overflow structure at lower right; land cleared and fenced at east end of main mill buildings for construction of Mill No. 7 and east end of Basin prior to construction of penstock and gate for Mill No. 7 (see Figures 17 and 18). (Source: Frank Ingalls, Photographer; Ingalls Photograph Collection, Nashua Historical Society).

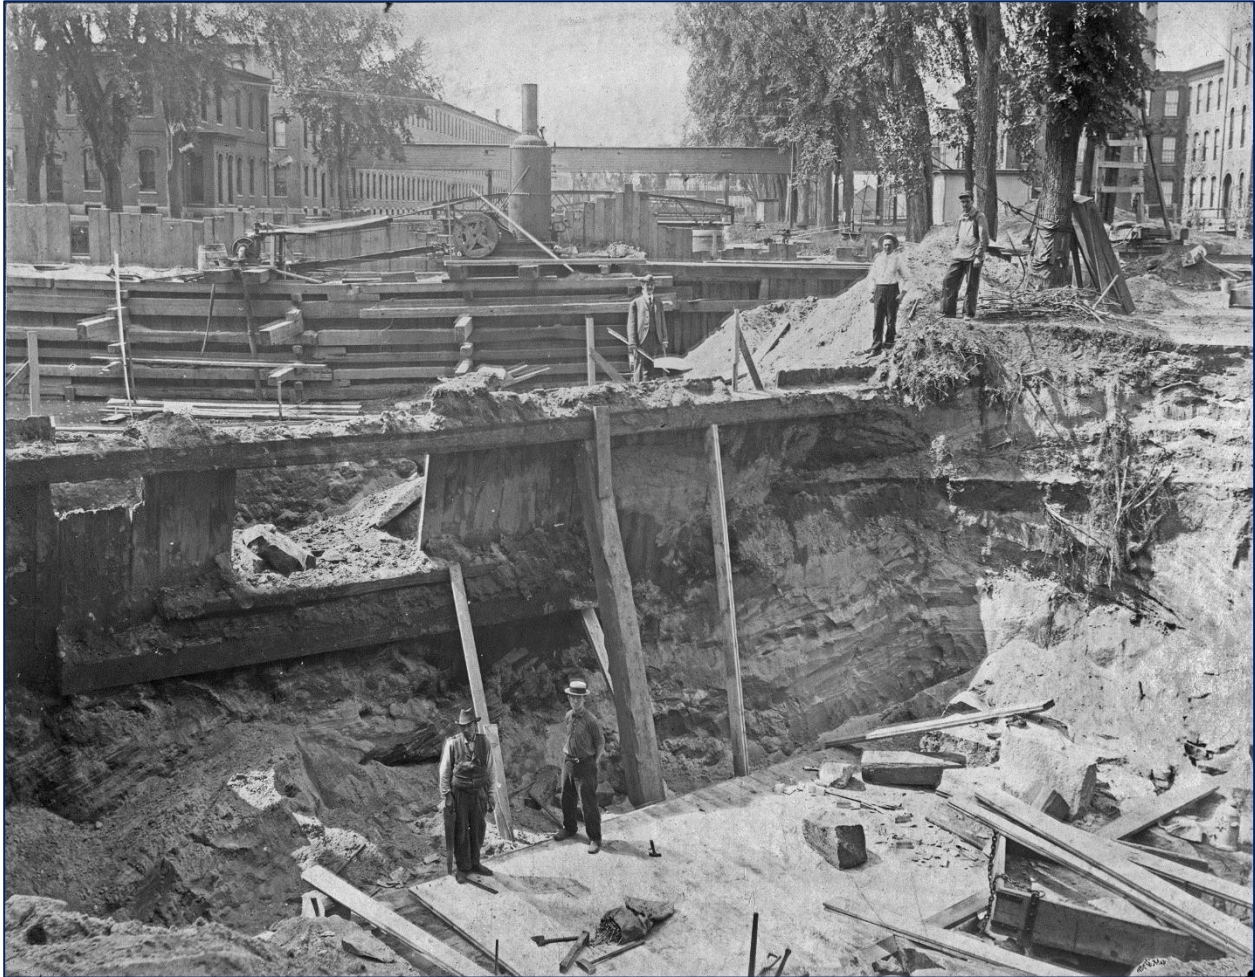
**FIGURE 17:** Photograph labeled "Cofferdam for Penstock and Gates, End of Canal, Summer 1904." The photo depicts the construction of new head gate for the 10' diameter penstock to serve water to Mill No. 7 turbine, the easternmost mill and penstock of the Nashua Manufacturing Co. complex (see 1907 plan shown in Figure 18). The Canal Basin, extending west behind the wood beam cofferdam wall behind the workers, was buried in 1972 under the present-day roadways and parking facilities. A new concrete canal outlet and overflow structure was constructed at that time at the new terminus of the open canal on Pine Street, its purpose to channel the overflow into a steel culvert that runs underground to empty in to the Nashua River. Visible in the background is a steam powered water pump for dewatering the cofferdam, and two bridges spanning the canal, an iron bowstring truss road bridge and an elevated and enclosed pedestrian bridge. (Source: Nashua Historical Society photograph collection).

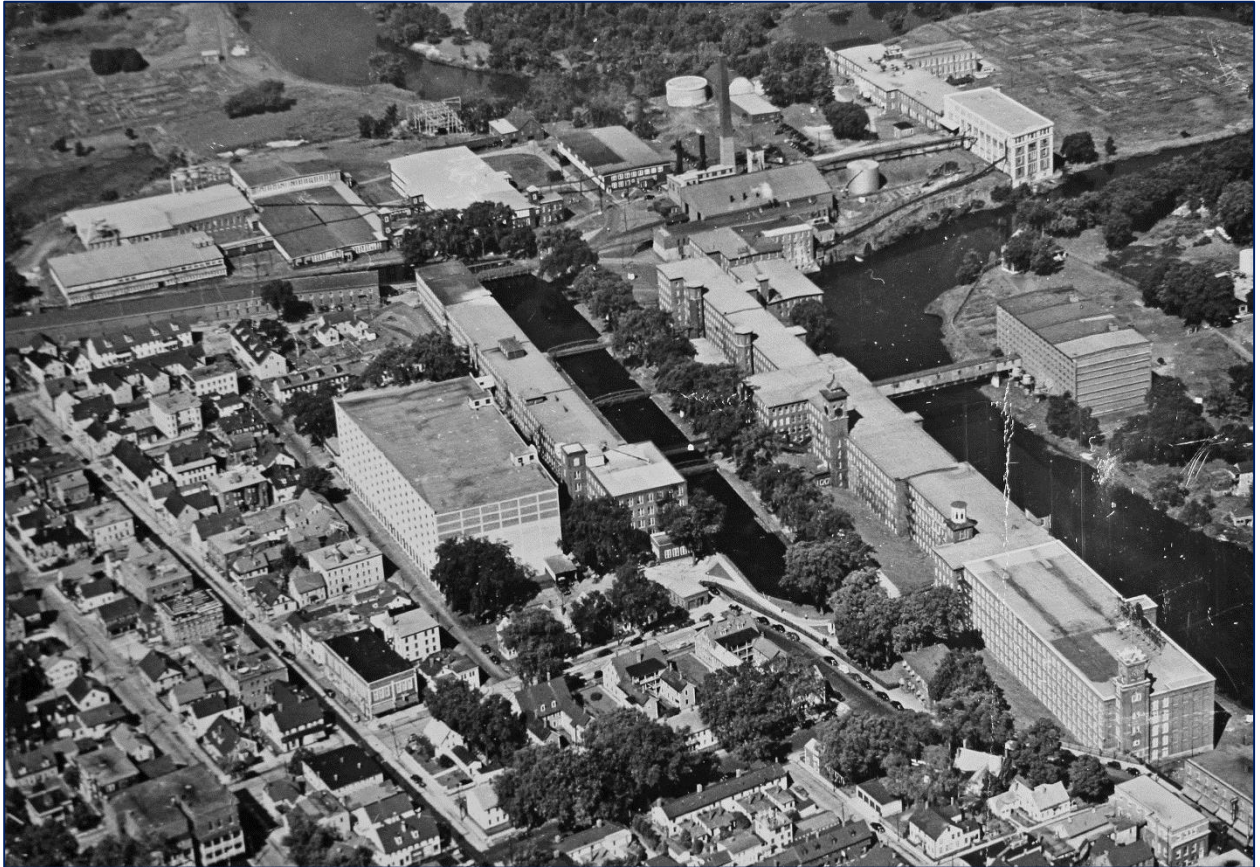
**FIGURE 19:** Aerial photograph of Nashua Manufacturing Co. circa 1940, showing Canal Basin before 1972 alterations to site that removed and or buried all of its features. Note bridges over Basin still extant at that time and massive eight story South Concrete Cloth Store House (near center of photo) occupying the open park area shown on the 1883 map (Figure 8). (Source: Nashua Historical Society photograph collection).

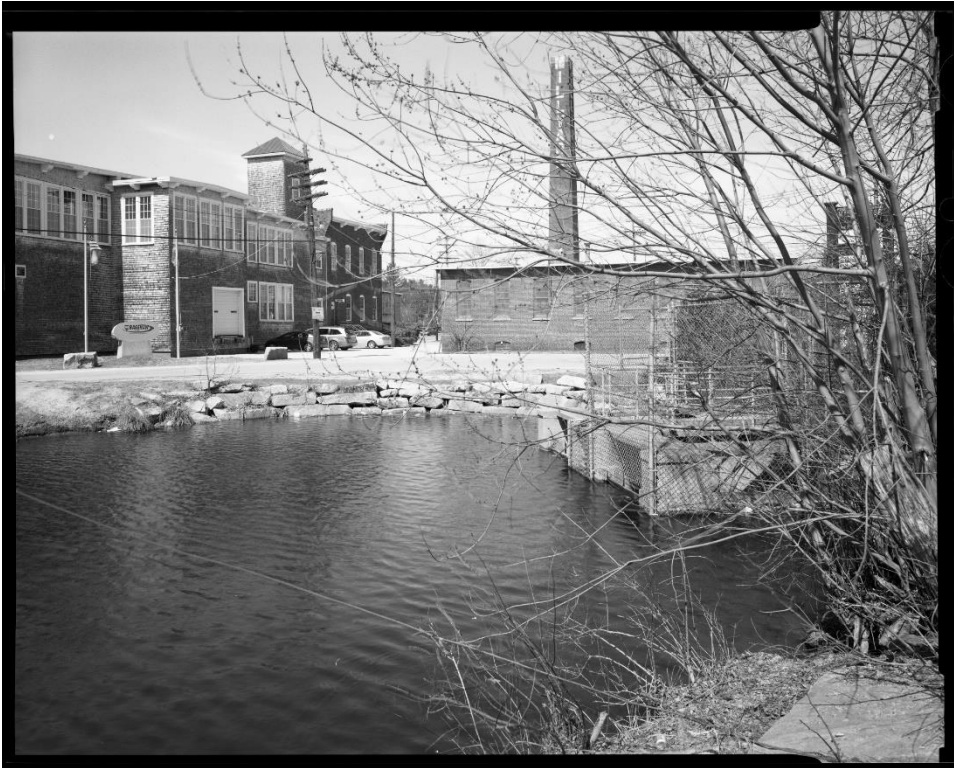
NH-538-G-1: North end of Power Canal showing stone termination wall and concrete overflow structure at right. Looking north.

the Canal and directs overflow into an underground culvert to the Nashua River. The overflow structure is rectangular, measuring approximately 12' deep, 22' wide and 6' high above the water level. It is equipped with removable wood flashboards to adjust the elevation of the weir and the level of the water in the canal. The back, or shore side of the structure is open to a corrugated steel-plate culvert of the closed bottom, horizontal ellipse type, approximately 6' high by 10' wide. According to Nashua drainage mapping, the culvert runs underground 175' northeast, then turns north and runs 270 feet, passing under the Picker Building to empty in the Nashua River. The point where the culvert turns north is the approximate location of the former overflow structure for the Canal Basin, depicted on the 1907 plan as the Waste Way (Figure 18) and visible in the ca. 1898 aerial photo (Figure 15). It was not determined if the new culvert connects with or utilizes any components of the former Waste Way.

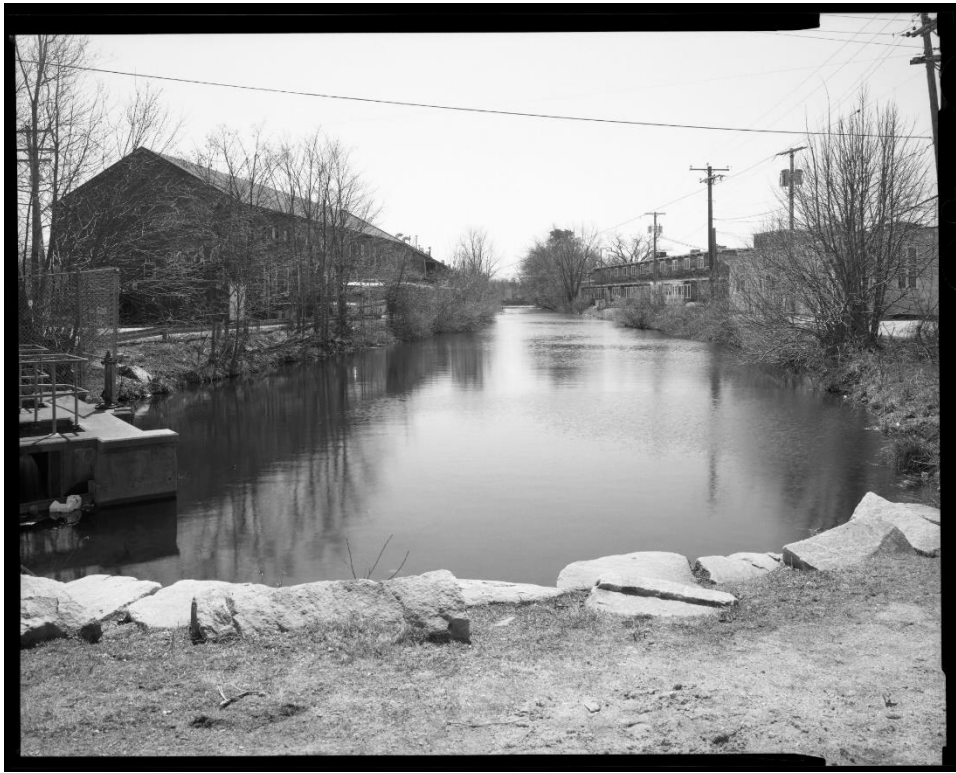
NH-538-G-2: North end of Power Canal with stone termination wall in foreground, overflow structure and Storehouse No. 2 at left, and canal channel running south. Looking south.

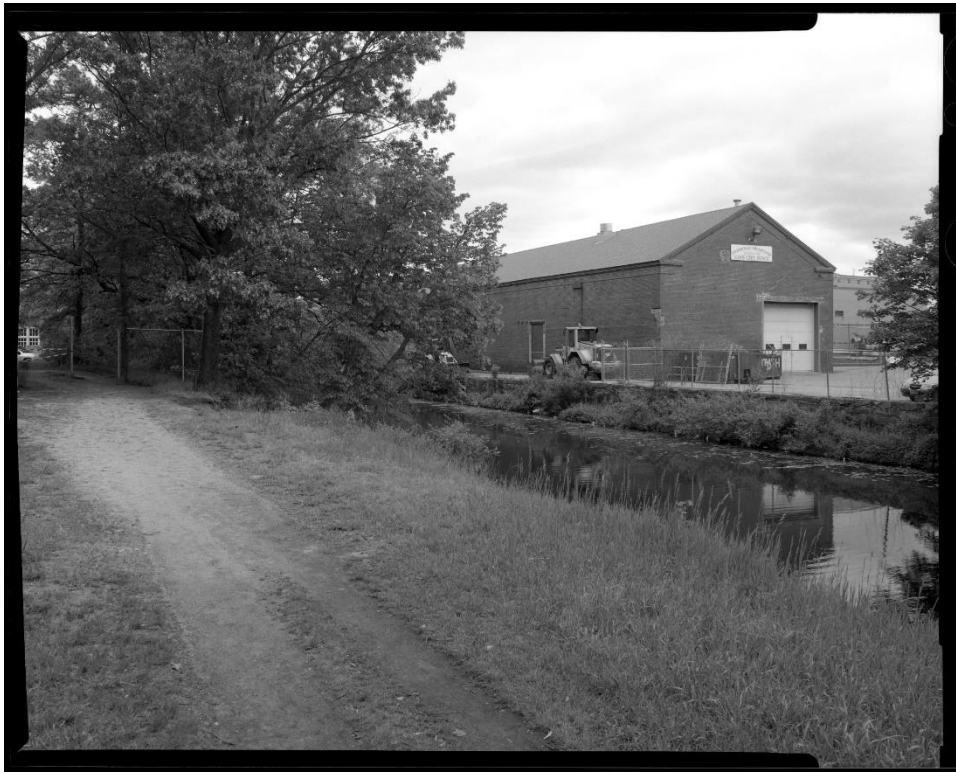
NH-538-G-3: Section of Power Canal at south end of Storehouse No. 2, showing earth bank on west side and stone wall along east side. Looking northeast.

The final northbound stretch of the canal, parallel to Pine Street, runs straight, with the east side of the Canal improved with a low stone retaining wall built circa 1848 with the arrival of the railroad to Nashua. The wall was evidently built to secure the embankment to allow construction of railroad tracks immediately alongside the canal and a long warehouse building (Storehouse No. 2) alongside the tracks.

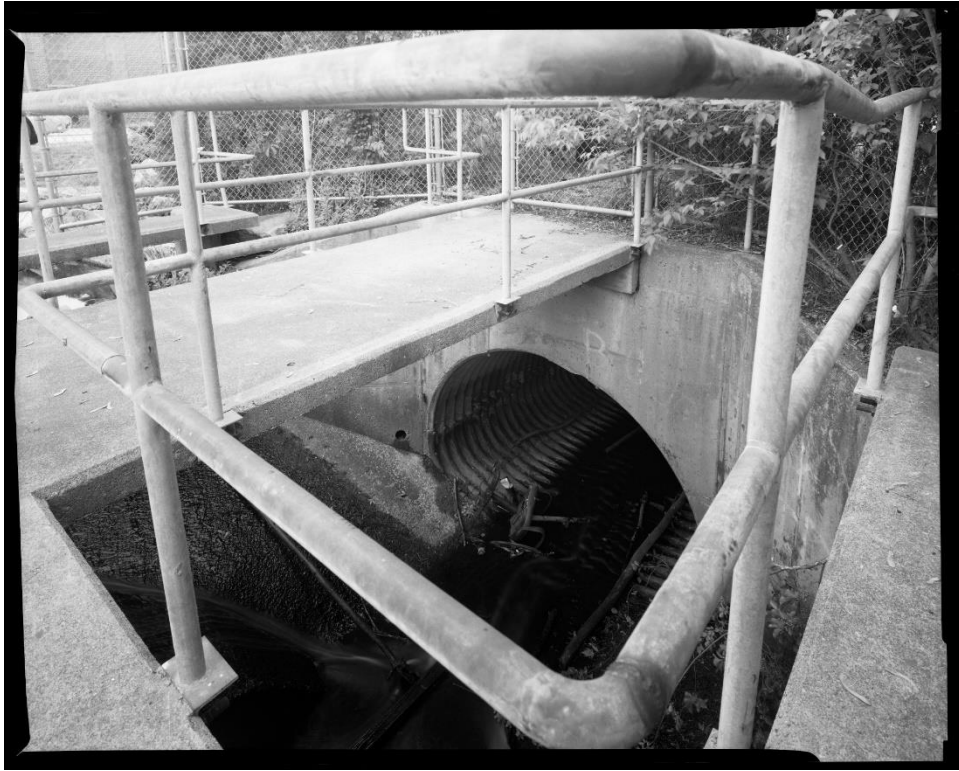
NH-538-G-4: Power Canal overflow regulating structure and inlet to underground steel culvert running east to Nashua River. Looking northeast.
