**NEW HAMPSHIRE HISTORIC PROPERTY DOCUMENTATION
NASHUA RIVER STONE RETAINING WALL,
NASHUA MANUFACTURING COMPANY, NASHUA, NH**

NH State No. 538-F

**PROJECT
INFORMATION:**

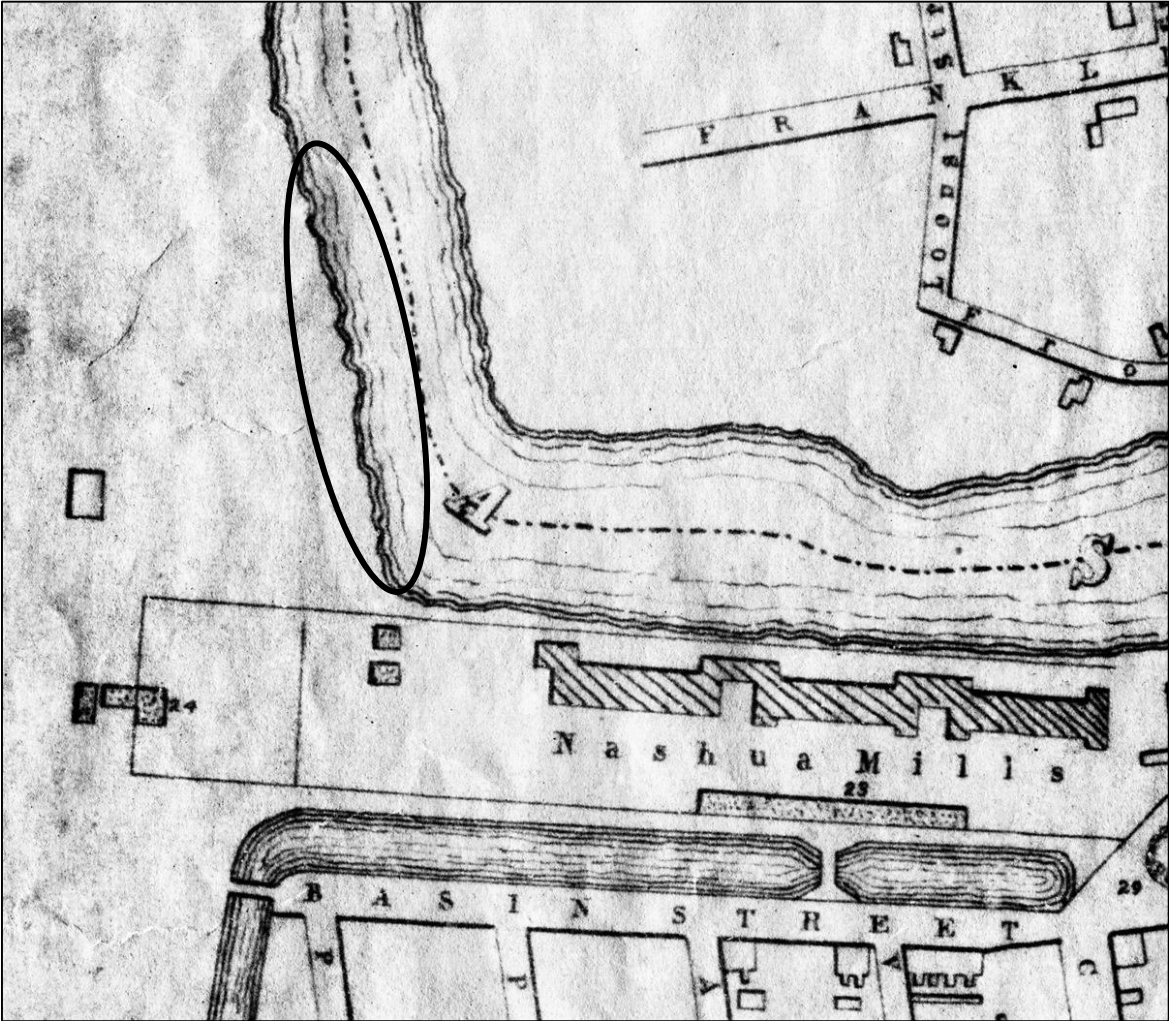
FIGURE 3: Map of Nashua Manufacturing Co. in 1842, showing approximate location of stone retaining wall, not yet present (Source: Hoar & Mead).

The map of Nashua drafted by Hoar and Mead in 1842 clearly depicted the irregular course of the shoreline in this area (see Figure 3). The 1883 Birdseye view map is extremely detailed, and clearly depicts the subject section of river bank in its unimproved state with what appears to be a slope at its natural angle of repose and a gently curving shoreline (see Figure 4). The companies that prepared fire insurance survey plans did not fully feature this portion of the riverbank until 1906 and onward. None of these insurance maps from the first half of the twentieth century actually depict the wall as a discrete landscape feature. The Associated Mutual Insurance Company (AMIC) plans for 1906 (see Figure 5) indicate a nearly straight shoreline in the wall's location, suggesting that the wall had been built by 1906 and that this had resulted in a linear configuration for the riverbank edge. The 1912 and 1949 Sanborn maps (see Figures 6 and 7), however, show a gently curving shoreline. The wall does have a slight bend in it as shown in the site plan (Figure 2) that was traced from the survey-based site plan for the new Nashua River Bridge project. An aerial photograph from around 1940 documents the wall as in existence at that date (see Figure 8). In the photograph, the wall is set back by just a few feet from the slightly irregular shoreline. It may be that the waterline edge depicted on the AMIC plans represents the wall but on the Sanborn maps it represents the actual shoreline. Regardless, the business of the fire insurance maps was buildings, not natural or manmade landscape features, and therefore cannot be relied upon for concise interpretation of those features.

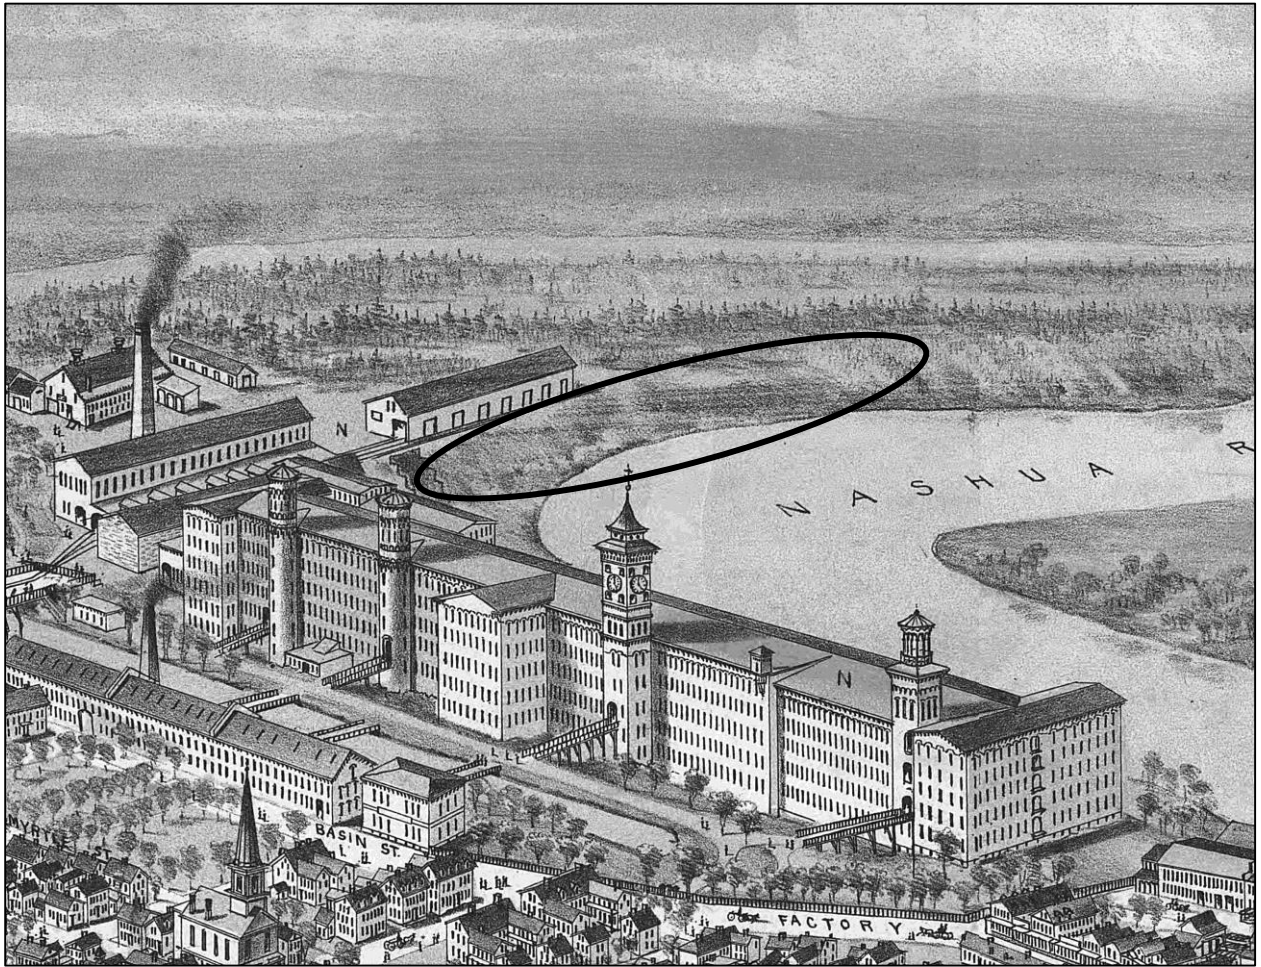
FIGURE 4: A portion of 1883 Birdseye view map of Nashua Manufacturing Co. showing approximate location of stone retaining wall along Nashua River, not yet present (Source: O. H. Bailey 1883).

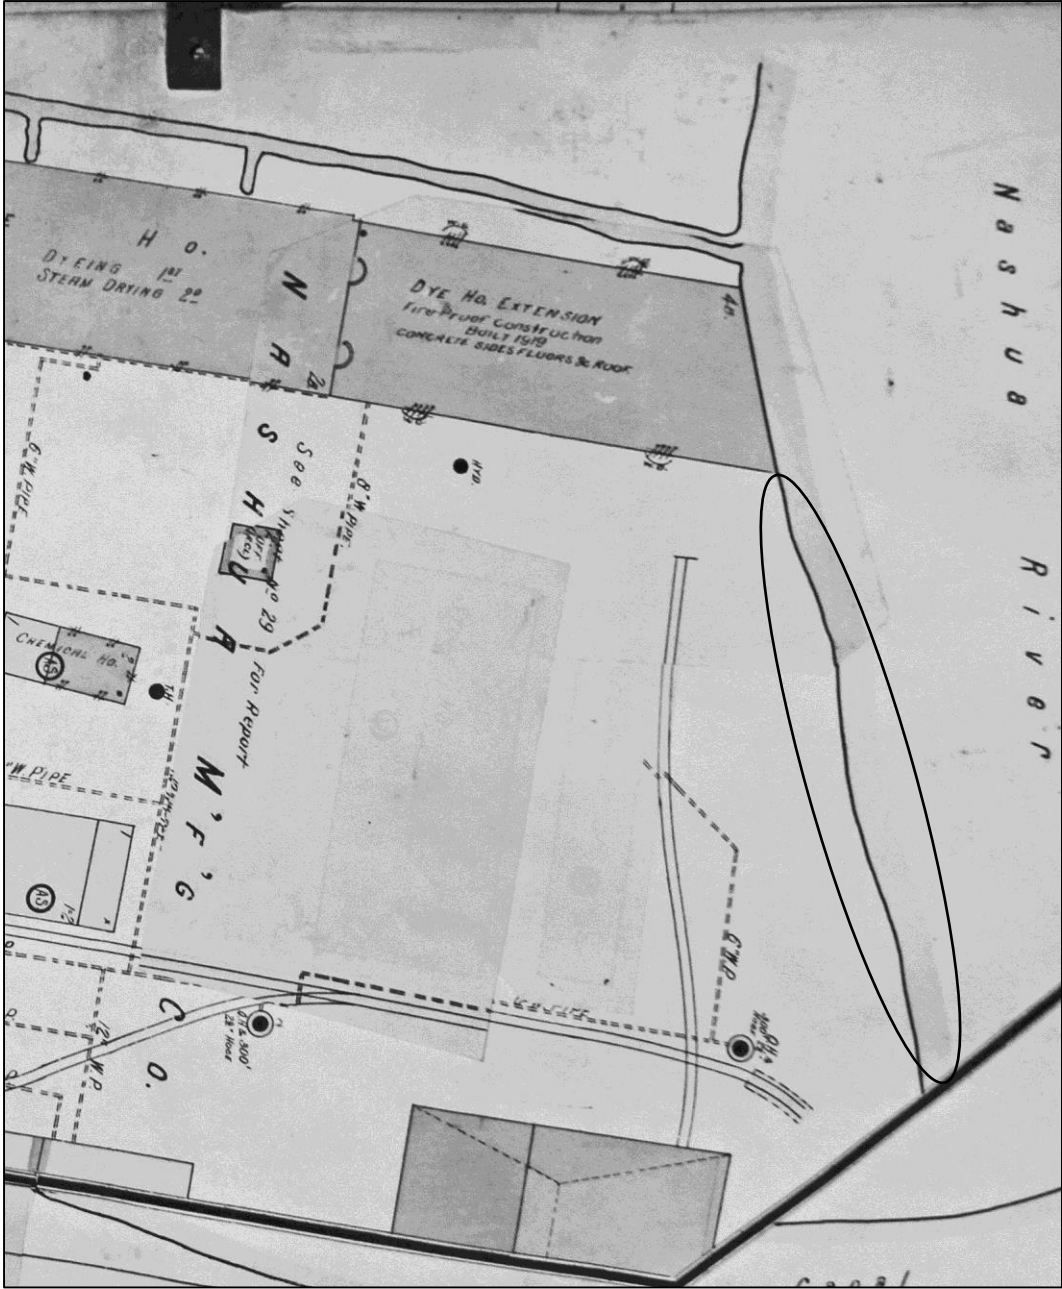
FIGURE 7: Portion of Sanborn Map Co. insurance map of Nashua Manufacturing Company, 1949, showing location of stone wall (Source: Sanborn Map Company).

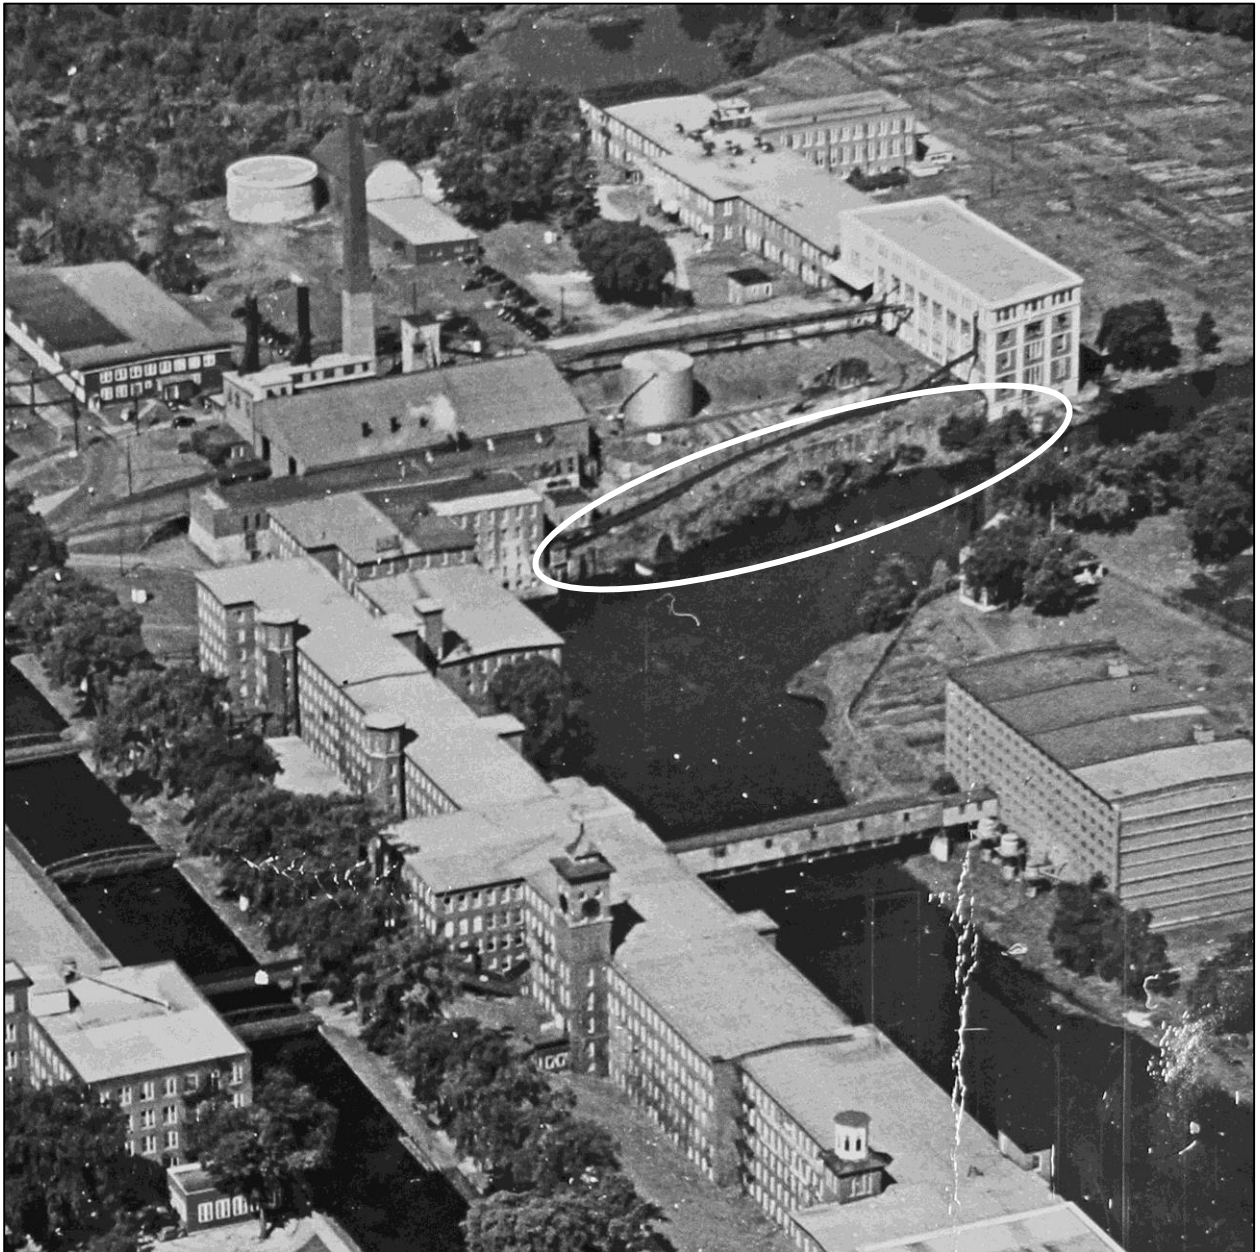
FIGURE 8: Aerial photograph of Nashua Manufacturing Co., ca. 1940, showing location of stone retaining wall along Nashua River (Source: Nashua Manufacturing Company Photograph collection, Nashua Historical Society).

The wall is at the very edge of the river, with toe of the wall either in the water or standing on a narrow strip of riverbank, typically one to three feet in width that submerges when the river rises in response to heavy rainfall or snow melt. This fringe of shoreline appears in a ca. 1940 aerial photograph and is likely to represent a continuation of the original condition from when the wall was built ca. 1892, as opposed to merely being deposited silt. The nature of the foundation of the wall below grade could not be determined from field inspection.

As indicated above, the buildings on the bluff above the retaining wall offer the best evidence for the approximate date of its construction. The ca. 1940 aerial photo shows a large, relatively level area to the west of the retaining wall and to the north and northwest of the boiler house that had apparently been built up with fill and then landscaped to provide building sites. The Bleachery and Dye House, still extant today, was constructed in this area in three stages: the west end of the building during 1892-1894, a central section in 1910-1913, and the east end in 1919.¹ The eventual enlargement of this building was probably anticipated from the first, i.e., by 1892, thereby necessitating construction of the wall around that date. In addition, the fire insurance maps from 1906 and 1912 indicate that frame storehouse buildings were erected in this area around 1900, although these structures were later taken down.

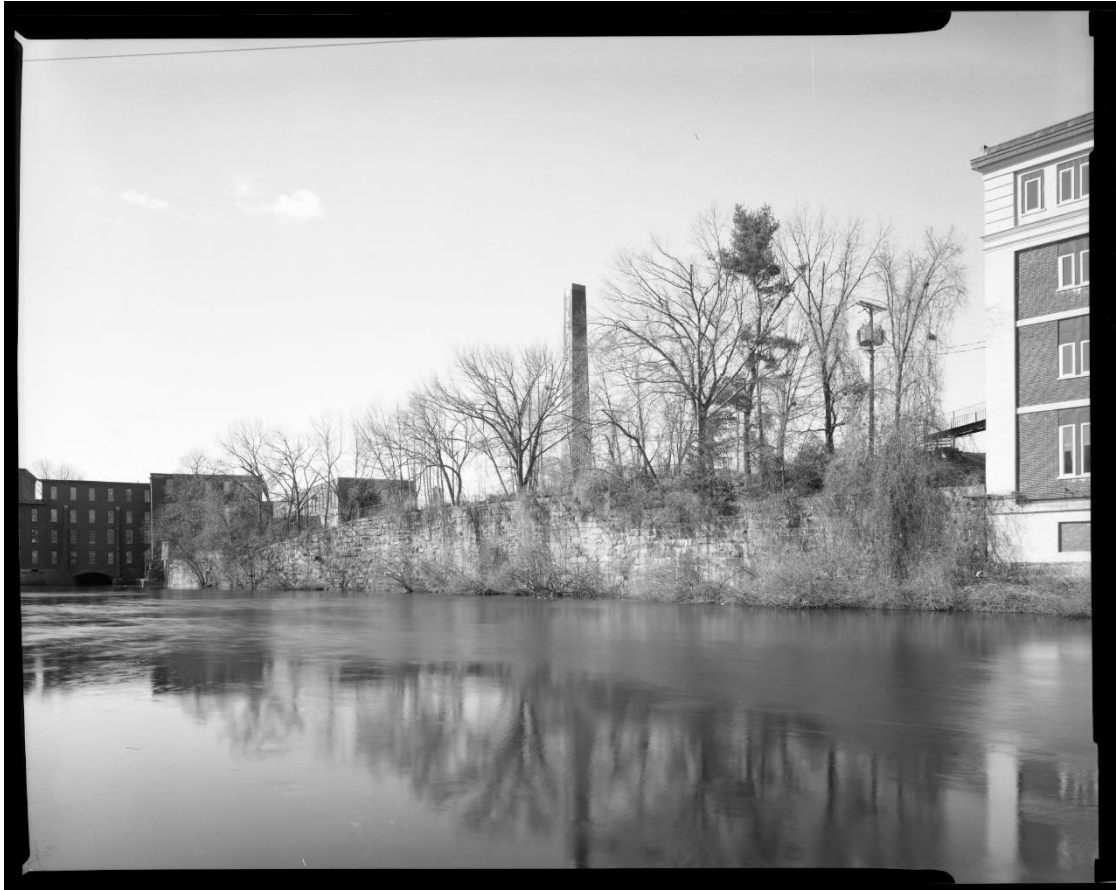
NH-538-F-1: Oblique view of wall in overall context from east bank of Nashua River, showing corner of Dye House building at right, Picker House No. 1 building in distance at left and brick Boiler House Chimney at center. Looking south southwest.

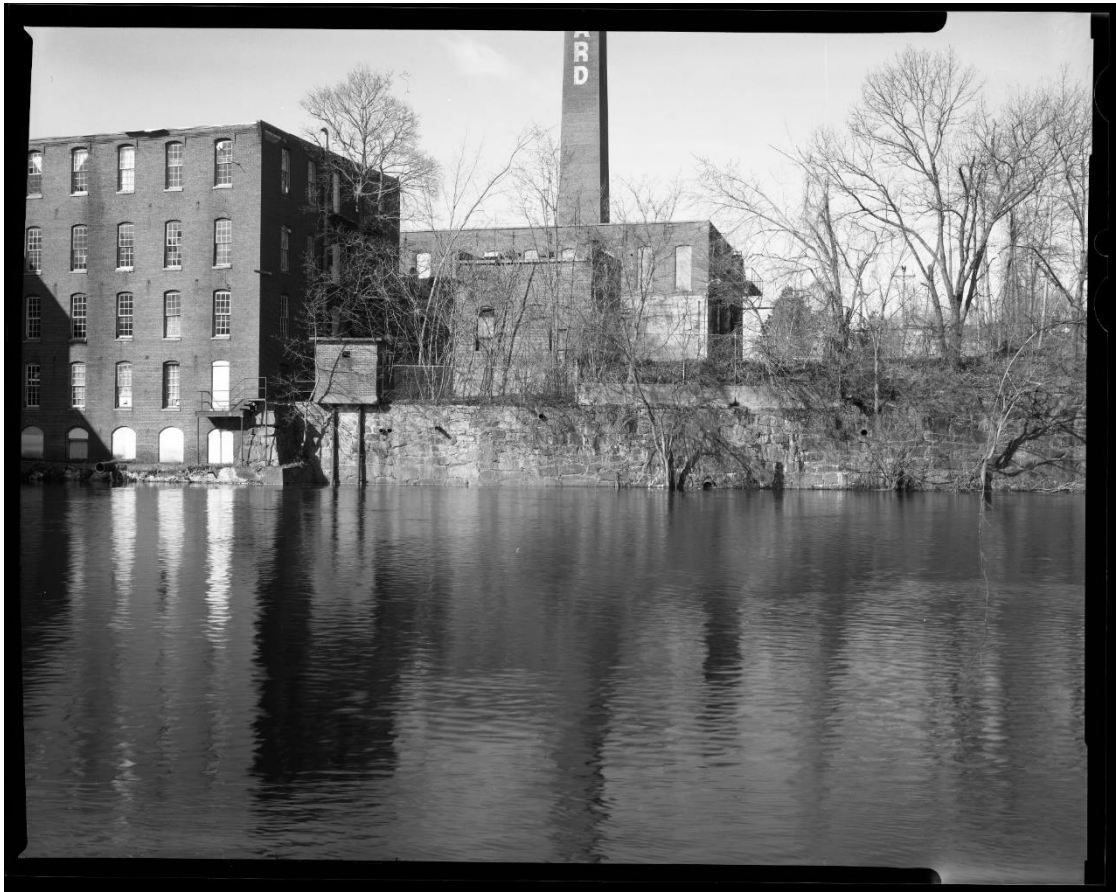
NH-538-F-2: Partial oblique view of south end of wall in context with adjoining Picker Building No.1 at left, small pump house structure atop wall and Boiler House Chimney. Looking west southwest.

The south section has two structures resting on the wall. Approximately ten feet from the Picker House is a small one-story brick pump house building that overhangs the wall about 2 feet. Two iron pipes extend through the overhanging floor down into the water. A concrete wall, approximately 42" high by 40' long sits on the wall as well, the purpose of which is unknown.

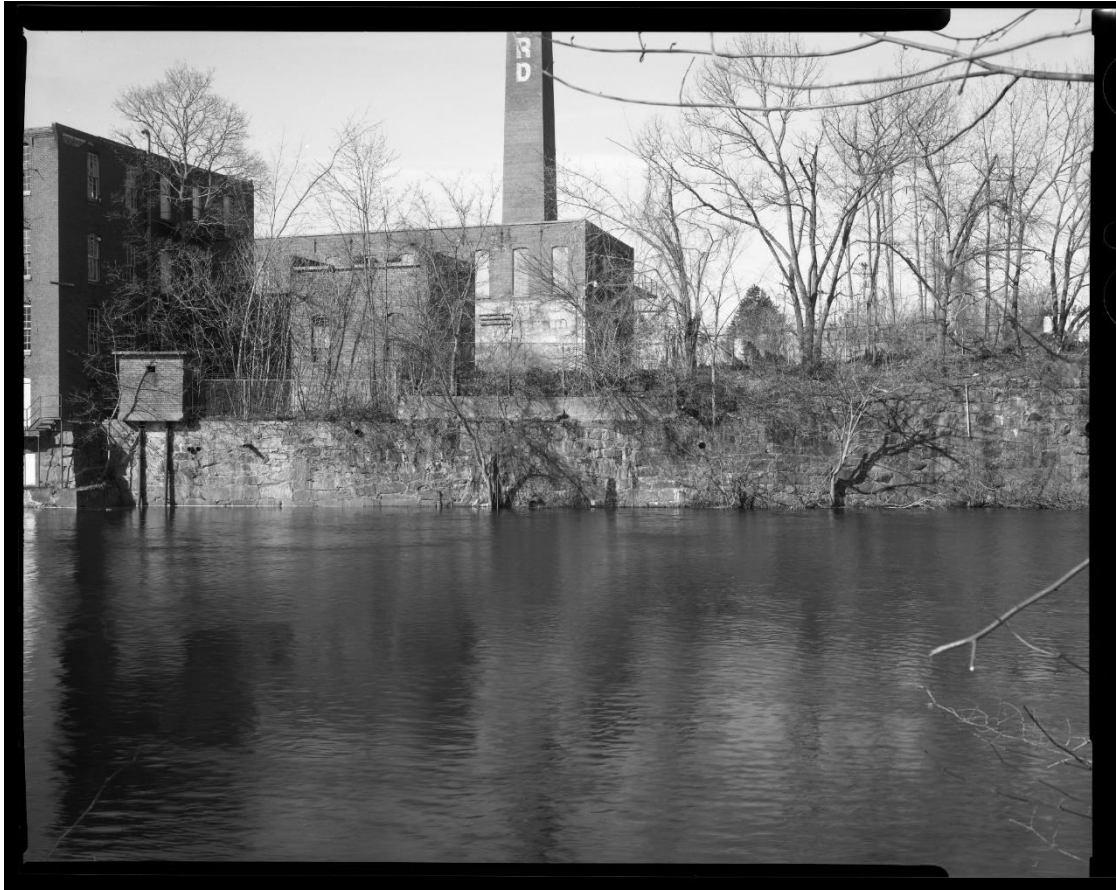
NH-538-F-3: Elevation of south section of wall. Looking west.

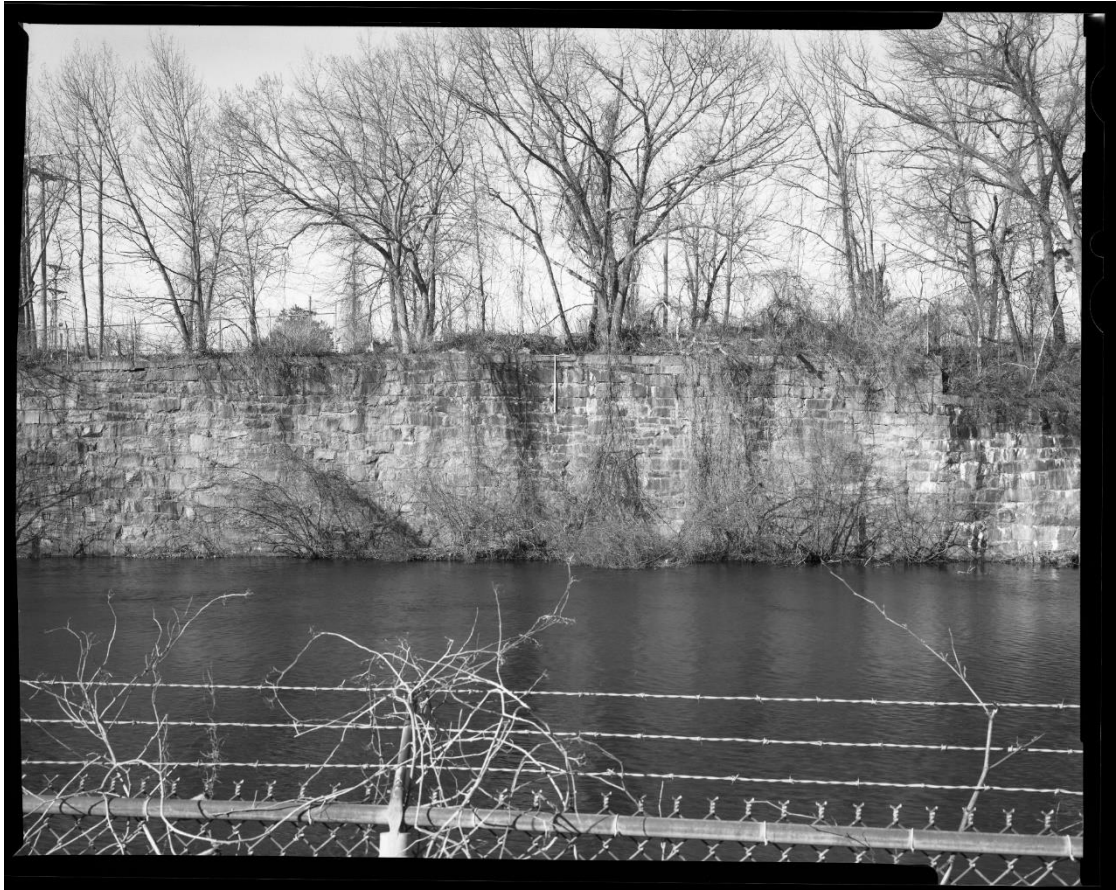
NH-538-F-4: Elevation of middle section of wall. Looking west.

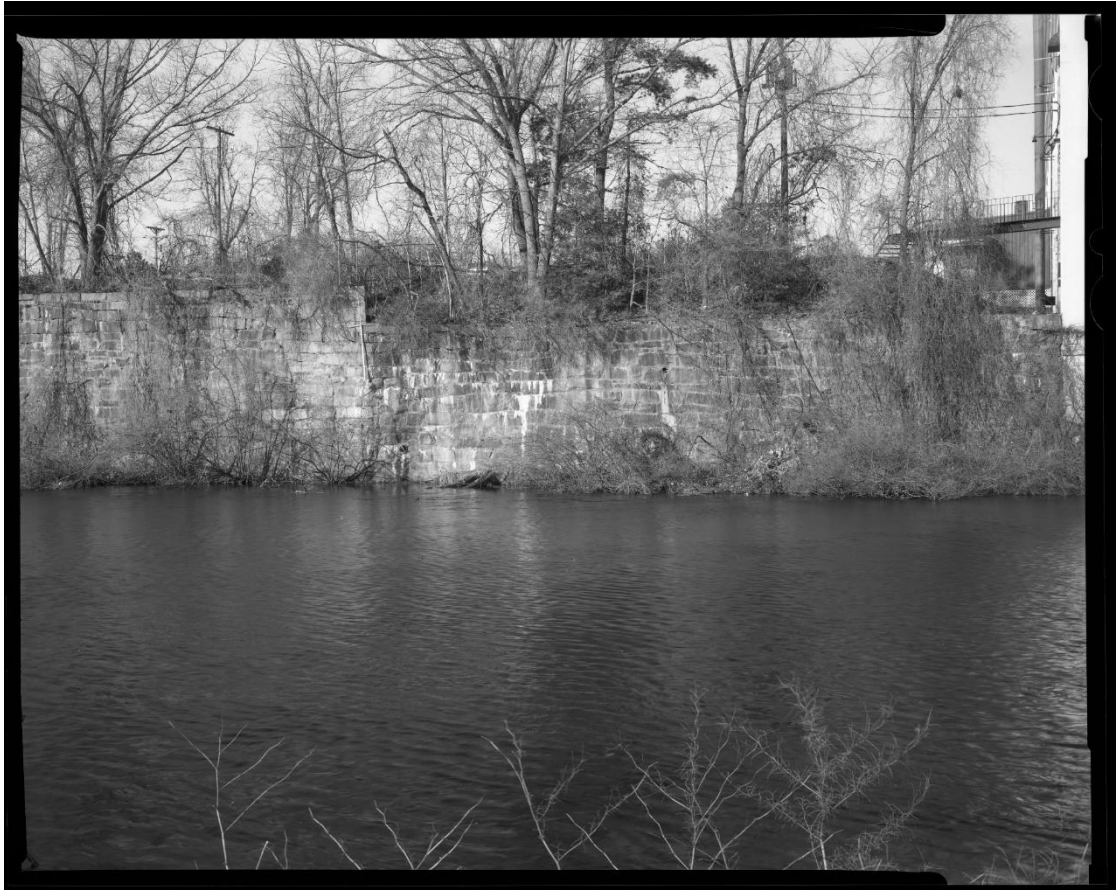
NH-538-F-5: Elevation of north section of wall adjoining Dye House building. Looking west.
