# National Register of Historic Places Registration Form

Historic name: Langdon Meeting House

Other names/site number: Langdon Town Hall

City or town: Langdon State: New Hampshire County: Sullivan

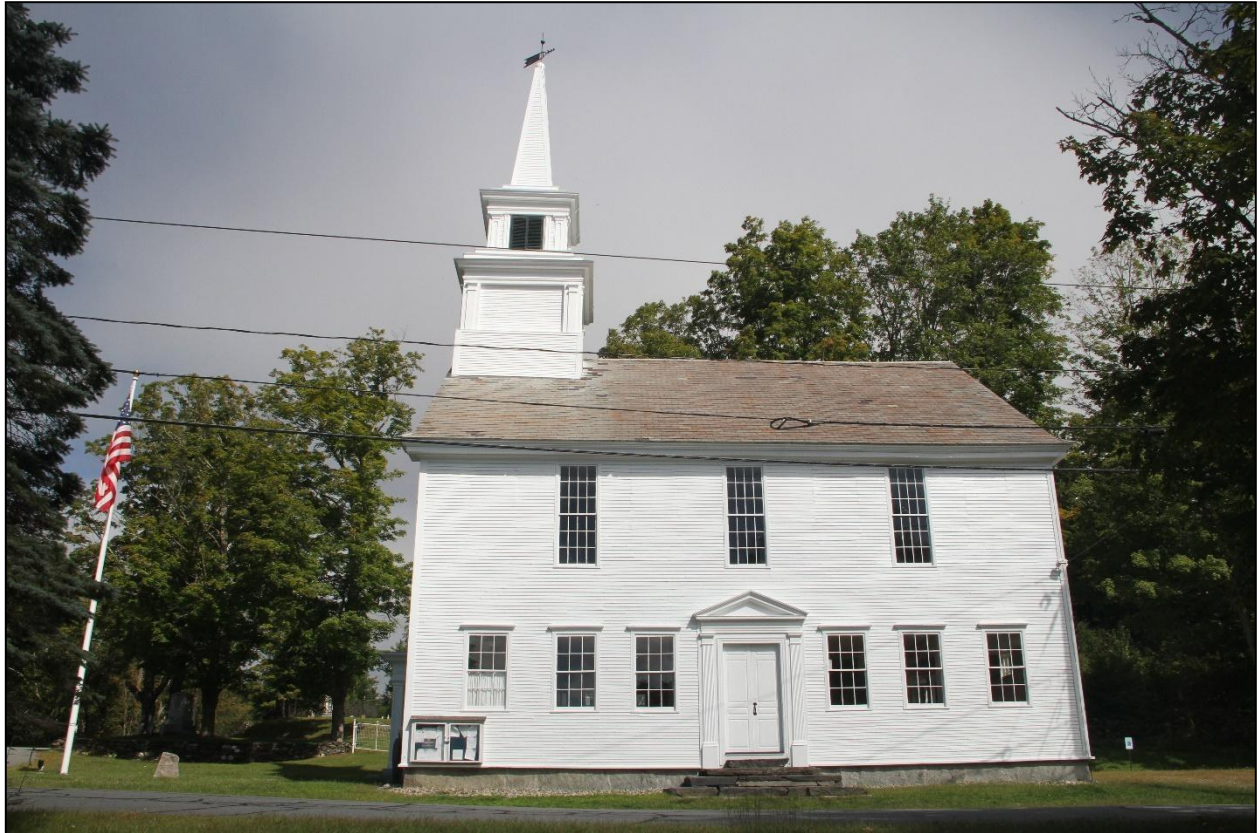
NH\_Langdon\_SullivanCo\_LangdonMeetingHouse\_0001: South side. Looking North.

Thirty three wood double hung windows light the building including nineteen 6/6 windows on the first floor and ten 12/12 twelve windows on the second floor (Photo Nos. 1-6). Two 12/12 windows in the gable walls date to the original 1803 construction. Many of the windows contain the original glass from 1851.

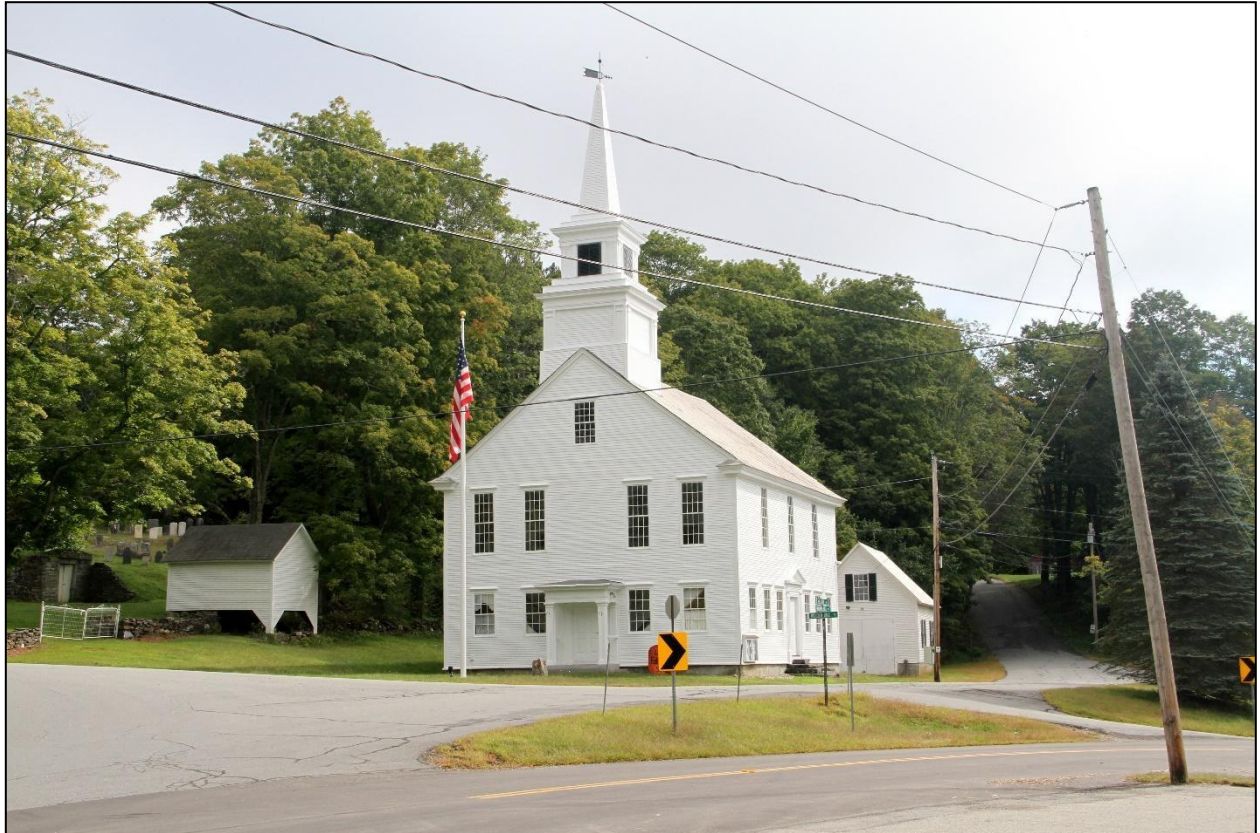
NH\_Langdon\_SullivanCo\_LangdonMeetingHouse\_0002: Overview of south and west sides. Looking East.

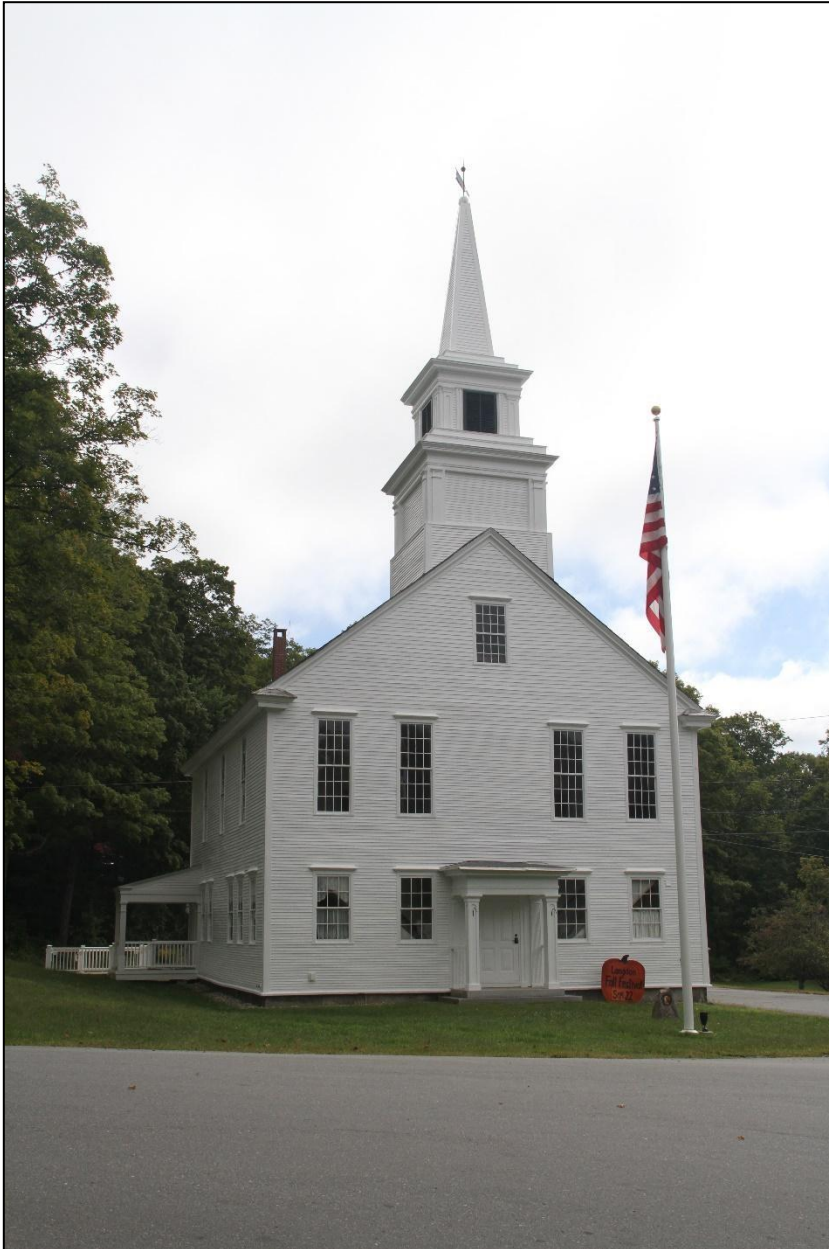
NH\_Langdon\_SullivanCo\_LangdonMeetingHouse\_0003: West side. Looking East.

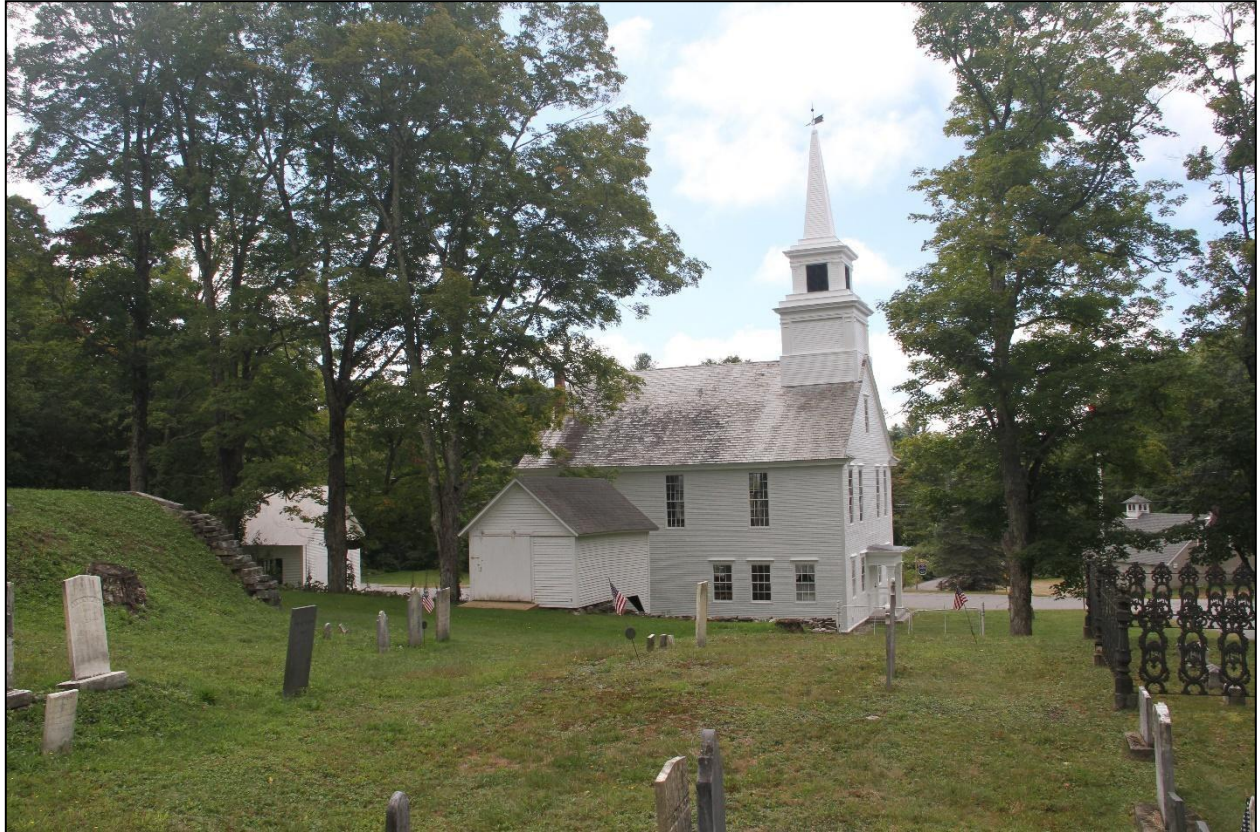
NH\_Langdon\_SullivanCo\_LangdonMeetingHouse\_0004: Overview of west and north sides from cemetery. Looking South.

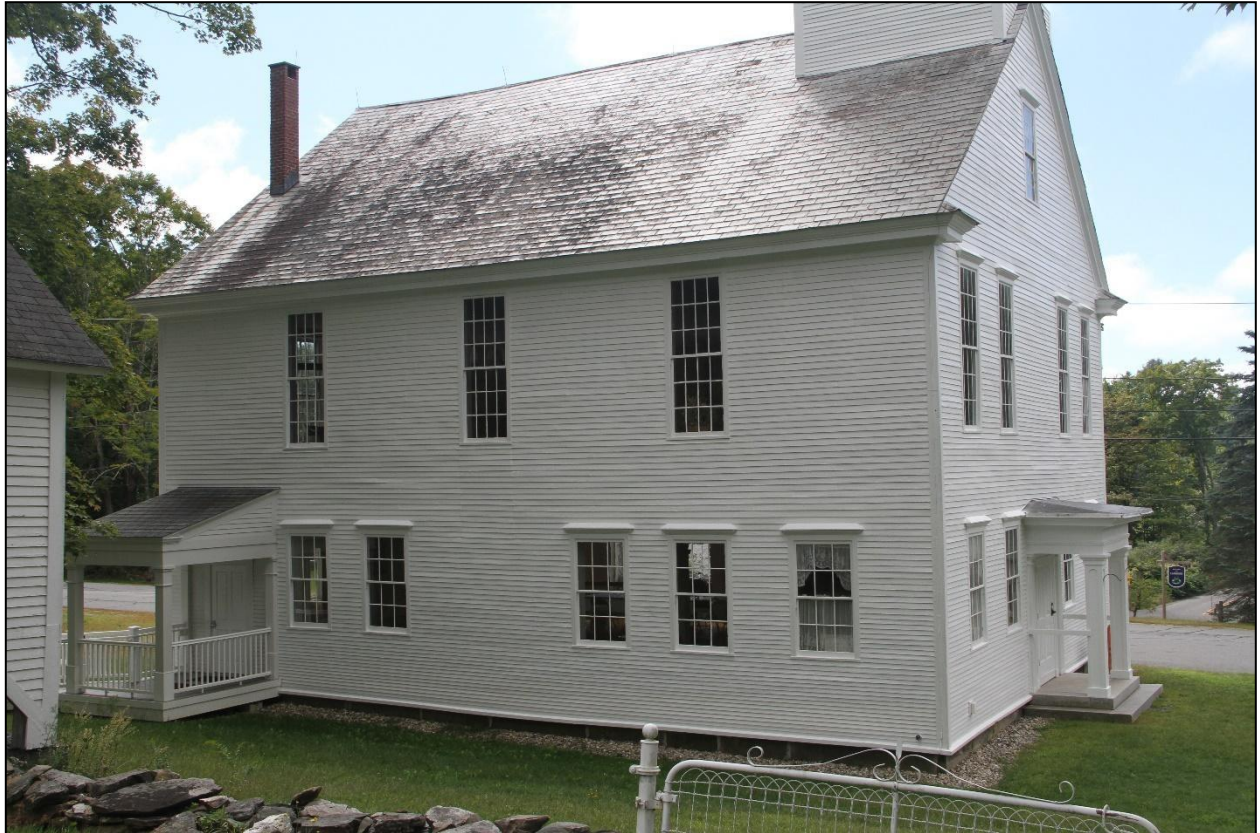
NH\_Langdon\_SullivanCo\_LangdonMeetingHouse\_0005: North side, showing ADA accessible sheltered entry at left. Looking South.

The third major renovation, from 2014 to 2016 included alterations to meet life safety and ADA code requirements. A secondary exit with wheel chair accessibility was added at the southeast corner of the building. A handicap parking area, ramp and covered porch were added outside the new entry. Two interior partitions on either side of the stage not original to the building were removed as previously described. In 2018 exterior repairs to the clapboards and steeple were made, also previously described.

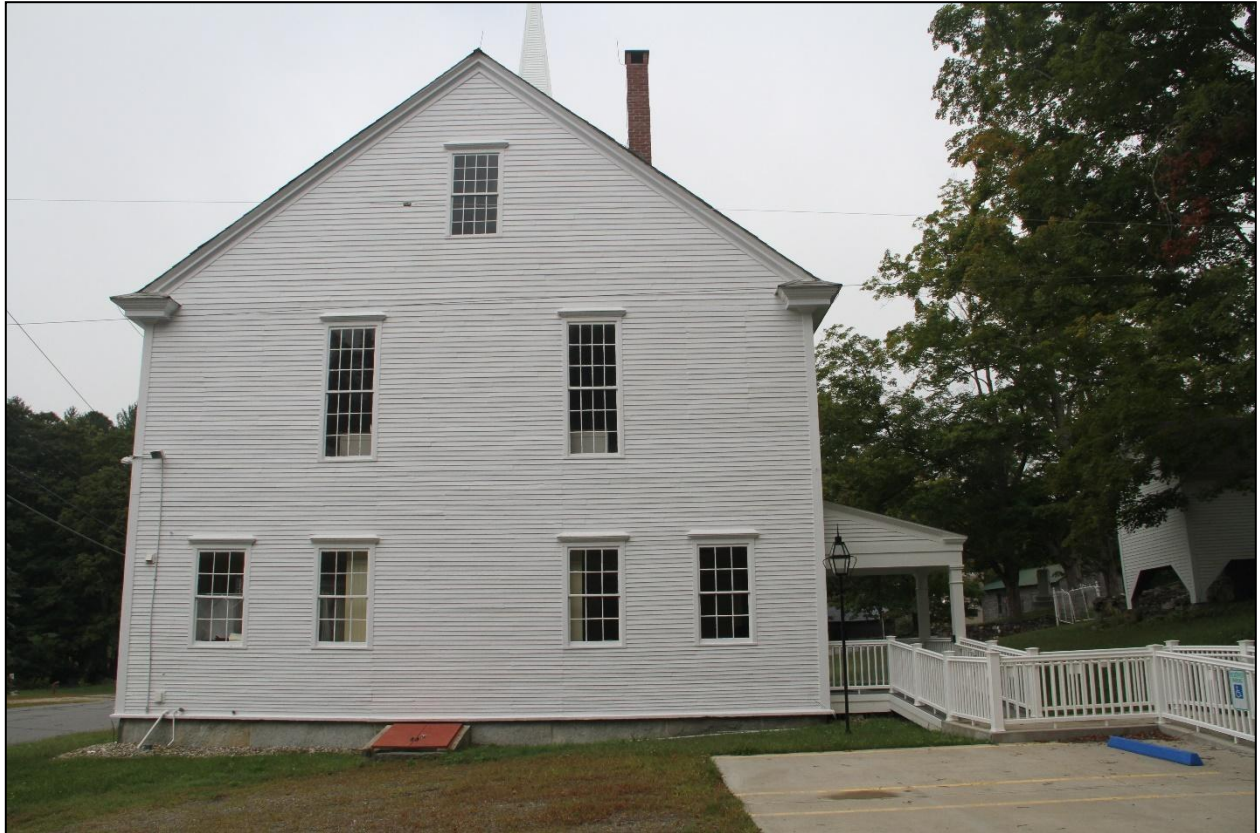
NH\_Langdon\_SullivanCo\_LangdonMeetingHouse\_0006: East side. Looking West.

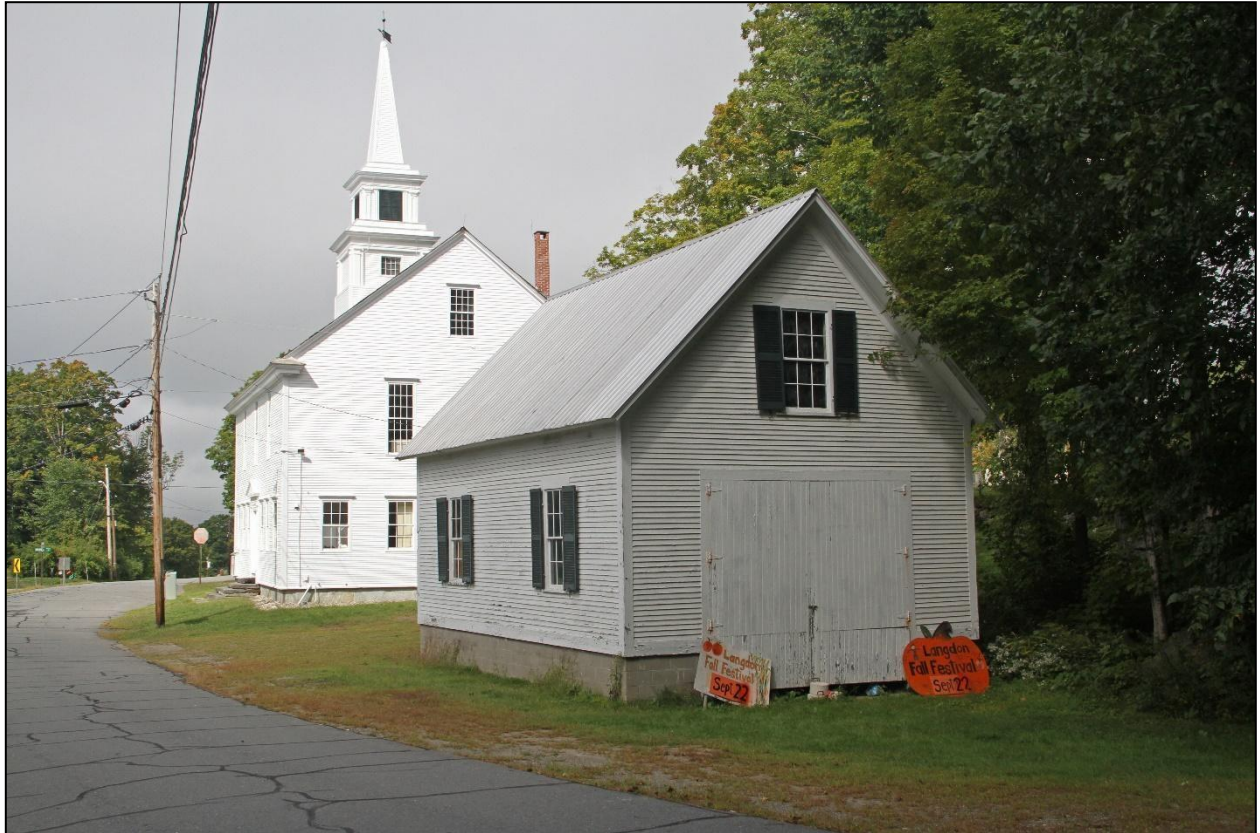
NH\_Langdon\_SullivanCo\_LangdonMeetingHouse\_0007: Salt Shed, east and south sides, with Meeting House in background. Looking West.

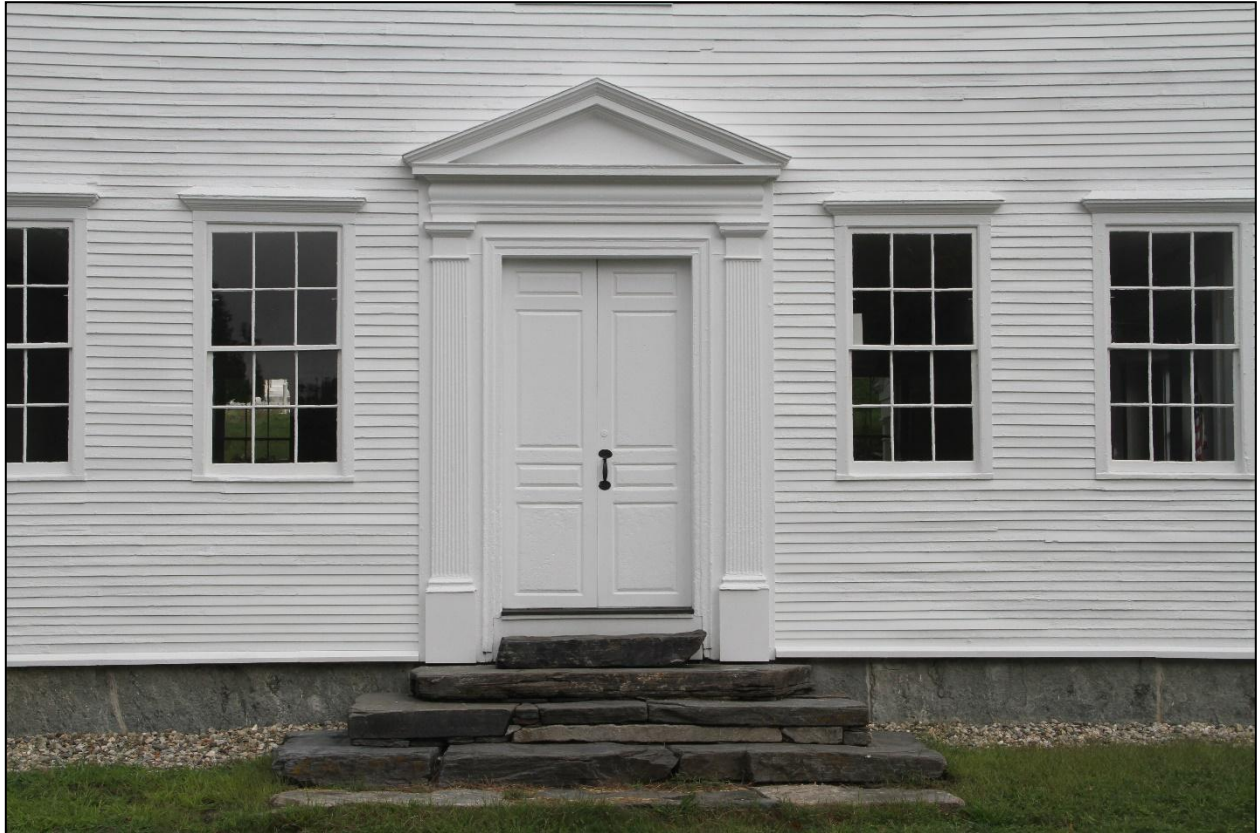
NH\_Langdon\_SullivanCo\_LangdonMeetingHouse\_0008: South entry. Looking North.

The large double door on the long south side of the structure is framed on either side by pilasters and is capped with a full pediment (Photo No. 8). The original wrought iron strap hinges are still in place (Photo No. 12). This “Door of Honor” originally opened onto the center aisle between wall to wall box pews offering an unobstructed view of the raised pulpit at the north wall and the illumination window elevated on the wall behind it. The pulpit and window were removed in the 1851 renovation; the size and location of the window is evidenced by the clapboard patchwork.

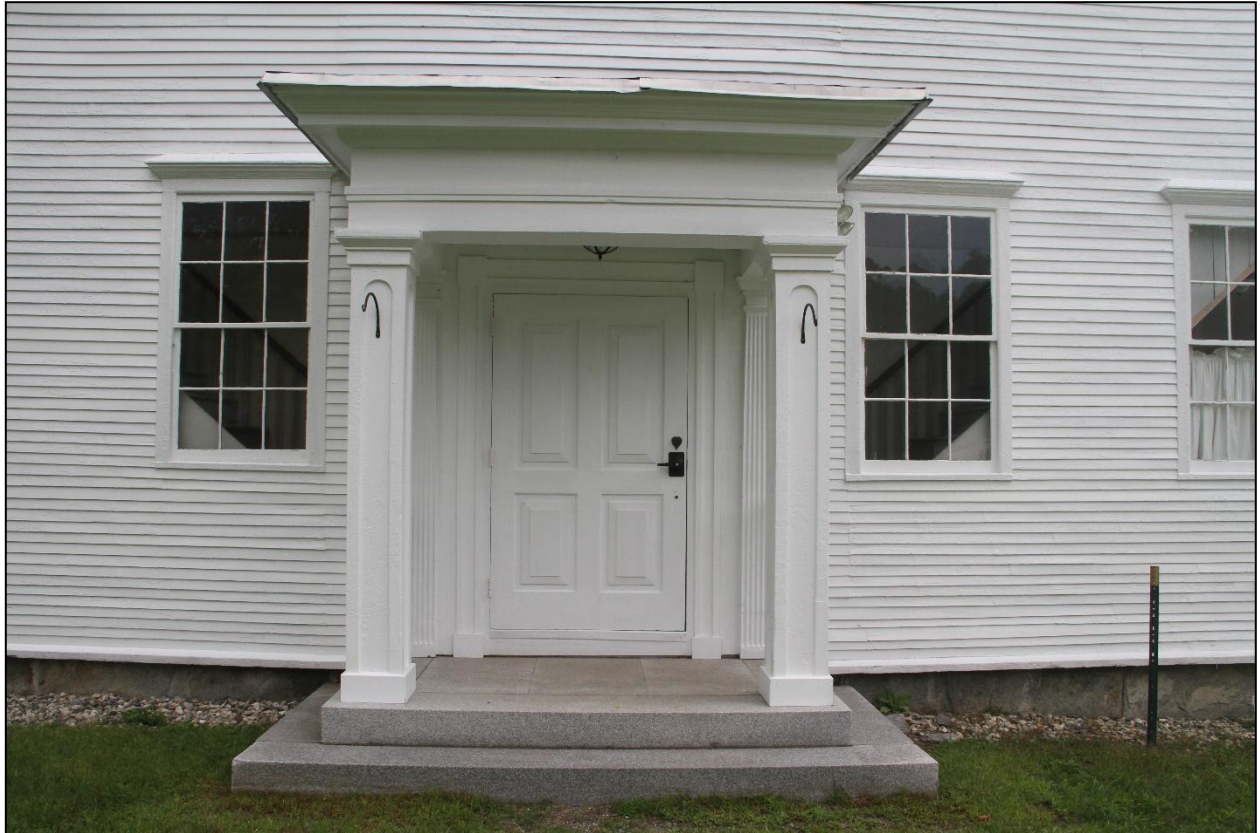
NH\_Langdon\_SullivanCo\_LangdonMeetingHouse\_0009: West entry. Looking East.

A three-story Greek revival steeple was added to the west end of the roof in 1851 (Photo Nos. 14, 10). The tower section has one fixed 12-light window on the east side. The belfry section has paired louvered shutters for attic ventilation in rectangular openings on all four sides. A bell was

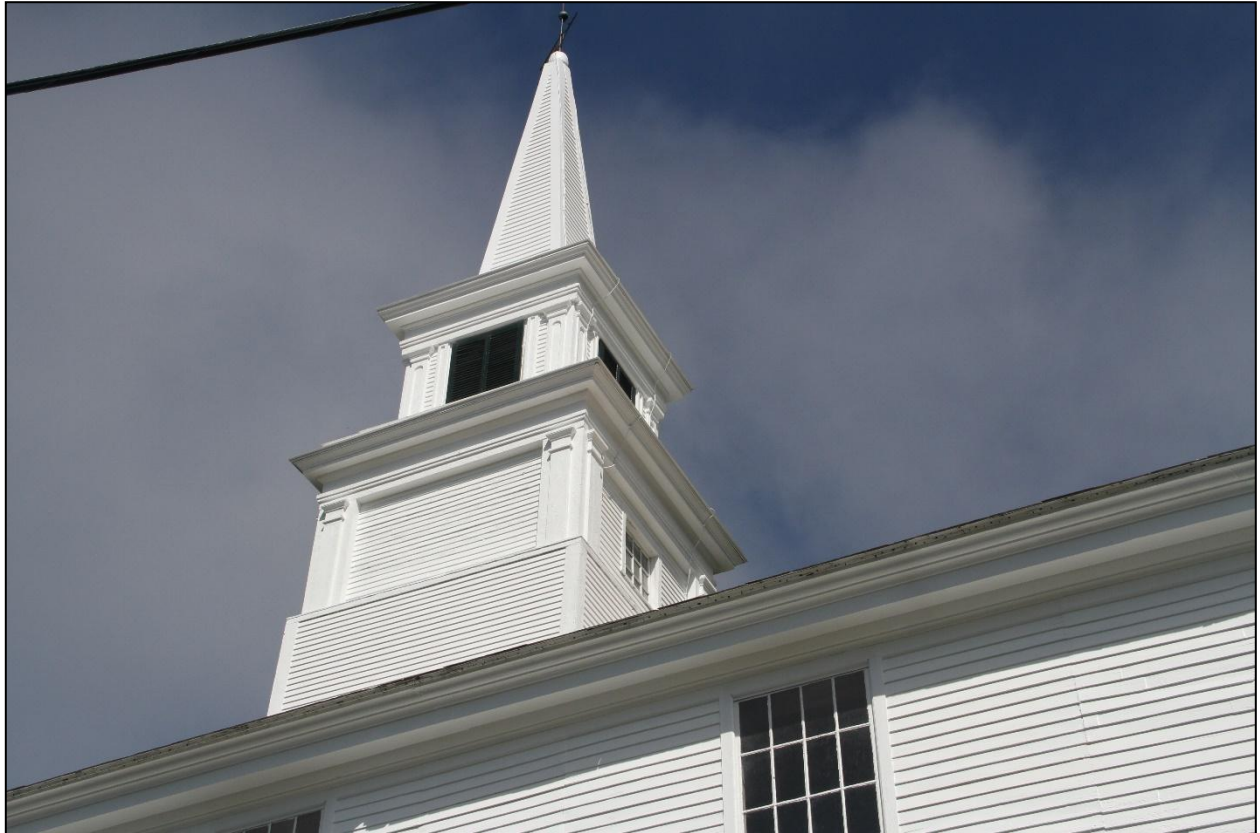
NH\_Langdon\_SullivanCo\_LangdonMeetingHouse\_0010: Steeple. Looking North.

never installed in the belfry.<sup>2</sup> The spire is pyramidal and topped with a five-foot weather vane cast by Langdon resident Lemuel Huntoon. The steeple is visible from Interstate 91 in Vermont, approximately twelve miles to the west. Restoration of the spire in 2009 replaced rotted clapboards and sheathing. The original four long saplings that form the structural frame of the spire were determined sound and left in place.

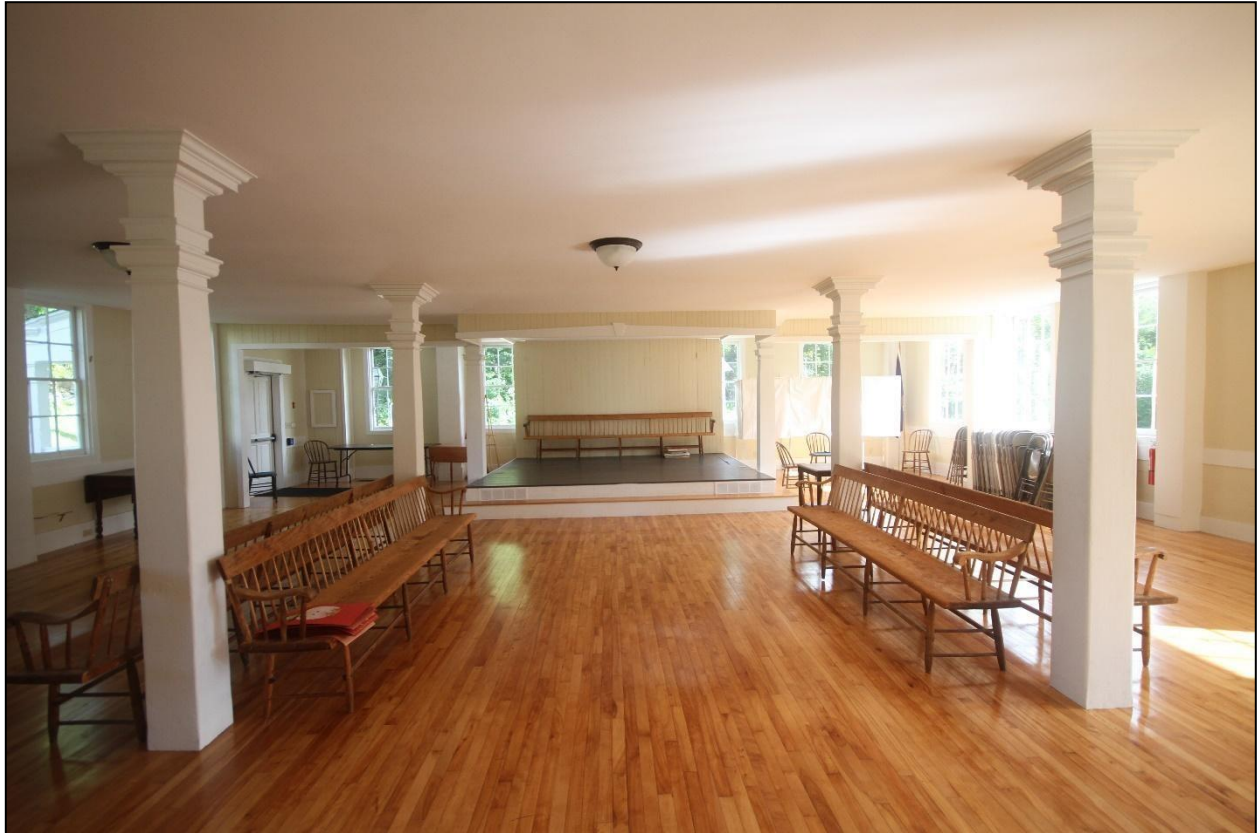
NH\_Langdon\_SullivanCo\_LangdonMeetingHouse\_0011: Interior, first floor, meeting room, overview. Looking East.

Originally the first floor was a single open room filled with box pews. The pews were removed in 1851, leaving trim boards on the north and south walls to which the pews were attached. It has not been determined if the original first-floor box pews were purchased by the Universalists in 1851 and are those presently installed on the second floor. The pews were replaced by long movable wooden benches for use by townspeople during the ongoing annual town meetings and social gatherings held in the room. Several of these ca.1851 benches remain serving the same purpose (Photo No. 11).

A raised stage, 12'-6" x 13'-8", is centered at east end of the meeting room. It is estimated the stage was installed sometime after the Civil War when presentations and entertainment became common in New England meetinghouses. During the 1930's the floor of the meeting room was shimmed to be made level and a hardwood floor layed over the building's original wide pine boards.

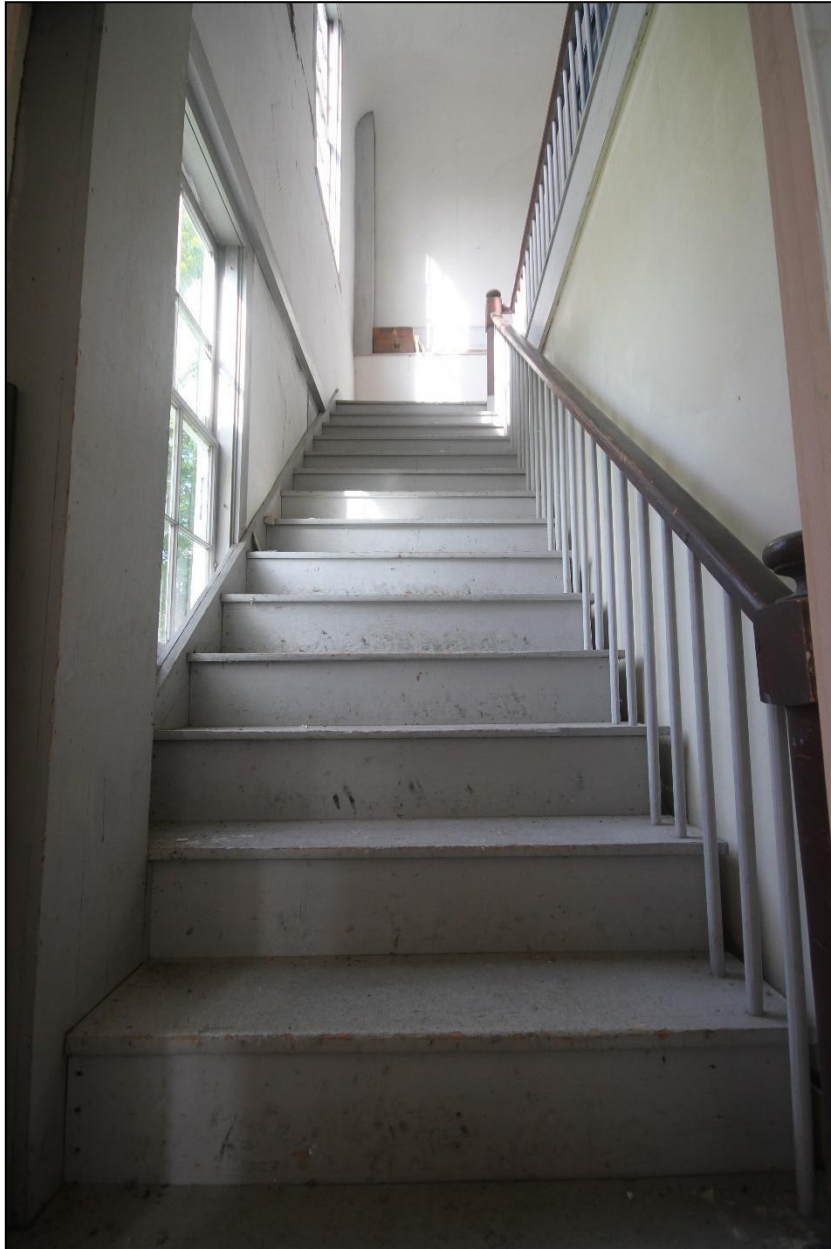
NH\_Langdon\_SullivanCo\_LangdonMeetingHouse\_0013: Interior, first floor, north staircase. Looking North.

Two interior staircases flank the west entry and lead up to a foyer that was the west gallery prior to the construction of the second floor in 1851 (Photo Nos. 13, 14). The foyer is 10' deep, corresponding to the building's first floor section purchased by the Universalists, and separated from the congregation hall, or auditorium, with a partition wall fitted with two door openings. The foyer retains its lath and plaster walls and curving vaulted ceiling from the original construction of the building. The stair balustrades are simple, with round shaved balustrades and plain turned newel posts with ball caps.

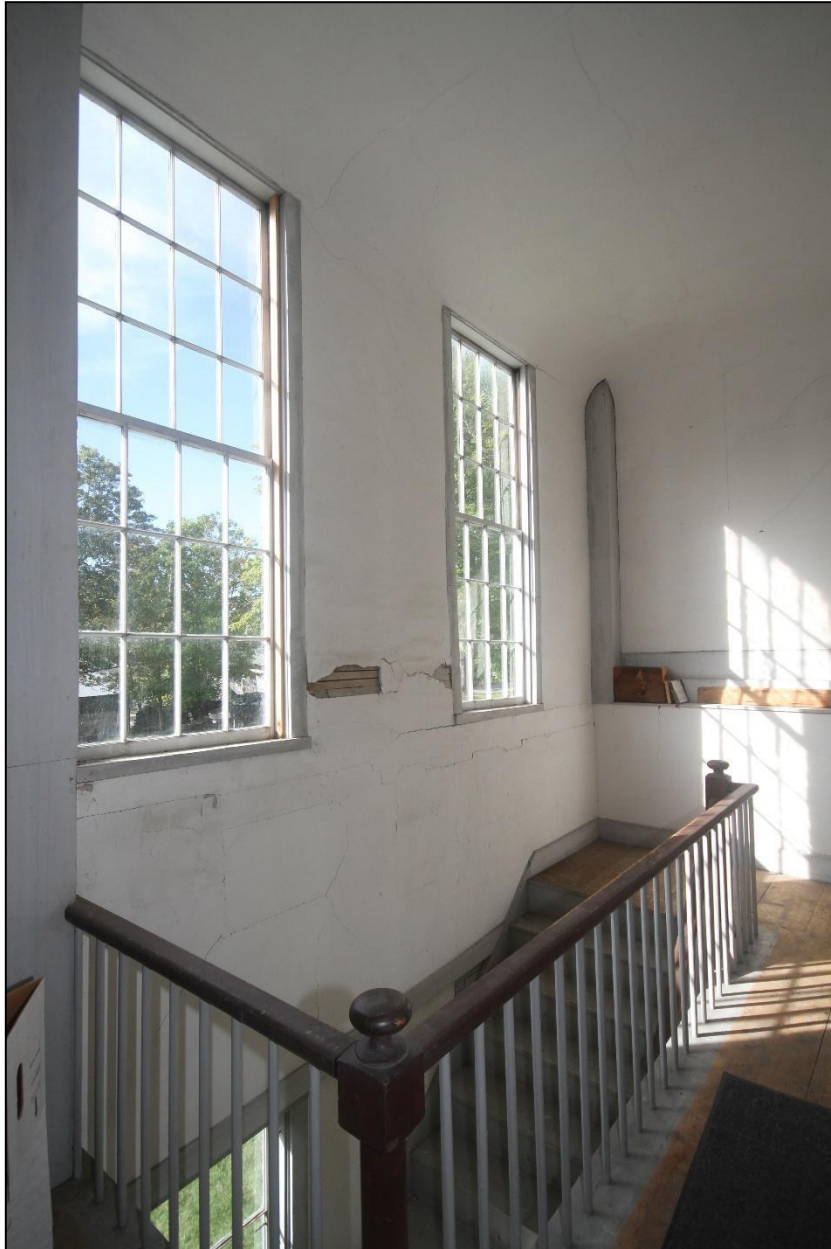
NH\_Langdon\_SullivanCo\_LangdonMeetingHouse\_0014: Interior, second floor, north staircase railing, showing original plaster and windows. Looking North.

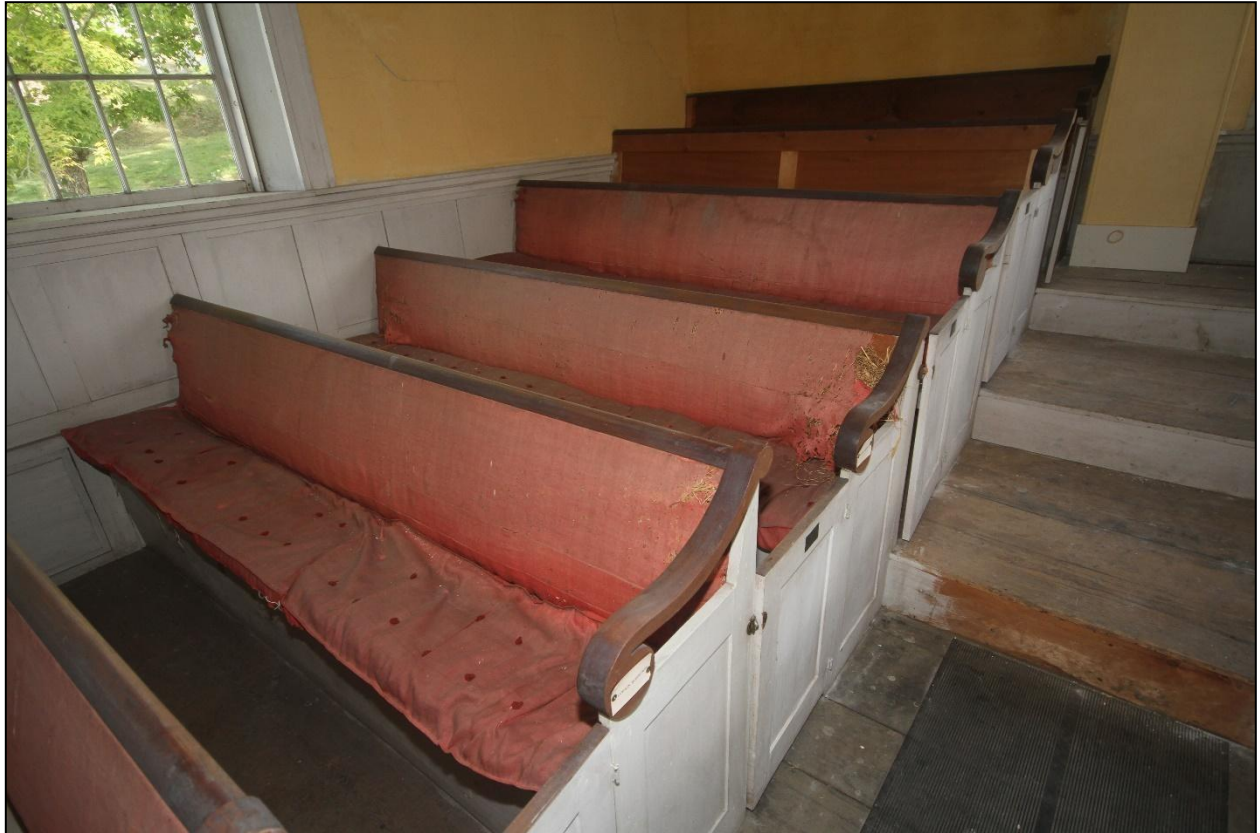
NH\_Langdon\_SullivanCo\_LangdonMeetingHouse\_0017: Interior, second floor, congregation room, pews with original horsehair cushions. Looking Northeast.

The closed pews with original hardware, paneled wainscoting, the unique dais, stenciling at the top of the walls, in grain carpet on the floor, a six plate wood stove, hand shaved balusters and other original features make this space a time capsule of its period. Francis Kingsbury notes in his history of Langdon that on November 15, 1851 the Boston newspaper *The Trumpet*, reporting on the dedication services for the new Universalist "church" writes, "The portion of the house appropriated for a church is very finely finished. The aisles are carpeted and the pews are all cushioned and lined. It will seat about 300."

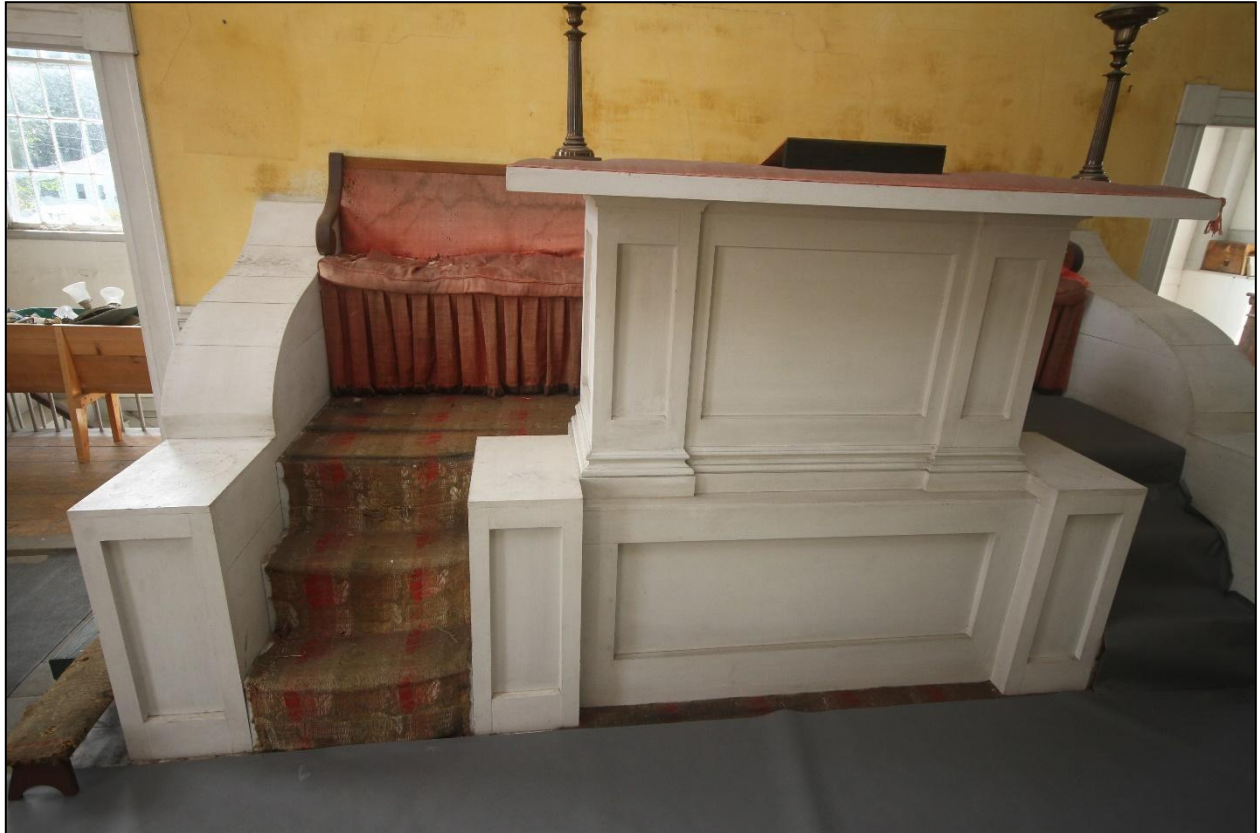
NH\_Langdon\_SullivanCo\_LangdonMeetingHouse\_0018: Interior, second floor, congregation room, pulpit. Looking West.

At the west end of the room against the foyer wall is a raised pulpit consisting of a simple paneled lectern flanked by stairs. An upholstered pew is located against the wall behind the lectern to accommodate additional speakers or honored guests. Two original brass oil lamps are mounted at each end of the lectern. The pulpit platform and the stairs are covered by its original ingrain carpet. The wood is painted in a pale yellow tone similar to the plaster walls.

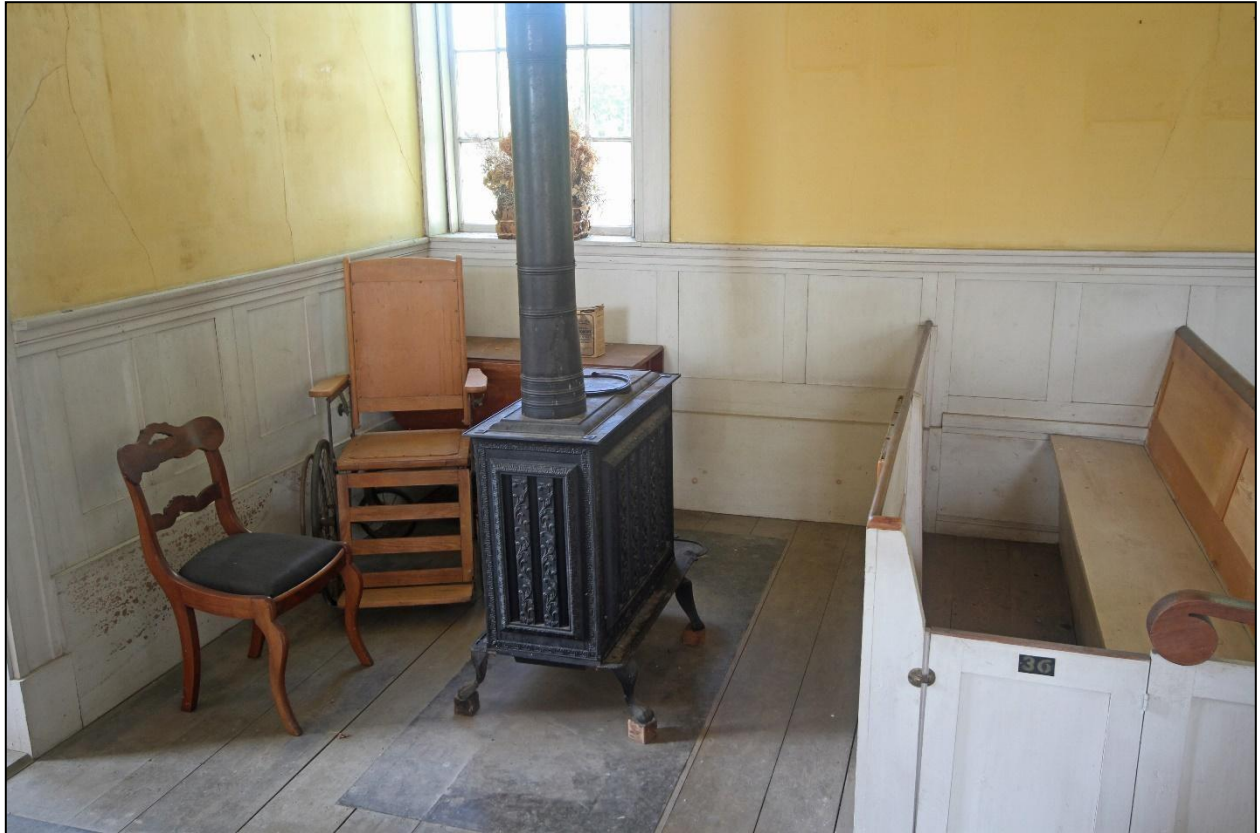
NH\_Langdon\_SullivanCo\_LangdonMeetingHouse\_0019: Interior, second floor, congregation room, showing original woodstove and wainscoting. Looking North.

A wood stove is located in the northwest corner of the auditorium (Photo No. 19).<sup>3</sup> Its flue pipe, suspended by wires, runs horizontally across the entire length of the room to a brick interior chimney north east corner of the building (Photos No. 6, 16. This chimney was determined to be original to the building when it was reconstructed in 2010. Structural repairs made in the attic in 2008 revealed evidence that a second similar original interior chimney was originally located in the southeast corner of the building.

<sup>3</sup> After a 2018 visit to the Langdon Meeting House, Rodney Rowland of Strawberry Banke Museum in Portsmouth, NH, described the stove in an email to the Langdon Heritage Commission. "The stove is quite wonderful. It was made by a foundry company in Pittsford, VT owned by Chester Granger and his partner George W. Hodges. Chester's father, Simeon Granger started the company in 1826, but the company used the Granger & Hodges name only from 1846 to 1852, after George Hodges bought a share of the company. This stove is actually a 6-plate stove (it has no wood box access doors which would make it a 10 to 16 plate) with "raised collar boiler hole". A detail specific to his patent. Most of this type of stove are for houses and would sit on a stand. This one was clearly made for commercial use and sits on 4 lion paw, cabriole legs. A nice detail."

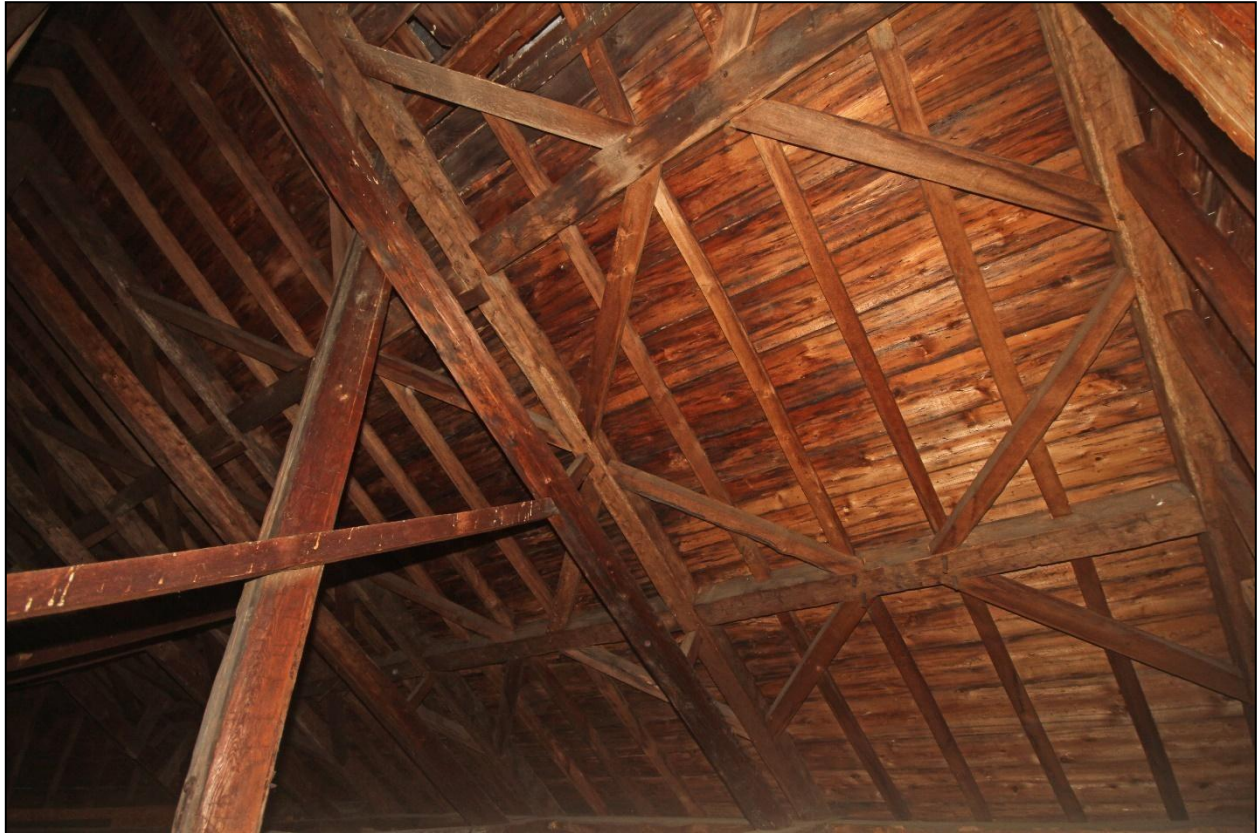
NH\_Langdon\_SullivanCo\_LangdonMeetingHouse\_0020: Attic, showing timber roof framing. Looking East.

Attic and steeple: The king-post and beam construction is visible in the attic. Four hand hewn 10 x 12 hardwood, slightly arched, collar ties reach forty feet to connect the outer walls and support the roof system. The king-posts sit atop them. Two original 12 over 12 double hung windows are at each gable end. Ladders are necessary to access the steeple; one to get into the tower, another to the belfry. One very old ladder is made of a split hard wood sapling with hand shaved rungs. There are louvered windows in the belfry and a small window on the back (east) wall of the tower. A few ancient, loose samplings are still placed horizontally in the joints where angled braces meet king posts. This is likely staging for the original builders.
