NHDHR INVENTORY # WEN0003

Name, Location, Ownership							
1. Historic name Village Bridge;							
2. District or area Wentworth Village Area Form (identified potential NR-eligible historic district)

9. Style 1-span riveted high Warren truss w/wood floor							
10. Architect/builder John W. Storrs, engineer; United Construction Co., contractor; American Bridge Co. truss fabricator

34. Date of Survey November 2014

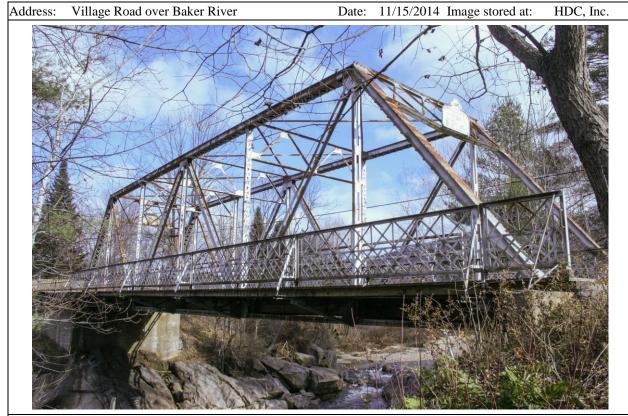
Photo # 4 description: Downstream (west) side of truss.

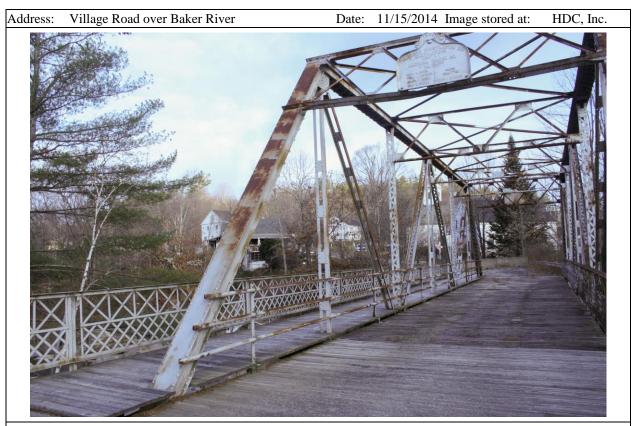
Photo # 5 description: Bridge deck, sidewalk, railing and truss frame details.

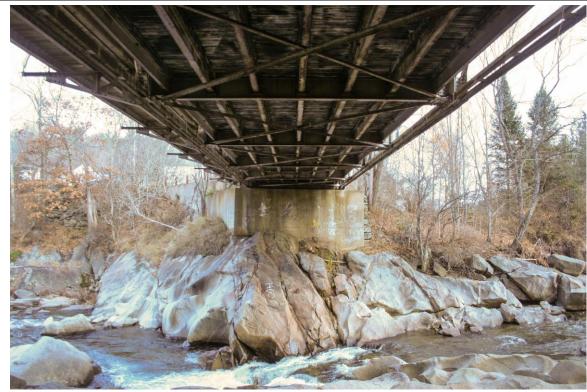
Photo # 6 description: North abutment and underside of deck showing floorbeams, stringers, lower chords and sidewalk brackets.

The abutments are of reinforced concrete with asymmetric wings. The north abutment is cast integral with a perpendicular stone abutment wingwall on the upstream side, evidently part of the earlier bridge abutment. The abutment wingwall on the downstream side is of reinforced concrete and angled slightly off the perpendicular. The south abutment wingwalls are both concrete, with the upstream wing angled slightly off the perpendicular and the downstream wing nearly straight.

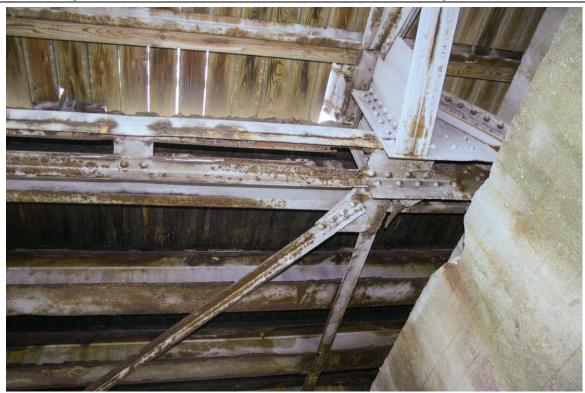
Photo # 7 description: Truss framing detail, lower chord, post, and sidewalk bracket connection, showing rust-thru of lower chord tension members.

Following routine scheduled inspection the bridge was closed to all pedestrian traffic in November 2013. In May 2014 the NHDOT performed an in-depth inspection of the bridge to determine the actual extent of deterioration. An analysis and load rating of the bridge "as inspected" was issued on October 10, 2014, finding: "Overall, the steel trusses are in "critical" condition, with areas of the lower chord in a state of "imminent" failure."

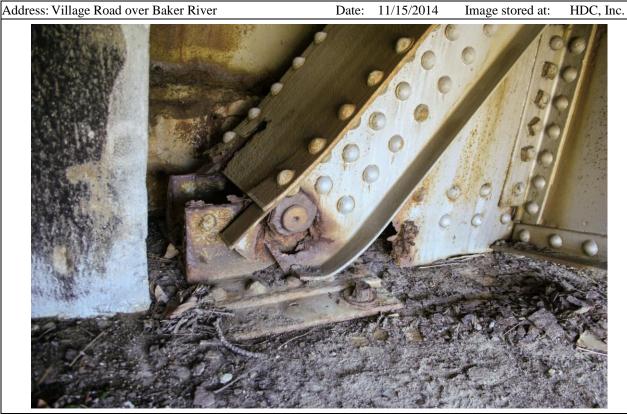
Photo # 8 description: Truss frame detail, fixed bridge bearing and endpost connection, north end, showing structural failure and rust-thru of members.
