Bath Village Covered Bridge Bath, New Hampshire

Rehabilitation Project Report

November 2011

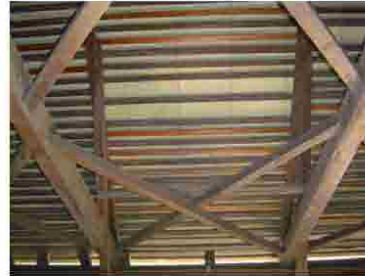
The roof consists of a metal roof on longitudinal 1-3/4"x3" purlins spaced at 12" on center. The purlins in turn are supported by transverse 4"x6" rafters at 8" on center. Approximately one-half of the purlins appear to be in their original locations based on notching patterns. The remaining purlins appear to have been added at a later date and are simply toenailed to the side of the rafters. Several purlins were either missing or loose and many are sagging between rafters with no obvious attachment to the metal roof. Several of the missing purlins have fallen out of place and landed on top of the upper lateral bracing.

Typical Roof Framing with Missing Purlins

The metal roof is in fair to good condition with some leaks noted, however the attachment of the roof to the purlins is poor. During light winds the roof makes a rattling noise as it moves over the purlins. The lack of attachment to the roof will reduce the service life of the roof, however due to the method of installation; it is impossible to add the correct type of additional attachments due to the type of roof. The purlins appear to be in good condition with the attachment at the rafters in poor condition in many locations. The rafters are fair to good condition with some minor rot noted at the rafter tails (lower end).

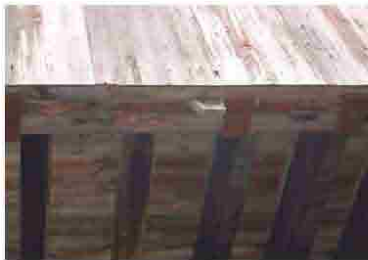
Span 5, North Lower Chord

The spans between Bent 2 and 3 (Span 3 over the recreational trail) and Pier 1 and 2 (Span 5 over the river) appear to be in the worst condition and exhibit the worst sag. Span 5 has rot and splits in the original chord members visible from below. This span was previously repaired by the addition of steel rods and an extra chord member in this location.

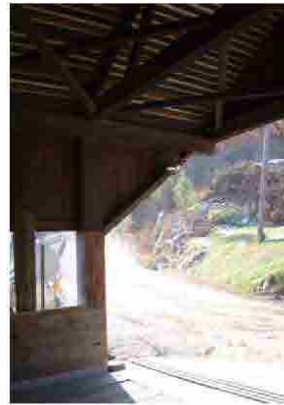
The upper chords of both trusses exhibit excessive deflection at the west end of the bridge where they support the portal. This condition appears to be caused by long term creep and inadequate support of the cantilevered portion of the top chord.

Deflection of South Truss Top Chord at the West Portal

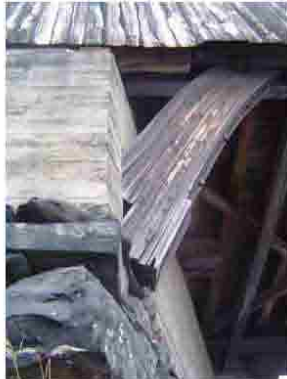
The arches are in good condition with the exception of the two (2) added arches between Piers 1 and 3 and portions of the integral arches near siding windows. The added arches are weathered on the downstream face, have very poor bearing on the piers and have begun to lose their shape as evidenced by the splitting of the laminations. The arches bearing on Pier one (1) are not well seated and, due to the steep

slope of the arch, could slip or potentially fall off the pier. It is very difficult to predict when this may occur, however this condition is serious and we recommend that it be addressed within the next year.

Southwest Arch Bearing at
Pier One

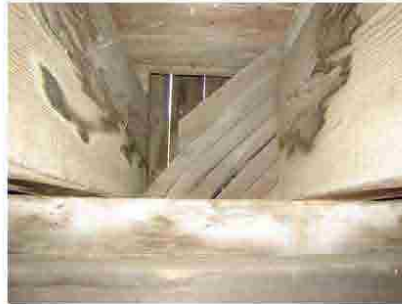
Separation of Arch Laminate at Pier
One

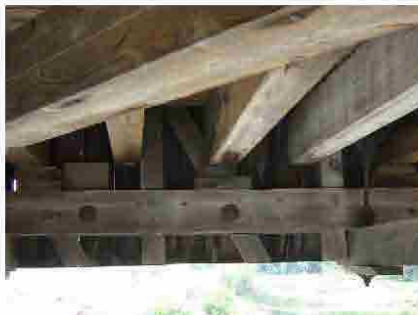
Missing Floor Beam Blocking

The floor beams have been shimmed up to 7" at the truss bearings due to the varying sag in the bottom chord of the trusses, however the blocking is missing in 26 locations. It appears that vibration from vehicles has loosened the blocking.

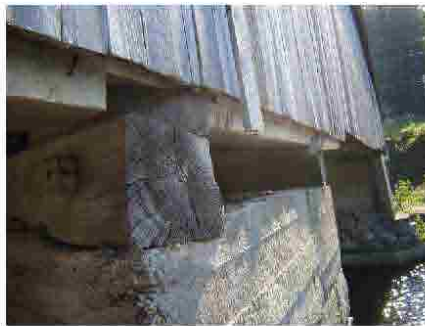
Rot and Crushing of Support Beams at Pier 2

The bridge trusses are supported at the abutments and piers by sleeper beams and transverse support beams. Most of the sleeper and transverse support beams are in poor condition with rot and crushing evident. At Pier 1, only the western edge of the sleeper beam is bearing on the pier due to movement of the pier.

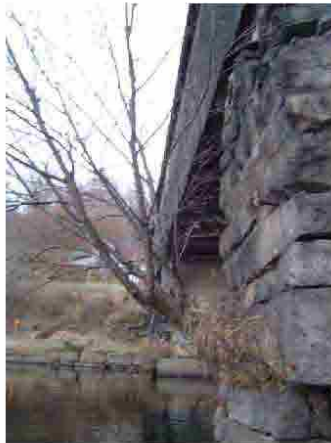
Tree Growing out of Pier 2

The three (3) river piers consist of largely dry laid stone with concrete caps and concrete toe wall. Piers 3 and 2 (easternmost pier and center pier respectively) are in poor to fair condition, while Pier 1 is in serious condition. Piers 3 and 2 are founded on ledge and Pier 1, which is not of original construction, is founded on partially exposed wood cribbing. All three Piers have varying amounts of vegetation growing in the joints with Pier 2 having a small tree growing out of the downstream face. All three Piers have some large stones and chinking stones missing.

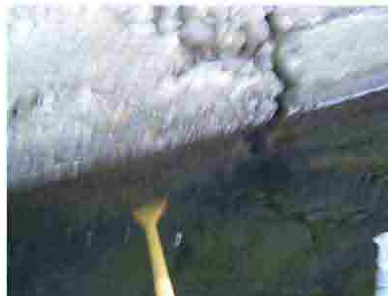
- Scour. Two (2) scour pockets measuring at least 3'x3'x3' and 2' deep by 4' long, which have exposed the wood cribbing under the bridge were noted under the East side of Pier 1. The NHDOT inspection report has noted this scour condition since October 2000. Once the wood cribbing is exposed to the oxygen in the river water, it will begin to rot, which may cause the pier to settle further.

Canoe Paddle Placed into Scour Hole under Pier 1

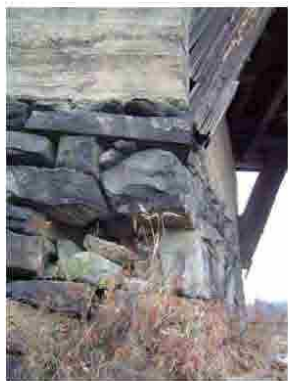
- Missing stones. A large stone is missing from the south face of the pier which has caused it to shift. Based upon photographic records from the NHDOT, this stone has been missing since at least the time when repairs to the bridge were made in the late 1980's. It is unknown how long this condition existed prior to these repair or why it was not corrected.

Stone Missing in South Face of Pier 1 (also note Arch Bearing Conditions)

- Cracked Concrete. The concrete toe wall around the base of the pier is cracked in several locations.
- Arch Bearing. The arches bearing on Pier one (1) are not well seated and, due to the steep slope of the arch, could slip or potentially fall off the pier.

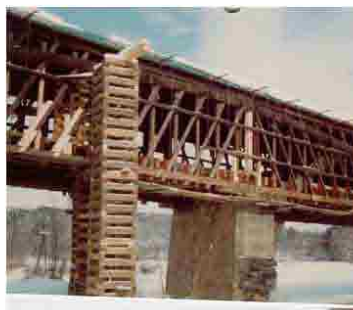
Pier 1 During Repairs made in the 1980's

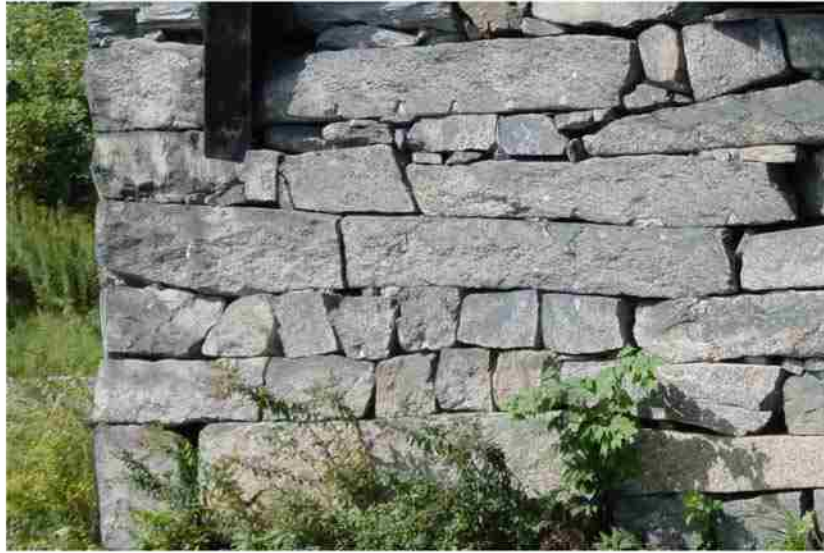
The same splitting technique is clearly visible in both Pier 1 and Pier 2 of the Bath Village Bridge.

Detail of east face of Pier 2, Bath Village Bridge

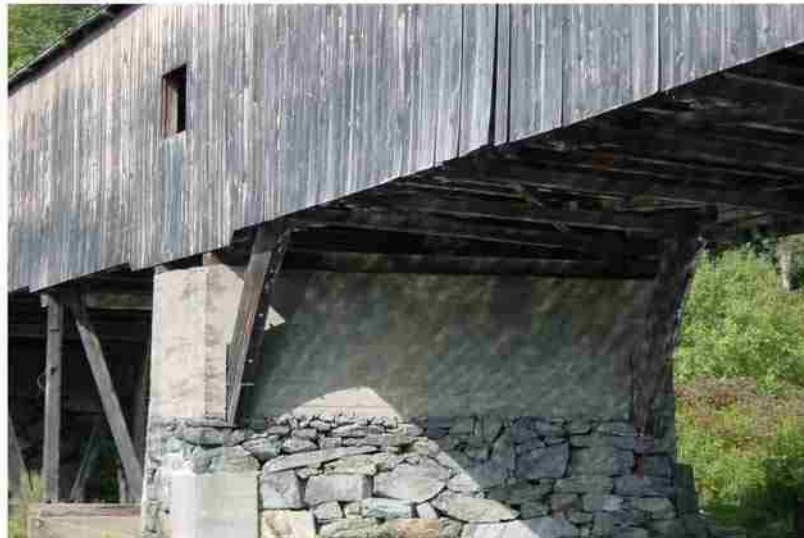
By contrast, Pier 3 has fewer large split stones than Piers 1 and 2:

East face of Pier 3, Bath Village Bridge

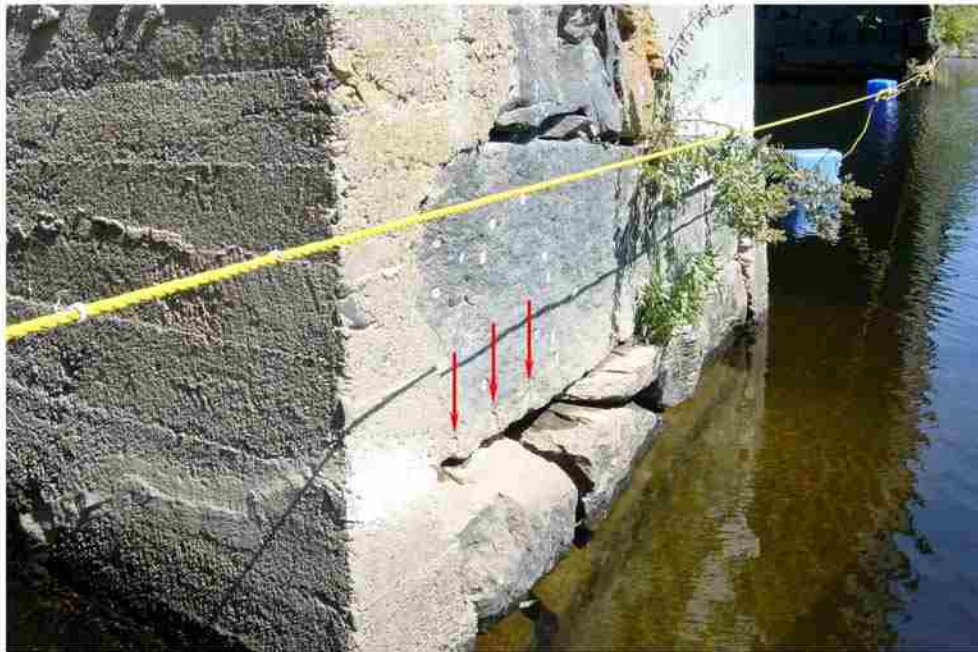
While Pier 3 shows less evidence of splitting techniques, one of the lowest stones in this pier, clearly original, displays the marks of the plug drill, denoting its later date:

South face of Pier 3, Bath Village Bridge

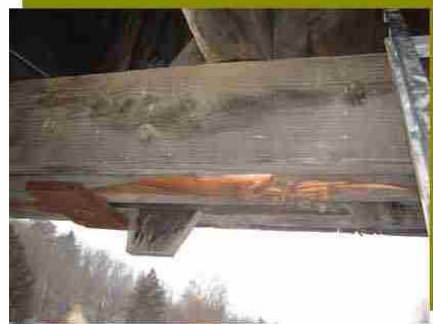
- North Truss. There was some moderate impact damage to the bottom chord of the truss as well as slight twisting of the truss between bents 2 and 3.
- South Truss.

North Truss Near Node 17

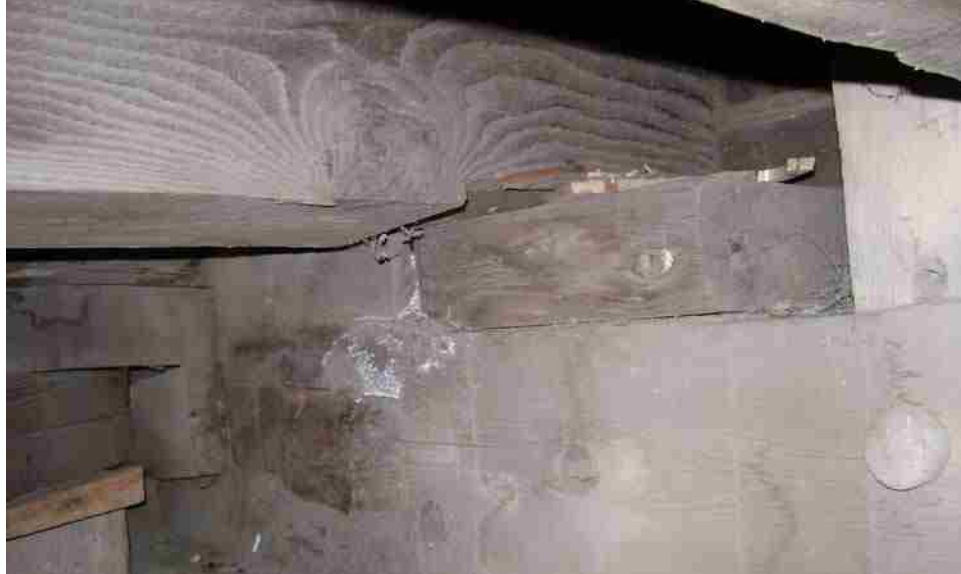
Photo No. 2-1 Bottom Chord N62 – N71 A, Rot near N63 & N70

Impacts:			
Approximately 17 percent of the total number of lower chord members require replacement. Members to be replaced will be replaced "in-kind" with wood members of the same size and workmanship.			
Alternatives:			
Due to the laminated design of the lower chord, there are no other practical treatment alternatives that meet engineering requirements and the Secretary's Standards other than repairing the chords by splicing in new wood members in the place of those determined structurally inadequate.			
Drawings: 35, 36, 37, 38, 39, 41, 42		Photos: See table below	
<p>Drawing No. 37</p> <p>4"x11" BOTTOM CHORD LAMINATION</p>		<p>Photo No. 2-1</p>

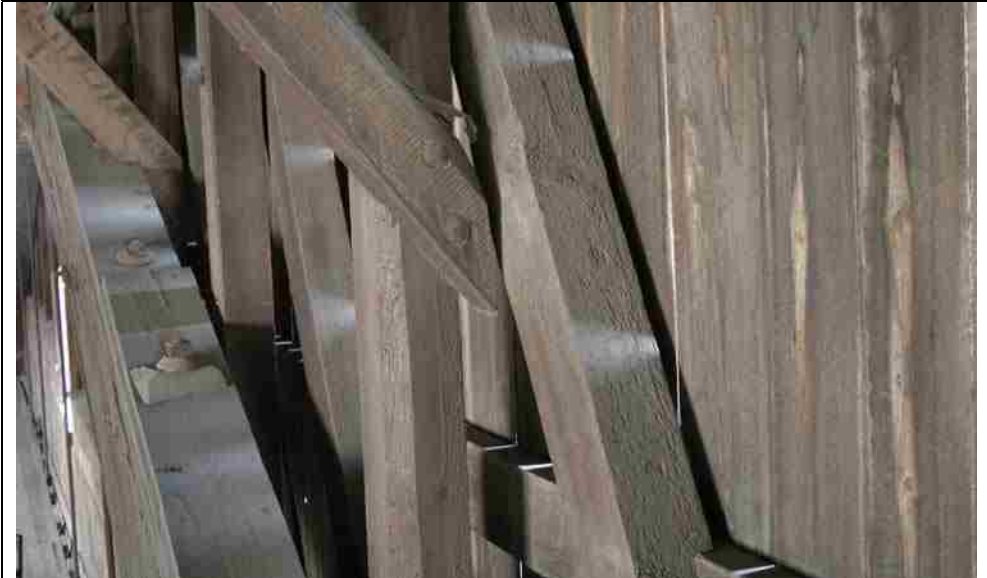
Photo No. 3-11 Vertical Truss Member N49, Large Knot

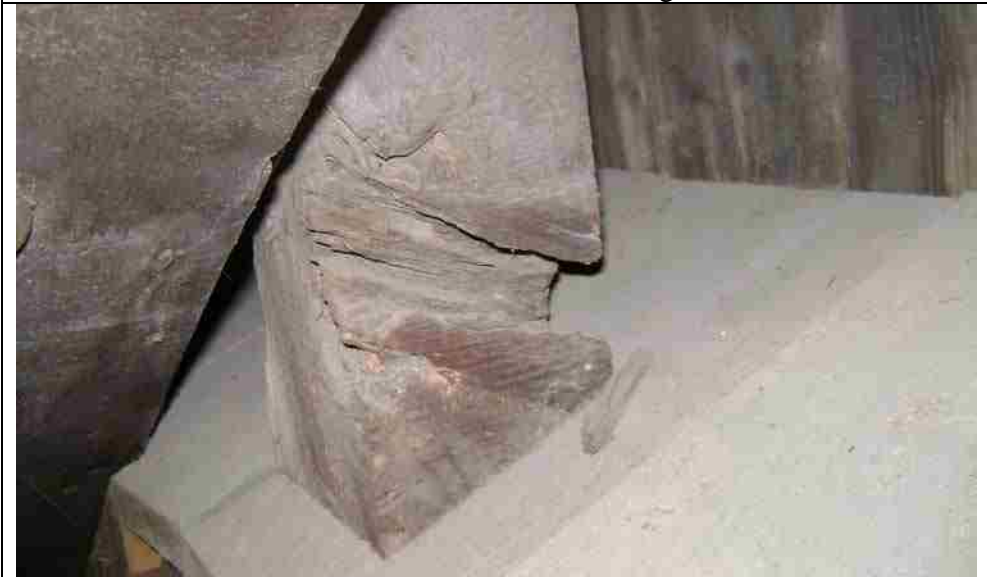
Photo No. 3-12 Vertical Truss Member N56, Split

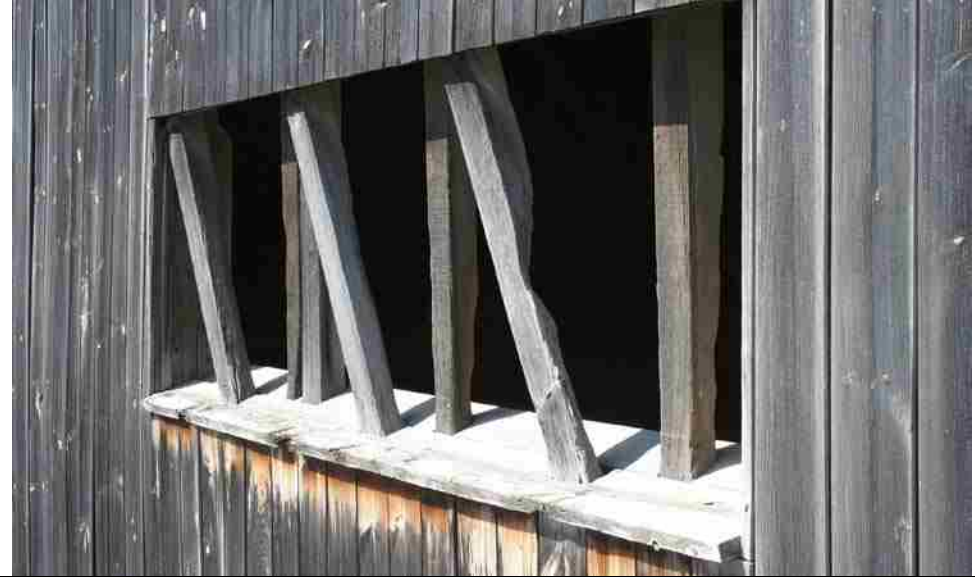
Photo No. 4-3 Diagonal S92L – S93U, Weathering

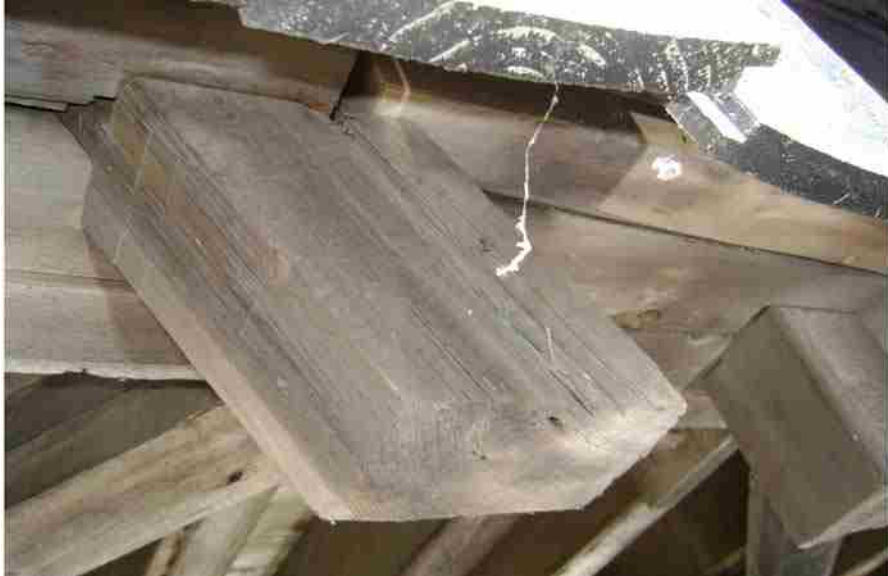
Photo No. 4-5 Diagonal S36U – S37L, Lower Tail missing

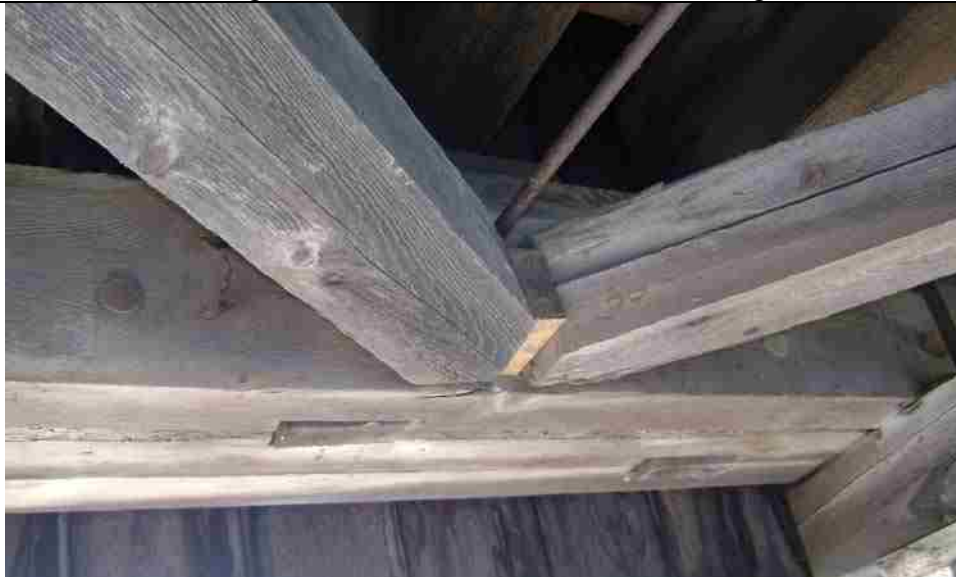
Photo No. 4-6 Diagonal S41L – S43U, Break, Splits, Rot

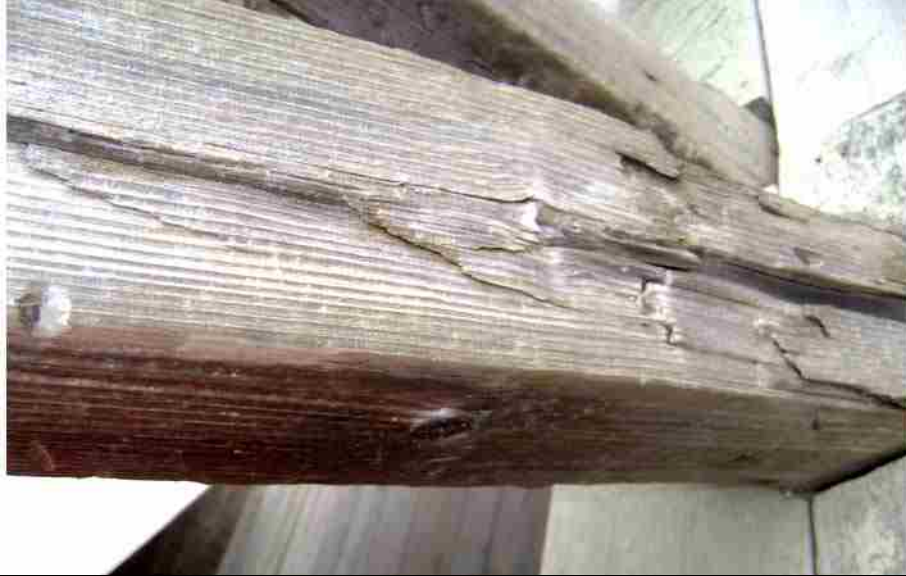
Photo No. 4-11 Diagonal N17L -N18U, Spliced Member

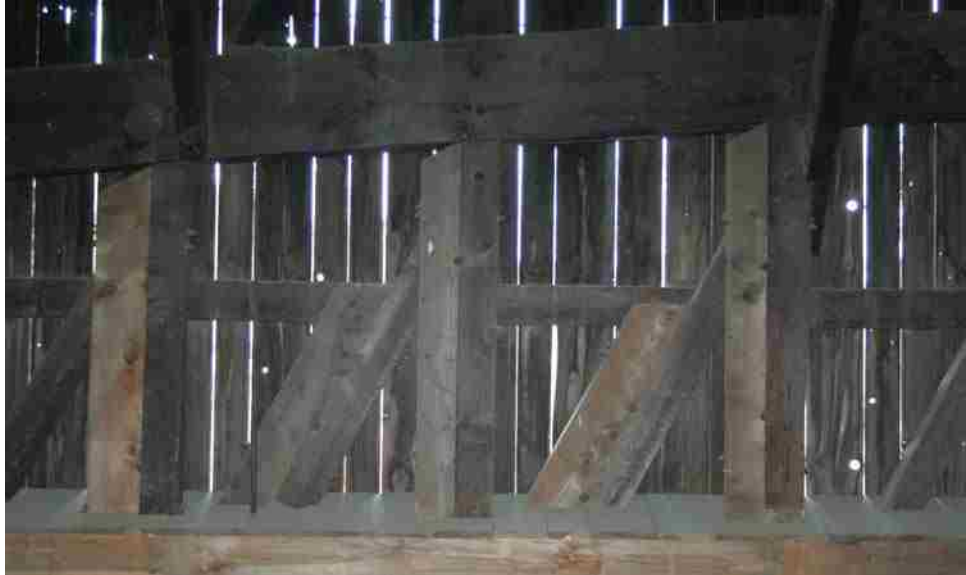
Photo No. 4-12 Diagonal N28U-N29L, Split at Lower Tail

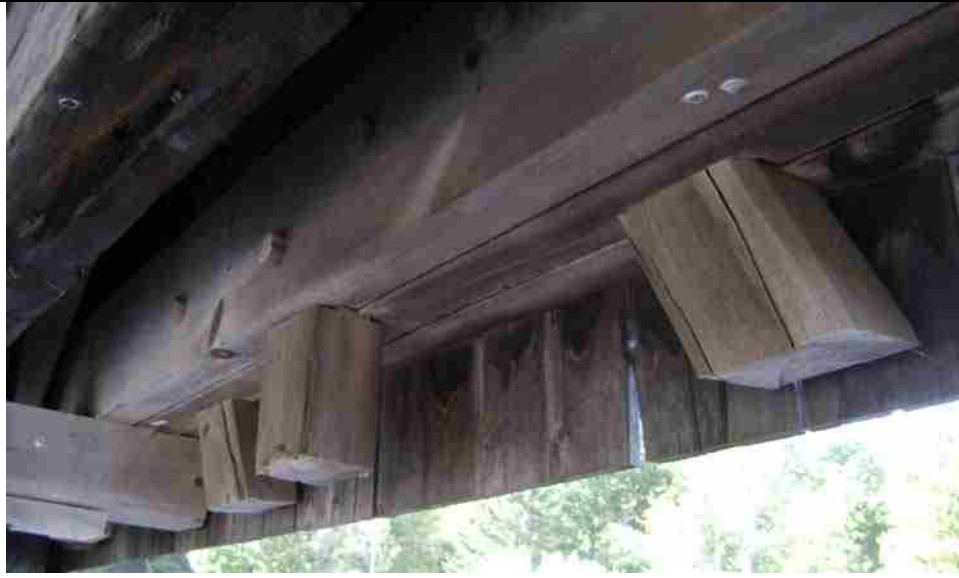
Photo No. 4-13 Diagonal N38U-N39L, Split at Upper Tail

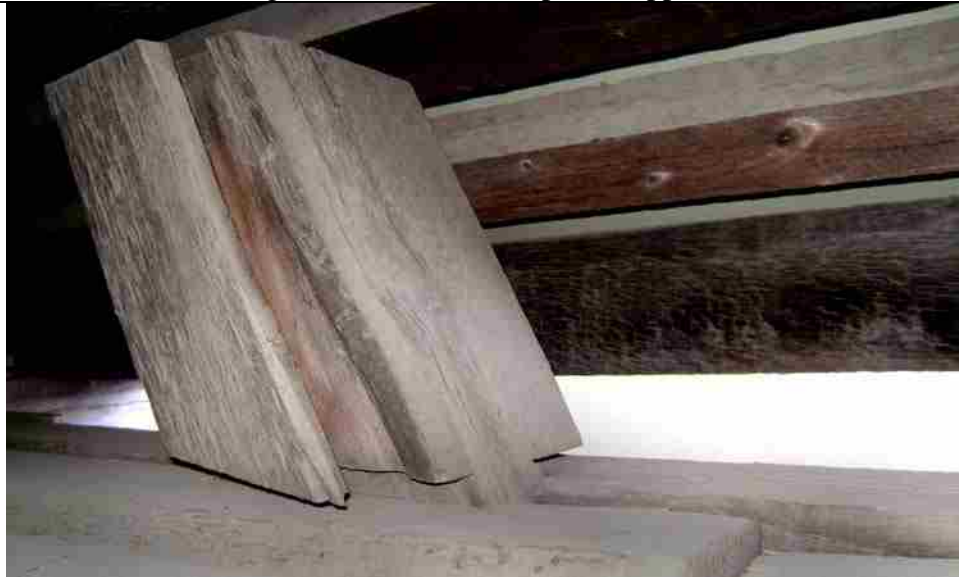
Photo No. 4-14 Diagonal N56U-N57L, Split

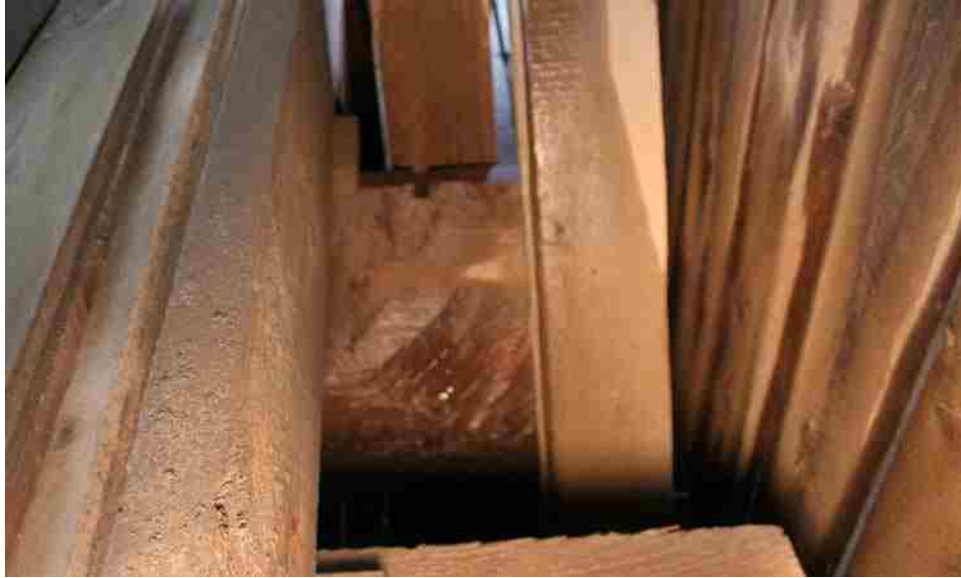
Photo No. 4-19 Diagonal S13L – S14U, Section loss; also Spliced Member

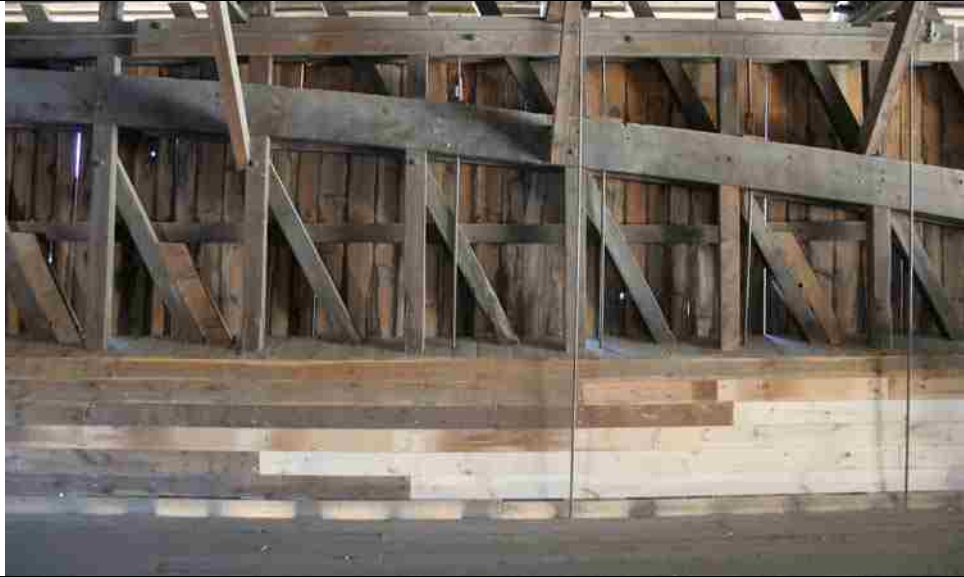
Photo No. 5-2 Built In Arch S18 – S14

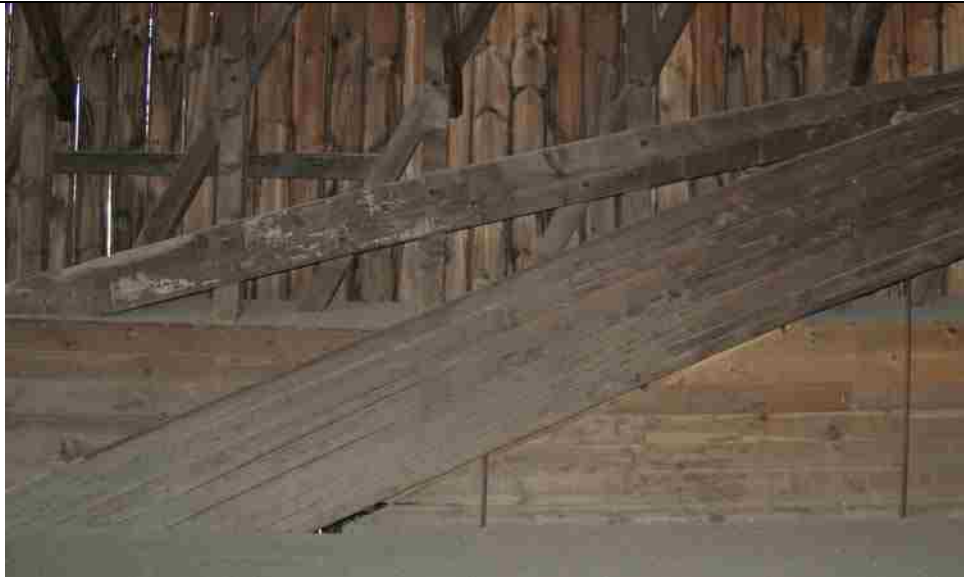
Photo No. 5-3 Built In Arch S90 – S86

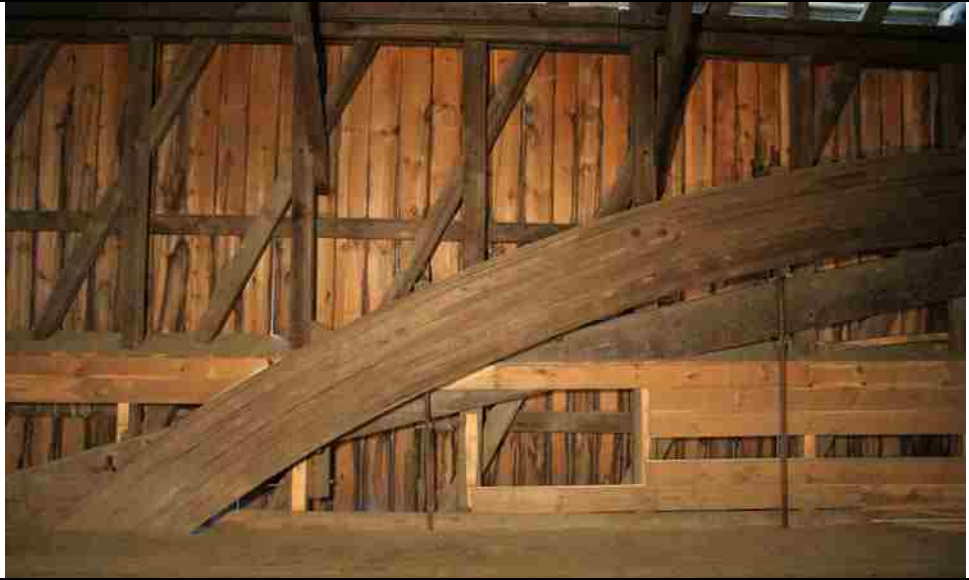
Photo No. 5-4 Built In Arch S40 – S34

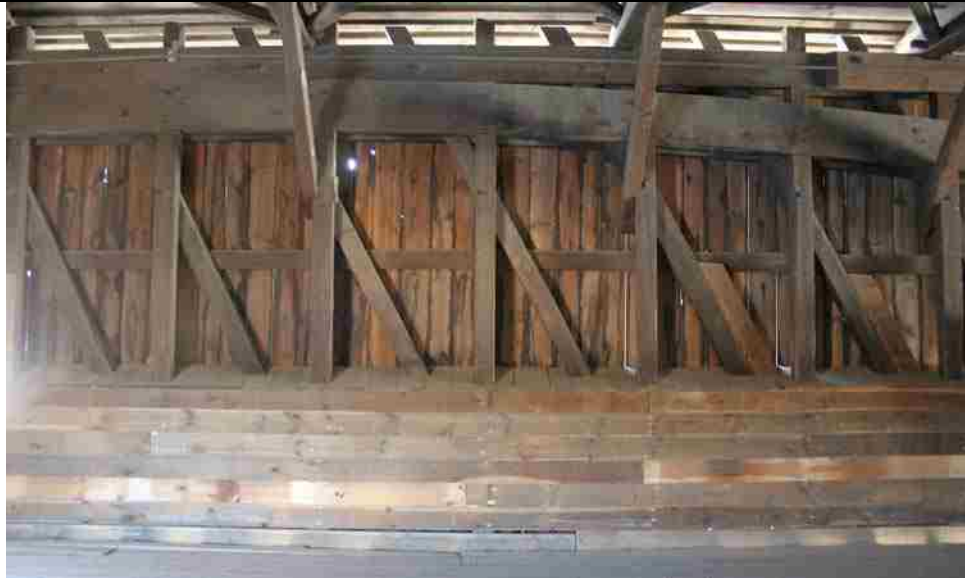
Photo No. 5-6 Built In Arch S22 – S18

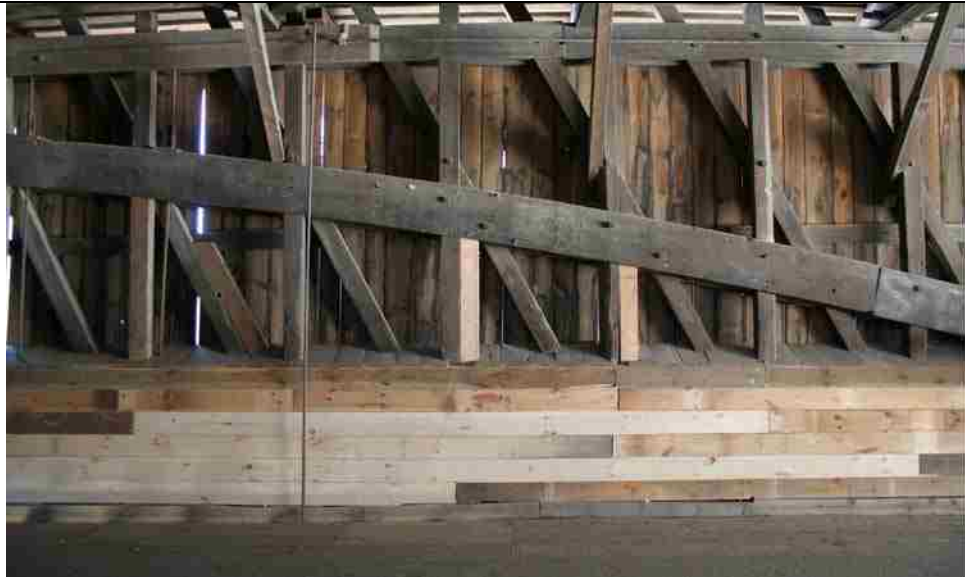
Photo No. 5-7 Built In Arch S14 – S10

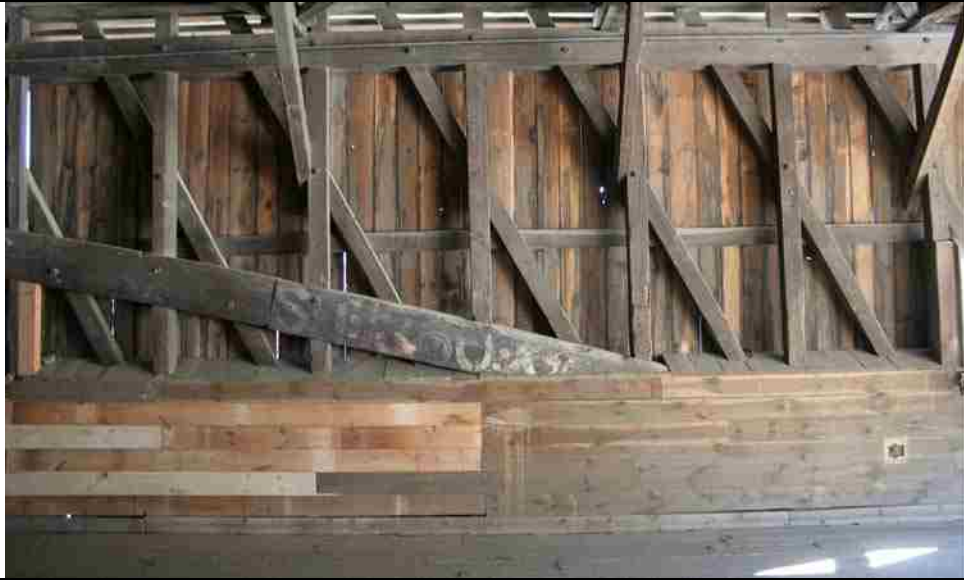
Photo No. 5-8 Built In Arch S10 – S6

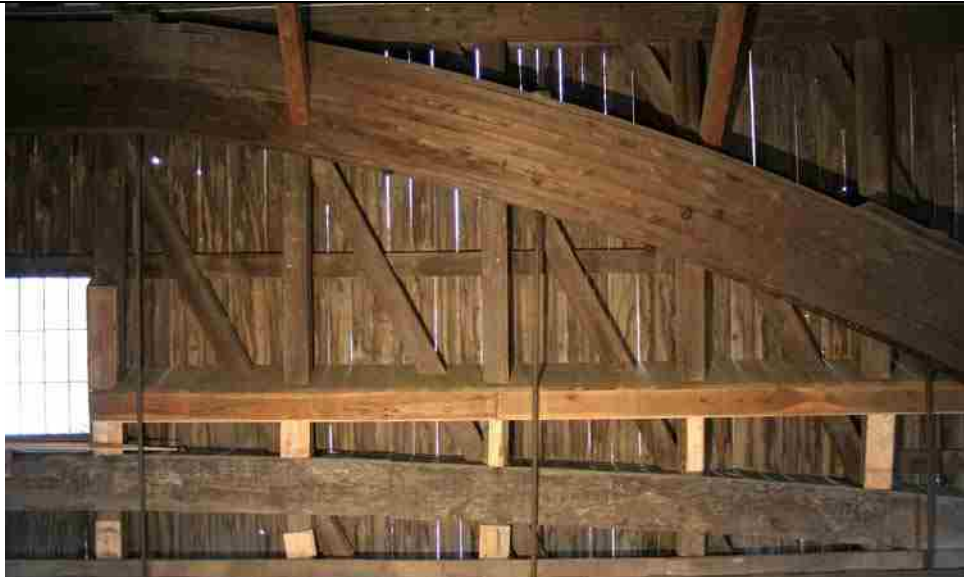
Photo No. 5-9 Built In Arch N58 – N54

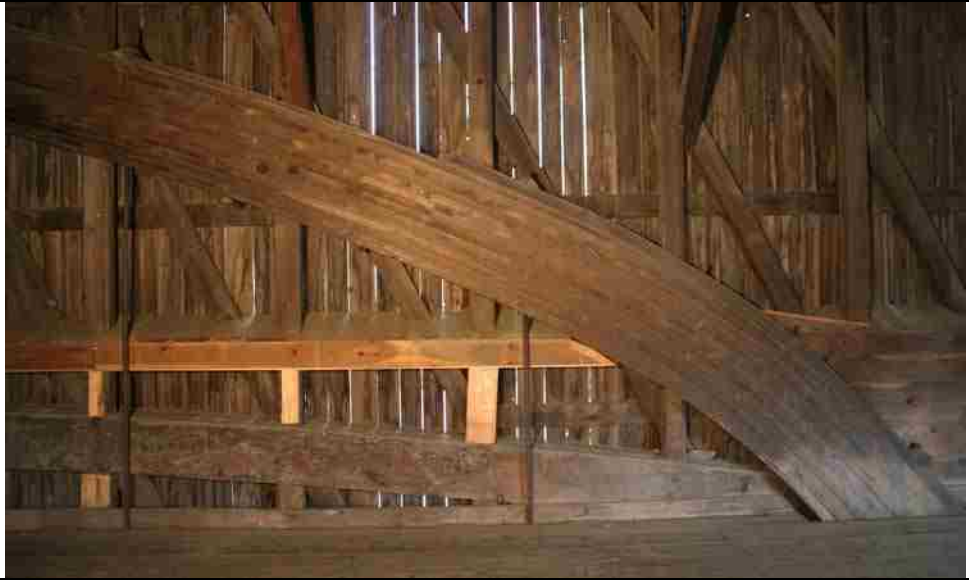
Photo No. 5-10 Built In Arch N56 – N61

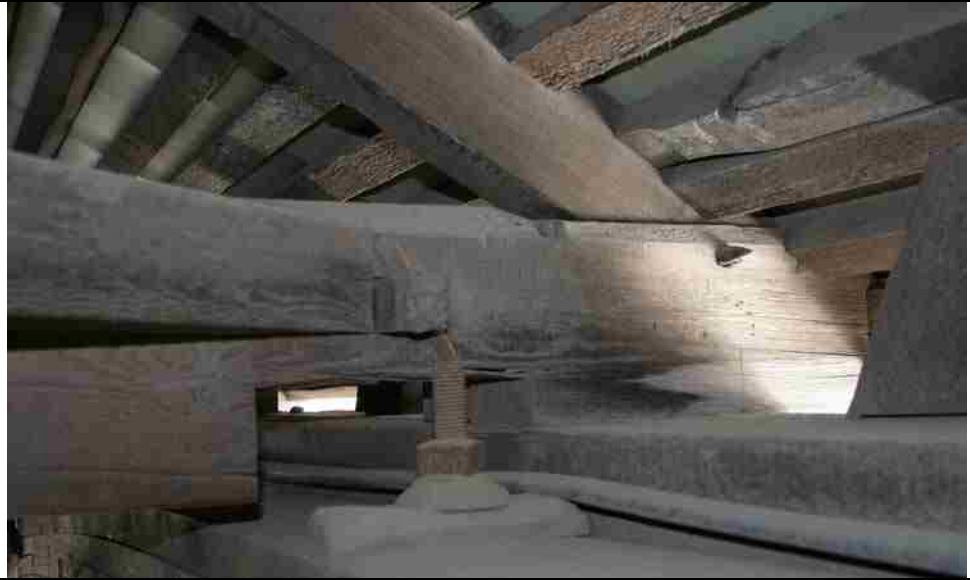
Photo No. 6-4 Cross Beam S79, Section loss due to notching

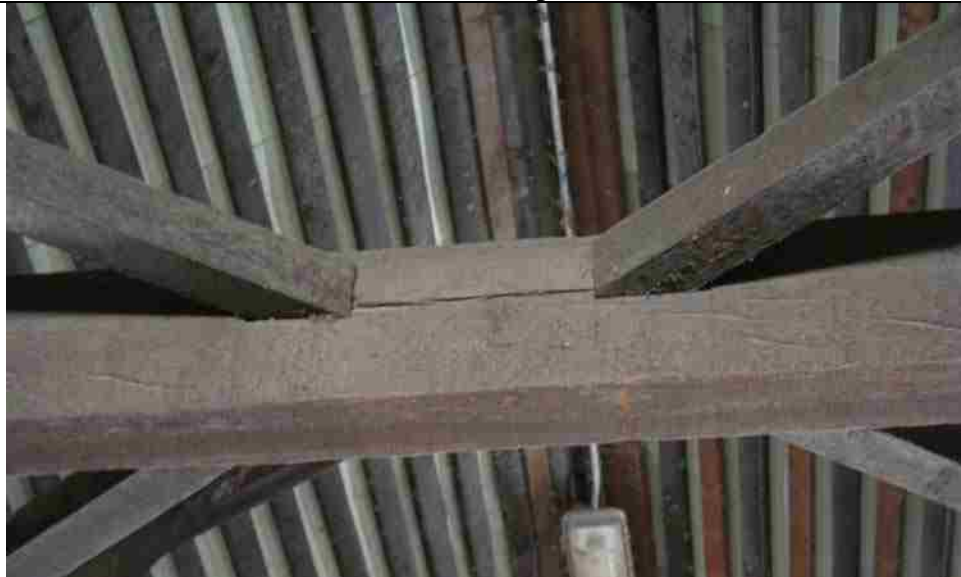
Photo No. 6-7 Cross Beam N21 – S21, Split between braces

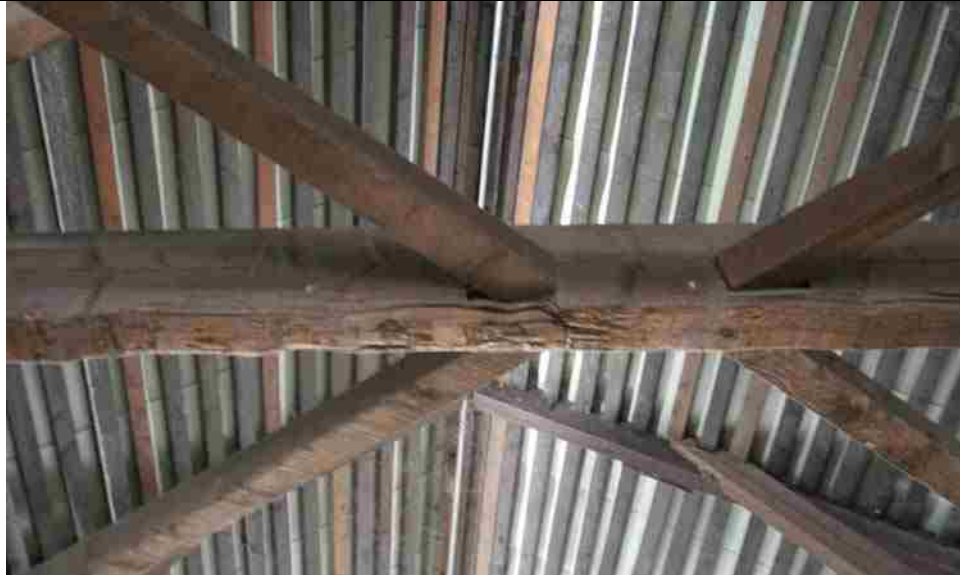
Photo No. 7-3 Upper Lateral S27– S29, Laterals joined to cross beam

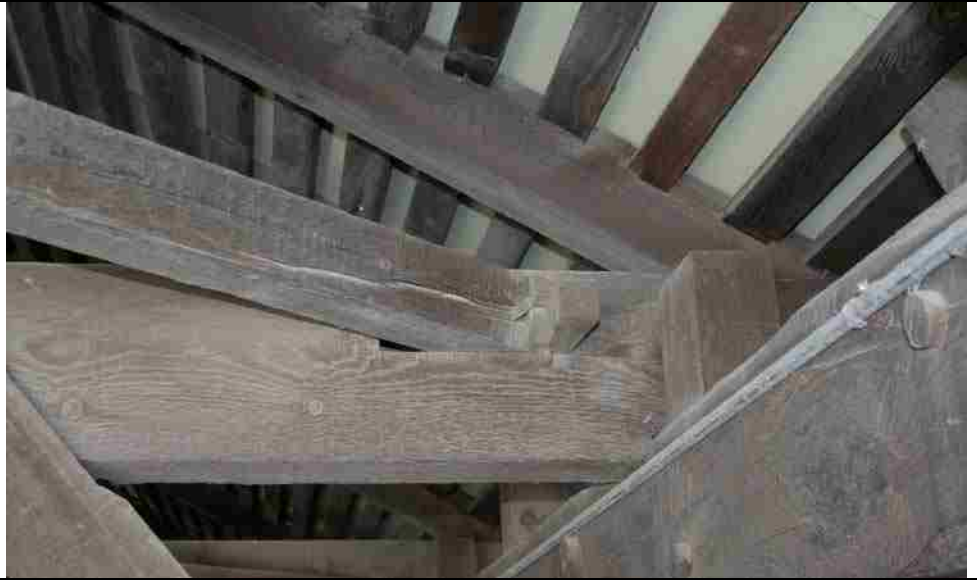
Photo No. 7-4 Upper Lateral N89 – N87, Split

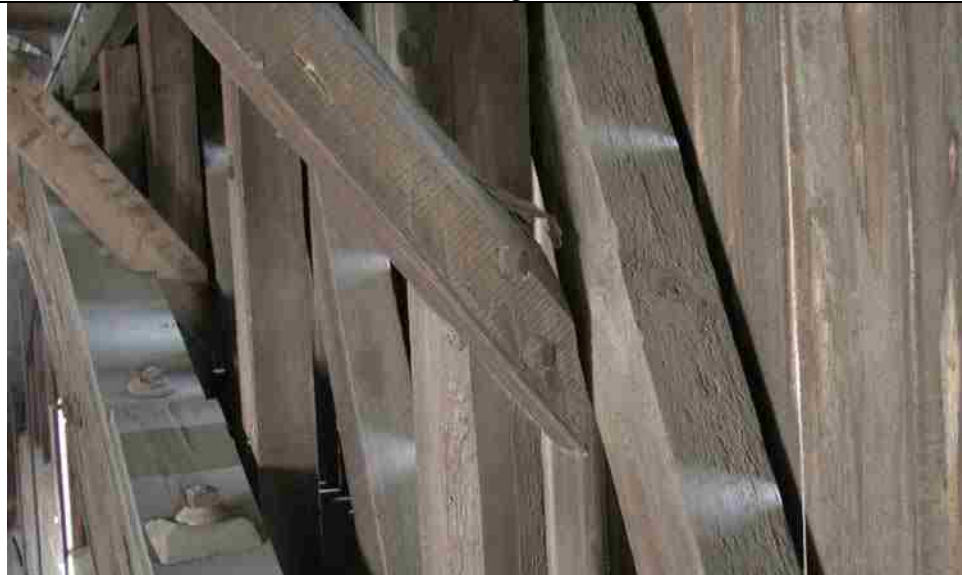
Photo No.8-3 Knee Brace N59, Waning

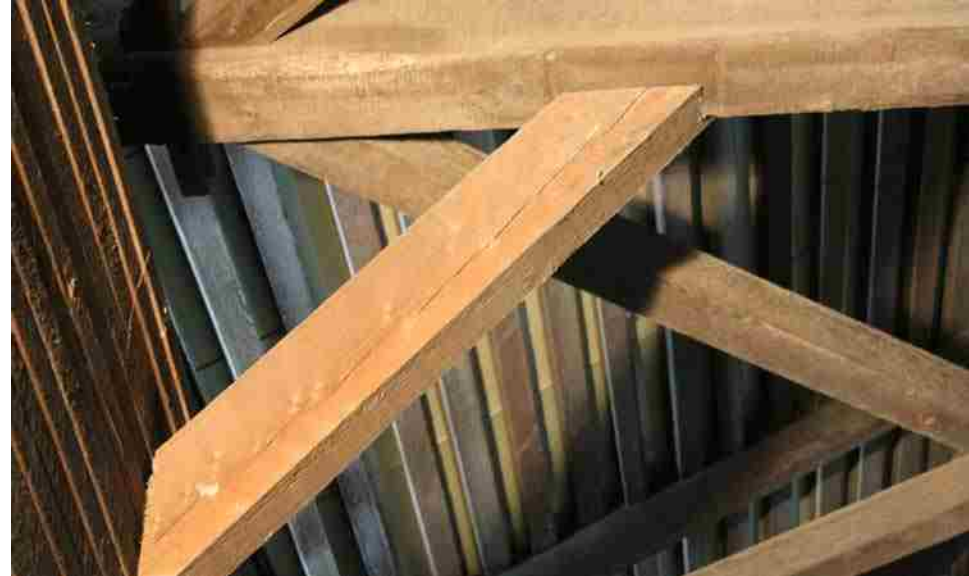
Photo No. 8-6 Knee Brace S49, Split

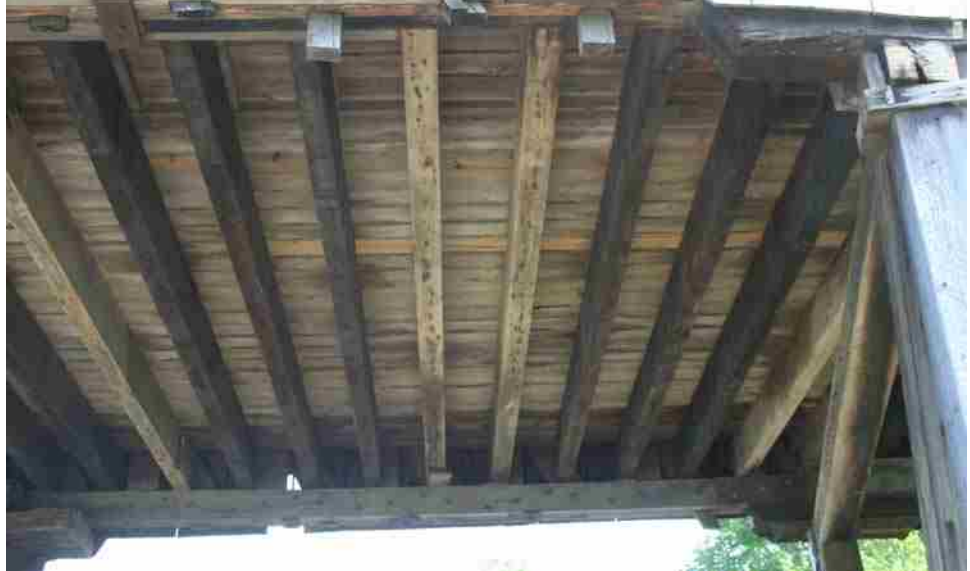
Photo No. 13-2 (6.17.09) Floor beams, dark new 1988; lighter are older

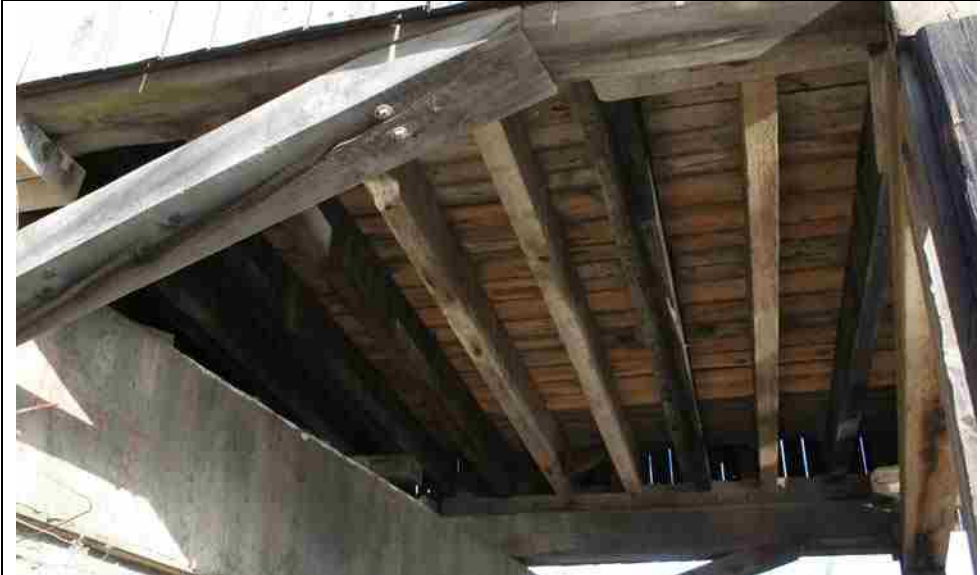
Photo No. 13-3 Floor Beams, West – Bent 1

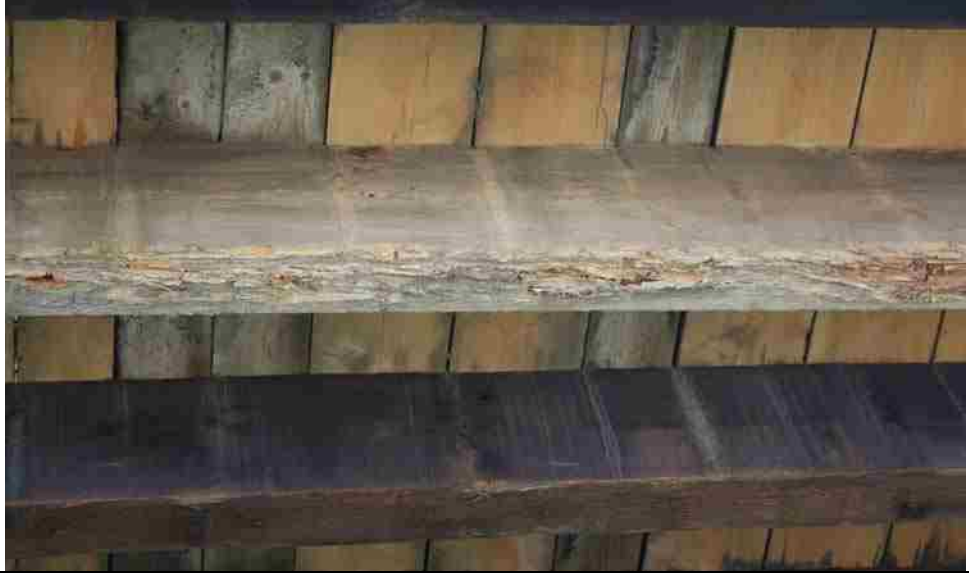
Photo No. 13-4 Floor Beams, older beam upside down

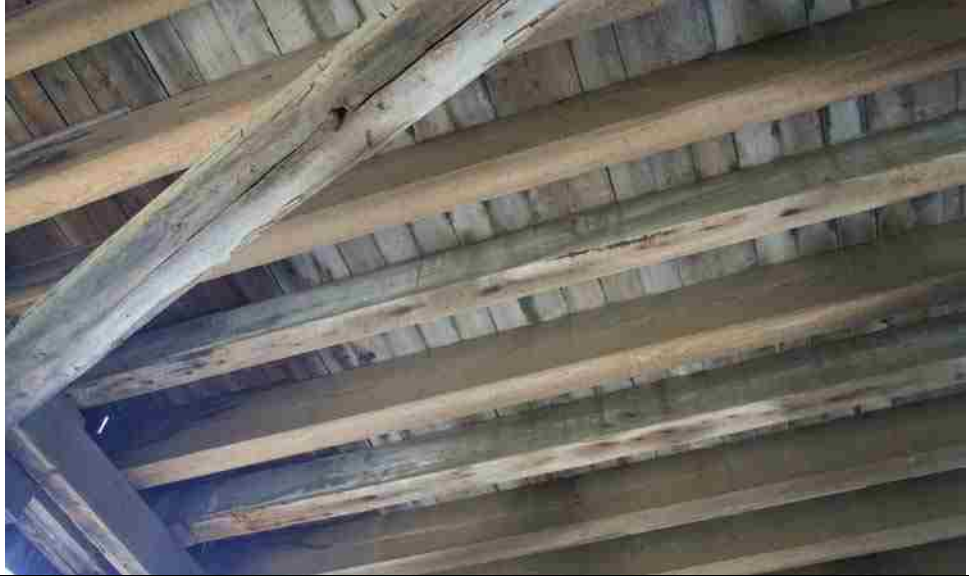
Photo No. 13-5 Floor Beams,

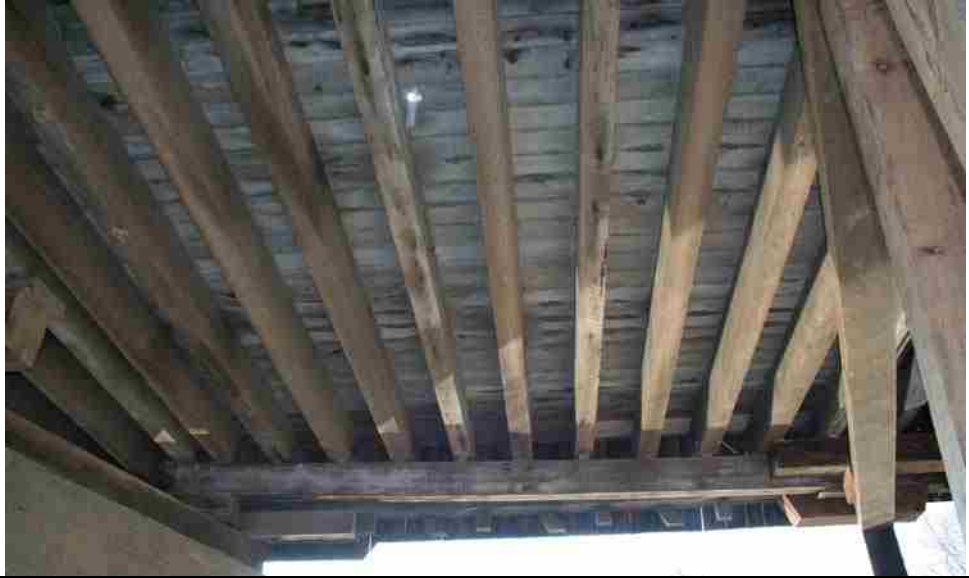
Photo No. 13-6 Floor Beams, Bent 3 – Pier 1

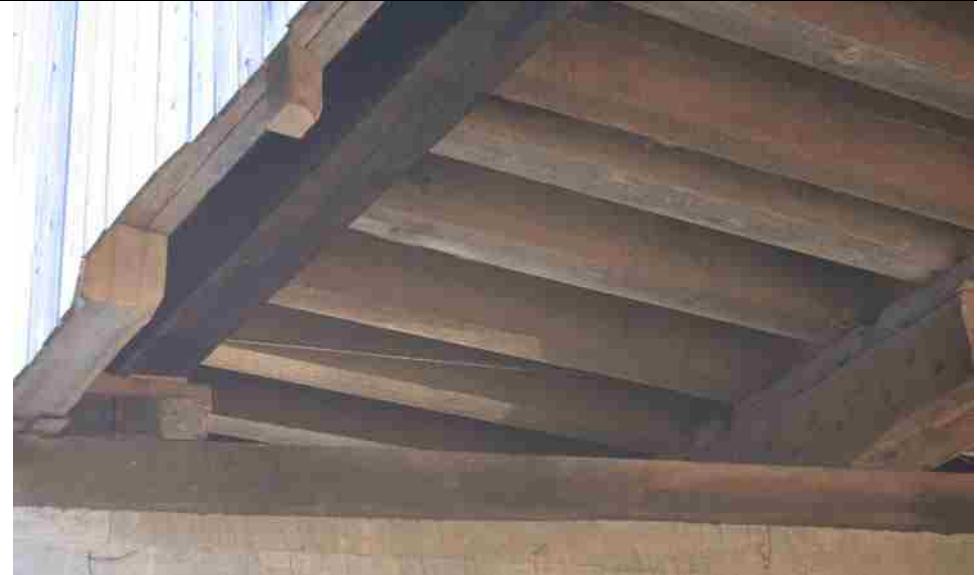
Photo No. 13-7 Floor Beams, N24 – N26

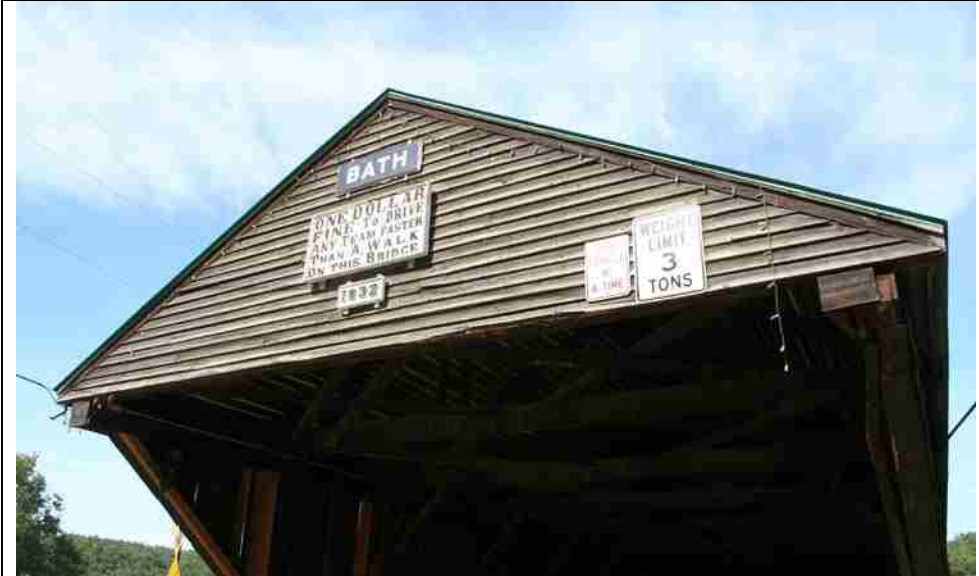
Photo No. 16-3 East Portal siding, weathering and splits
