Bath Village Covered Bridge Bath, New Hampshire

Rehabilitation Project Report

November 2011

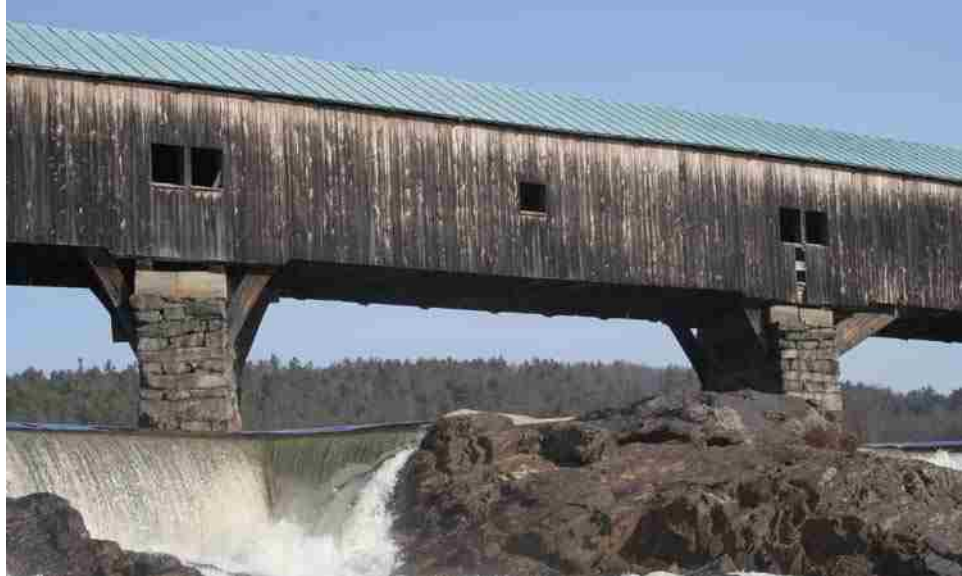
Photo No. 17-3 Siding S Bent 2 – 3, Weathering

<p>Condition: The 1988 replacement siding on the south side is in fair condition; north side siding ranges from poor to fair condition.</p>	
<p>Describe Work: All siding is to be removed and replaced in kind (W-17, Sheet 2). Existing boards with vertical saw marks will be preserved and reinstalled.</p>	
<p>Project Need: Siding must be removed to effect repairs to truss members. Siding is at the end of its service life.</p>	
<p>Impacts: The siding as a whole lacks integrity of original materials, with only seven boards out of approximately 1200 boards showing vertical saw marks that could possibly be original to the bridge. Vertically sawn siding boards will be preserved; other siding will be replaced in-kind with rough sawn boards of varying widths.</p>	
<p>Alternatives: There are no other practical repair alternatives that meet engineering requirements and the Secretary's Standards other than "replacement in-kind" and preservation of the presumed historic fabric.</p>

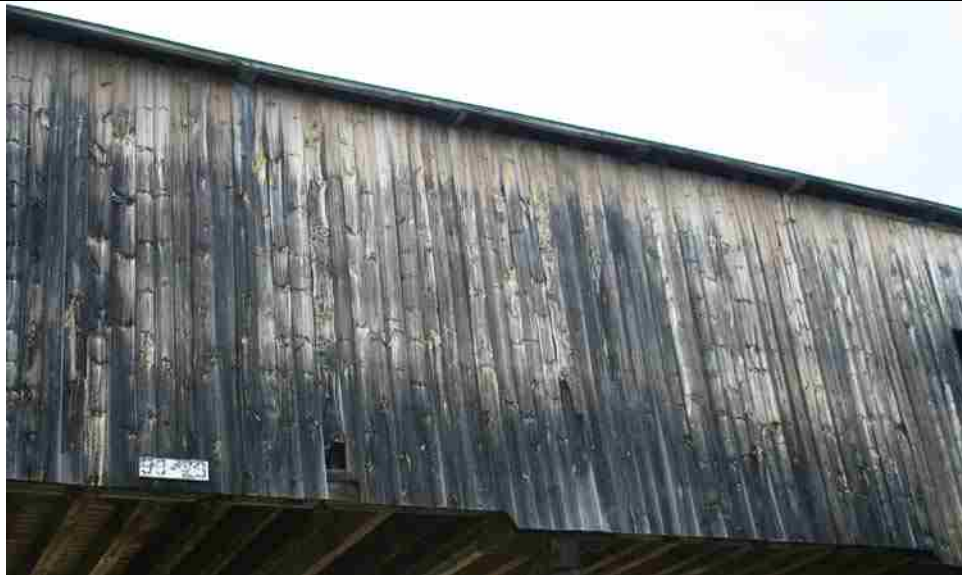
Photo No. 17-4 Siding N East – Pier 3, Weathering

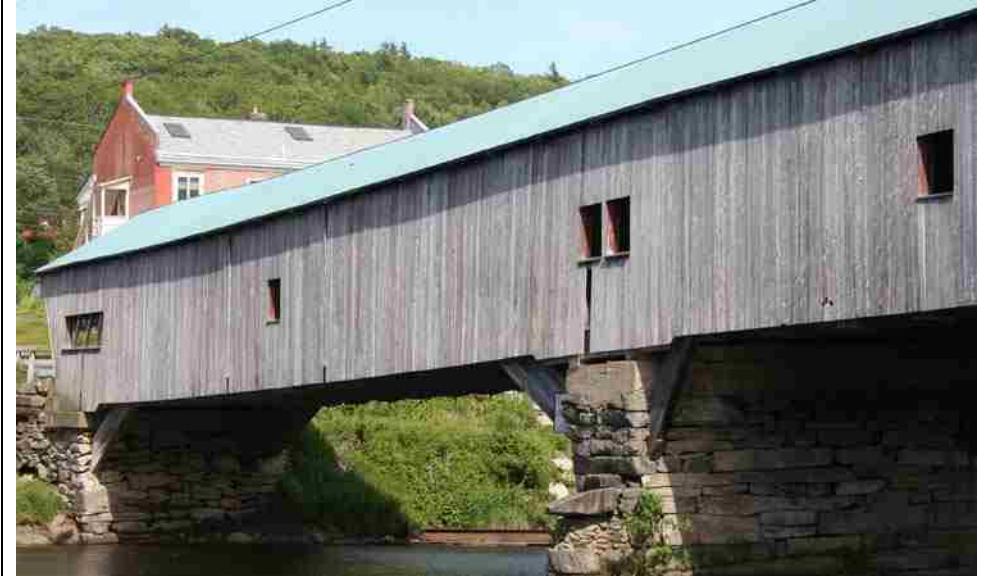
Photo No. 17-5: 15-1/2" & 10-3/4" boards @ Post N10-N11 w/ vertical saw marks

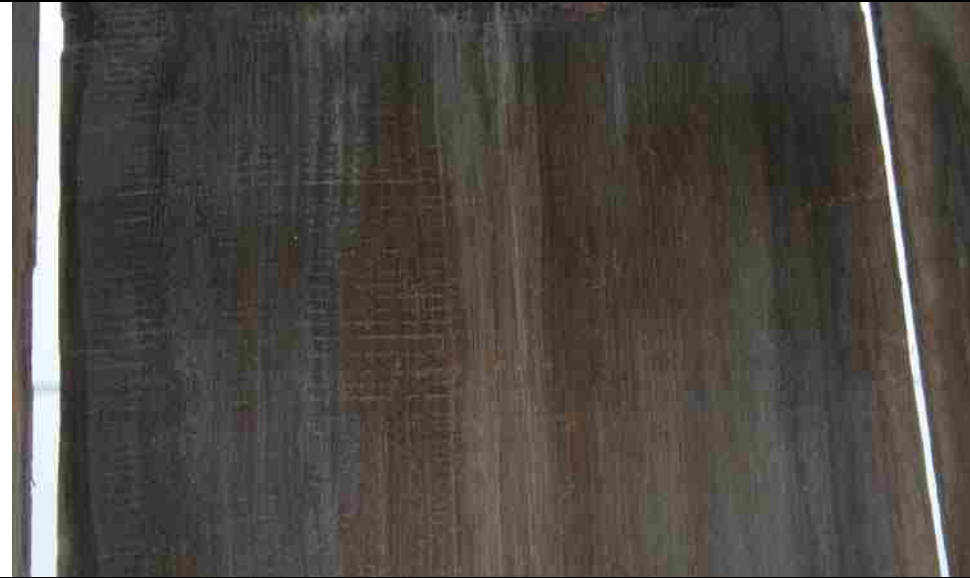
Photo No. 17-7: Post with vertical saw marks; siding board with circular saw marks

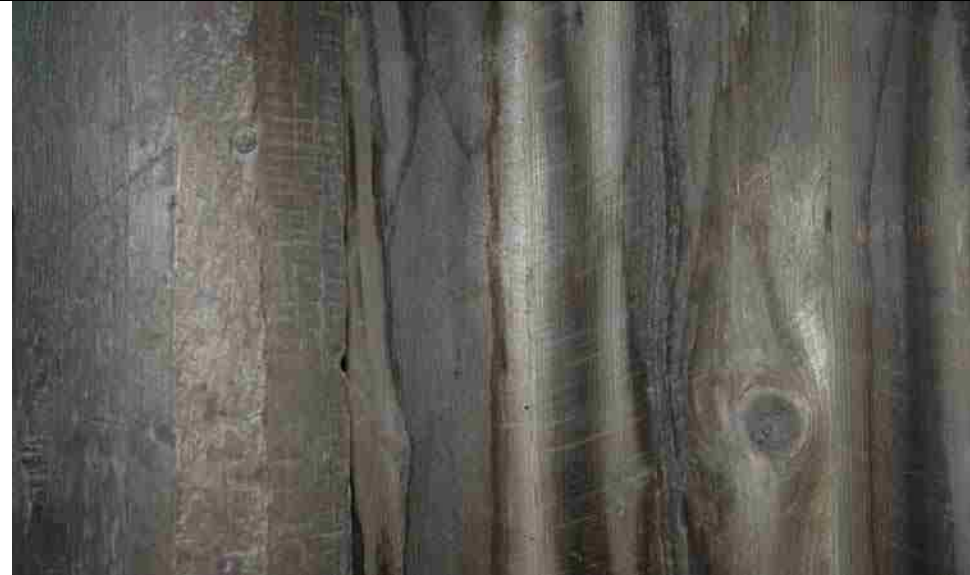
Photo No. 17-8: Vertical saw marks on diagonal considered original for comparison

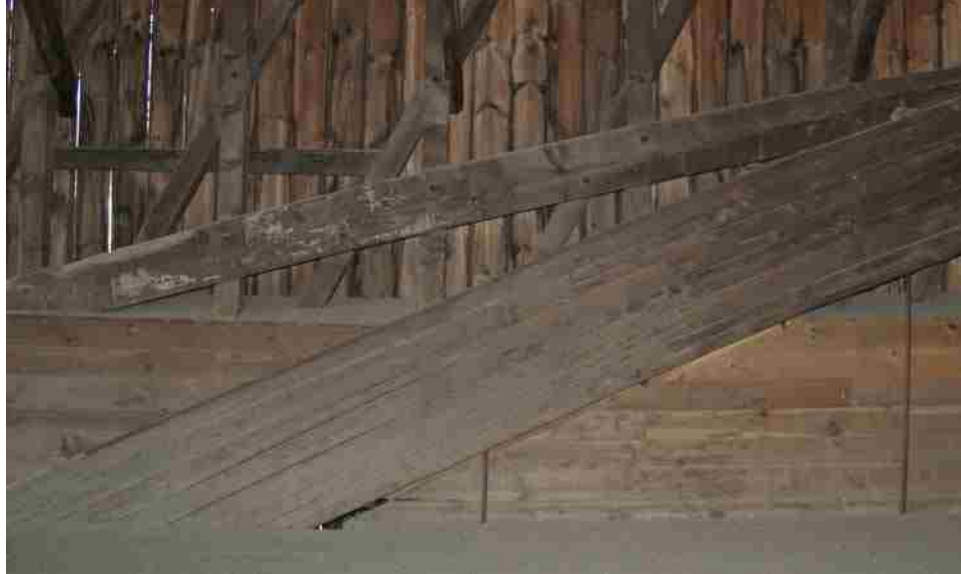
Photo No. 19-2 Added Arch S90 – S86 with flatter Built-in arch behind

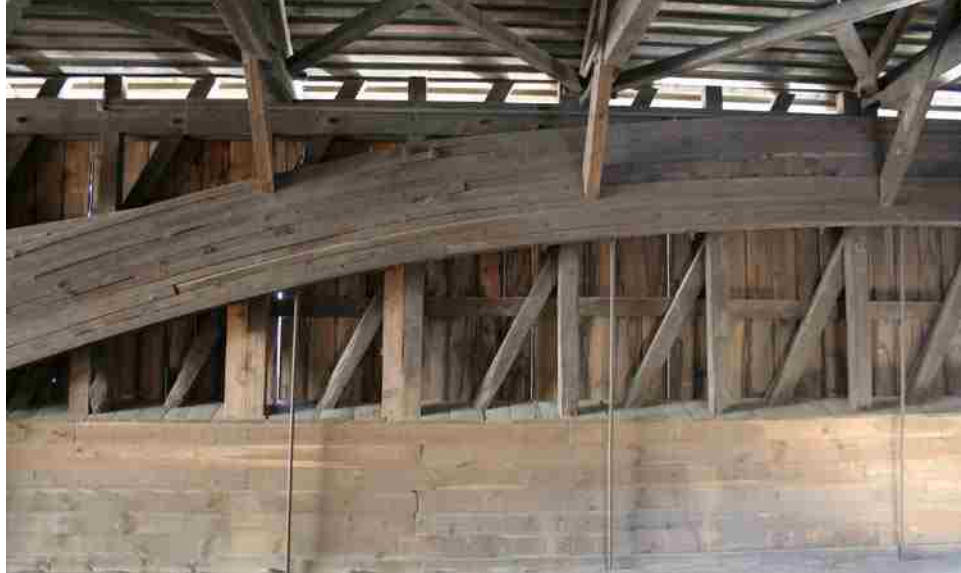
Photo No. 19-3 Added Arch S87 – S82, knee braces cut and nailed to arch

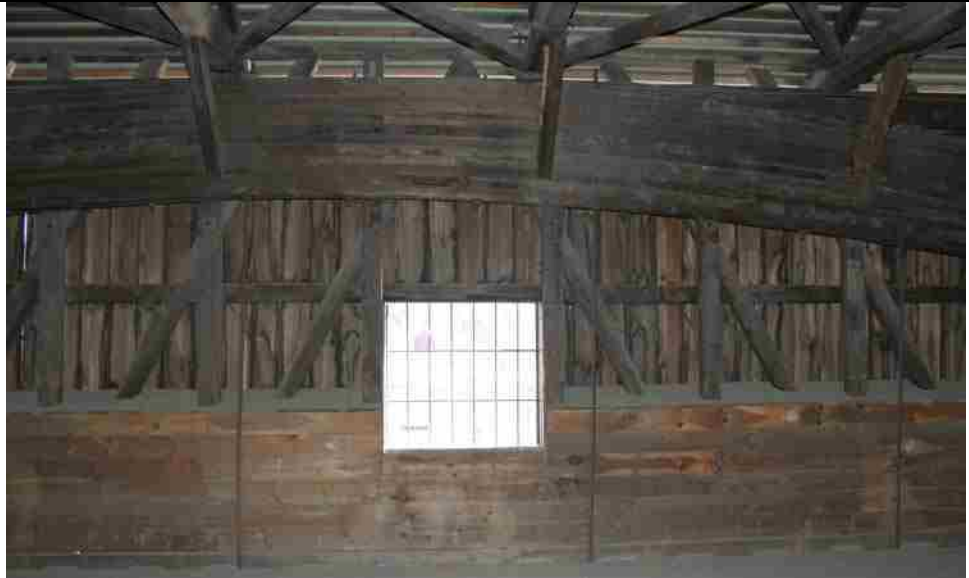
Photo No. 19-4 Added Arch S79 – S75

Condition:			
<p>Good condition with the exception of the two added arches between Piers 1 and 3 and portions of the integral arches near siding windows. The added arches are weathered on the downstream face, have very poor bearing on the piers and have begun to loose their shape as evidenced by the splitting of the laminations. The arches bearing on Pier one (1) are not well seated and, due to the steep slope of the arch, could slip or potentially fall off the pier (see HTA Engineering Report).</p>			
Describe Work: Existing bridge shall be jacked and braced as required to straighten, release stresses, plumb and re-align the trusses and arches (RS-3, Sheet 2). All existing members shown to be replaced are to be replaced "in-kind" with new members identical in dimensions and configurations as the members originally used in the covered bridge (GC-12, Sheet 2).			
Project Need: As noted, the Added Arches provide important structural support to the trusses. Although not original to the bridge, the Added Arches are notable for their association with the modification of the bridge by the railroad and therefore can be considered a later alteration of historical significance.

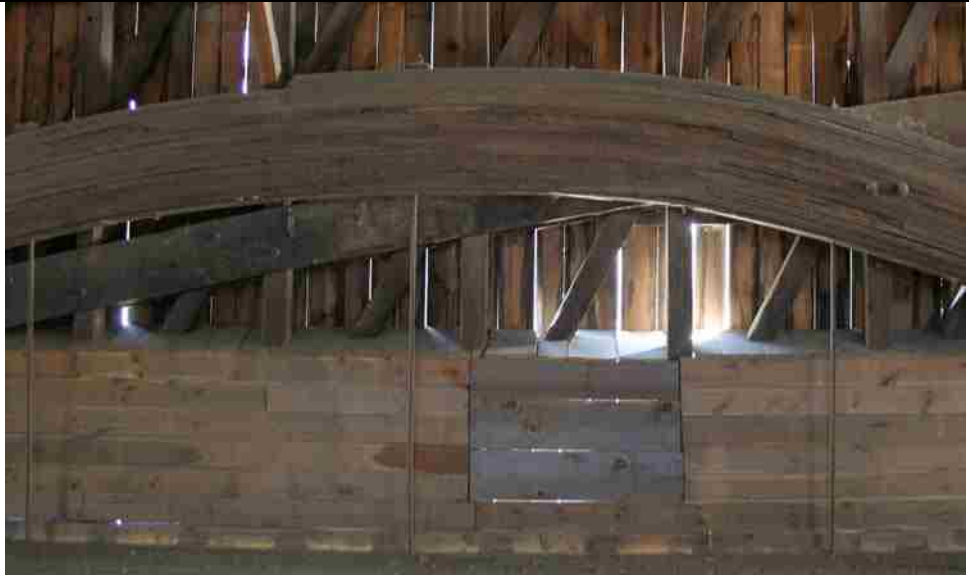
Photo No. 19-5 Added Arch S33 – S30, arch raduis deformed

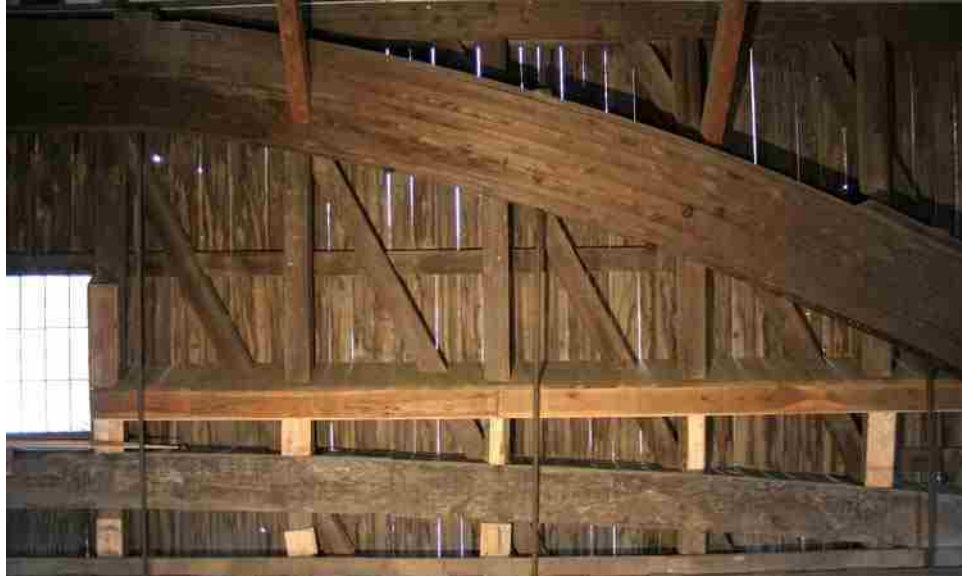
Photo No. 19-6 Added Arch N58 – N54 above Built-in arch below

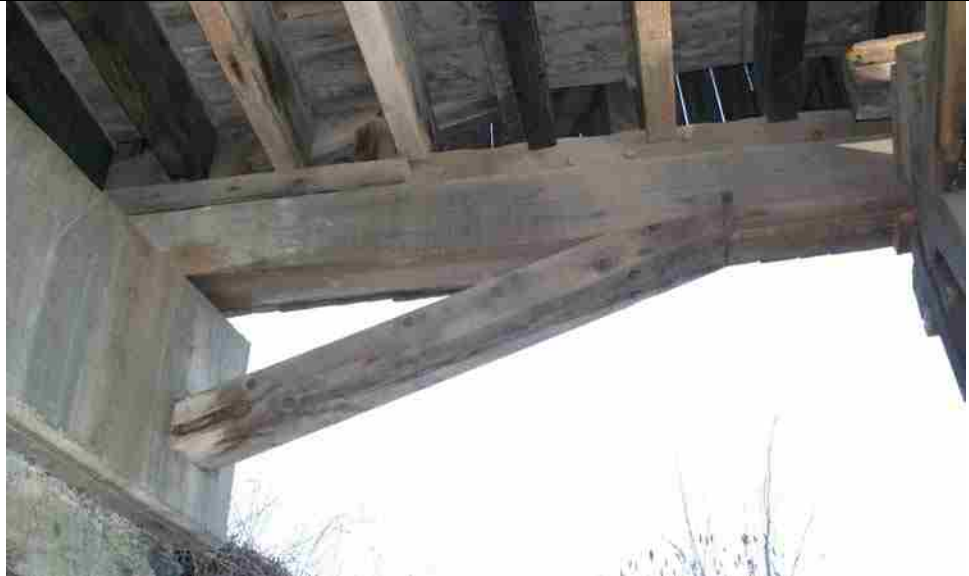
Photo No. 22-3 Sleeper South West Abutment, Drying Splits

Describe Work: Struts will be evaluated for replacement during construction. All Sleeper and bedding timbers are scheduled for replacement in-kind to the extent possible with treated timbers of both soft and hardwood. Low-profile reinforced concrete bearing seats will be installed on top of piers and abutments to provide a uniform and structurally sound bearing for the sleepers.			
Project Need: The bridge members must have structurally sound decay-free bearings.			
Impacts: The struts, bedding and sleeper timbers are assumed to be features of the 1918-19 bridge rehabilitation when the bridge was raised to increase clearance over the railroad tracks. They do not have any significant association with the original bridge design and are sacrificial elements of the design.			
Alternatives: There are no other practical repair alternatives that meet engineering requirements and the Secretary's Standards other than "replacement in-kind." .

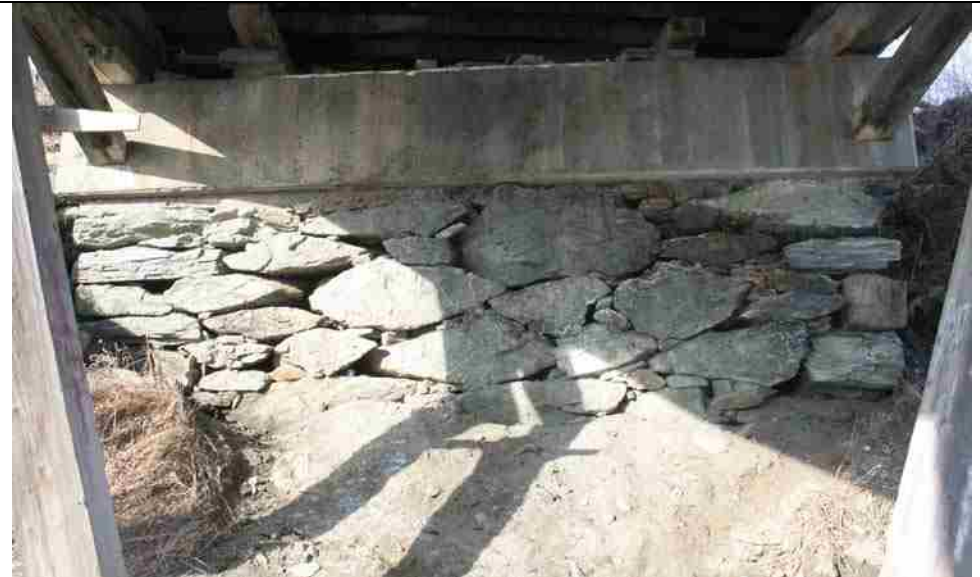
Photo No. 24-3 Abutment, West

BRIDGE FEATURE INVENTORY & TREATMENT FORM			
No.	24	Feature: Abutments	
Total members:	2	Members affected:	2
Date:	1831	Explain: see below	
Description: The abutments and wingwalls are built with dry laid random rubble stone and date to the original construction of the bridge in 1831. Documentary evidence indicates they were constructed along with the piers by Luther Butler for \$1400. Concrete caps were added to the abutments when the bridge was raised in 1918-19.			
Condition: Fair. Differential settlement, missing stones and evidence of loss of backfill.			
Describe Work: Replace missing stones with similar stones as required. Chink open joints on faces of abutment and wingwalls, compact loose fill behind wall stones. New stones shall closely match the color, texture and pattern of existing stones. Stones shall be approved by the resident engineer prior to use.			
Project Need: Abutments support the bridge and must have structural repairs to meet project design requirements.

Impacts: Proposed repairs will be made consistent with the Secretary of the Interior's Standards for Rehabilitation.			
Alternatives: The repair methods will meet the Secretary's Standards therefore other alternatives were not considered.			
Drawings: 11, 12, 13, 14		Photos: 24-1 to 24-6
