Bement Covered Bridge, Bradford, New Hampshire Rehabilitation & Preservation Plan

Prepared by

Historic Documentation Company, Inc.
Portsmouth, Rhode Island

February 2018

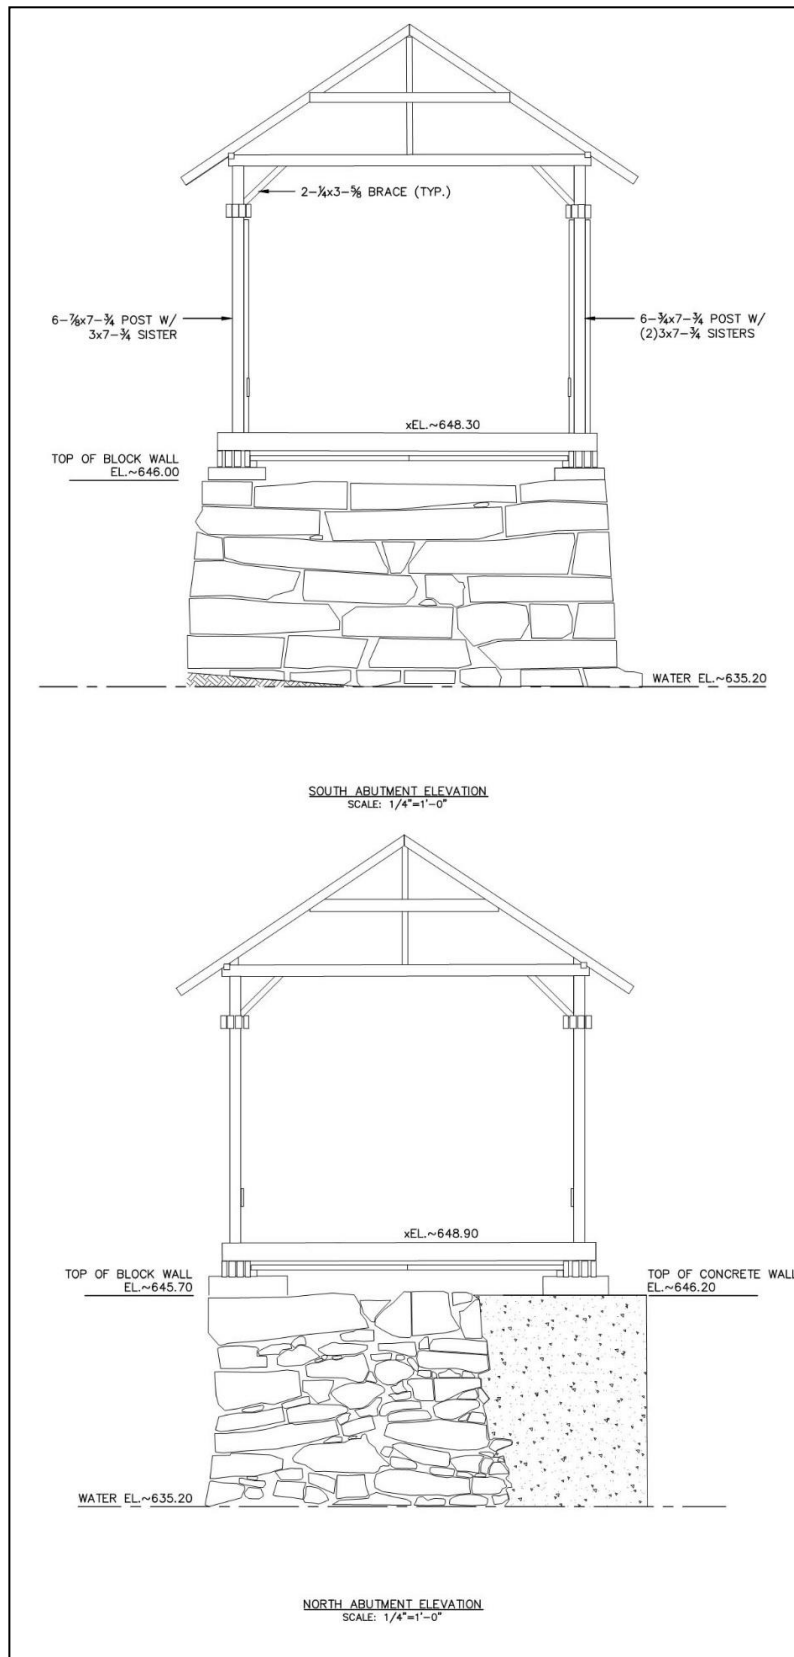
FIGURE 5: Bement Bridge, current conditions scale drawing from 3D laser field scanning August 2016, showing south and north abutments and section through respective portal framing. Note differences in stonework of abutments: the south abutment is assumed to be a later replacement; the north abutment is of more primitive construction with a large concrete repair made between 1939 and 1942 (Doucet Survey, Inc. for Hoyle Tanner Associates 2016)

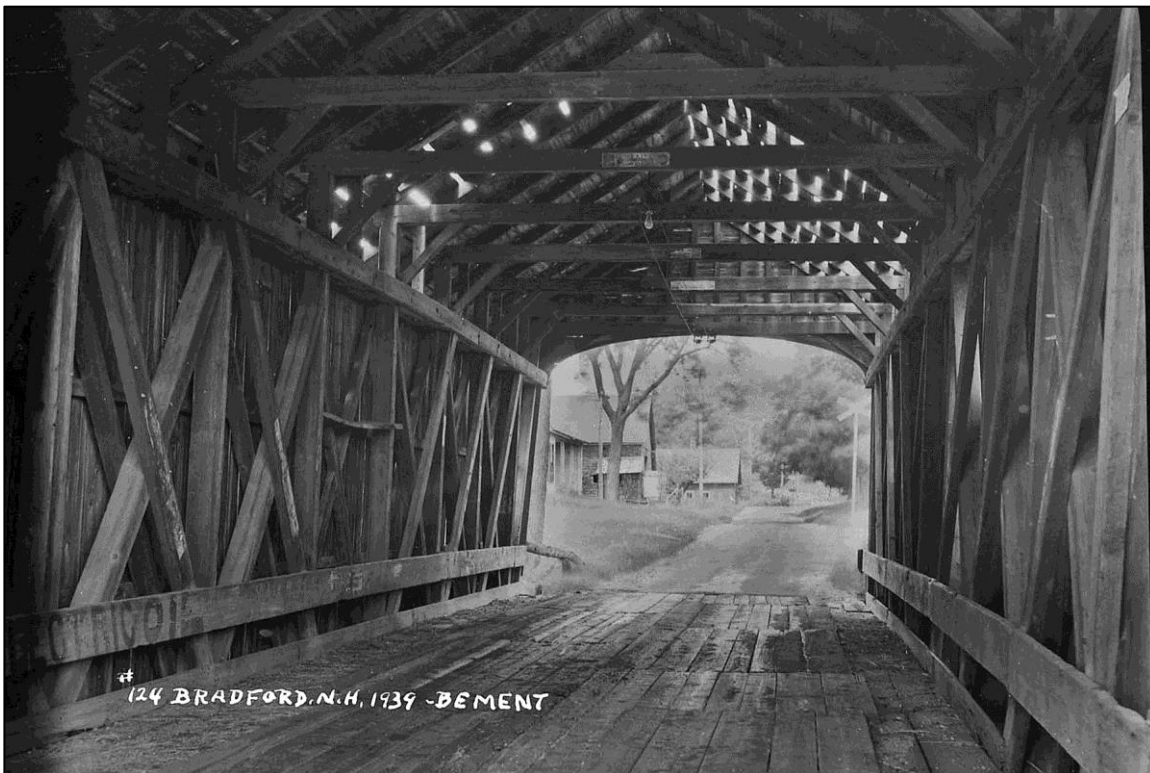
FIGURE 9: Bement Bridge, interior, looking out north portal, 1939. Note roofing missing and also former Boston & Maine Railroad right-of-way crossing Center Road just north of the bridge, now occupied by NH Route 103 (source: Town of Bradford).

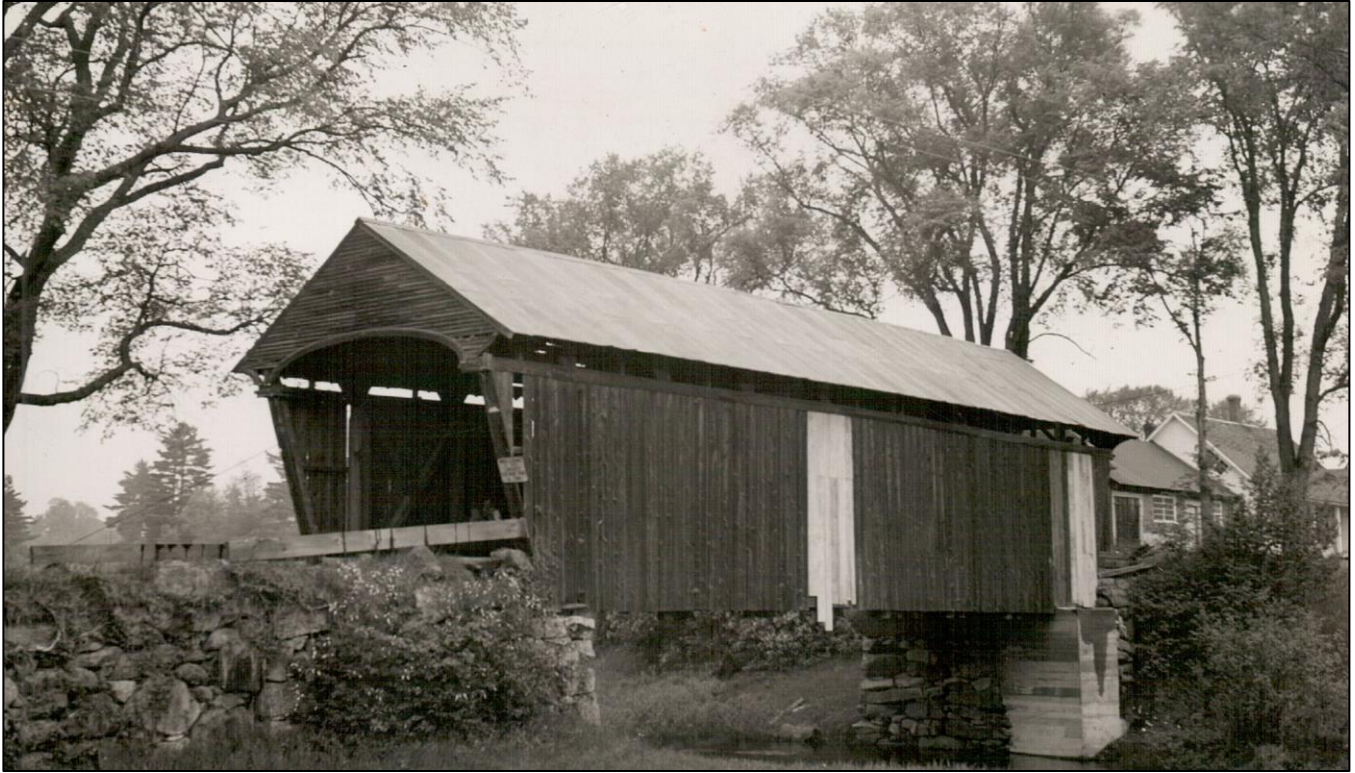
FIGURE 10: Bement Bridge, south portal and downstream (east) side, 1942, showing north abutment repaired with cast-in-place concrete, repairs to wood siding and to corrugated sheet metal roof (NHHD Bridge Inventory Card 5/20/1942).

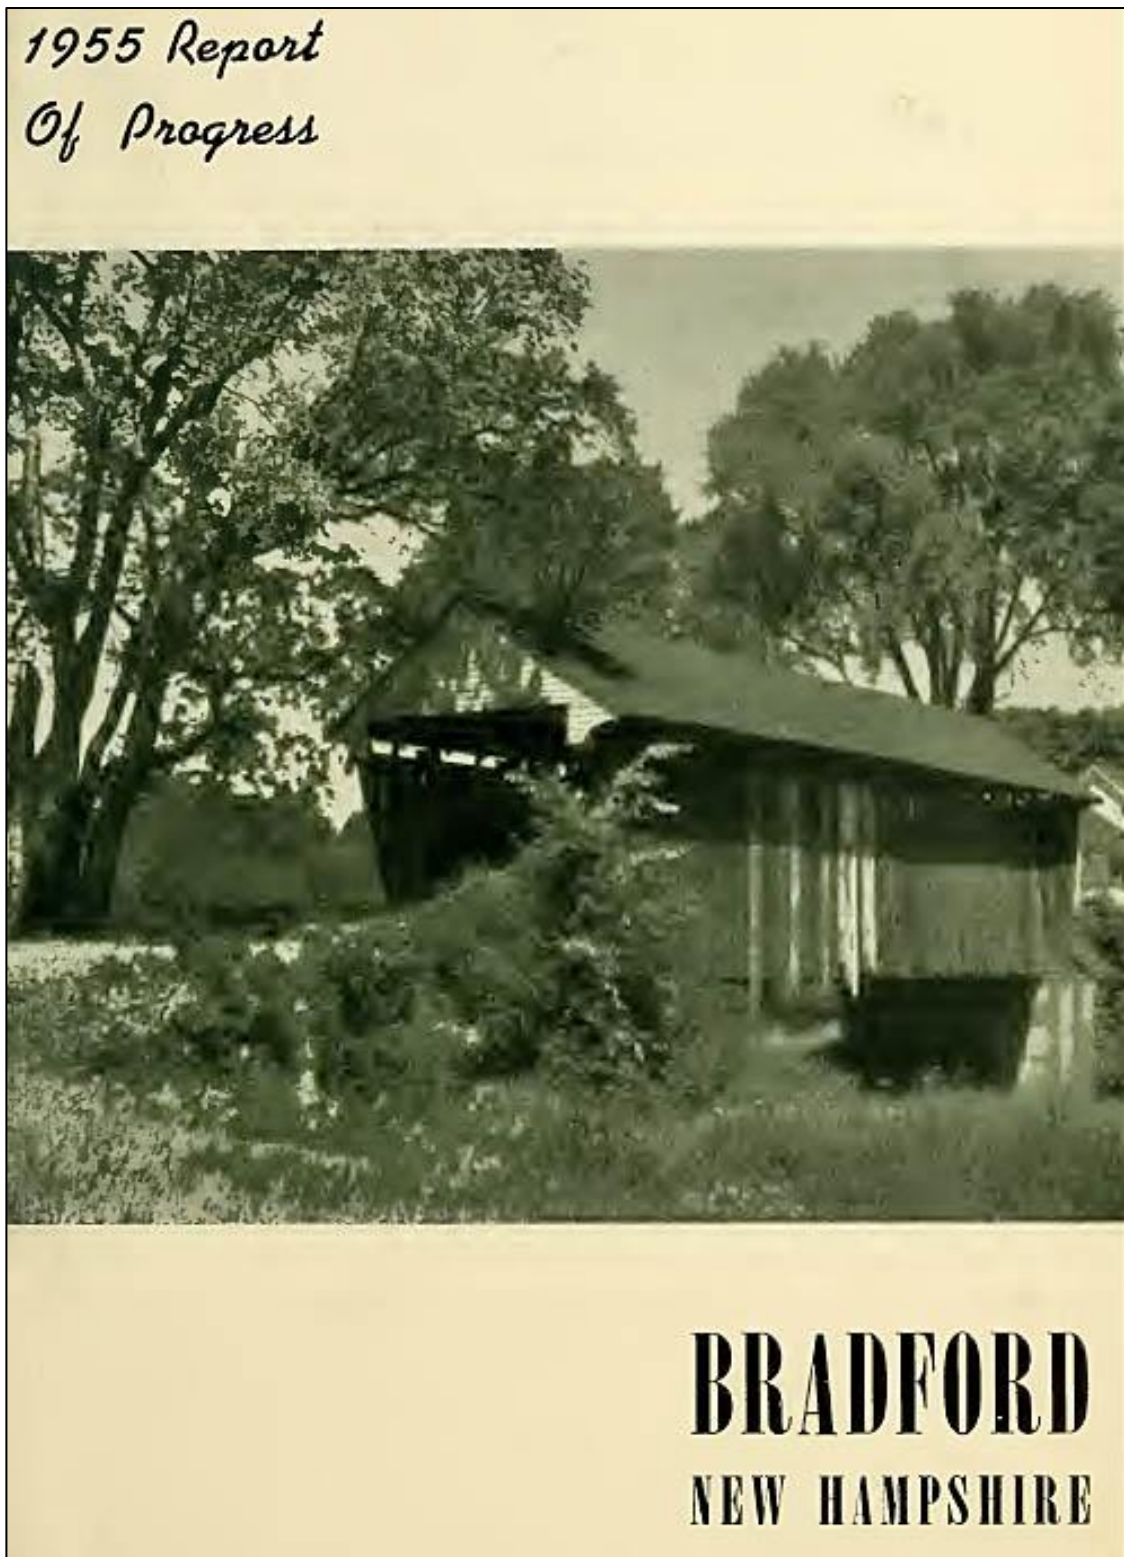
FIGURE 12: Bement Bridge on cover of Bradford Annual Report for year ending 1955 showing south portal and downstream (east) side. Note prior corrugated metal roofing replaced with asphalt shingles and portal rebuilt with its present squared opening. The work was done by the Town under the general bridge maintenance account in 1954. Photo is credited to Don Sieburg, New Hampshire State Planning & Development Commission.

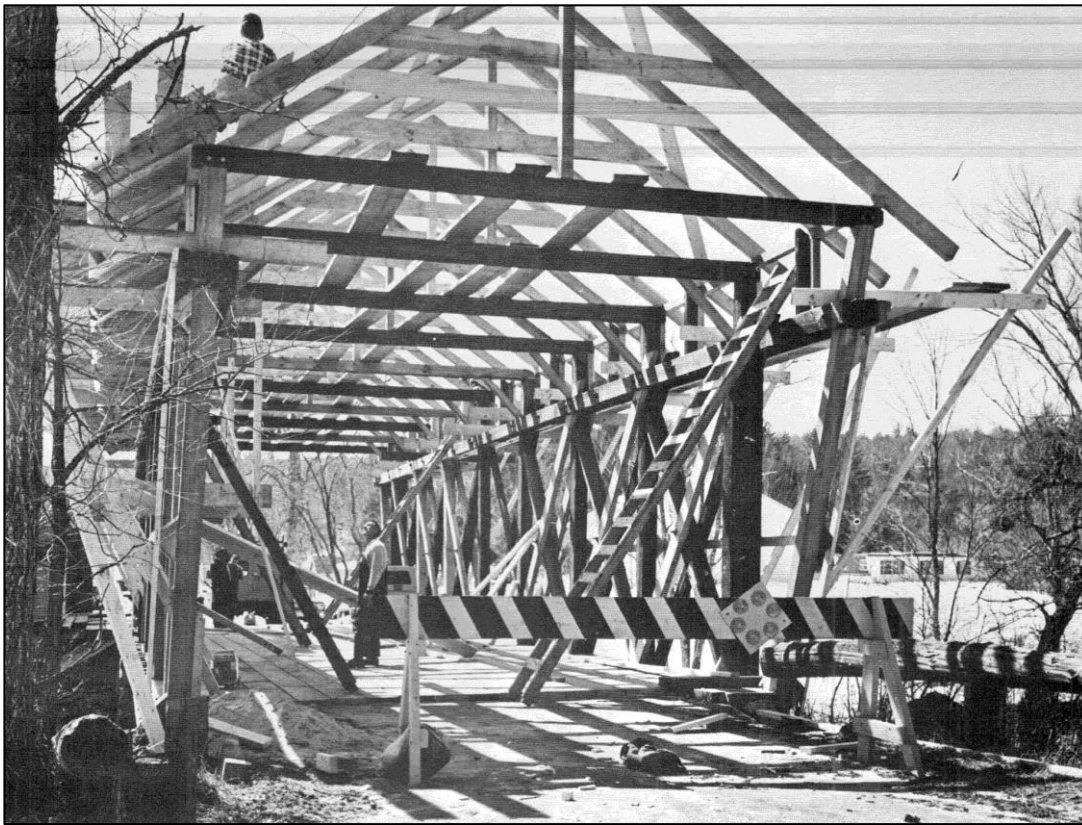
FIGURE 14: In 1968 the Town of Bradford determined Bement Bridge to be unsafe, confirmed by an inspection by bridge engineers from the state highway department. The state agreed to pay two-thirds of the rehab costs and provide their expert covered bridge repair team out of New Hampton to do the work. The project got underway late in 1968, continued through the winter and wrapped up in May 1969 (source: Whitney 1971, p. 18).

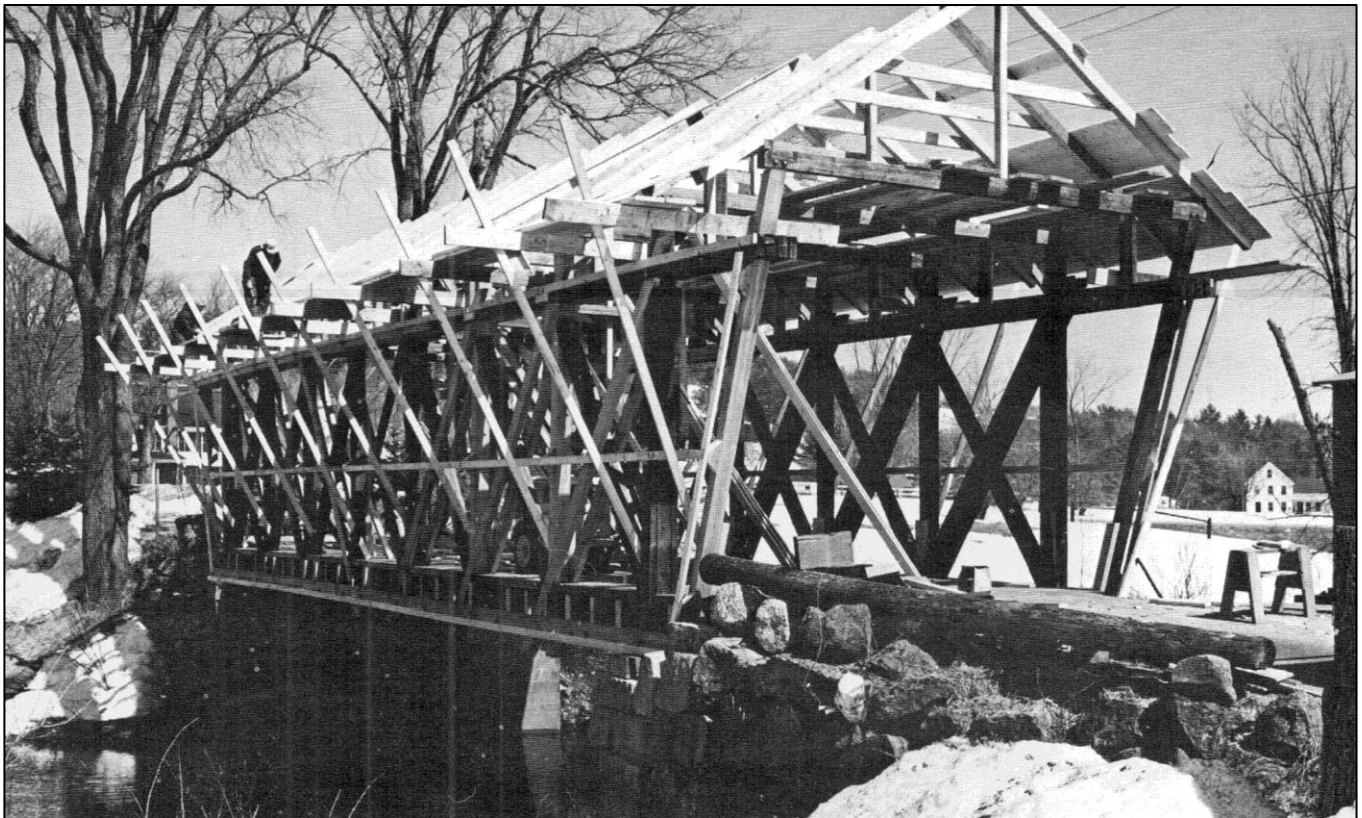
FIGURE 16: The 1968-69 repairs included a new roof system and replacement of many structural members but an exact report of the work done was not located. The total cost of the work as reported in the Town Annual Report for 1969 was \$24,478.14, of which the town's share was \$8,159.38 (source: Whitney 1971, p. 18).

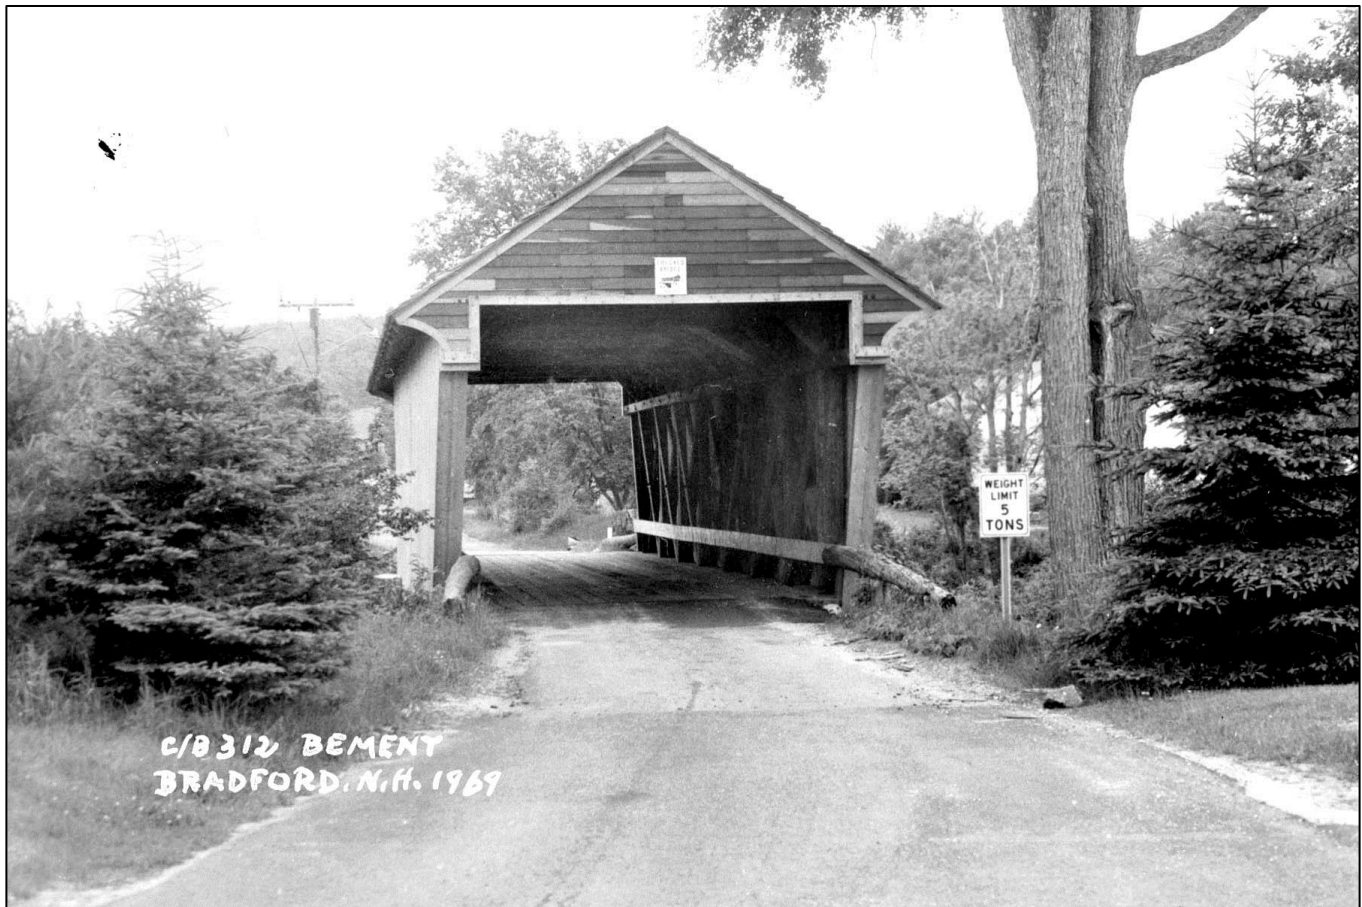
FIGURE 17: The north portal in 1969 after completion of repairs by the State Highway Department. Note what appears to be all new siding visible on the east (downstream) side. Also note use of recycled clapboards on the portal wall evidently dating from the 1954 rehab by the Town. A few new clapboards can be seen patched in (source: Town of Bradford).

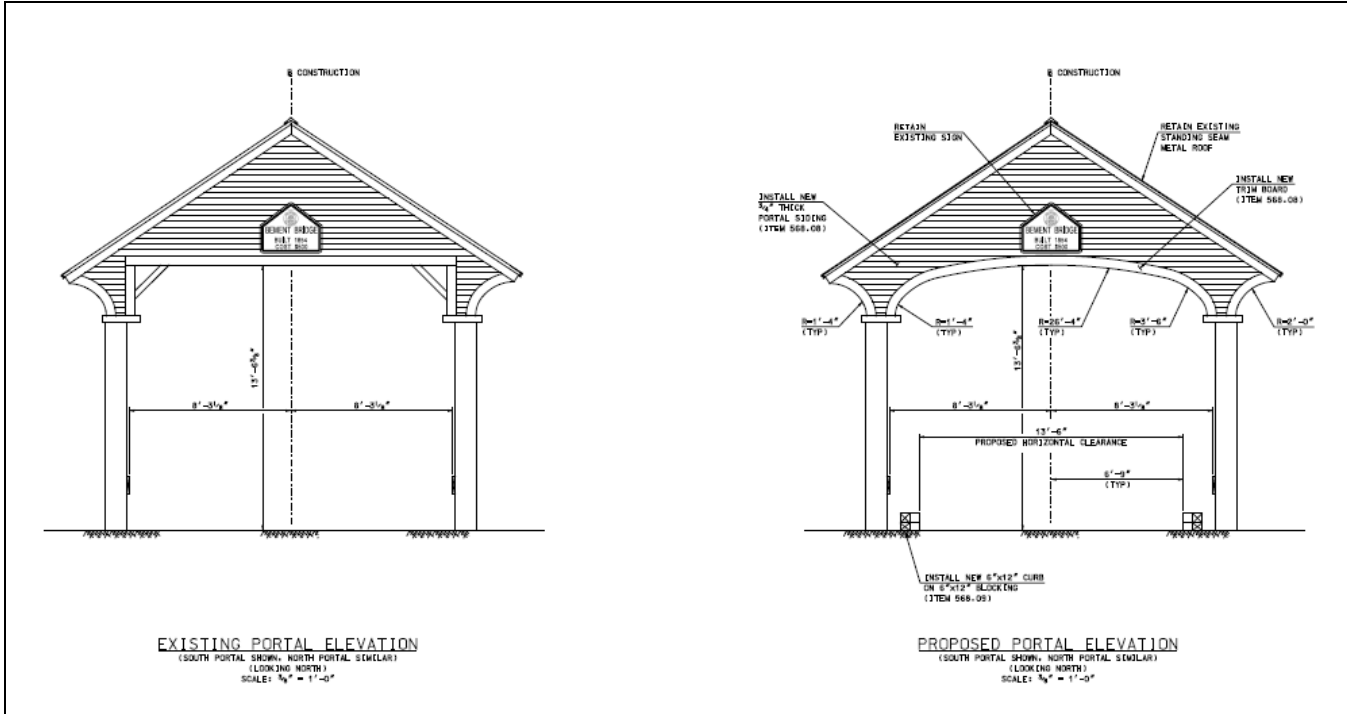
Plan Reference:
 Sheet 7

Existing and Proposed Portal Elevations

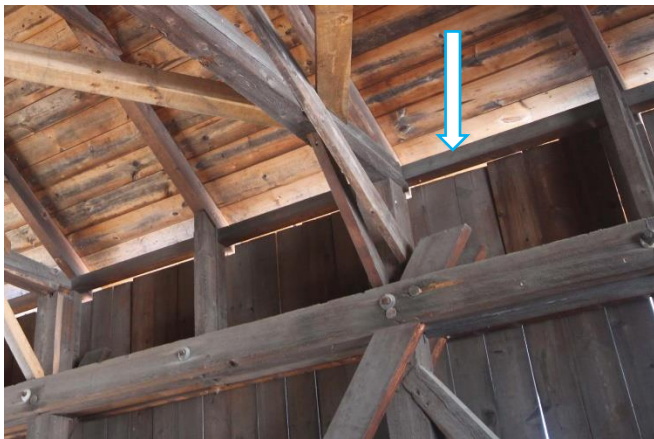
Rafter support beam carried on end of crossbeams and jack posts, not an original feature.

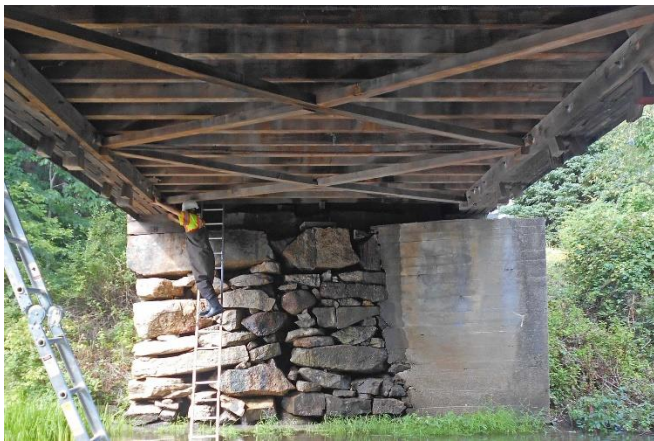
Floor beams span between lower chords.

Rearrange and replace floor beams as required.

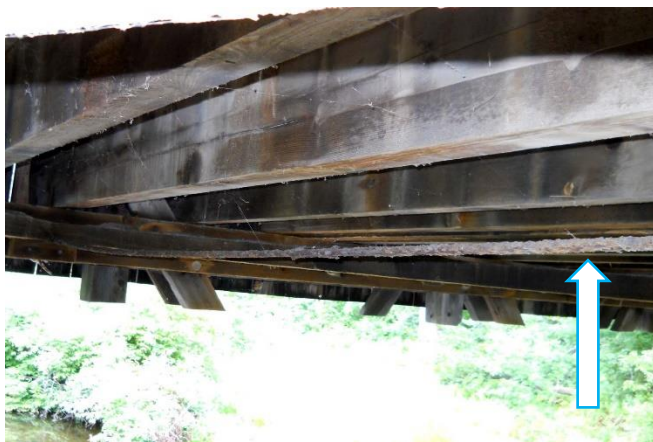
Project Need:	The lower lateral bracing helps to stiffen the bridge and to transfer lateral loads across the bridge without creating racking or other distortions in the truss. Failure of the existing deteriorated tie rods and bracing member connections to the bottom chord would compromise the structural integrity of the lower lateral bracing system and the stability of the bridge.		
Impacts:	All five tie rods are to be replaced. New bearing blocks and two new struts are also proposed to strengthen the connection of the lower bracing members to the bottom chord. The new ties rods, blocking and struts will be compatible in size and material to the members replaced. Work complies with Secretary's Standards for Rehabilitation, <i>Replacing Deteriorated Historic Materials and Features</i> .

Steel tie rod running across bridge below floor beams to join lower chords of each truss.

Replace all lower lateral bracing tie rods with new galvanized steel tie rods.

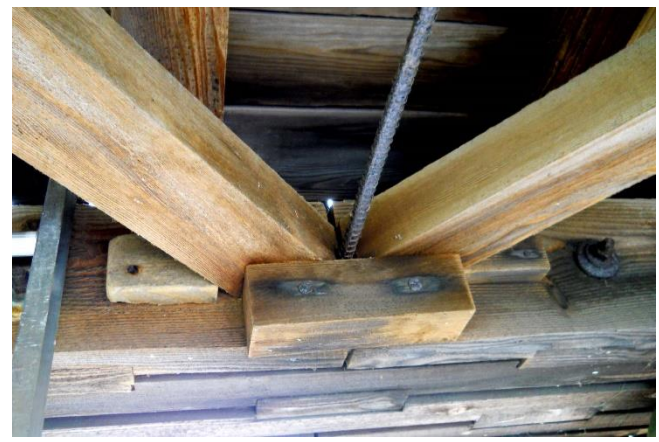
Tie rod connection to lower chord at lower lateral cross bracing bearing point.

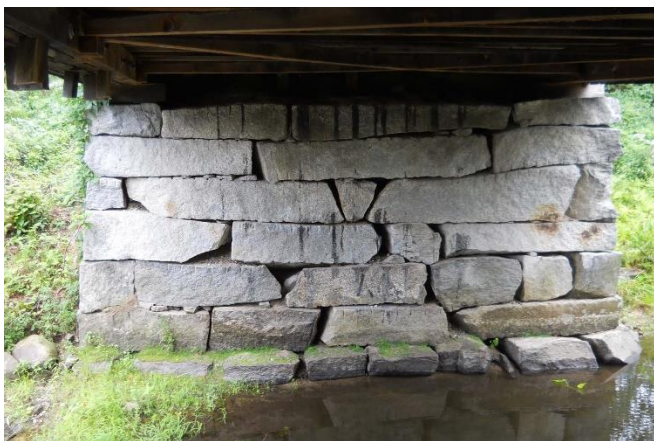
South abutment.

Describe Work:	<p><i>North Abutment:</i> Completely remove and replace the abutment and wingwalls dictated by observed deficient structural conditions and the deficiencies noted in the size and quality of existing stones.</p> <p><i>South Abutment:</i> Reconstruct portions of the east and west wingwalls to stabilize, remove bulges and prevent continued deterioration. Partially rethick and wedge abutment stemwall using compatible stonework. Construct a new concrete backwall and concrete cap to provide required structural bridge and approach foundation; concrete to be at ground level and largely concealed from the view. See Plan Sheets 20-27 – Substructure Modifications.</p>
Project Need:	Substructure is structurally deficient and in need of rehabilitation to provide a safe supporting structure for the bridge..
Impacts:	Work complies with Secretary's Standards for Rehabilitation, <i>Replacing Deteriorated Historic Materials and Features</i> .

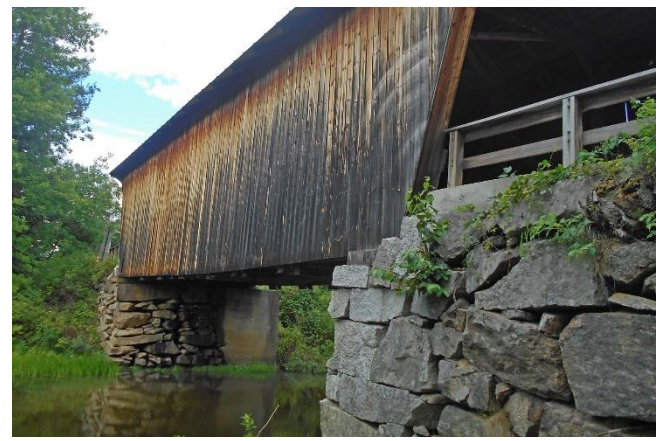
South abutment, downstream side at left; north abutment visible across river.

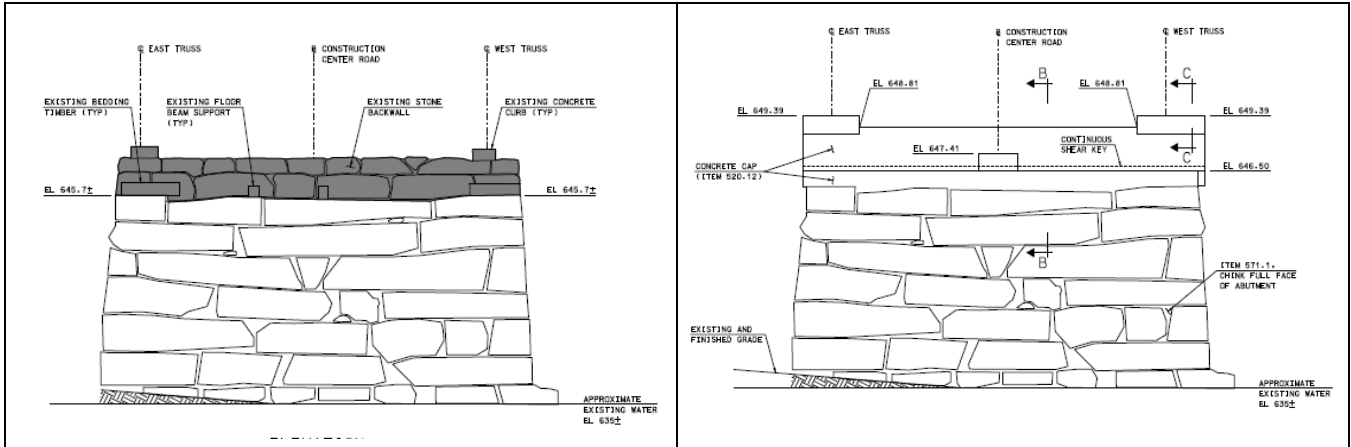
Plan Reference: Sheet 20, 21 South abutment: Existing (left); Repair design (right).
