Stark Covered Bridge Stark, New Hampshire

Historic Structure Report

July 2012

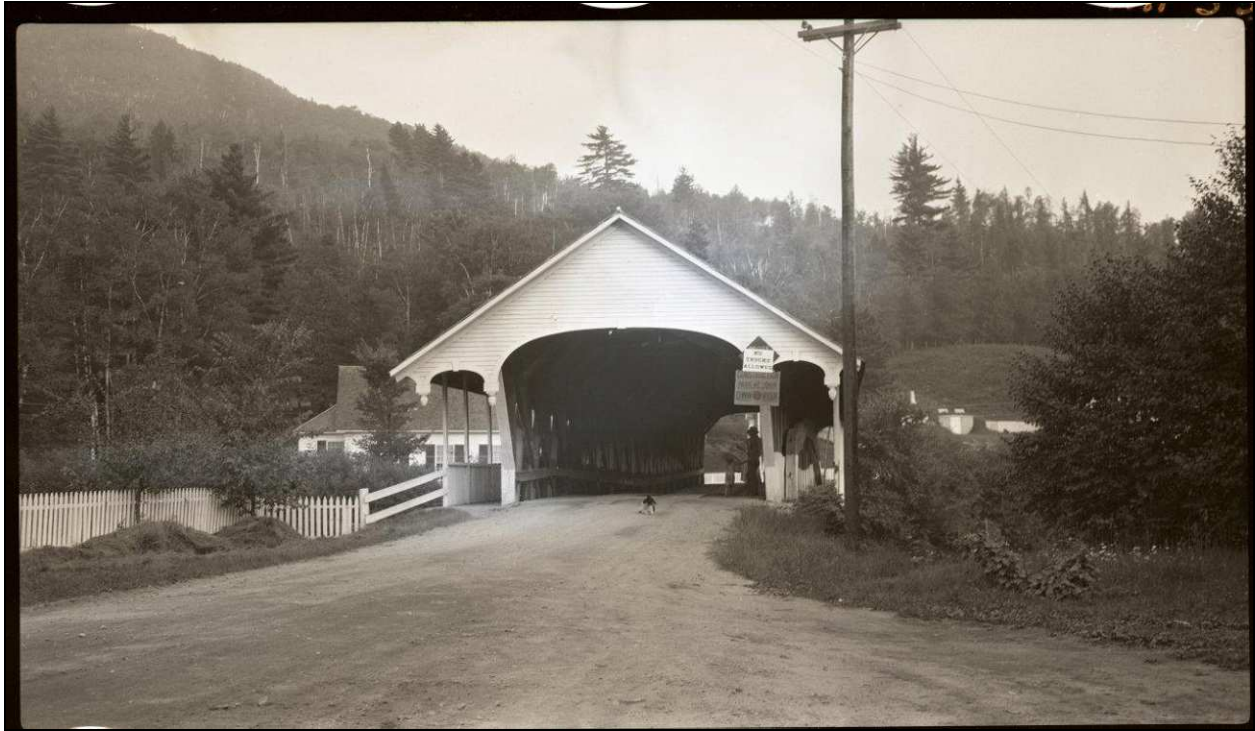
Figure 12: Photo dated August 28, 1948, prior to construction of pier. Note sag in bridge seen in the roadway guardrail. (Source: Collection of the National Society for the Preservation of Covered Bridges).

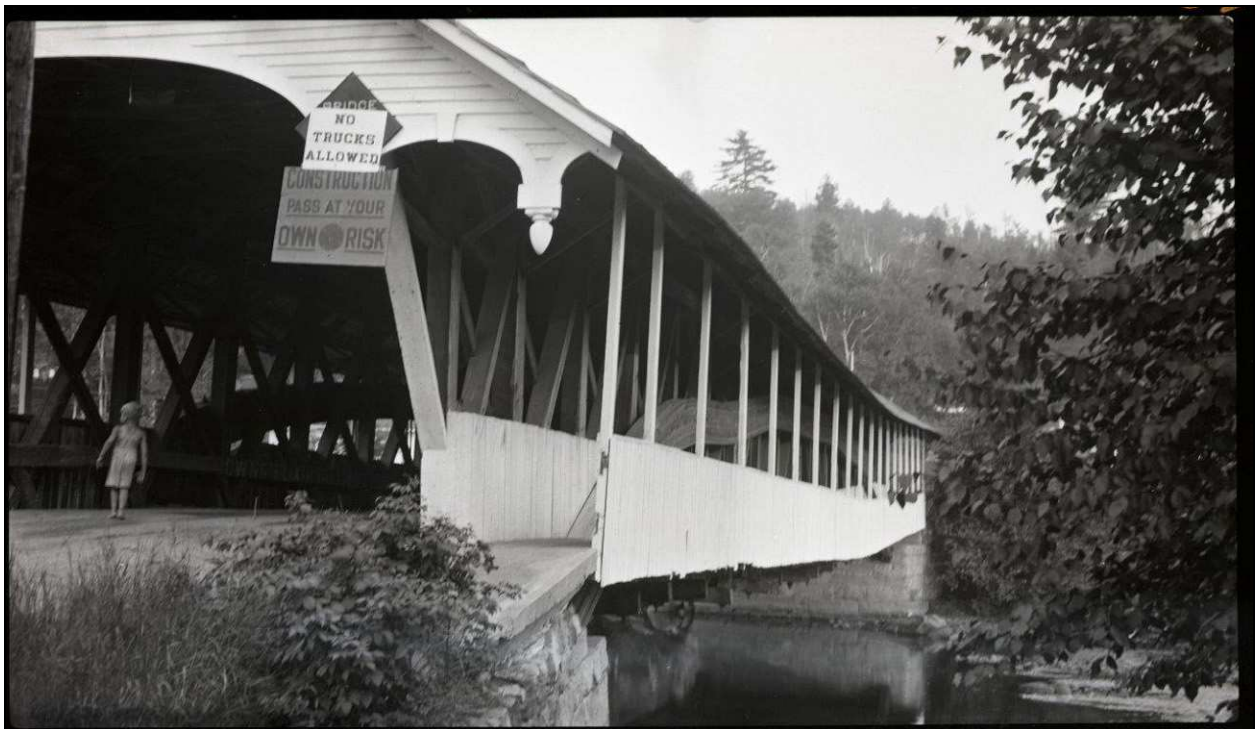
Figure 13: Photo dated August 28, 1948, prior to construction of pier. Note deformed arch. (Source: Collection of the National Society for the Preservation of Covered Bridges).

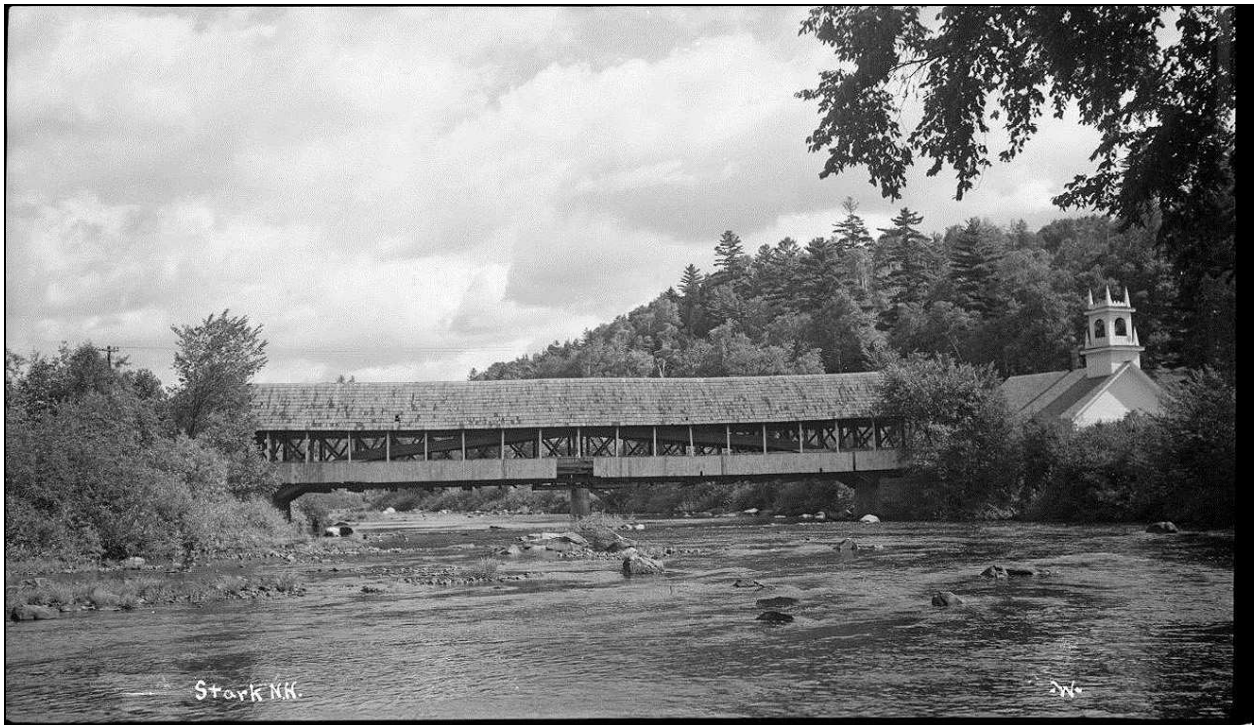
Figure 15: Photo of downstream side of bridge, circa 1950. New pier supporting bridge visible under removed siding. (Source: Collection of the National Society for the Preservation of Covered Bridges).

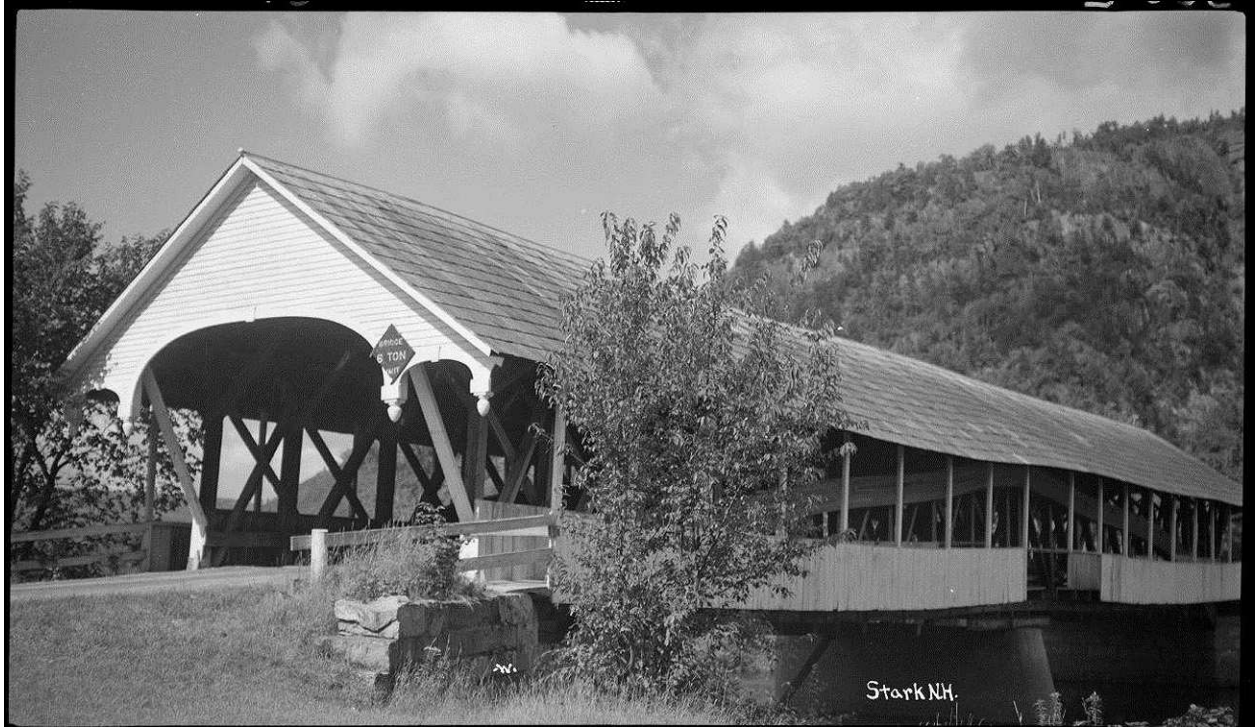
Figure 16: Photo of upstream side of bridge, circa 1950. New pier supporting bridge visible under removed siding. (Source: Collection of the National Society for the Preservation of Covered Bridges).

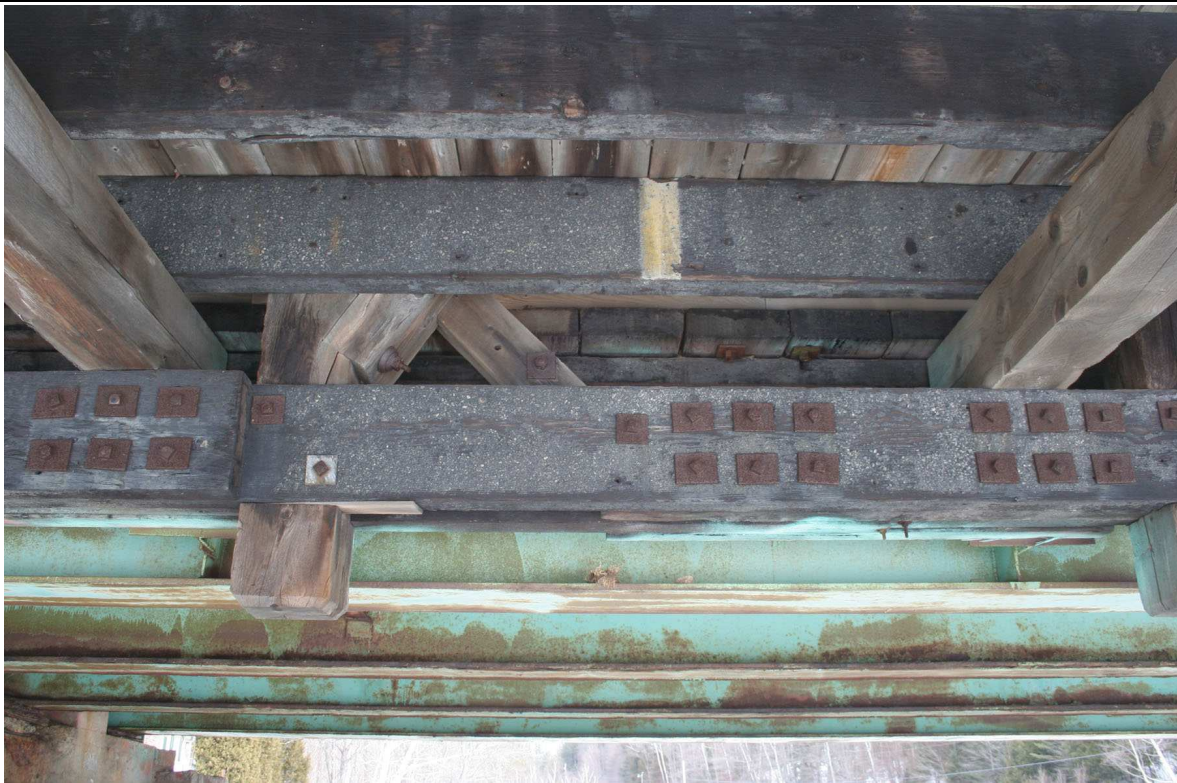
<p>Condition:</p> <p>The lower chords are in fair to good condition due to being treated against rot and coated with asphalt.</p>	
<p>Proposed Treatment:</p> <p>All lower chords will be replaced with new wood members compatible with existing original truss components.</p>	
<p>Project Need:</p> <p>The lower chords are primary structural members of the truss that carry the live and dead loads. The lower chord members and their thru-bolt connections are of insufficient strength and do not possess the required structural integrity to carry the required loads.</p>	
<p>Impacts:</p> <p>The existing chord members are not original to the bridge and are incompatible with the original design because they were salvaged deck timbers of different size, surfaced with asphalt pavement.</p>	
<p>Alternative Treatments Considered:</p> <p>None. There are no other repair alternatives that meet the Secretary of the Interior's Standards for Rehabilitation.</p>

FIGURE: 4.3-4: Lower chord members bolted to posts and diagonals. The same salvaged deck members are also used for intermediate floor stringers between the I-beam stringers; two are visible in upper half of photo.

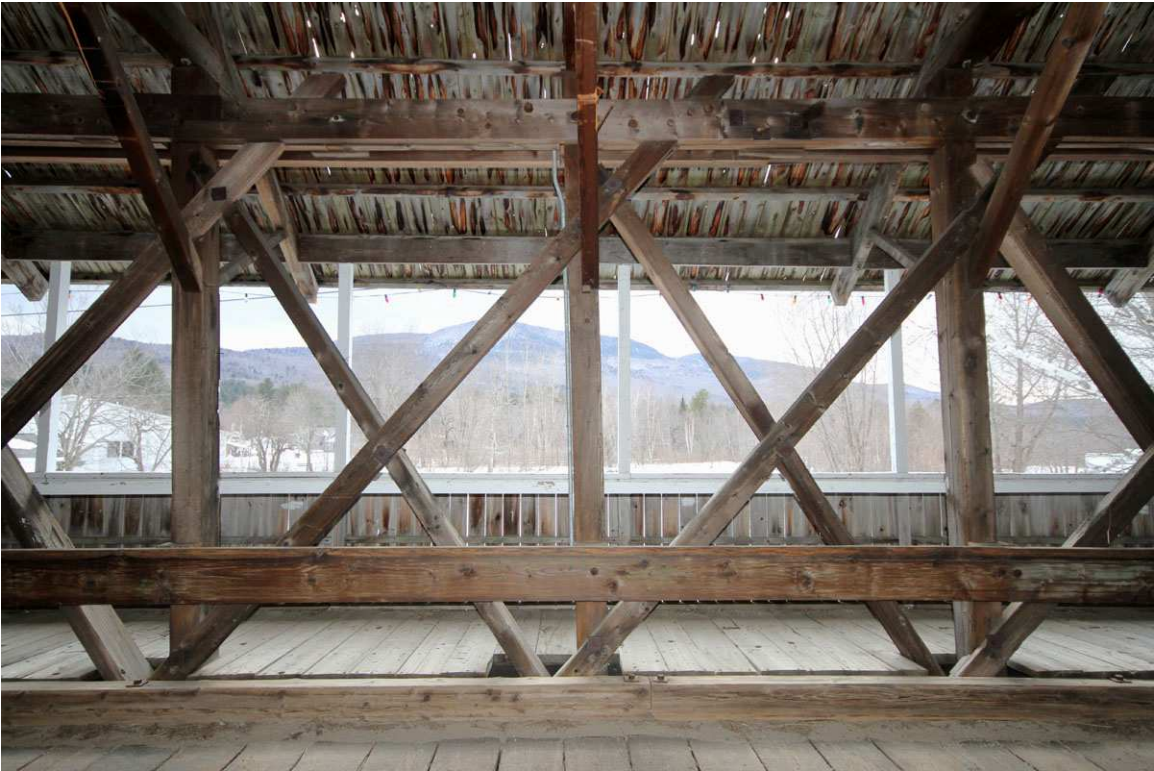
<p>Condition: (information from HEB 2012 Engineering Study)</p> <p>Due to the many alterations to the bridge and the sagging of the trusses due to deterioration and loose joints, many of the diagonals currently are not functioning in their intended structural capacity. Most diagonals show signs of rot or insect damage at the lower portion of the member.</p> <p>Several of the main diagonal joints have opened up, indicating that the members are no longer acting in compression. Spacer blocks have been added to some of the open joints in an attempt to put a bearing load on the member. Many of the main diagonals have unused notches, notches that have been widened, and unused holes suggesting they have been moved from their original locations; three appear to have been replaced and one has been spliced. The counter braces are in similar condition, with numerous additional holes and notches; one has been spliced.</p>

FIGURE: 4.5-3: Overall view of diagonals

<p>Proposed Treatment:</p> <p>Restore trusses to original two-span configuration; relocate several diagonal members in their original locations; splice or replace members in-kind to achieve structural integrity. Repair estimate per truss: 14 counter braces require splices; 10 main diagonals require splices; 8 main diagonals require replacement; 8 main diagonals require repositioning.</p>	
<p>Project Need:</p> <p>Restoration of the structural integrity of the truss is necessary to enable it to carry the live and dead loads being placed on it.</p>	
<p>Impacts:</p> <p>The work impacts original historic features of the bridge. The repair and/or replacement of the timber members will be done in-kind, replicating the materials, design and workmanship of the original members, consistent with Secretary of the Interior's Standards for Rehabilitation (SOI Standards).</p> <p>The restoration of the trusses to the original two-span configuration removes incompatible repairs that have compromised the overall structural integrity of the bridge, and is constant with SOI Standards.</p>

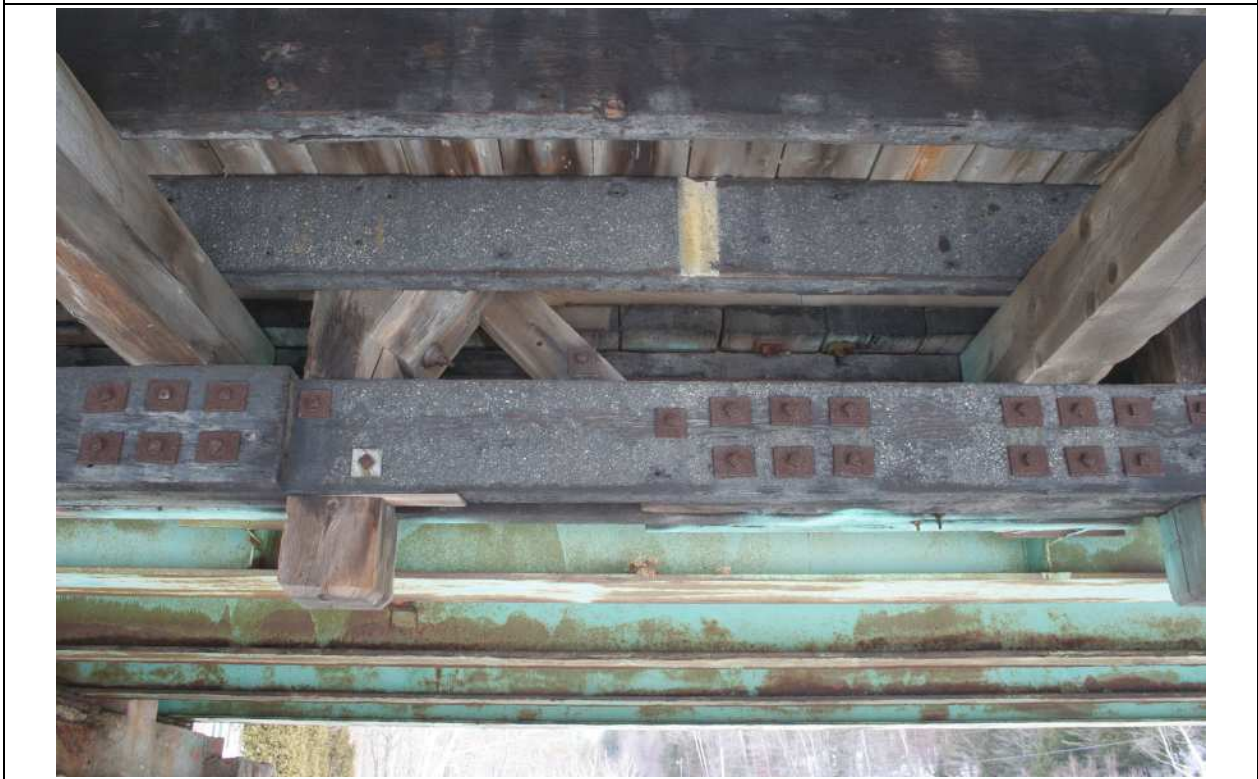
FIGURE: 4.5-6: Diagonal connections at bottom chord; compression member shown in notch and bolted to the post above chord; tension member extends between chord members and bolted to them.

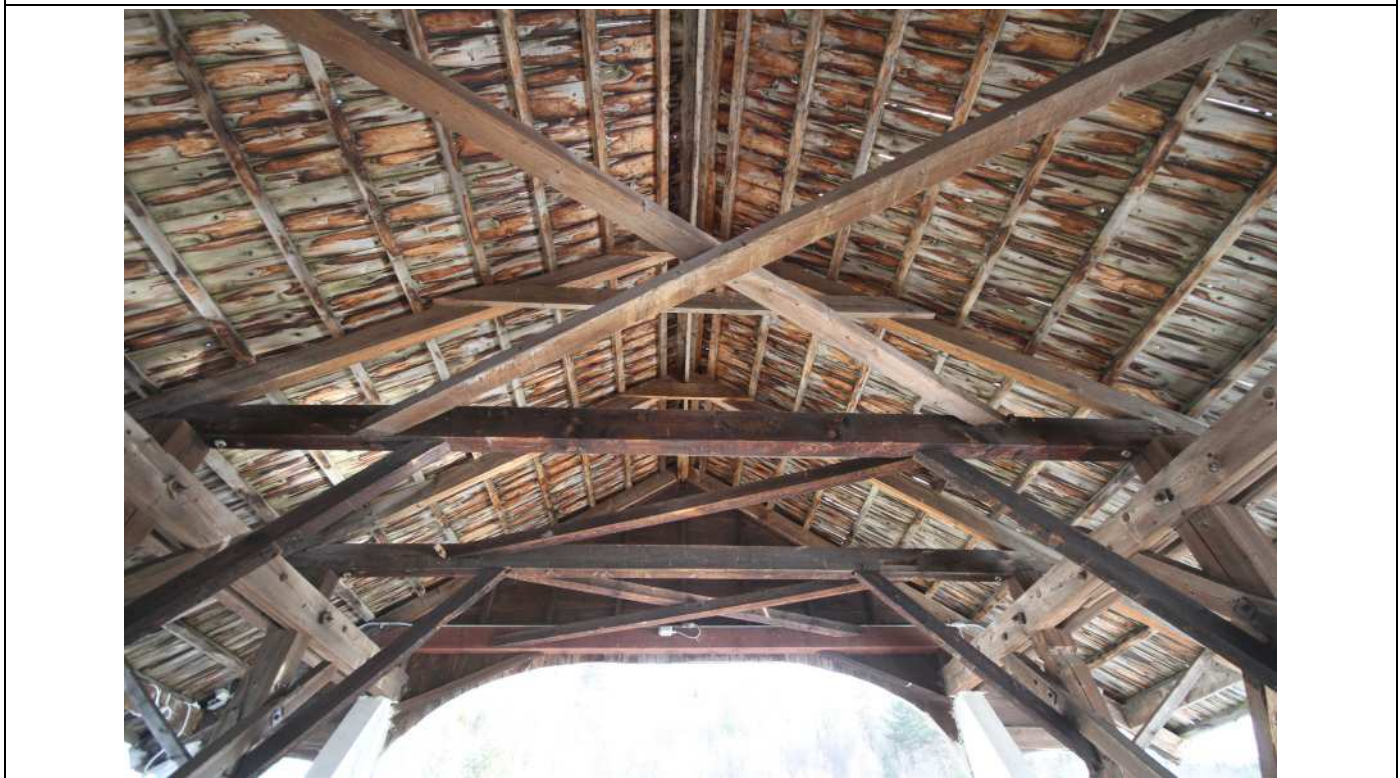
FIGURE: 4.7-3: Overall view of roof system.

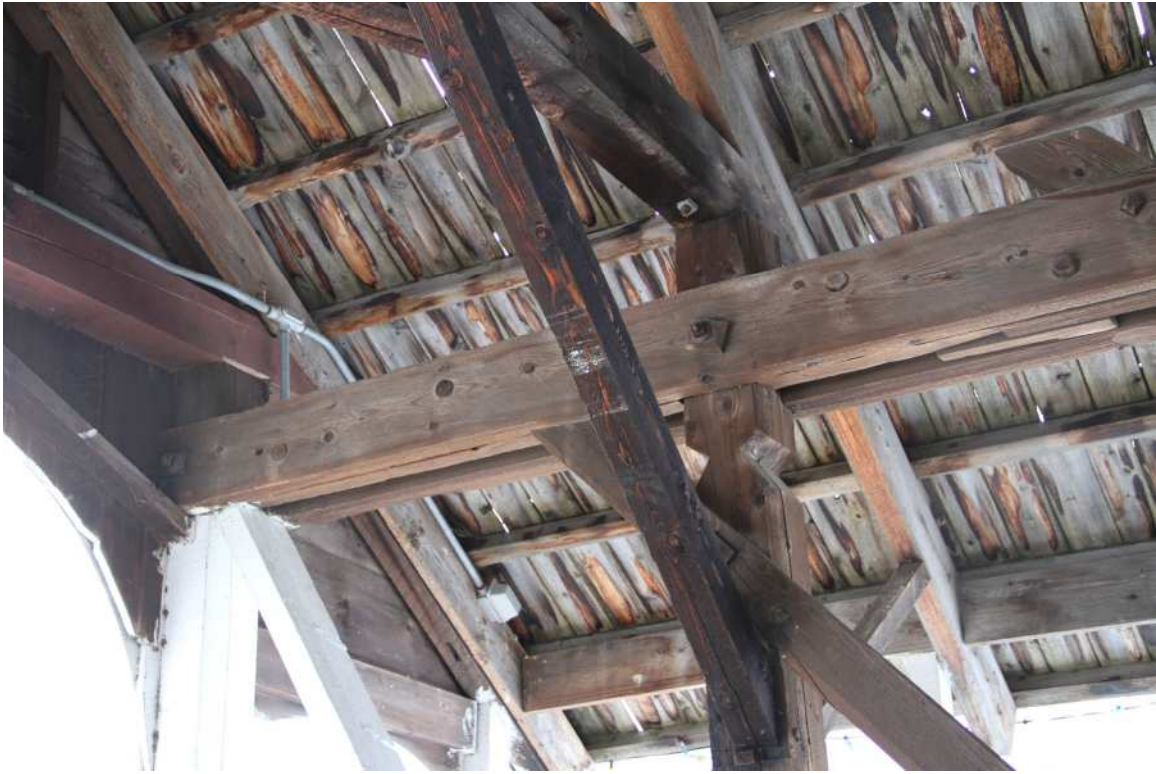
FIGURE: 4.7-4: Detail of underside of roof showing holes and gaps in shingles.

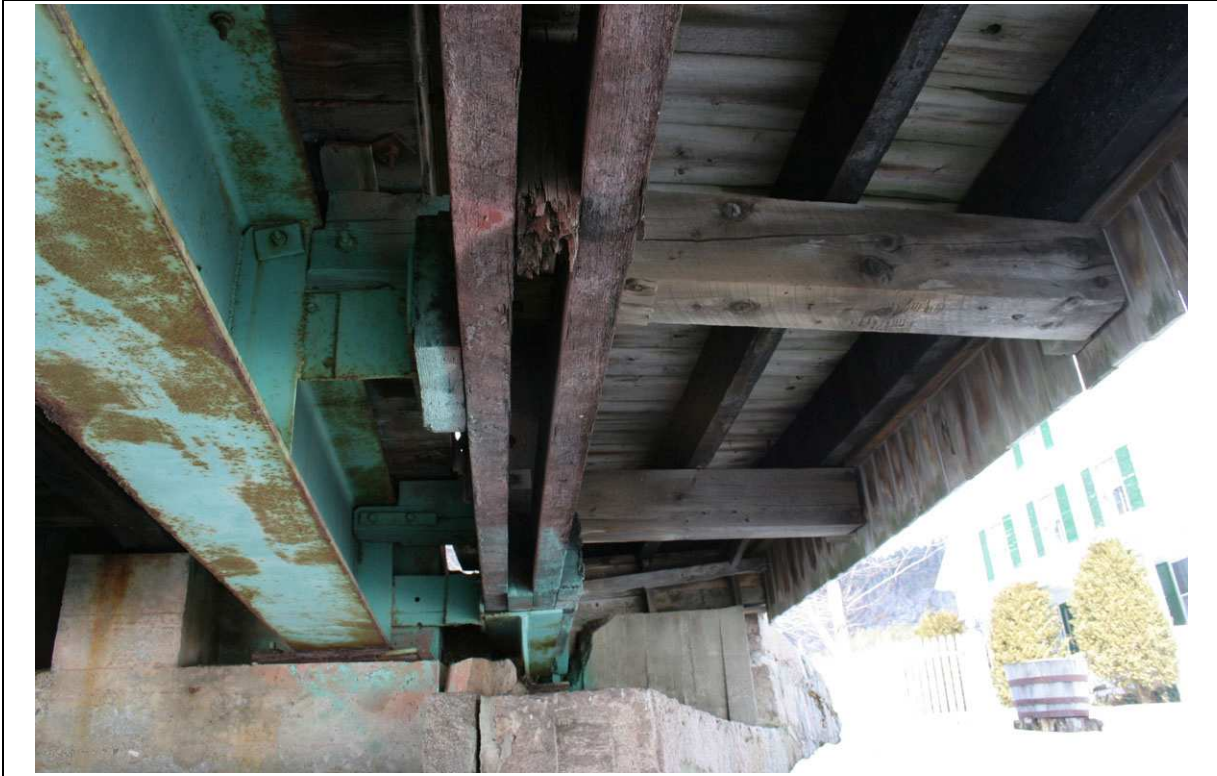
FIGURE: 4.9-3: Underside of sidewalk showing cantilevered floor beams and stringers.

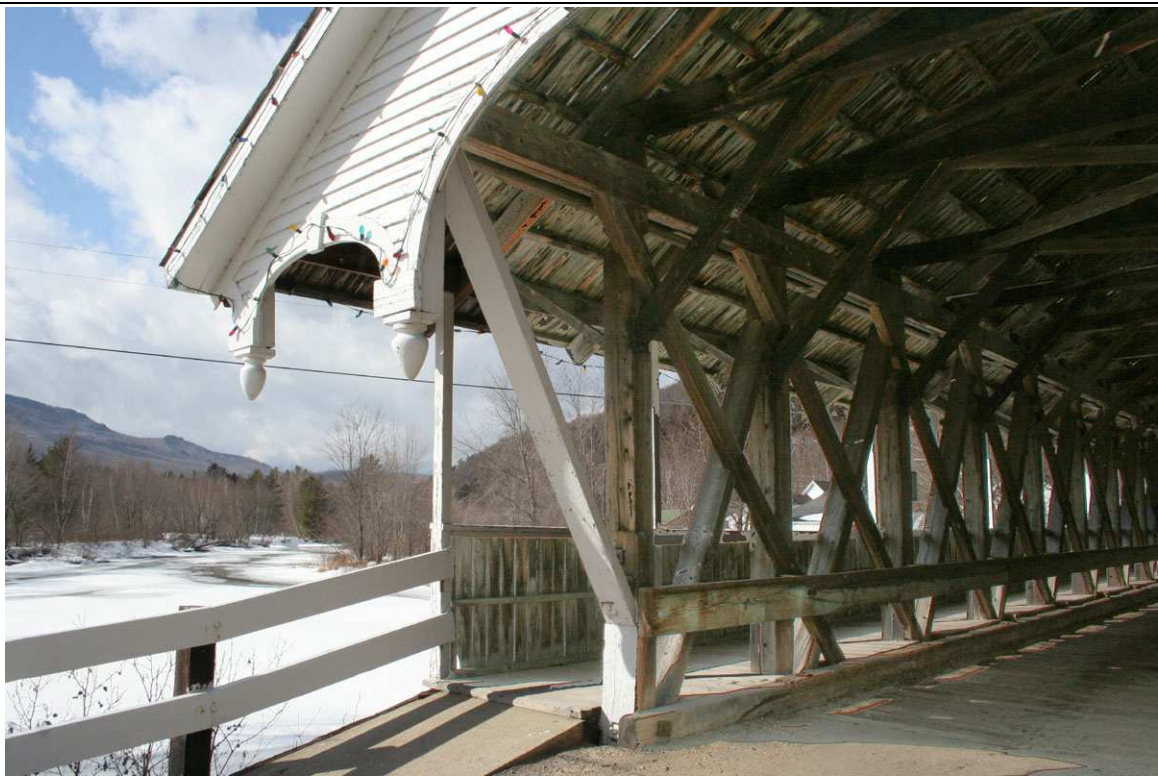
FIGURE: 4.9-4: Interior view of sidewalk.

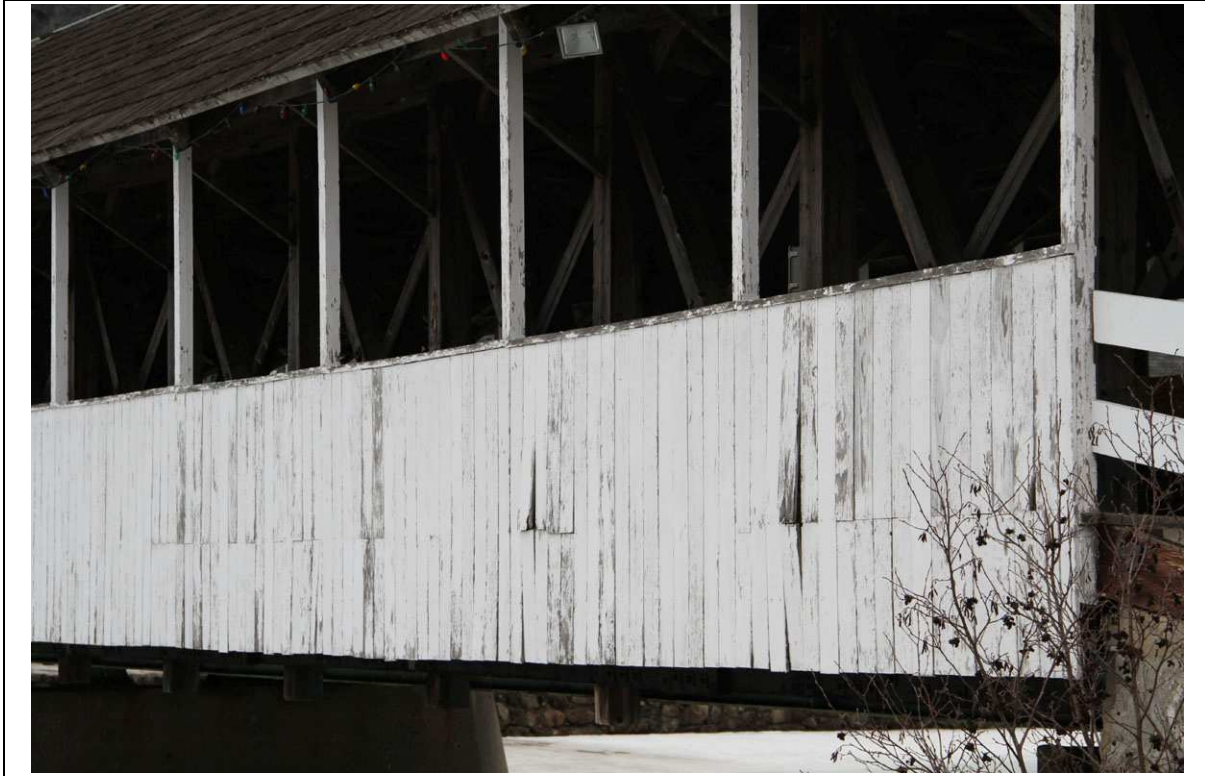
FIGURE: 4.9-5: Vertical wood siding railing on sidewalk.

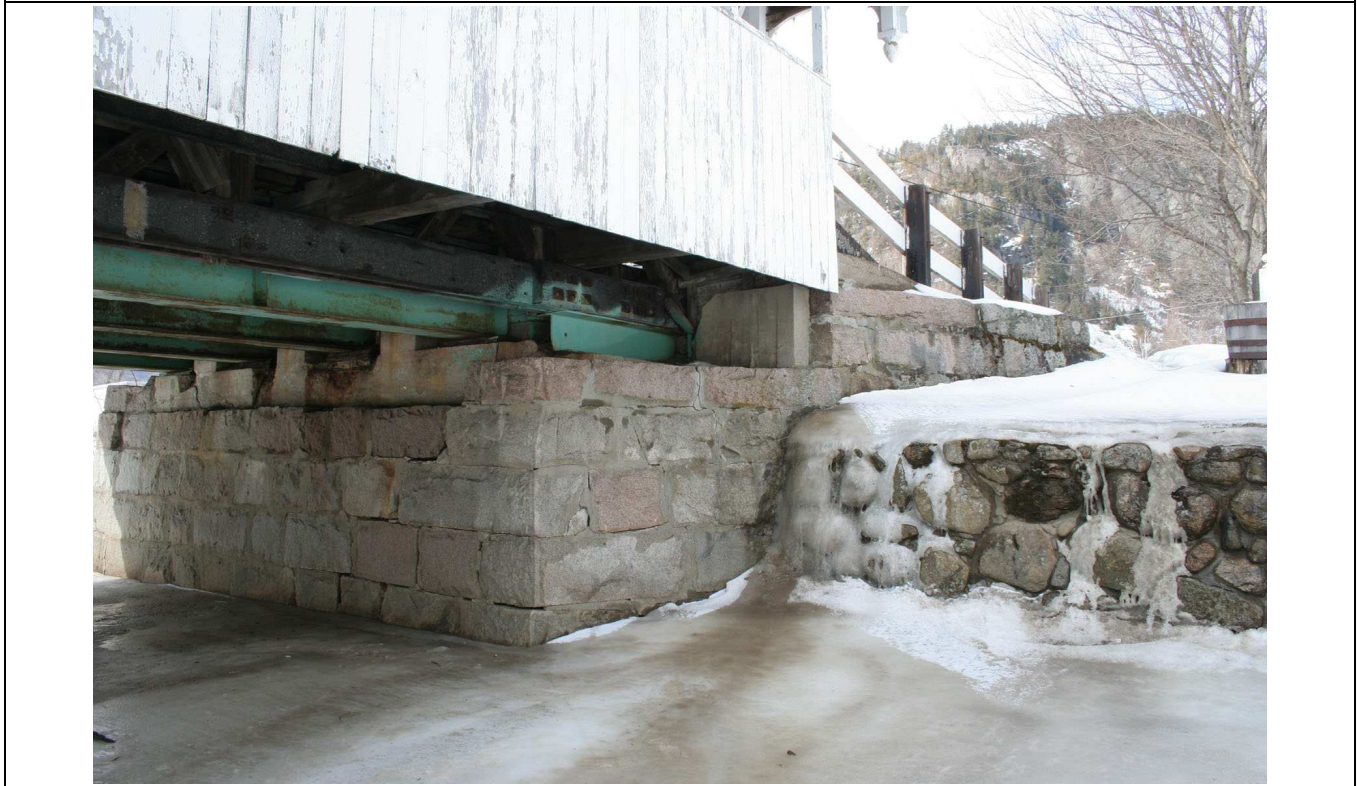
<p>Significance:</p> <p>The cut granite abutments are an original and character-defining feature of the bridge. Subsequent repairs and extensions to the wingwalls have been done in a haphazard way, with poor application of repointing mortar, and use of random fieldstone that does not match to the original workmanship.</p>	
<p>Condition: (information from HEB 2012 Engineering Study)</p> <p>The facewalls of both abutments show isolated cracking and minor deterioration of mortar joints. The north abutment has a pronounced diagonal crack that has opened along vertical and horizontal joints with resultant loss of mortar. The north abutment upstream wingwall shows significant settling with associated cracking and deterioration of the mortar joints. The south abutment and wing-walls are in good condition with minor cracking and deterioration of the mortar joints. Portions of the joints have been re-pointed.</p>

FIGURE: 4.10-2: North abutment, upstream corner.

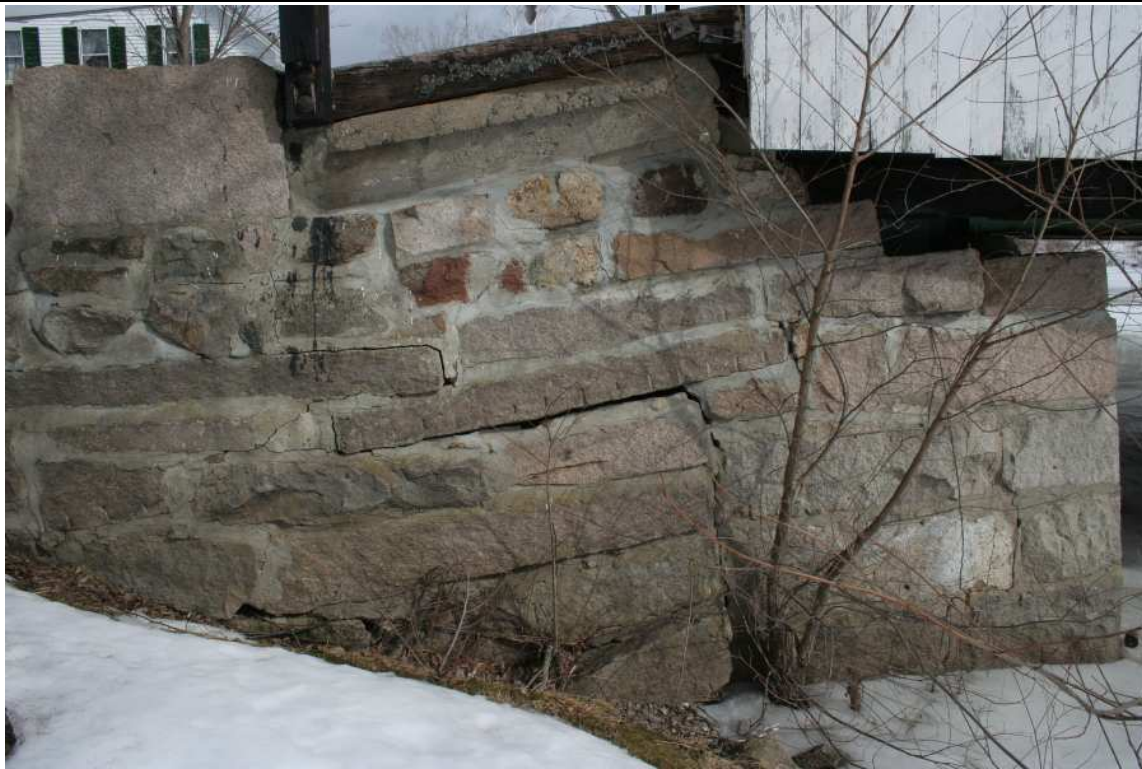
FIGURE: 4.10-6: Detail of north abutment, downstream wingwall.

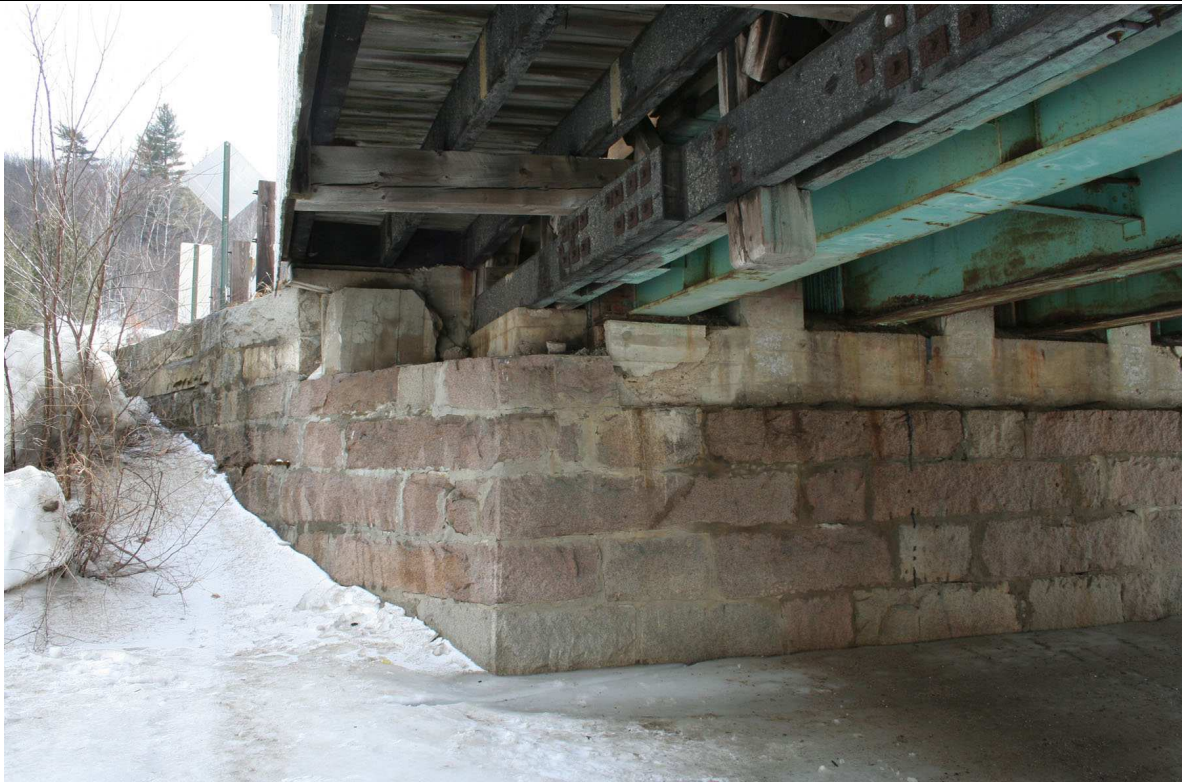
FIGURE: 4.2.1-5: South abutment, face and upstream corner

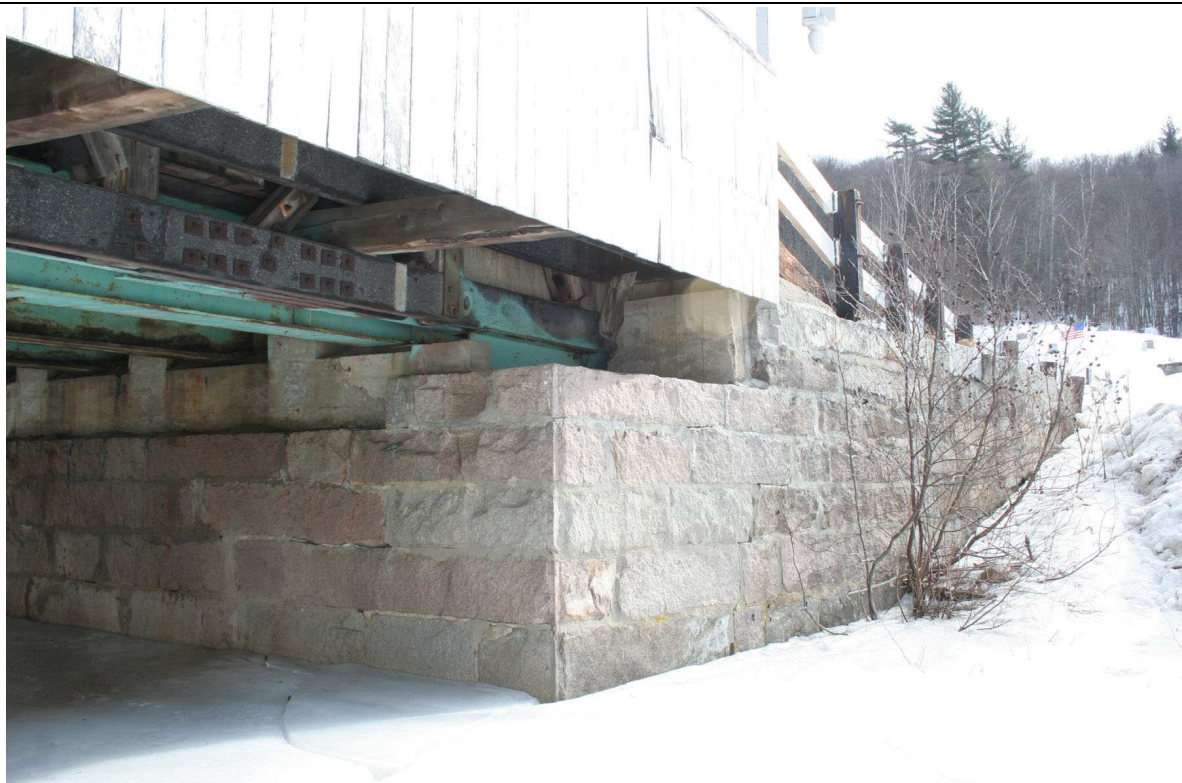
FIGURE: 4.2.1-6: South abutment, face and downstream corner

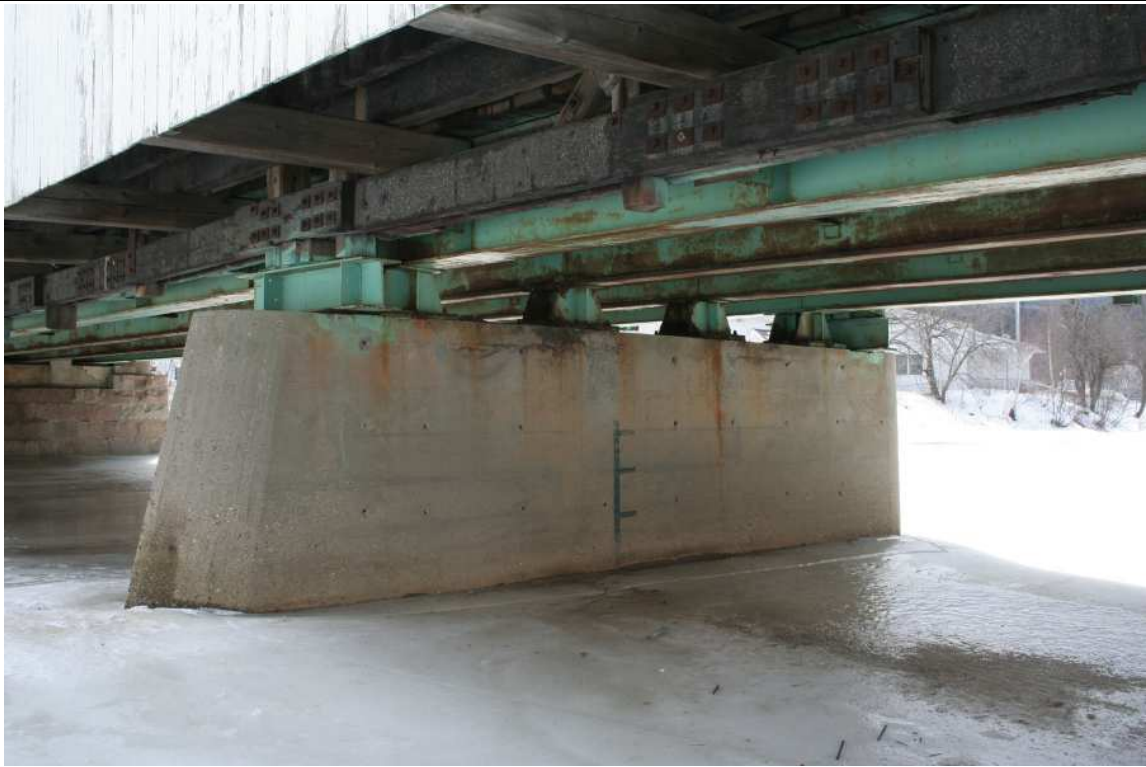
FIGURE: 4.11-4: View of pier and pedestal bearings.
