**TABLE OF OBSERVED FEATURES
 SURVEY AREA 1
 ORIGINAL MAIN LINE
 CONNECTICUT RIVER BRIDGE, WOODSVILLE TO
 LITTLETON
 (PHOTO KEYS FOLLOW TABLES)**

**PHOTOGRAPHS SURVEY AREA 1
ORIGINAL MAIN LINE
CONNECTICUT RIVER BRIDGE, WOODSVILLE TO
LITTLETON**

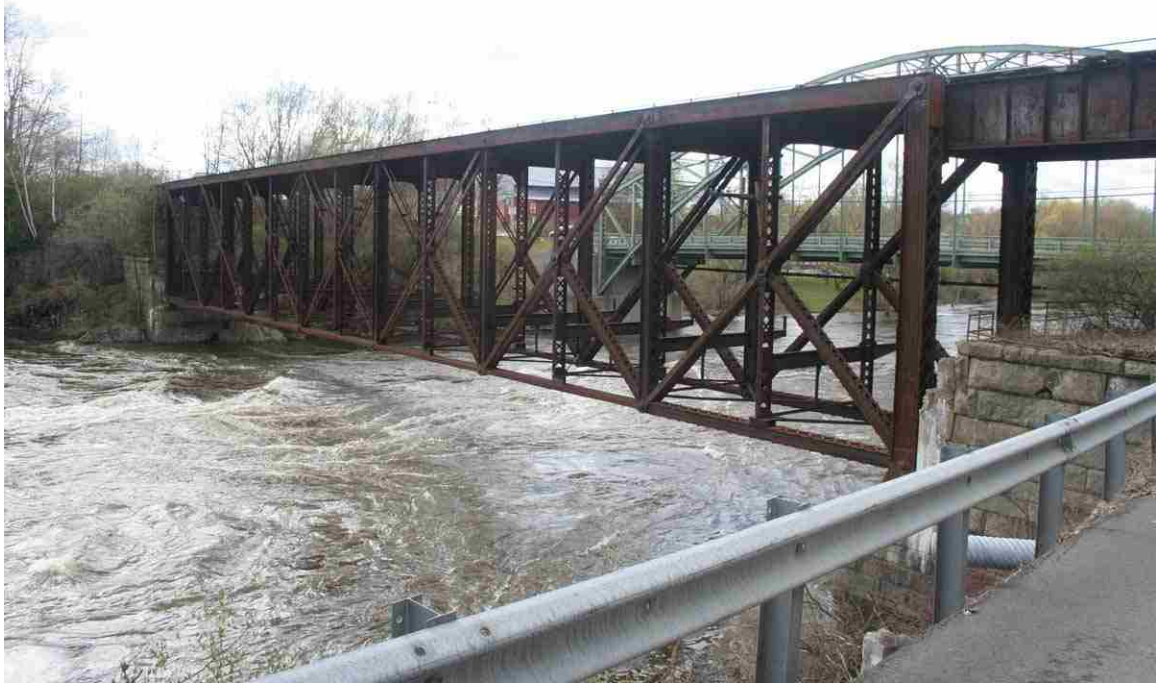
Photo # 1 description: Bridge 93.74 over Connecticut R. Bridge, Woodsville. Pin connected steel deck truss. Deck plate girder over Shaeffer Hill Rd. 1904.

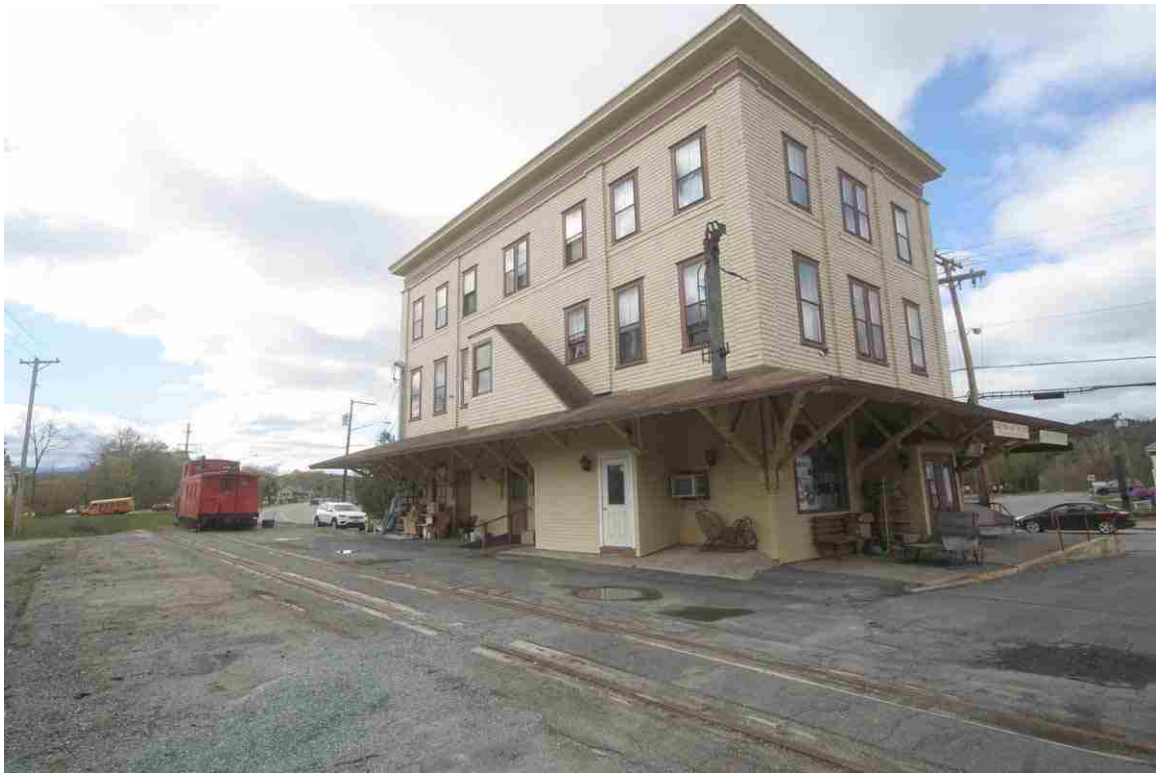
Photo # 5 description: Woodsville Station, Track side, with track remaining. mp 93.60. 1890, 1921.

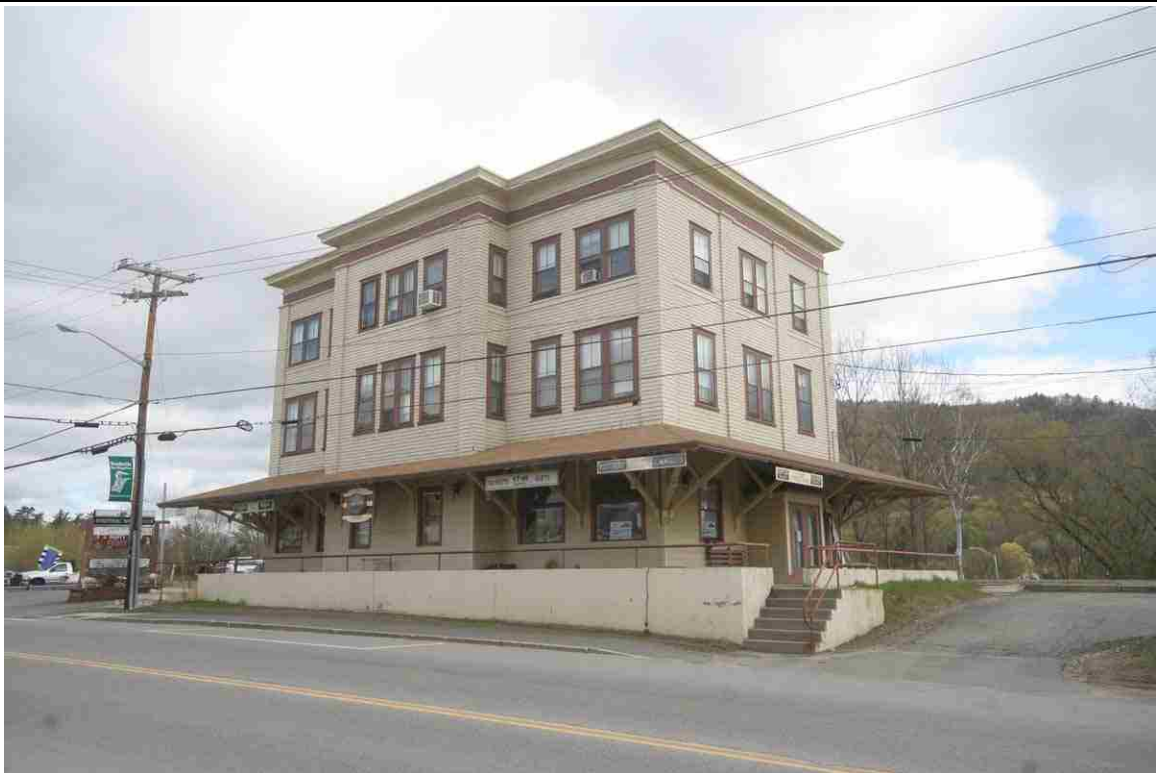
Photo # 6 description: Woodsville Station. Street side, with track remaining. mp 93.60. 1890, 1921.

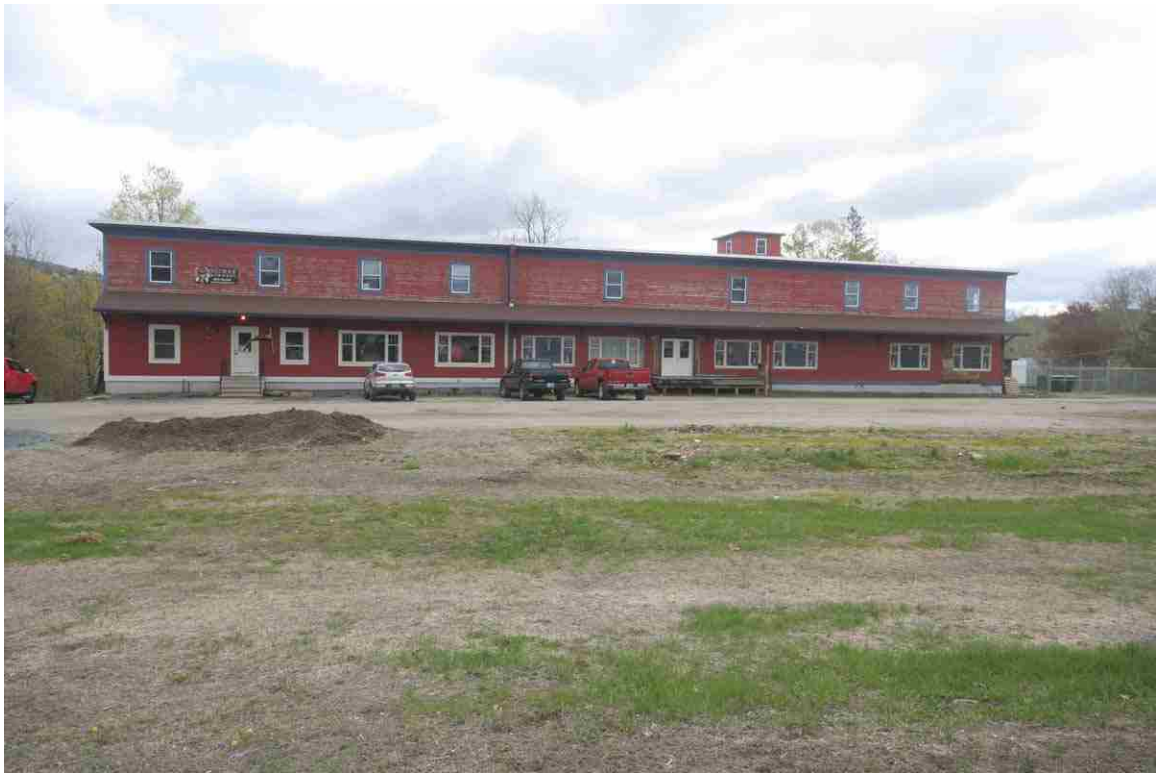
Photo # 7 description: Freight House No. 1, Woodsville, west side. mp 93.65. nd.

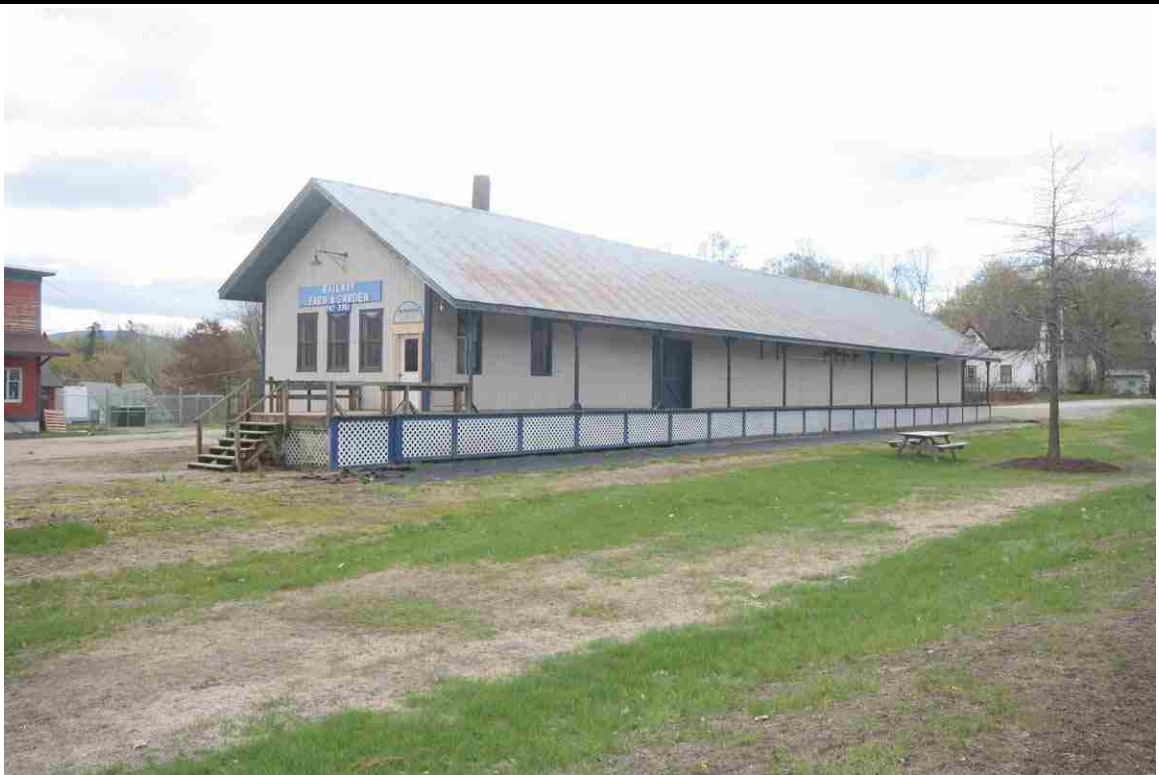
Photo # 8 description: Freight House No. 2, Woodsville, north and west sides. mp 93.65. nd.

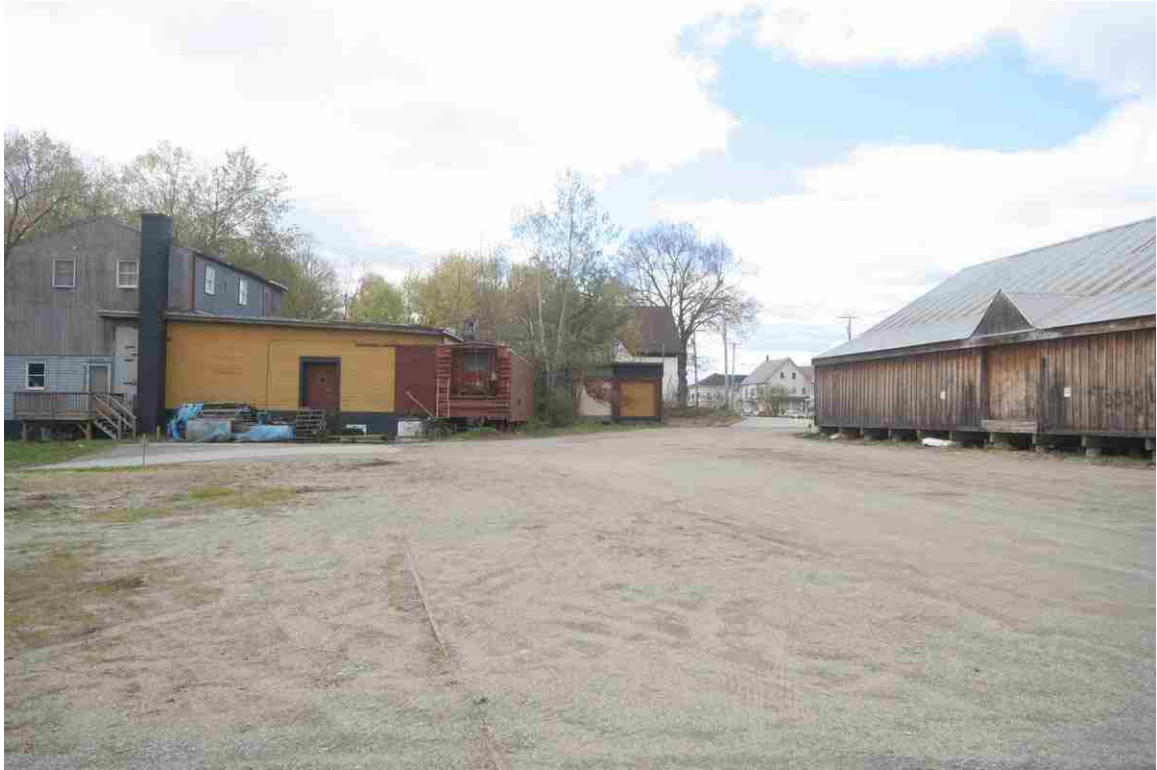
Photo # 9 description: Freight Building No. 3, Woodsville, north side. mp 93.65. nd. Note siding track and freight car remain. East side of Freight Building No. 2 at right.

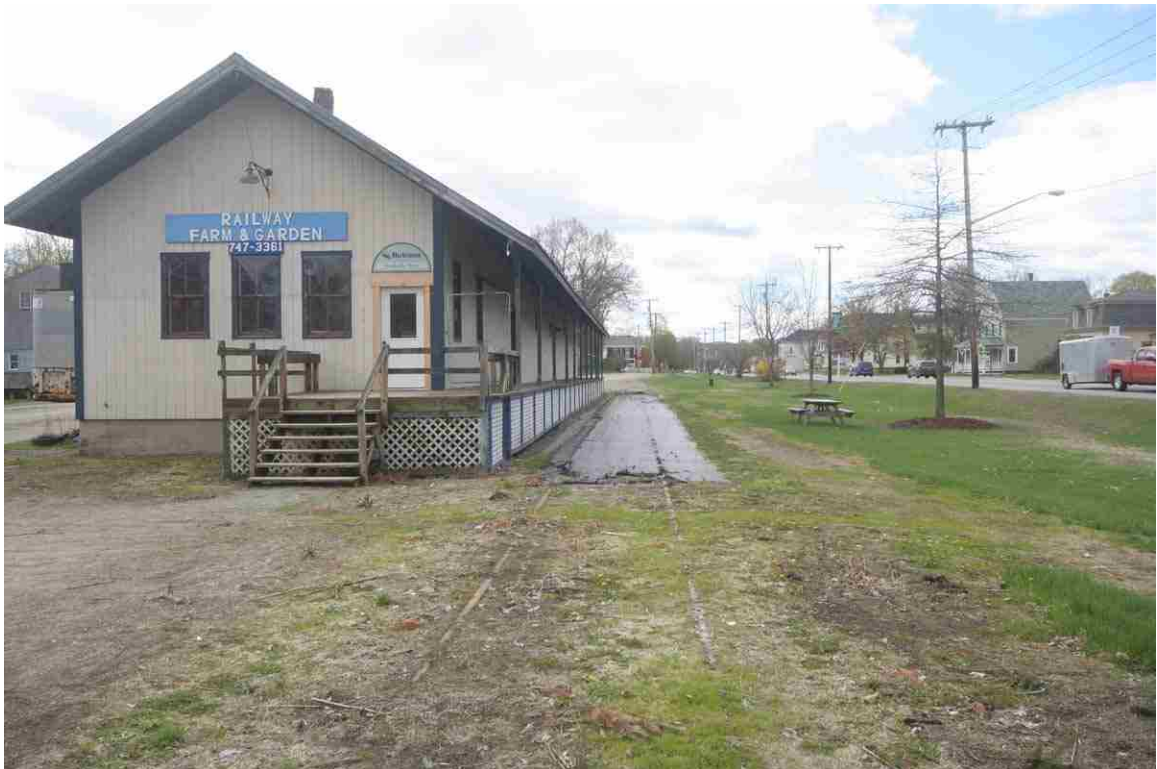
Photo # 10 description: Freight Building No. 2, Woodsville, north side, showing remaining track. mp 93.65. nd.

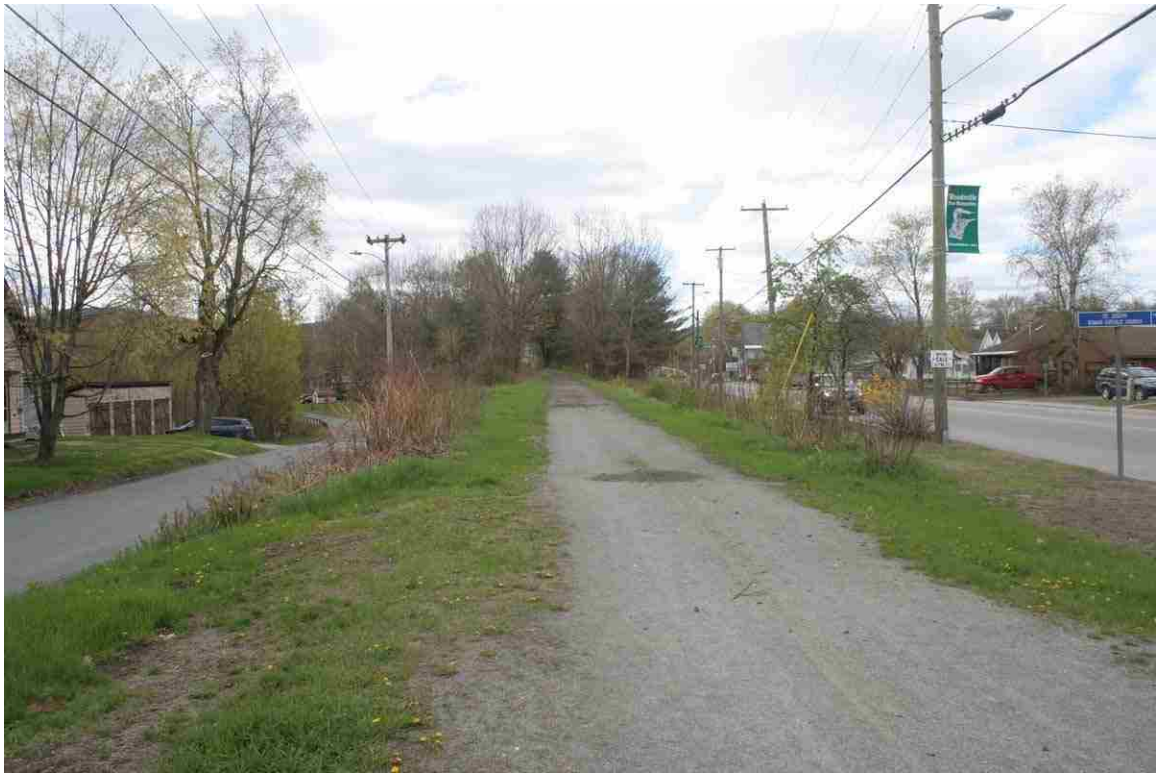
Photo # 11 description: Railbed (trail), Woodsville, character along Central St., right and Railroad St., left. mp 93.68.

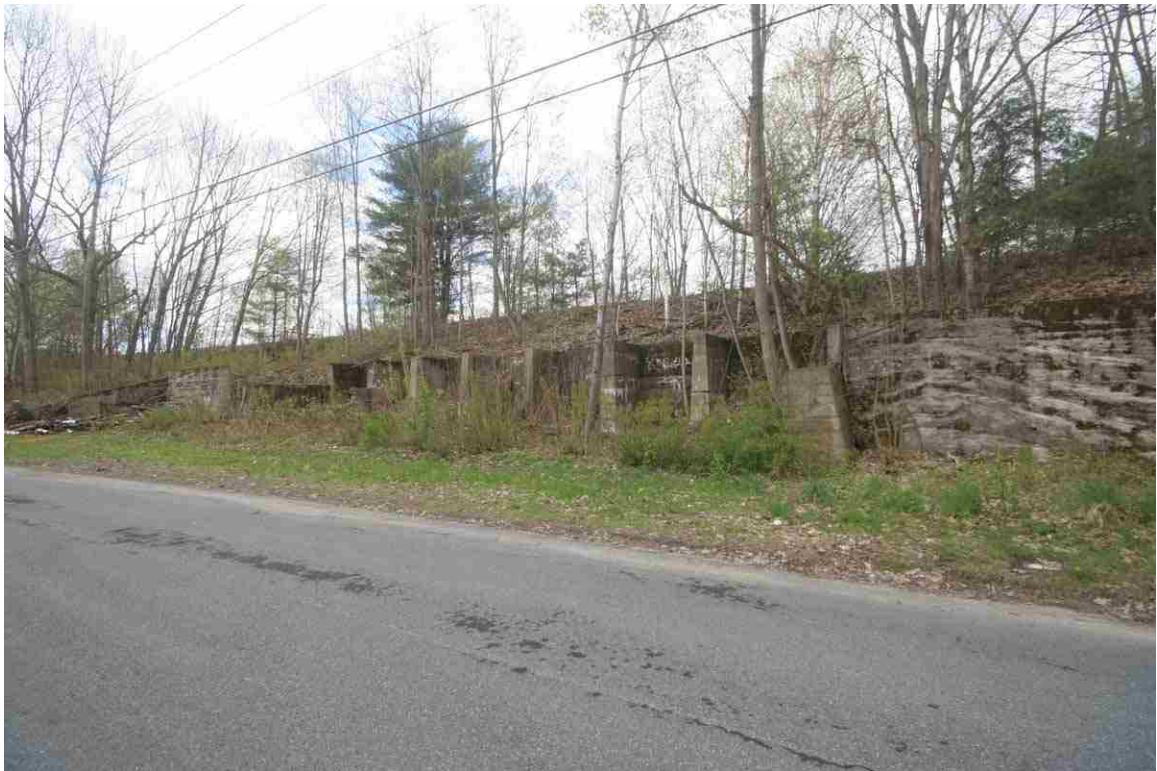
C. E. Randall Coal Pockets, Woodsville	93.70	Haverhill	N/C	12	c.1900	On Mill Street. Lack of integrity. Insufficient remaining features to identify the property type.
Mill Street underpass, Woodsville.	94.79	Haverhill	N/C	13	2018	New bridge. This report is part of the mitigation for the adverse effect of demolition of the prior Mill St. bridge.
Bridge No. 95.07 over Dartmouth College Rd., Woodsville.	95.07	Haverhill	C	14	1937	Steel deck plate girder on reinforced concrete abutments. B&M.
Culvert No. 95.57	95.57	Bath	C	15-16	?	Stone box.
Bridge No. 95.75	95.75	Bath	C	17-18	1930	Concrete slab. B&M
Mile marker No. 95.75	95.75	Bath	C	19	?	Concrete. Probably B&M, 1930.
Culvert No. 96.21	96.21	Bath	C	20	1924	Cast iron pipe, 18", concrete headwalls. B&M.
Culvert No. 96.27	96.27	Bath	C	21-22	1921	Railtop concrete slab, concrete encased stone walls. B&M
Bridge No. 96.52	96.52	Bath	C	23-24	1929	Precast concrete slab on stone walls. B&M

Photo # 12 description: C.E. Randall Coal Pockets, Mill St., Woodsville. Reinforced concrete. mp 93.70. c.1900.

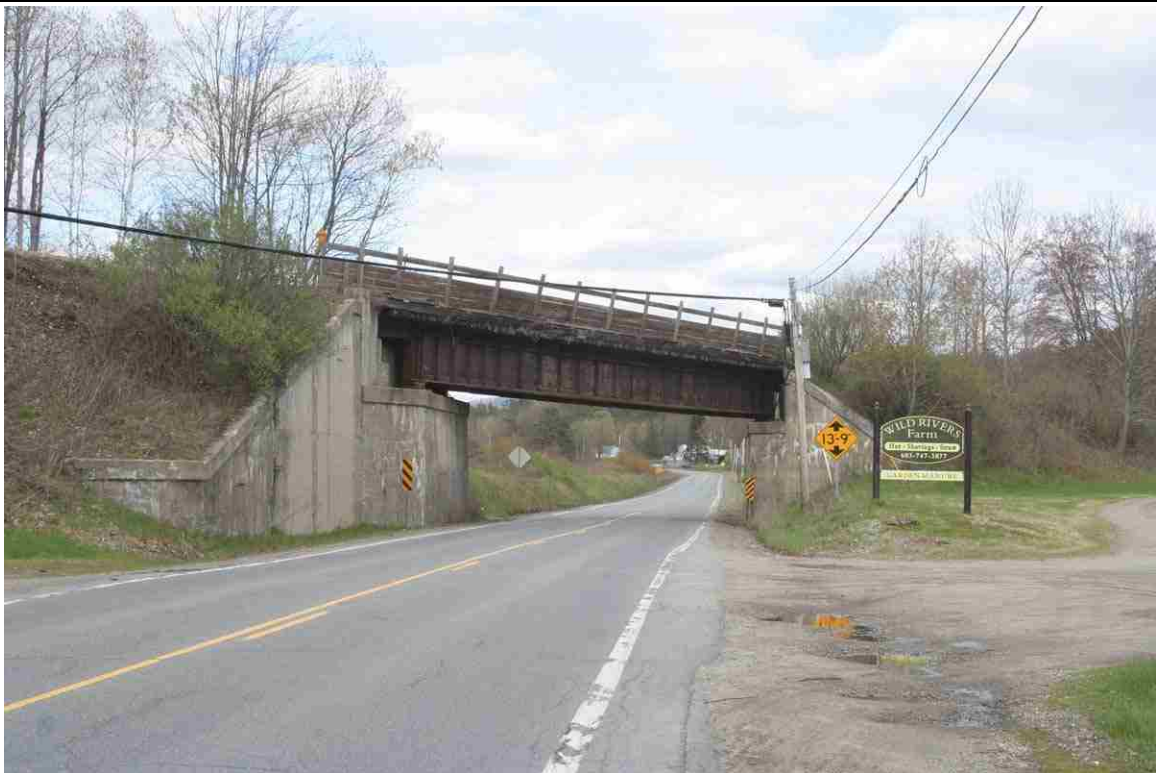
Photo # 14 description: Bridge No. 95.07 over Dartmouth College Rd., Woodsville. Steel deck plate girder on reinforced concrete abutments. 1937.

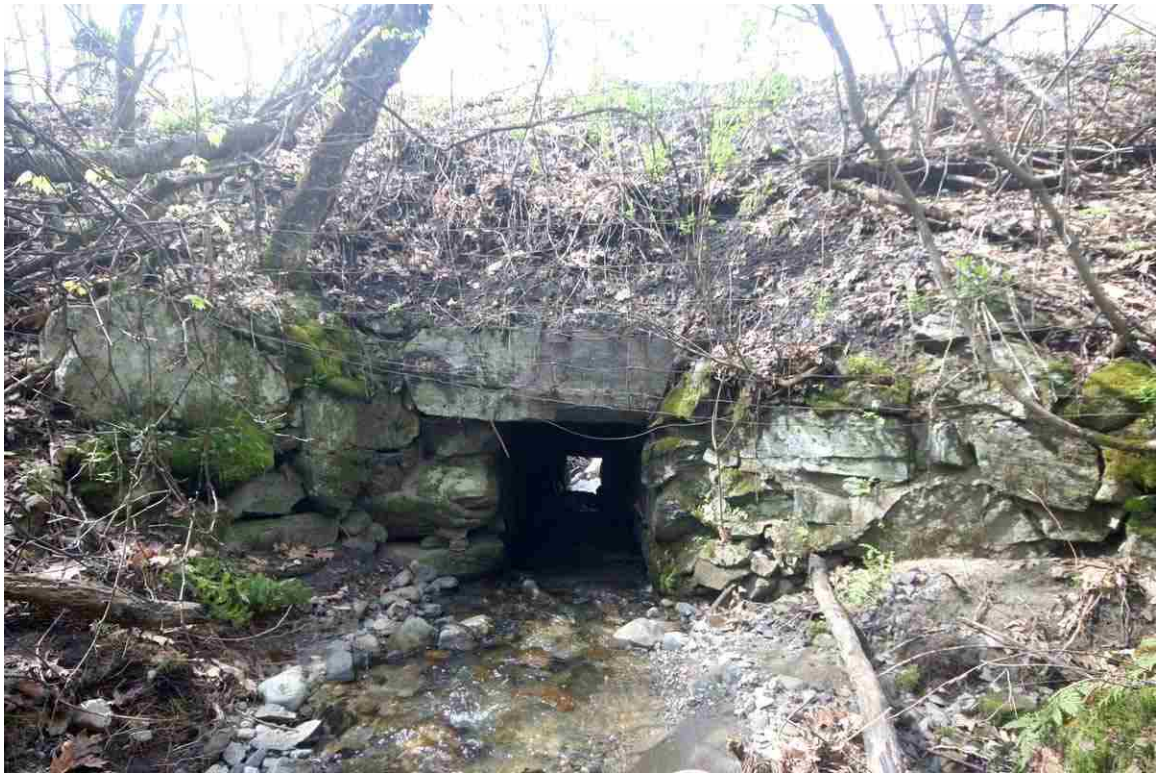
Photo # 15 description: Culvert No. 95.57 (mp), Bath. Stone box, field & ledge stone, 3-6 x 4-0. nd. Outlet. (1 of 2).

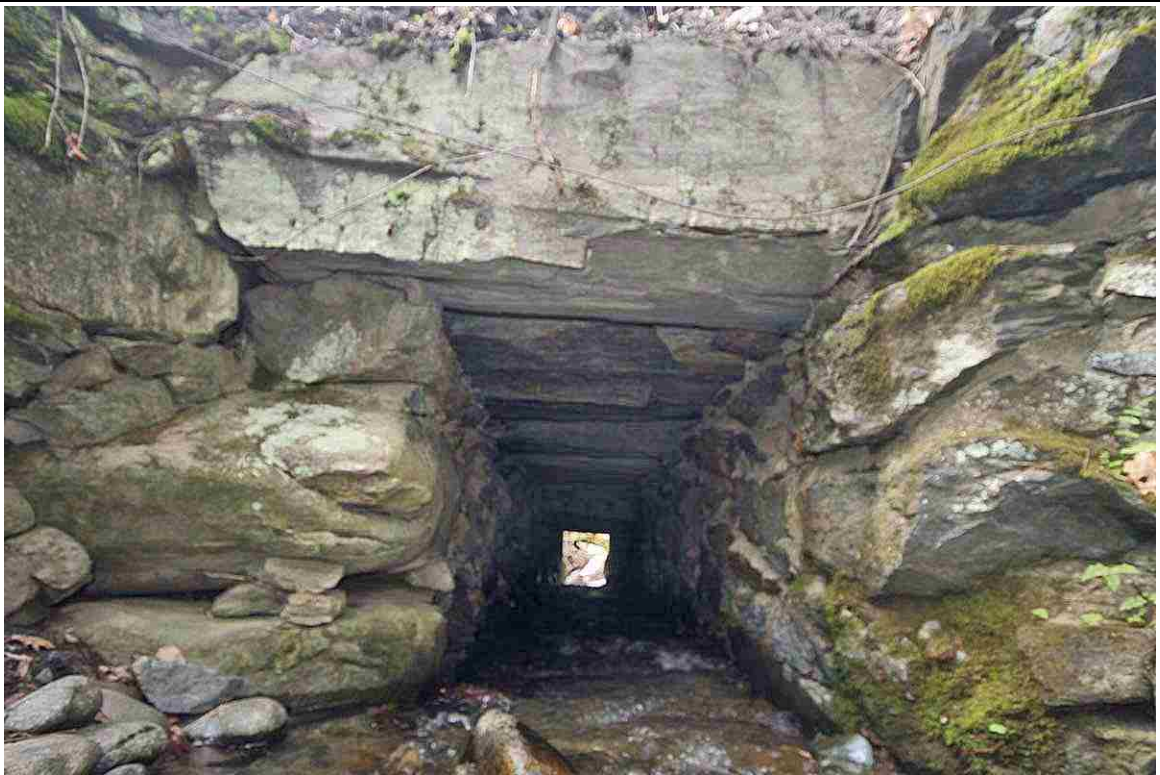
Photo # 16 description: Culvert No. 95.57 (mp), Bath. Stone box, field & ledge stone, 3-6 x 4-0. nd. Interior view showing large ledge-quarried cover stones. (2 of 2).

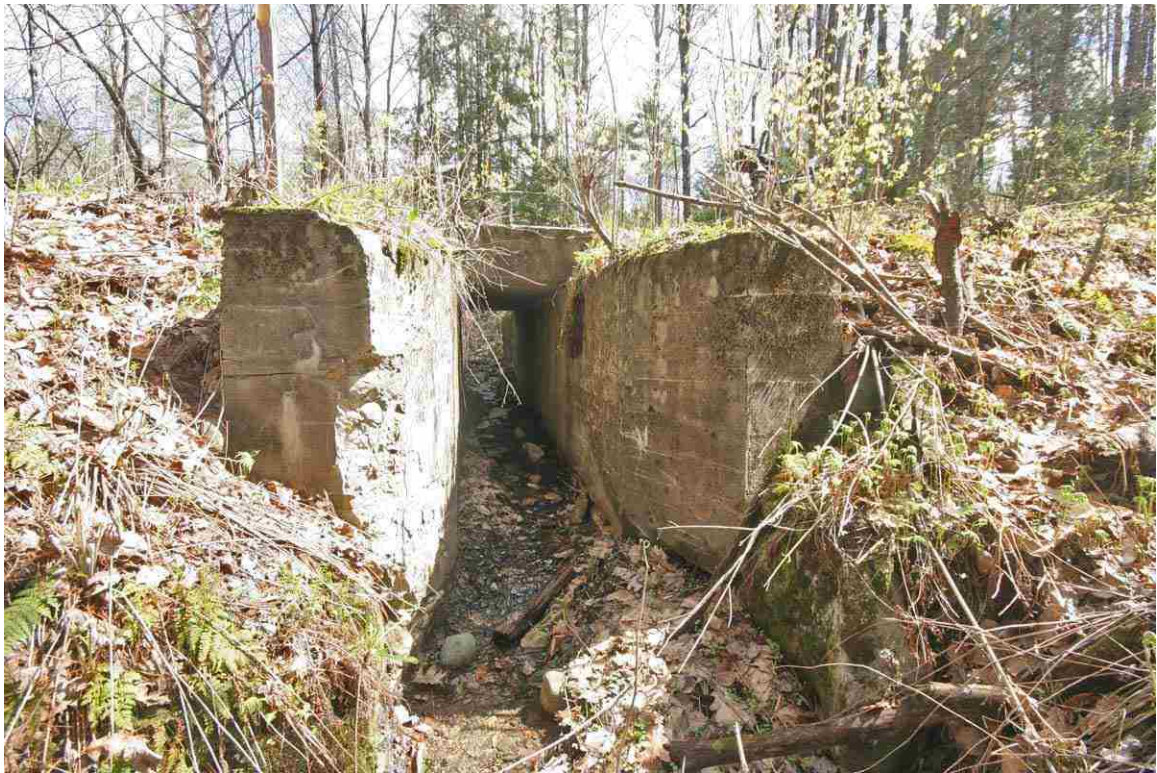
Photo # 17 description: Bridge No. 95.75 (mp), Bath. Concrete slab on concrete walls. 4-0 span. 1930. Outlet. (1 of 2).

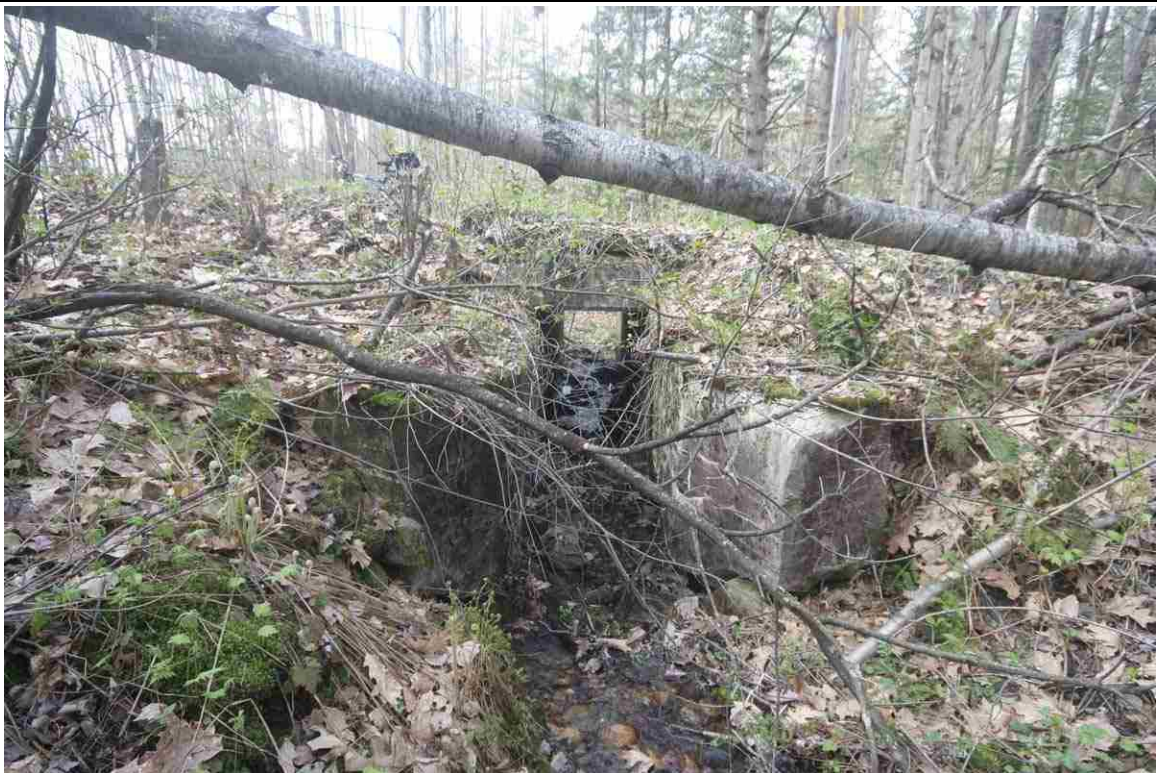
Photo # 18 description: Bridge No. 95.75 (mp), Bath. Concrete slab on concrete walls. 4-0 span. Inlet. 1930. (2 of 2).

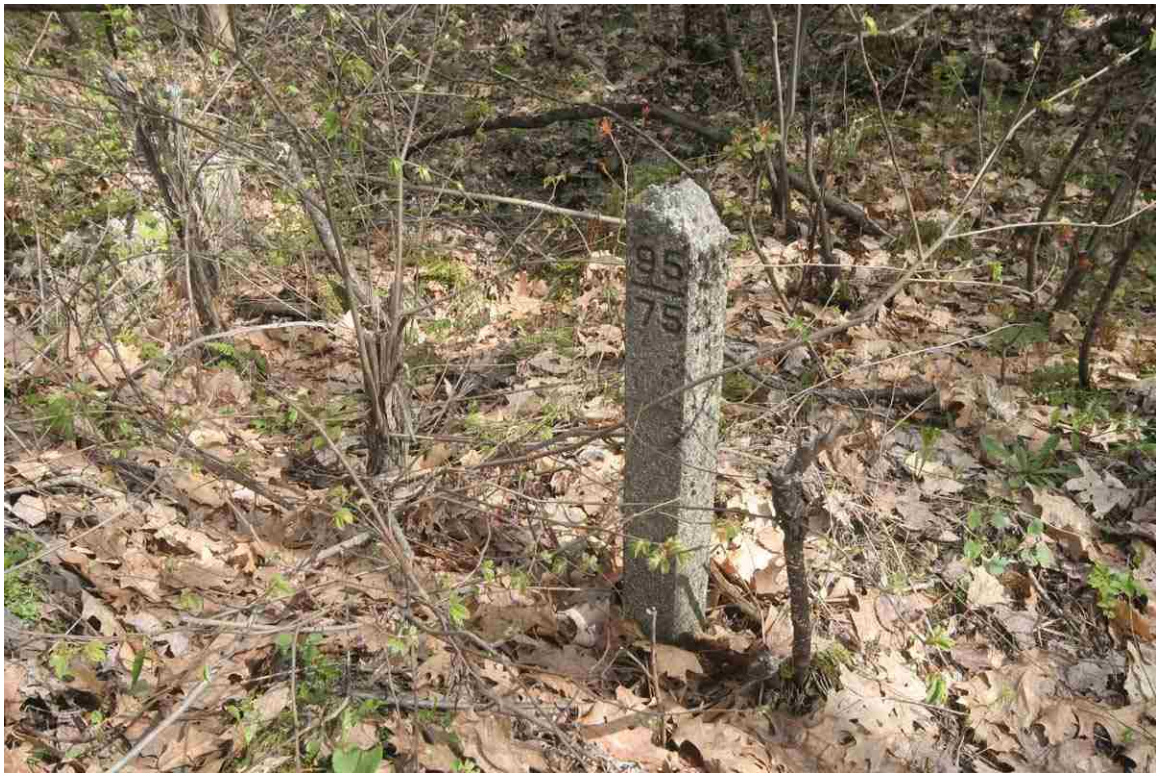
Photo # 19 description: Mile Marker 95.75, Bath. Concrete. nd.

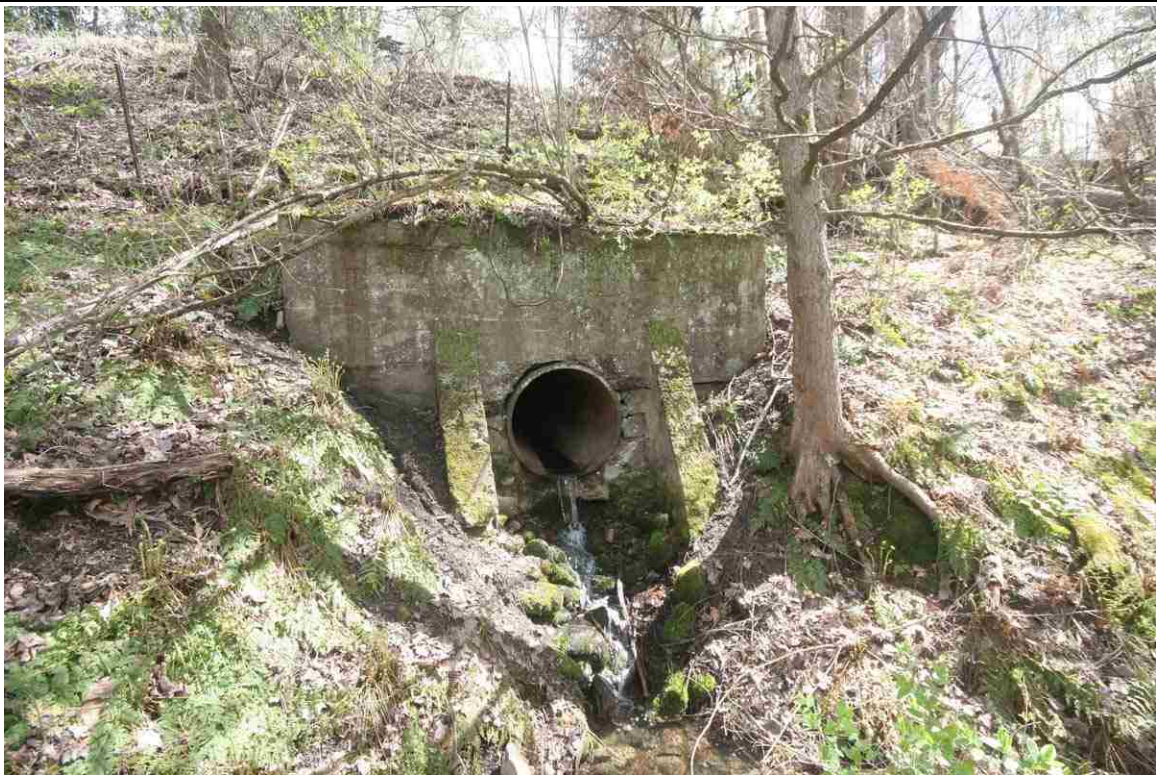
Photo # 20 description: Culvert No. 96.21, Bath. Cast iron pipe, 18", concrete headwalls. Outlet. 1924.

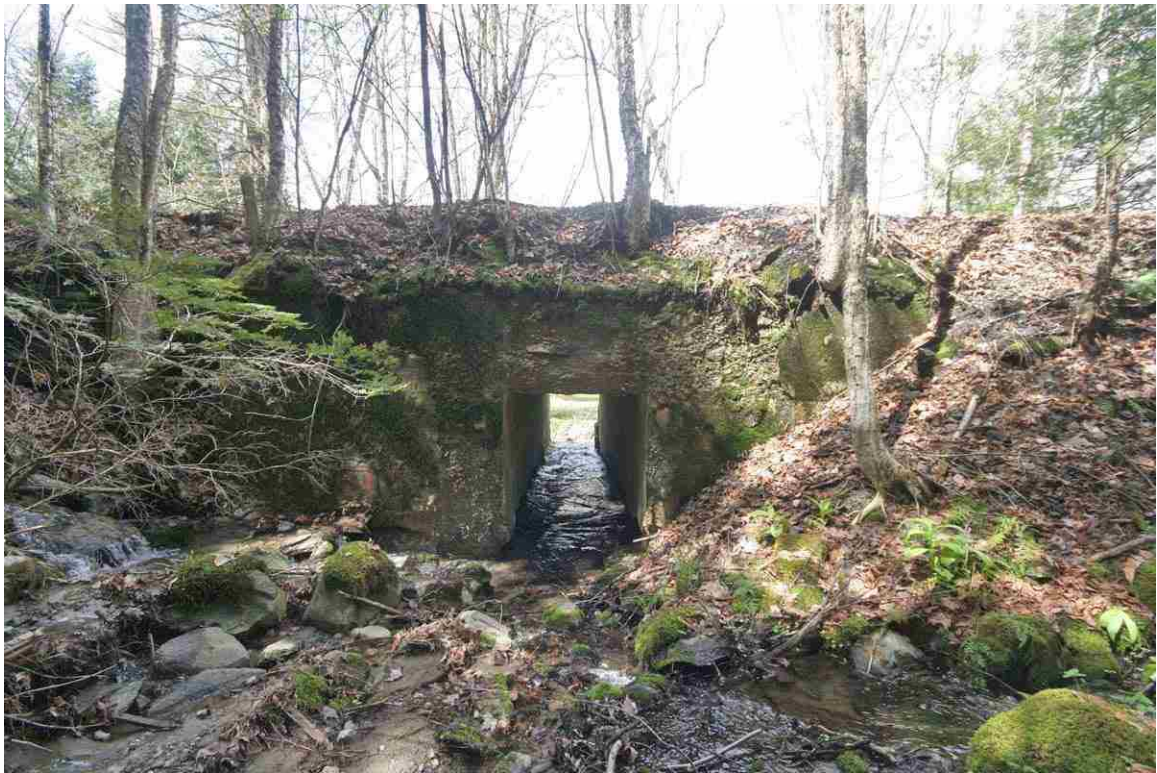
Photo # 21 description: Culvert 96.27, Bath. Railtop with concrete cast in place on stone walls, 4-0 x 5-0. Inlet. 1921. (1 of 2).

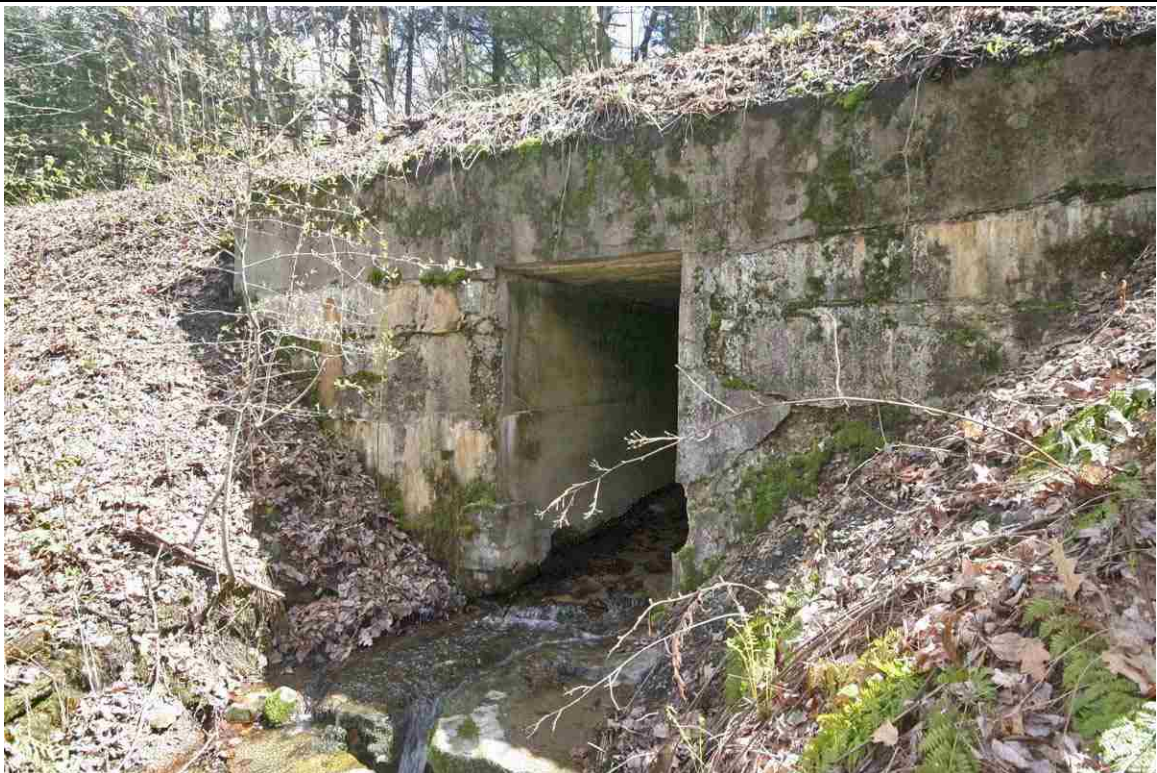
Photo # 22 description: Culvert 96.27, Bath. Railtop. Outlet. 1921. (2 of 2).

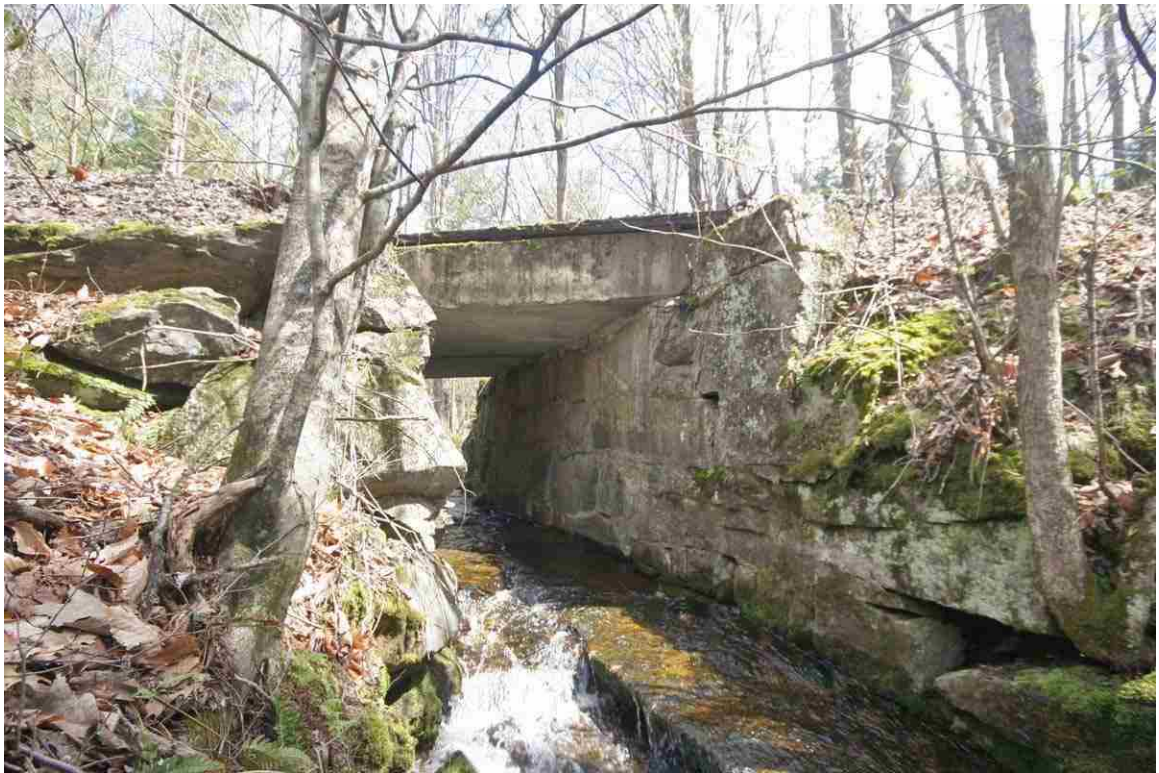
Photo # 23 description: Bridge No. 96.52, Bath. Precast concrete slab on stone walls. 9-0 span. 1929. Outlet.
(1 of 2).

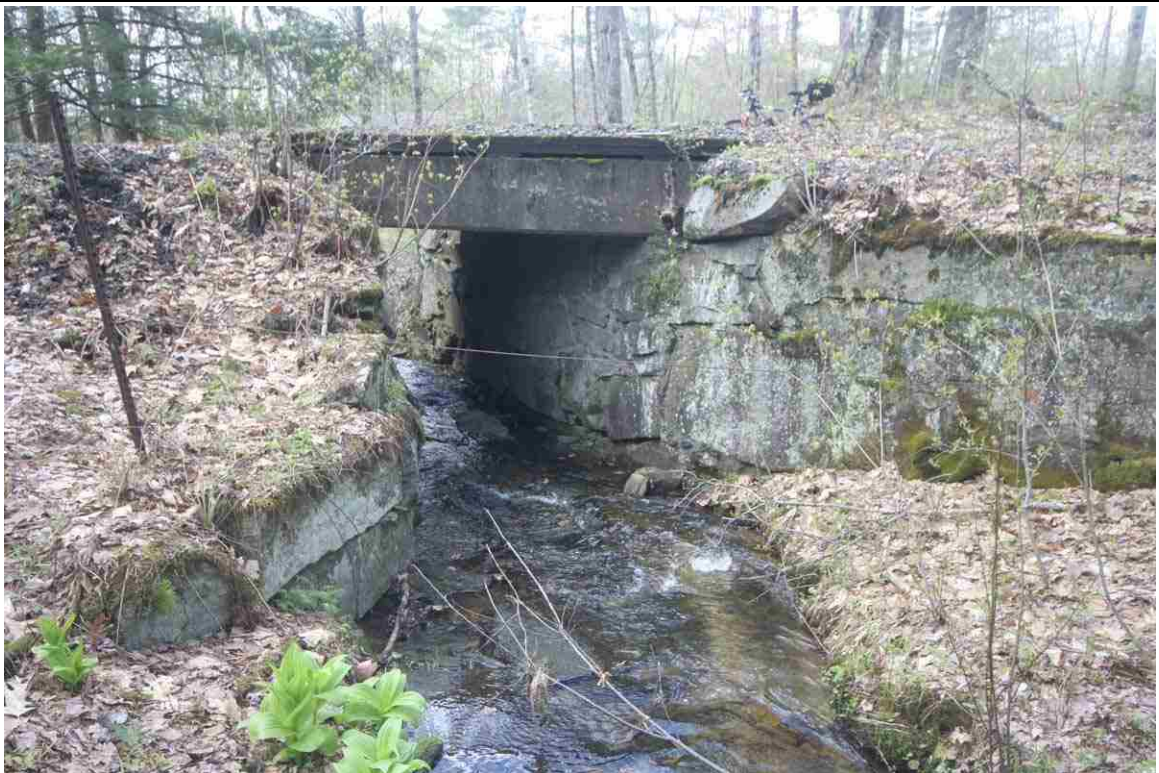
Photo # 24 description: Bridge No. 96.52, Bath. Precast concrete slab on stone walls. 9-0 span. 1929. Inlet.
(2 of 2).

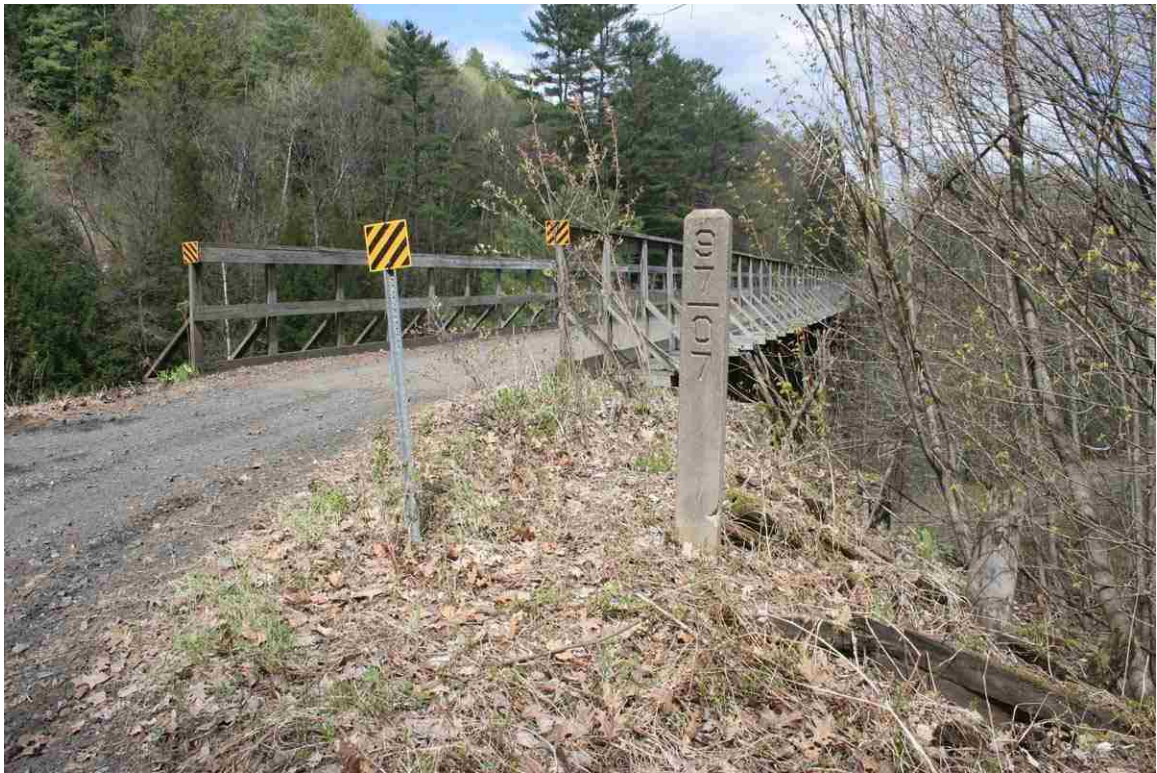
Photo # 25 description: Bridge 97.07 over Ammonoosuc R., & concrete mile marker, Bath. Deck plate girder, 3 span, 348'. 1911. West approach. (1 of 3).

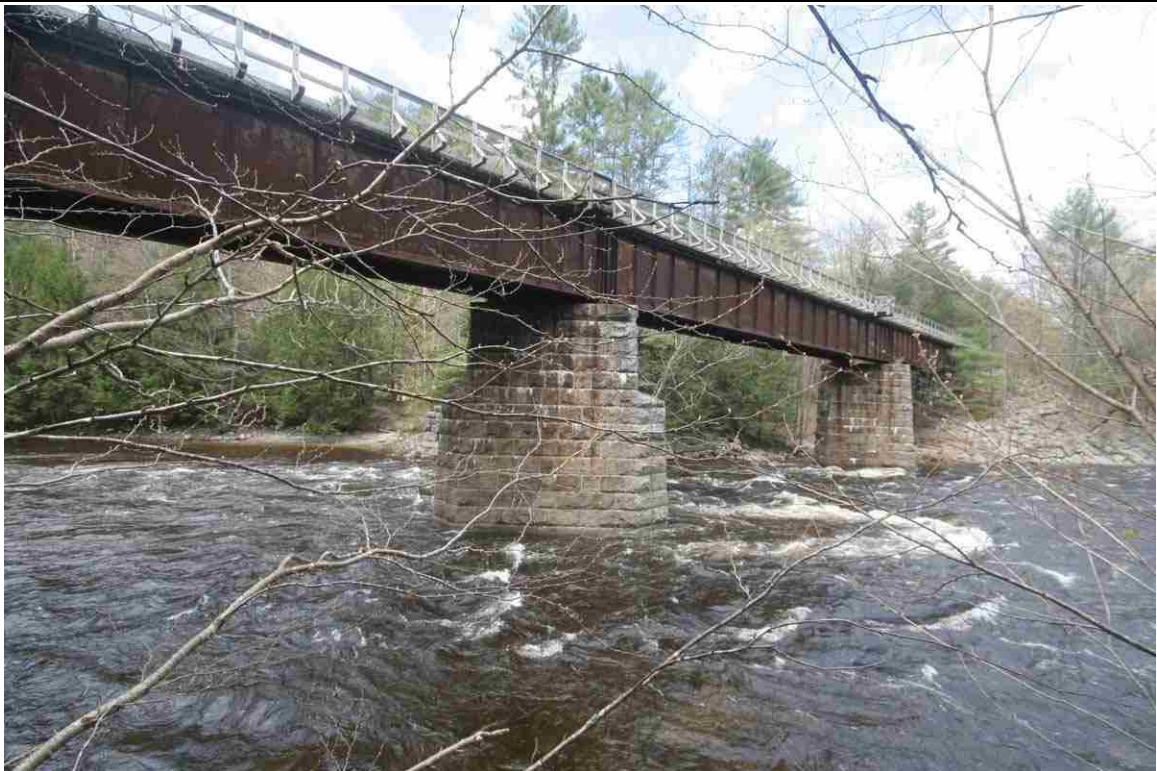
Photo # 26 description: Bridge 97.07 over Ammonoosuc R., & concrete mile marker, Bath. Deck plate girder, 3 span, 348'. 1911. East upstream side. (2 of 3).

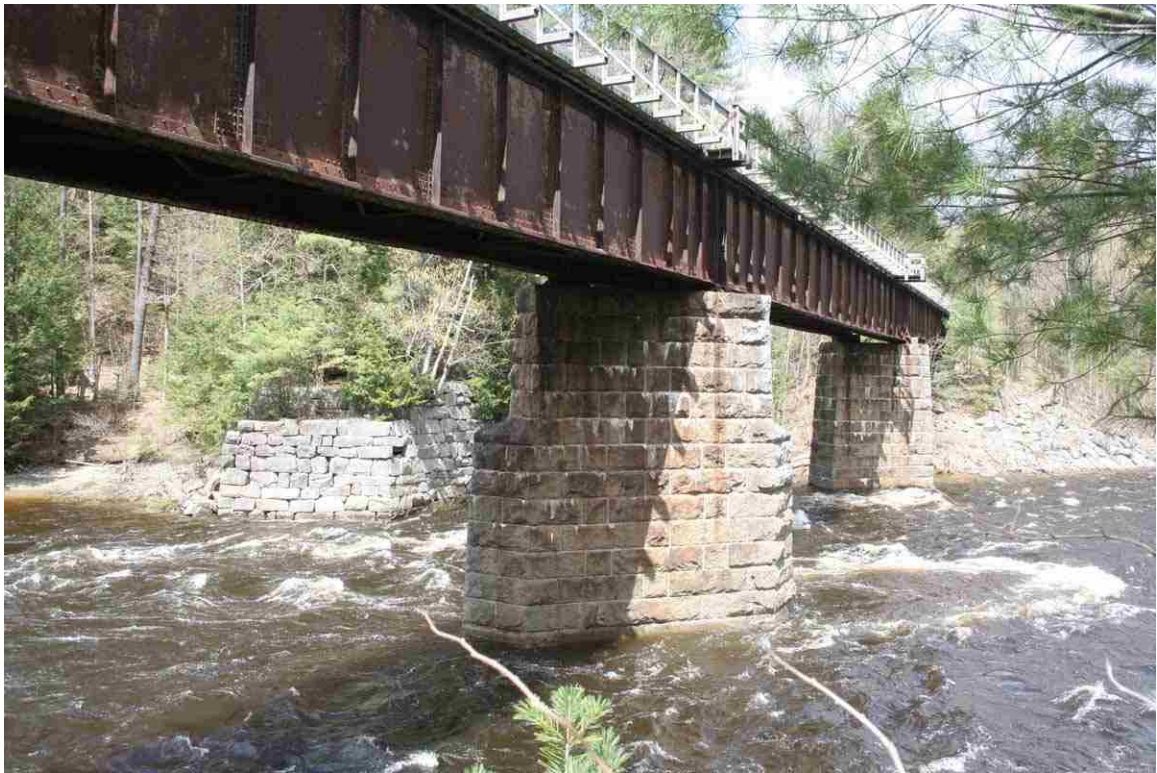
Photo # 27 description: Bridge 97.07 over Ammonoosuc R., & concrete mile marker, Bath. Deck plate girder, 3 span, 348'. 1911. Pier detail; stone abutment of earlier bridge at left. (3 of 3).

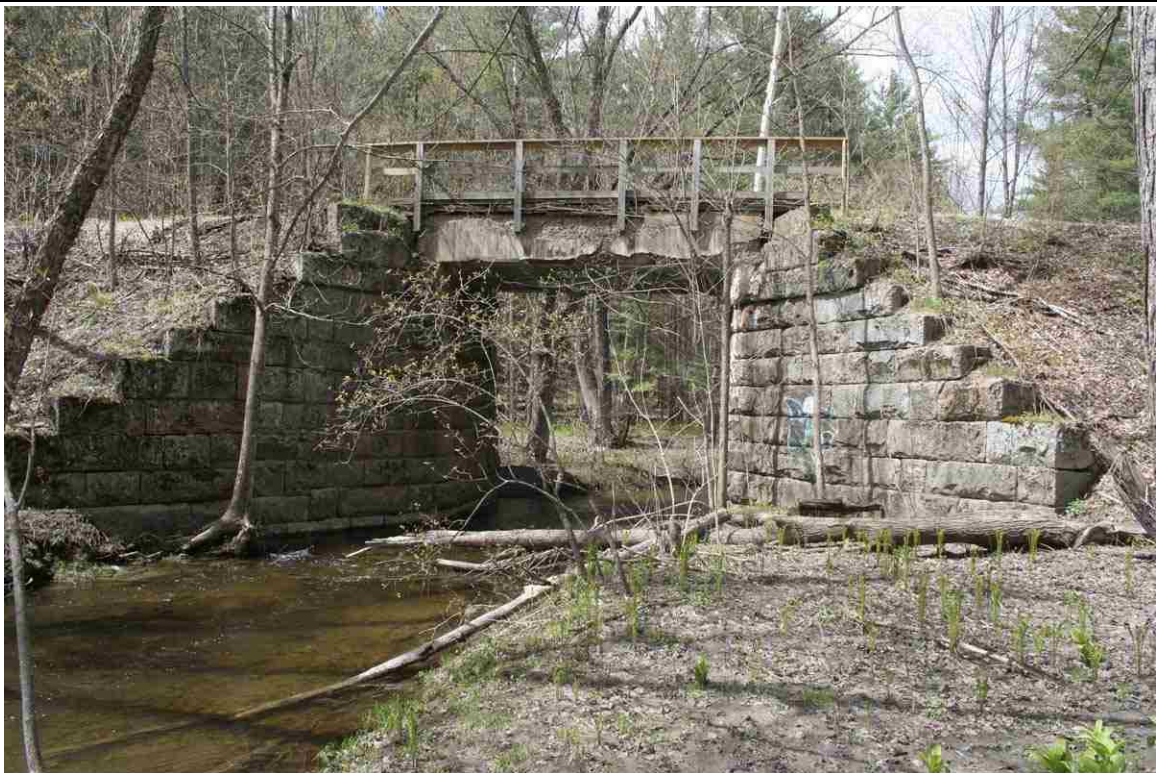
Photo # 28 description: Bridge No. 97.40 over Childs Brook, Bath. Precast concrete slab on stone abutments. 20' span. 1930. South downstream side. (1 of 3).
