**TABLE OF OBSERVED FEATURES
 SURVEY AREA 1
 ORIGINAL MAIN LINE
 CONNECTICUT RIVER BRIDGE, WOODSVILLE TO
 LITTLETON
 (PHOTO KEYS FOLLOW TABLES)**

**PHOTOGRAPHS SURVEY AREA 1
ORIGINAL MAIN LINE
CONNECTICUT RIVER BRIDGE, WOODSVILLE TO
LITTLETON**

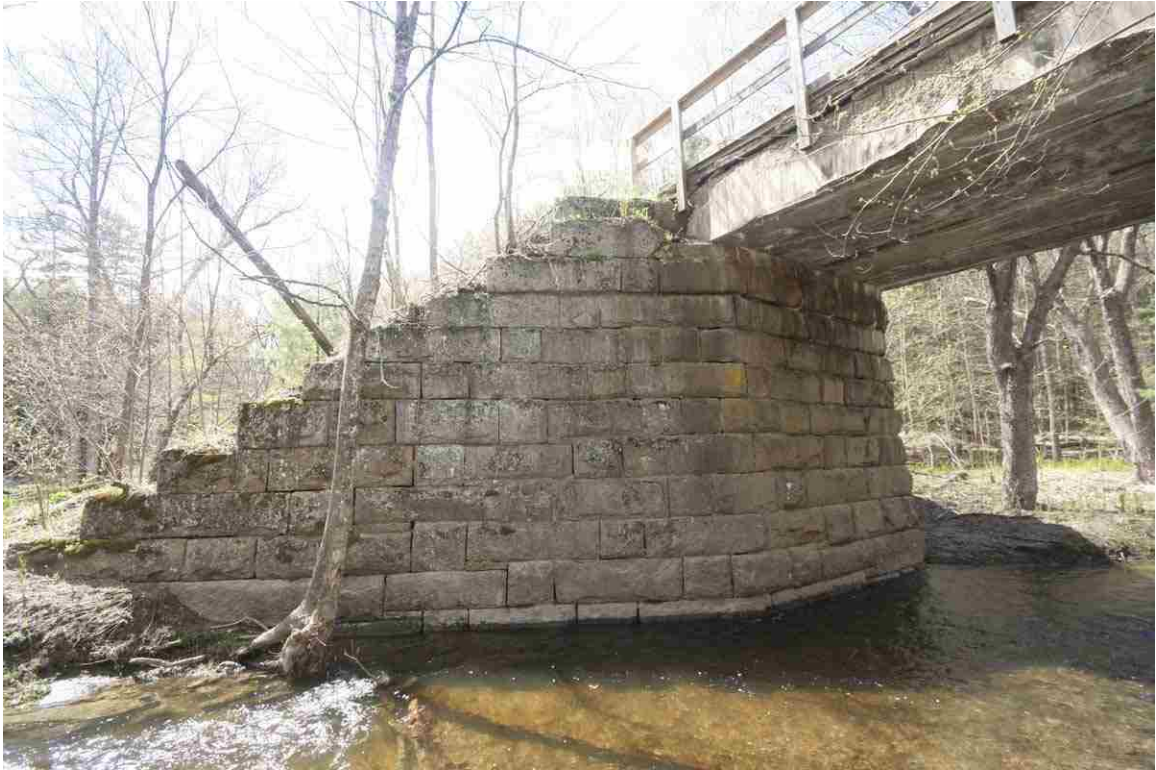
Photo # 29 description: Bridge No. 97.40 over Childs Brook, Bath. Precast concrete slab on stone abutments. 20' span. 1930. West abutment. (1 of 3).

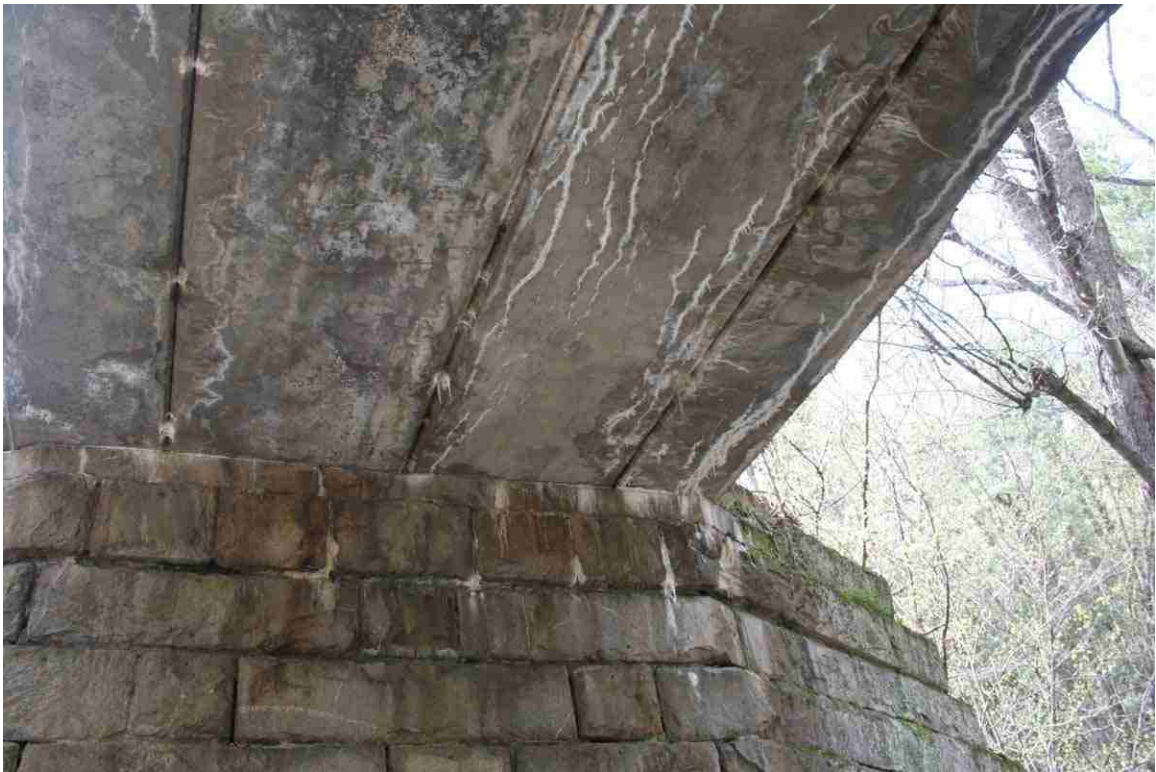
Photo # 30 description: Bridge No. 97.40 over Childs Brook, Bath. Precast concrete slab on stone abutments. 20' span. 1930. Underside showing concrete seat and separate precast slab members. (3 of 3).

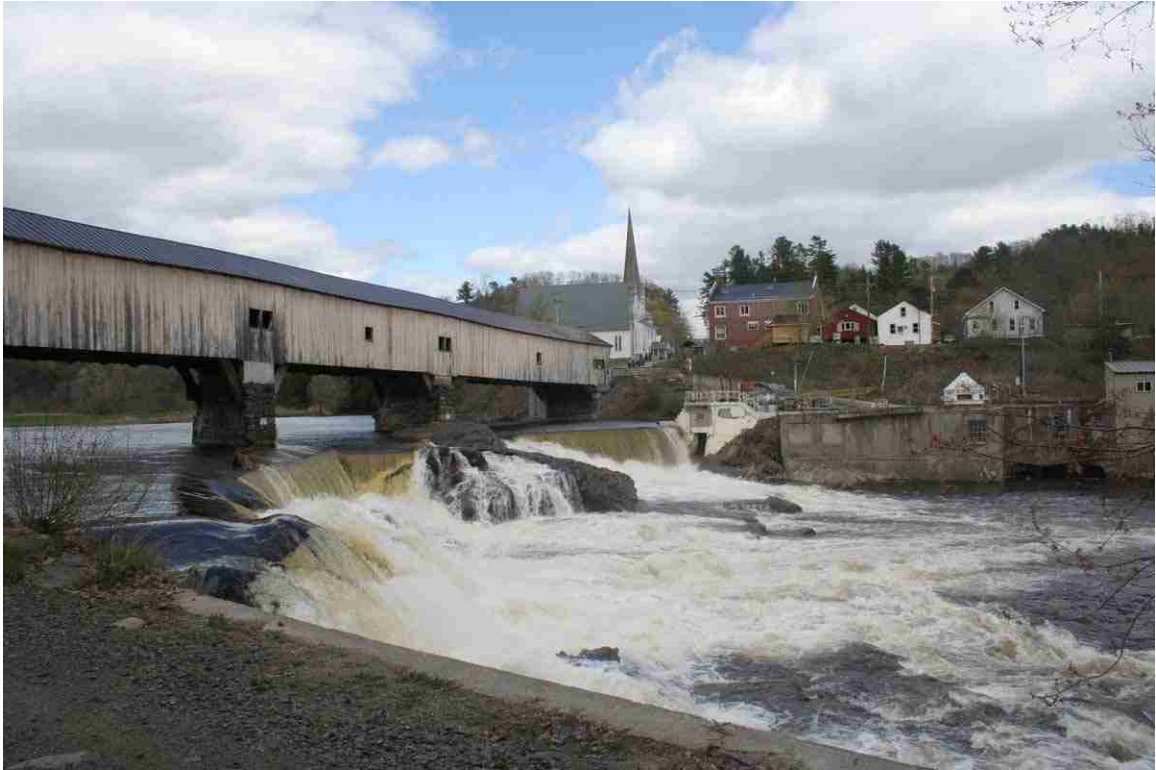
Photo # 31 description: Railbed in foreground at Bath Village. Concrete retaining wall, evidently built by railroad, supports railbed along edge of Ammonoosuc R. mp 98.33. nd.

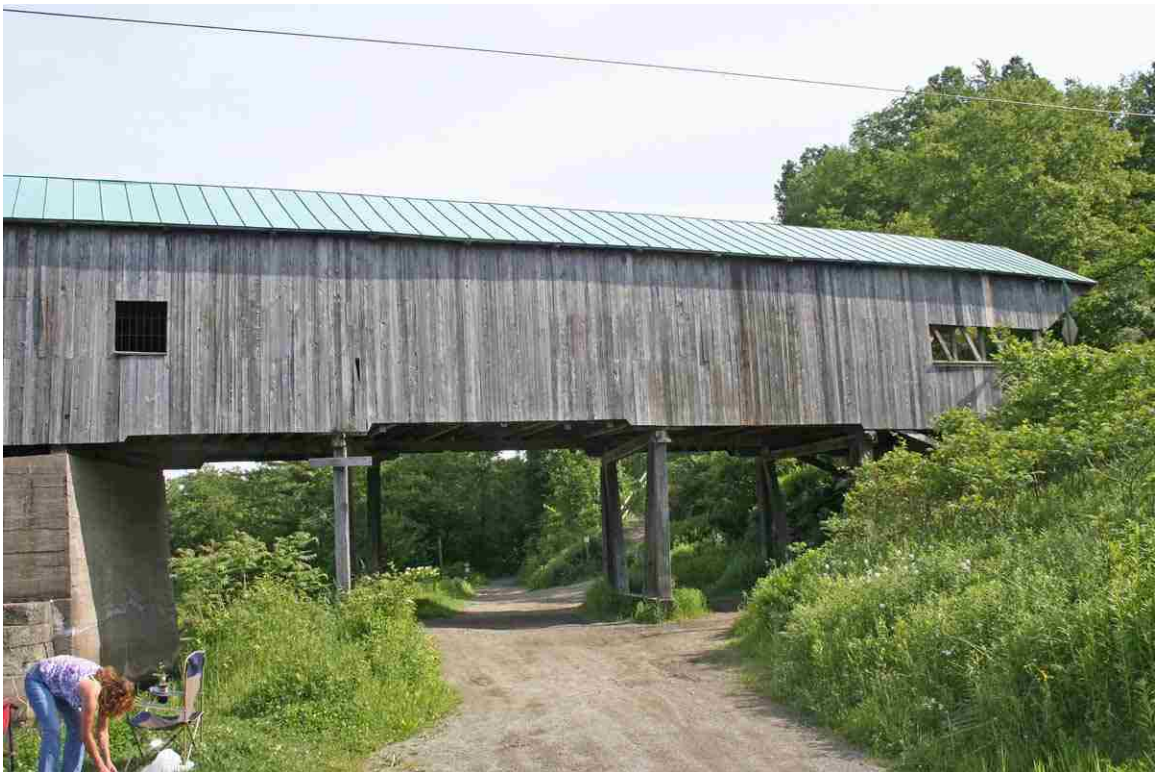
Photo # 32 description: Railbed passing under Bath Village Covered Bridge, showing timber bents added by railroad to lend additional structural support. mp 98.33. nd.

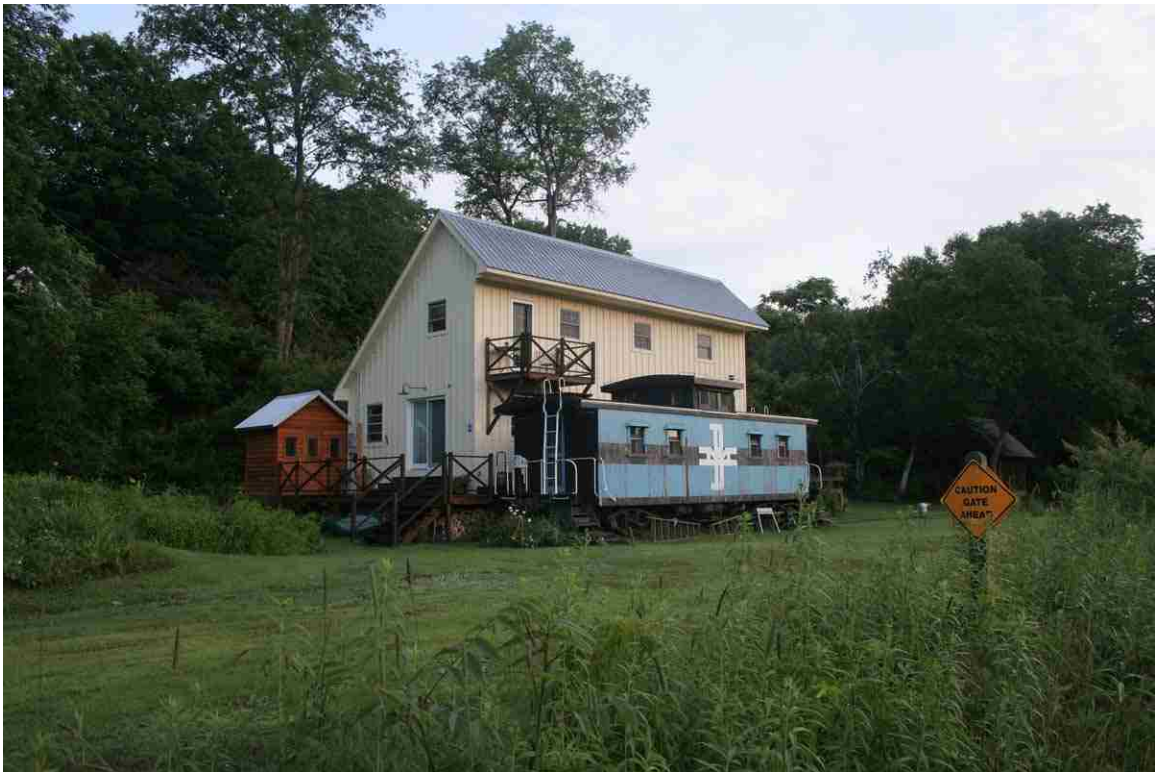
Photo # 34 description: Bath Station location. Nature of existing building(s) unknown. B&M caboose parked on station siding. mp 98.34. nd.

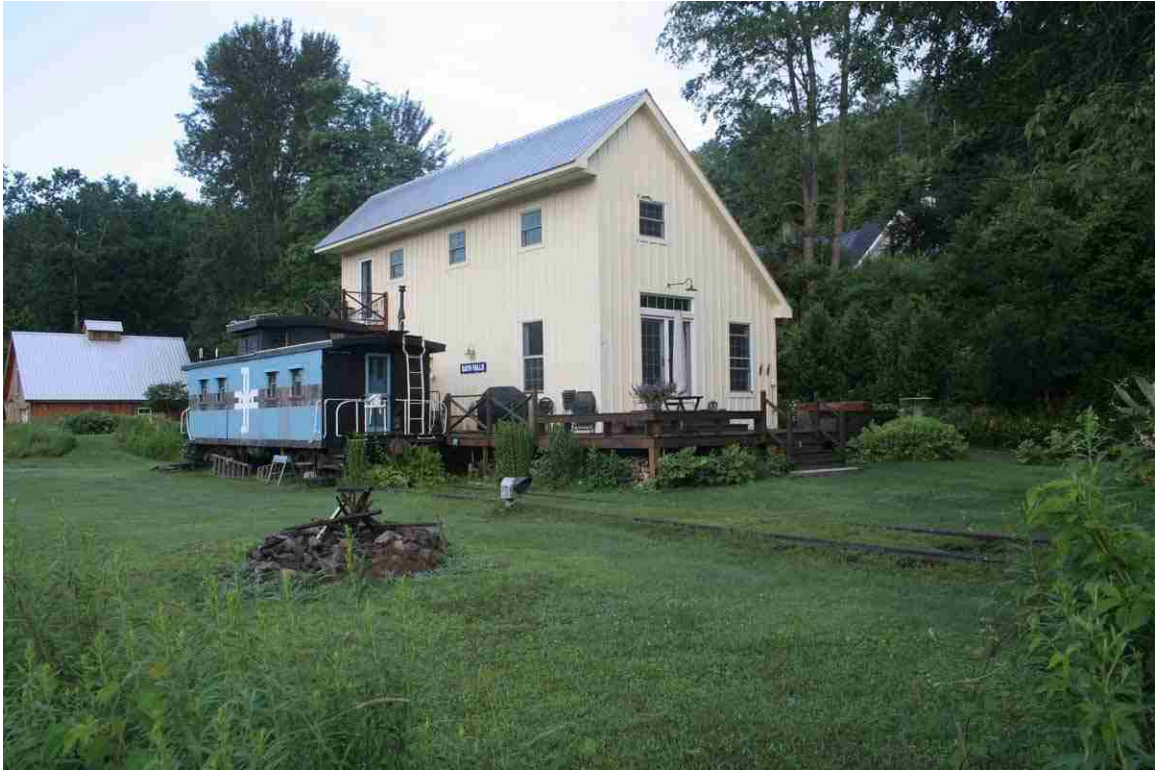
Photo # 35 description: Bath Station location. Nature of existing building(s) unknown. B&M caboose parked on station siding. mp 98.34. nd.

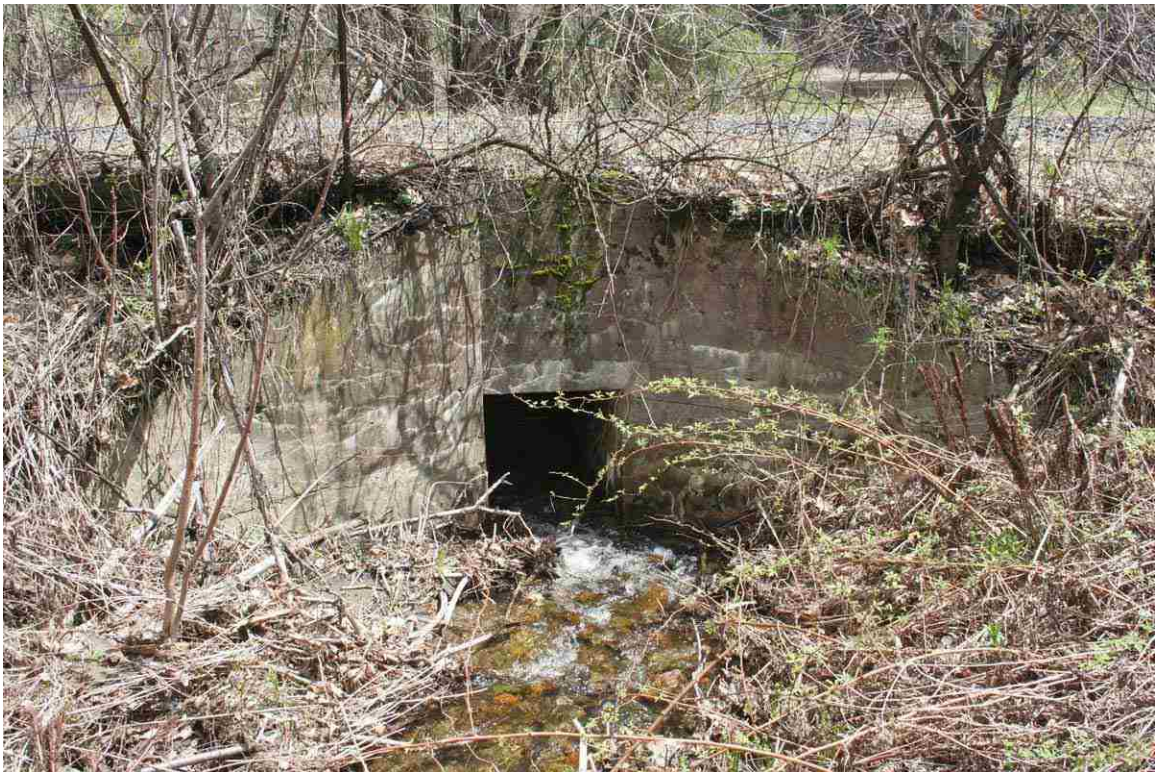
Photo # 36 description: Culvert No. 98.59, Bath. Concrete slab with concrete encased stone side and wing walls, (reconstructed stone box). Outlet. nd. (1 of 2).

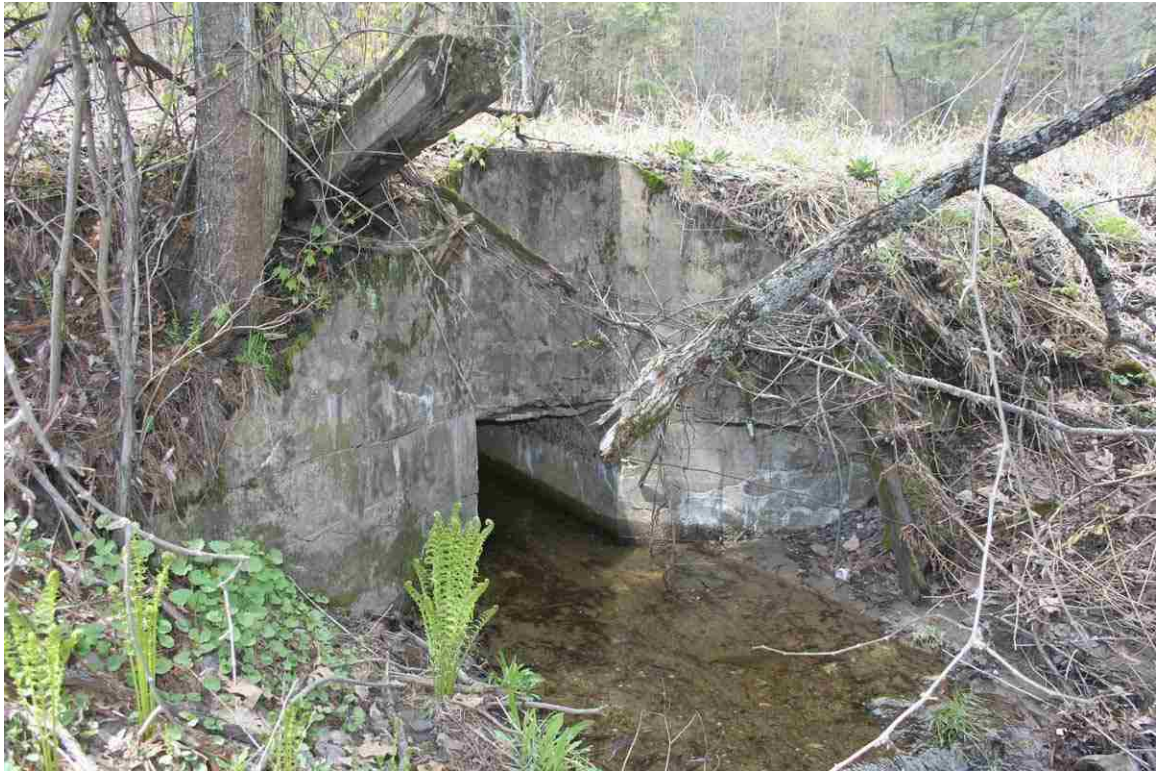
Photo # 37 description: Culvert No. 98.59, Bath. Concrete slab with concrete encased stone side and wing walls, (reconstructed stone box). Inlet. nd. (2 of 2)

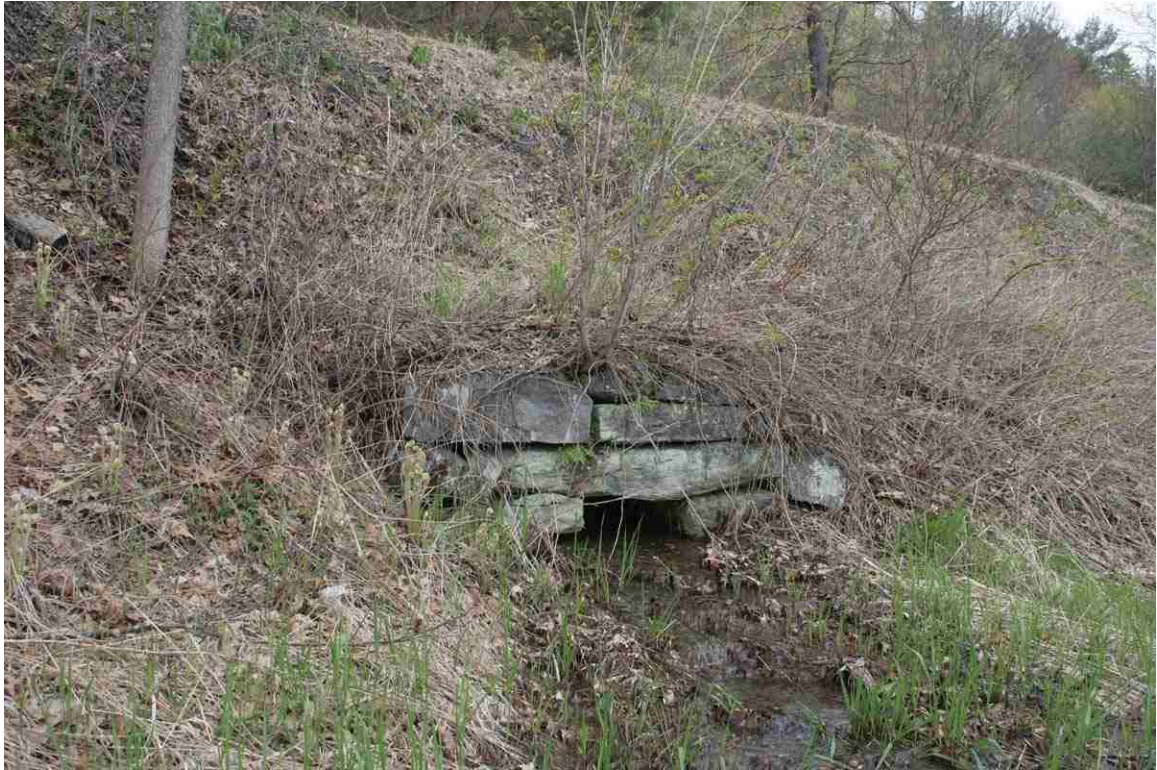
Photo # 39 description: Culvert No. 98.97, Bath. Stone box, 3-0. nd.

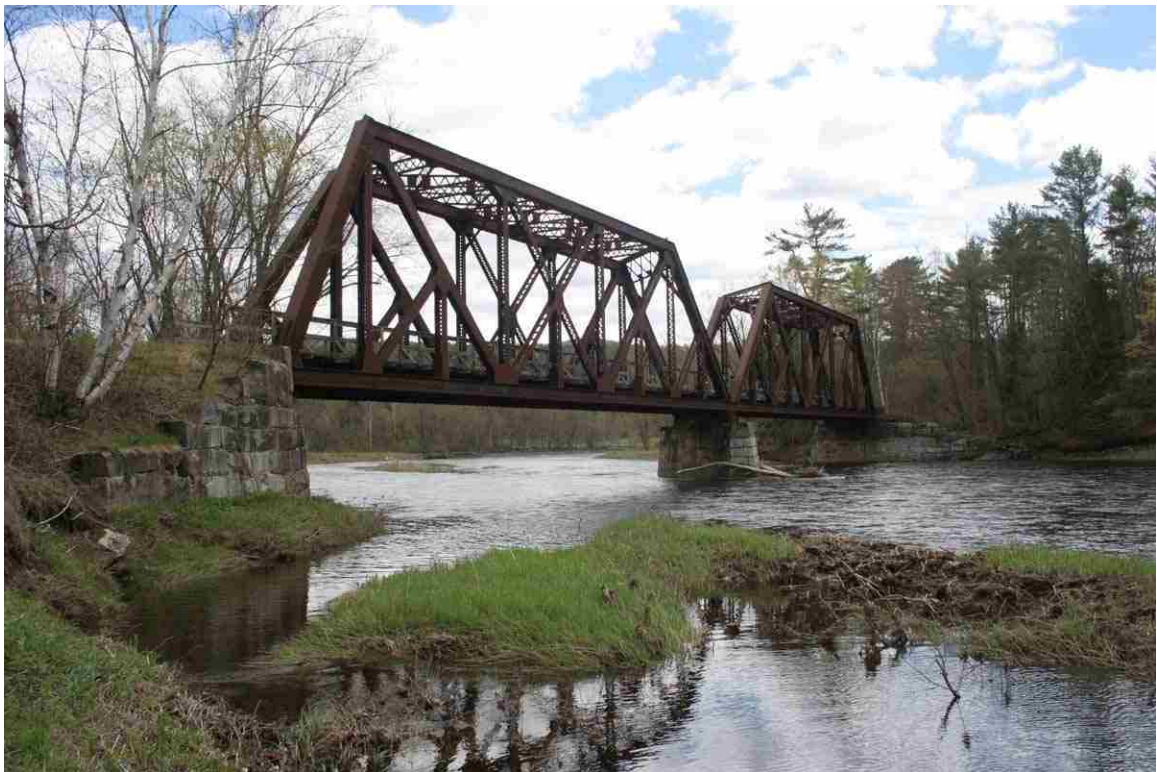
Photo # 40 description: Bridge No. 100.23 over Ammonoosuc R., Bath. Riveted 2-span thru-truss, 265'. 1911.

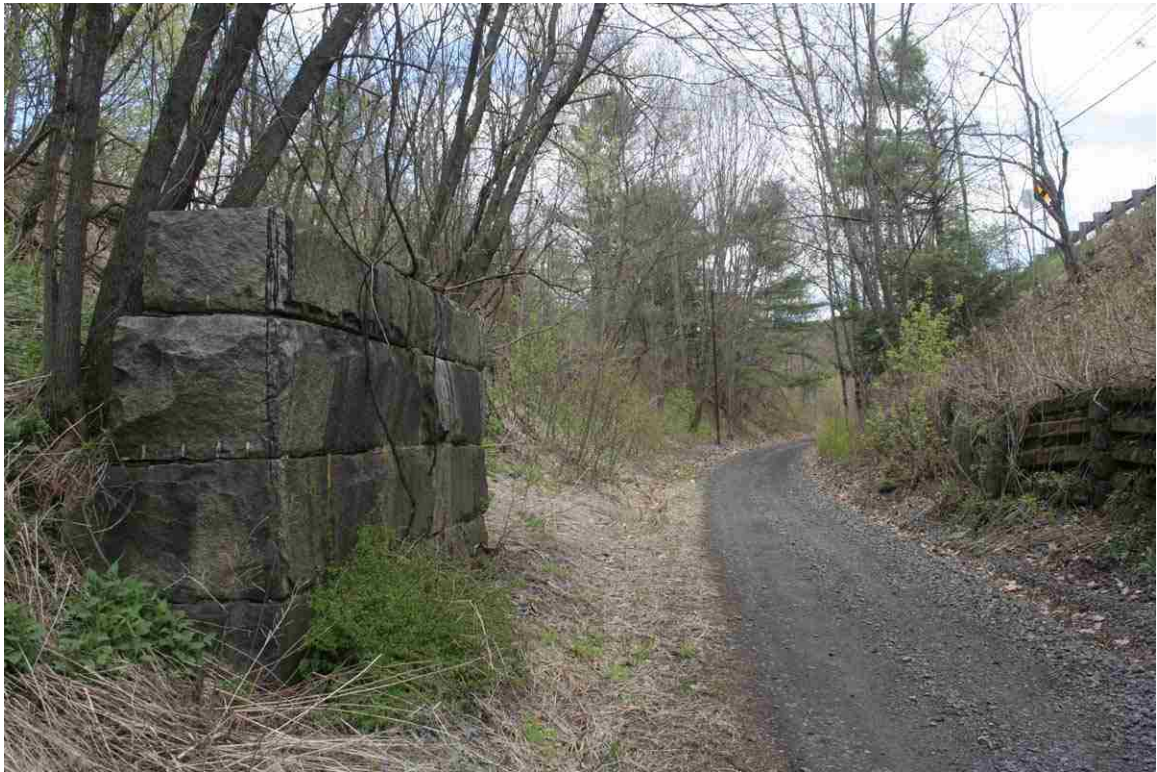
Photo # 43 description: Bridge 101.52, Bath. Detail of stonework, clearly by B&M. (3 of 3).

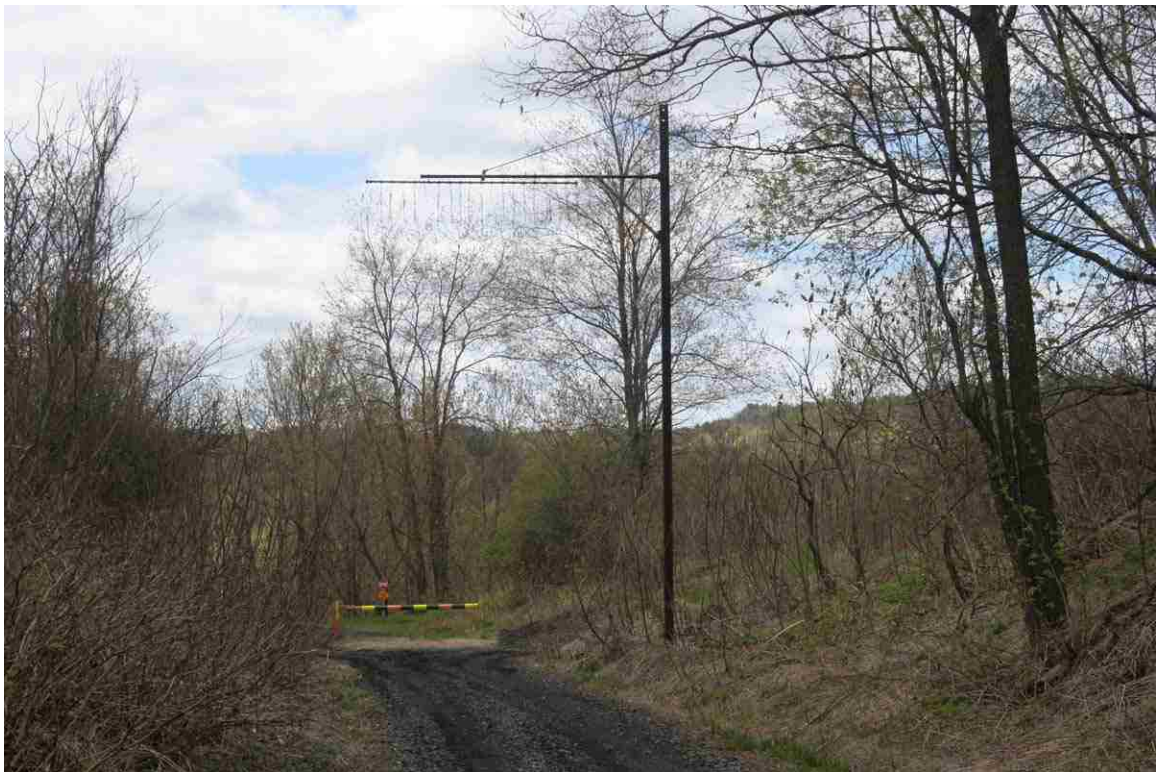
Photo # 44 description: Tell Tale, Bath. Steel poles with hanging chains to indicate clearance of overhead bridge 101.52 remain about 400 feet east and west of bridge crossing. West pole shown.

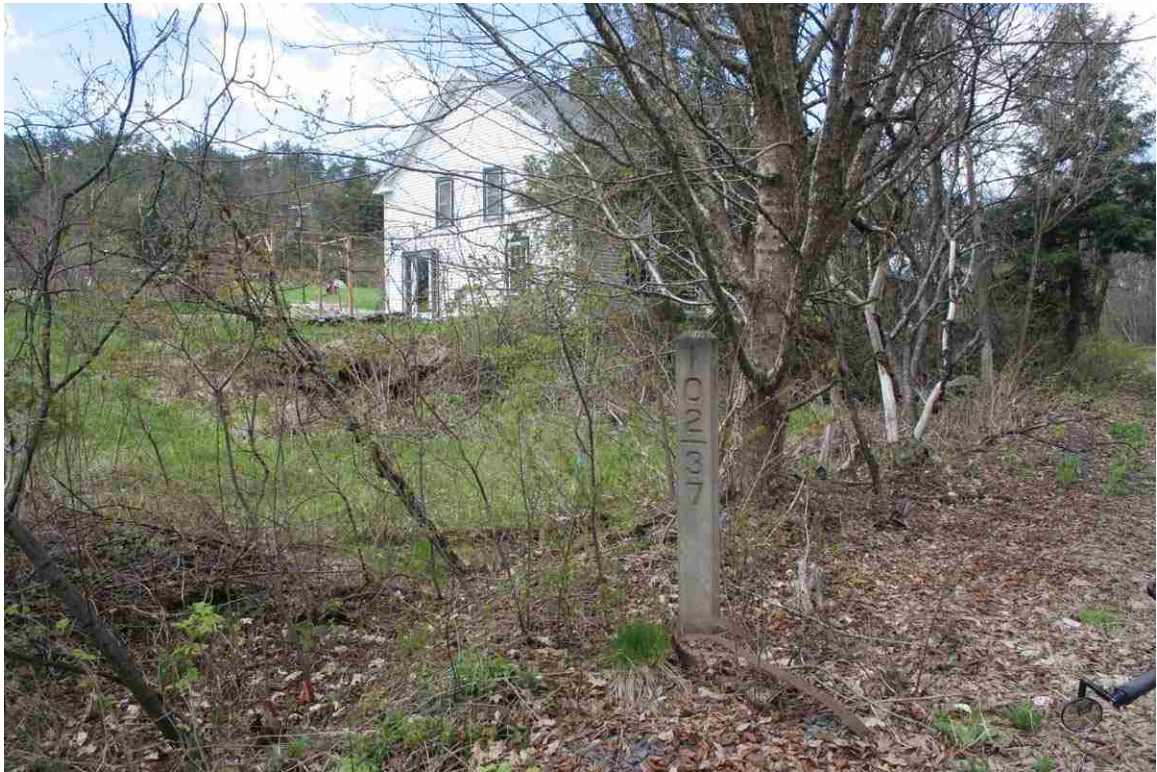
Photo # 45 description: Mile Marker 102.37, Landaff. Concrete. nd. Located at bridge, next photo.

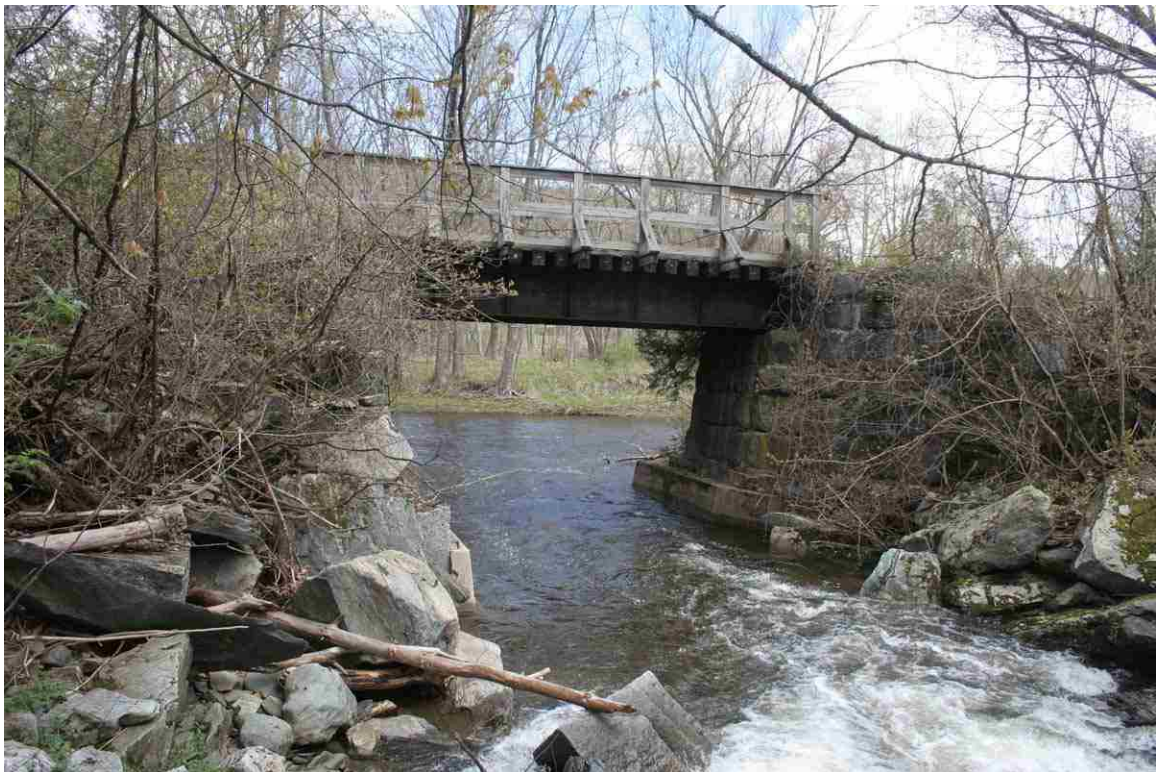
Photo # 46 description: Bridge 102.37 over Mill Brook, Landaff. Steel deck plate girder, 22'-7" span. 1914.

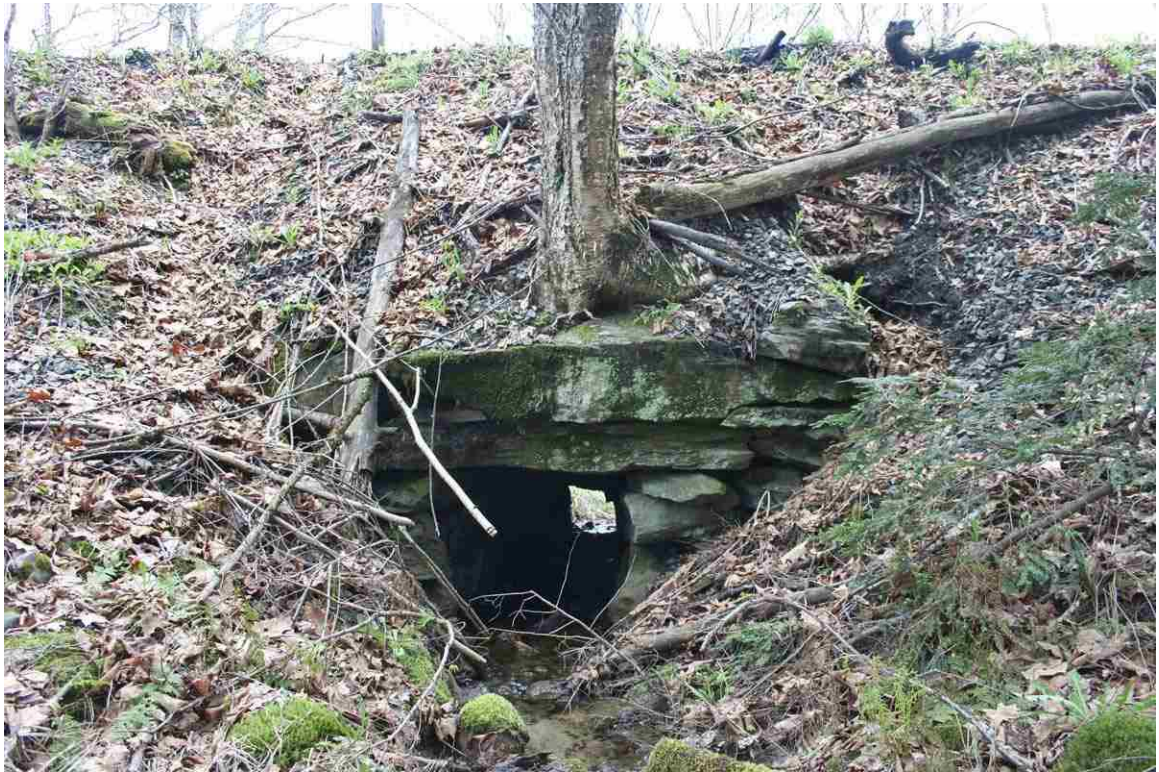
Photo # 47 description: Culvert No. 102.69, Landaff. Stone box, 3-6. nd. Inlet. (1 of 2).

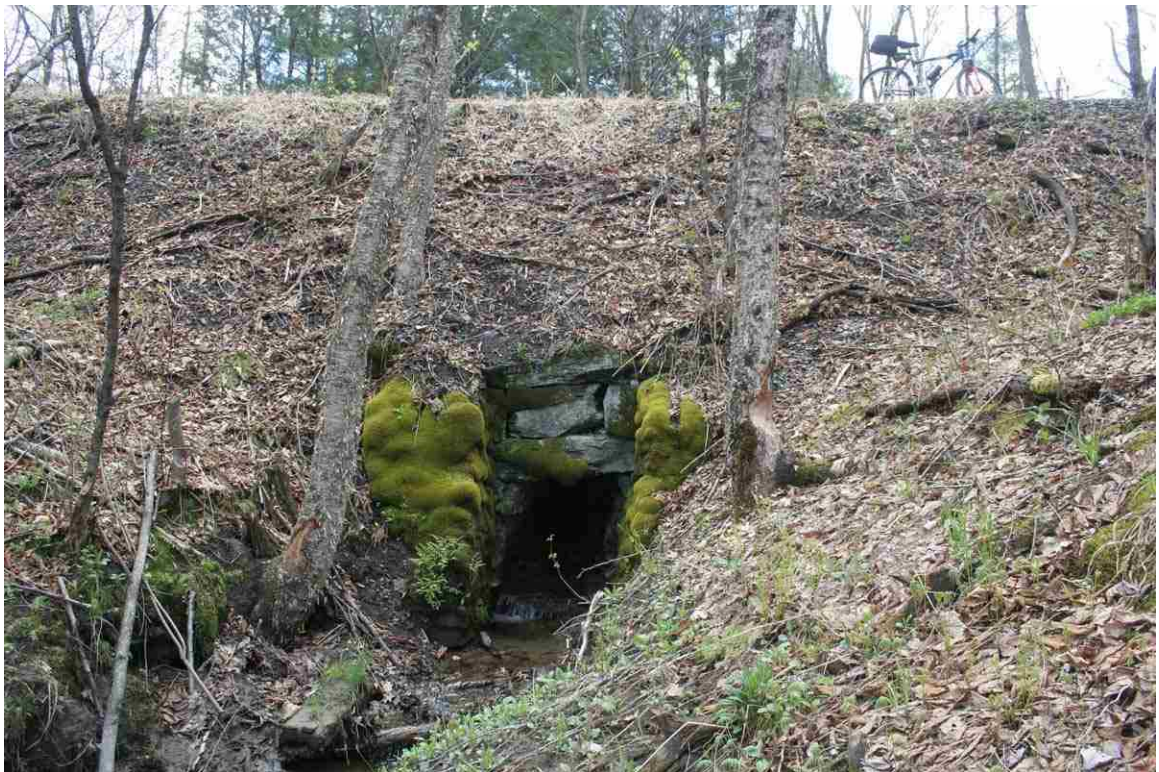
Photo # 48 description: Culvert No. 102.69, Landaff. Stone box, 3-6. nd. Deeply buried (14'-6"). Outlet. (2 of 2).

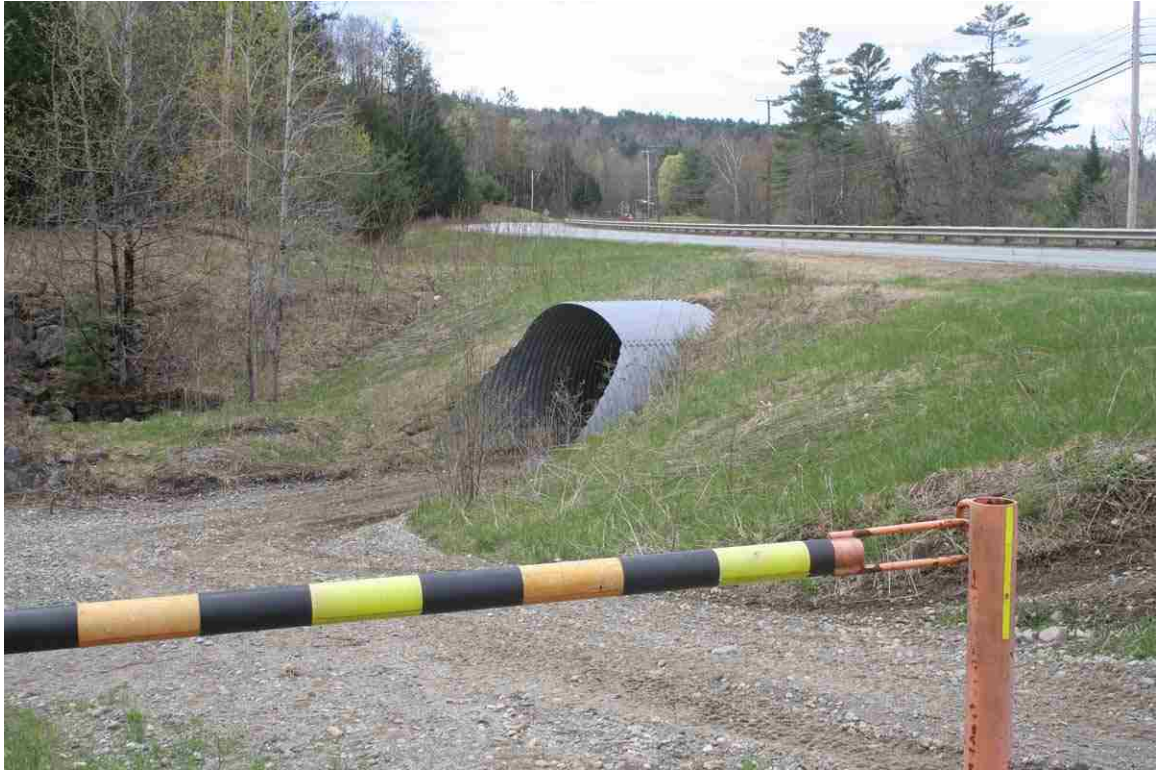
Photo # 49 description: Trail Tunnel under US302/NH10. Arched metal plate culvert. NHDOT bridge # Landaff 077/176.

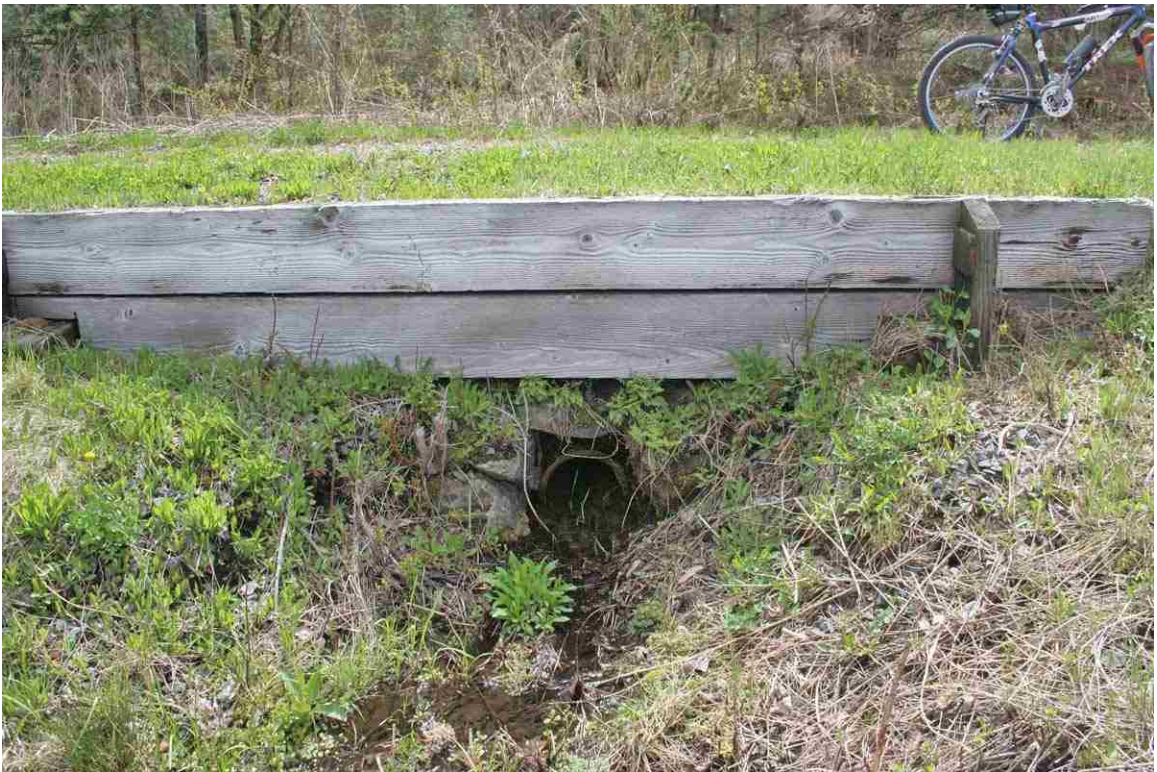
Photo # 50 description: Culvert No. 103.05, Landaff. Vitreous pipe, 1-0. nd. Outlet.

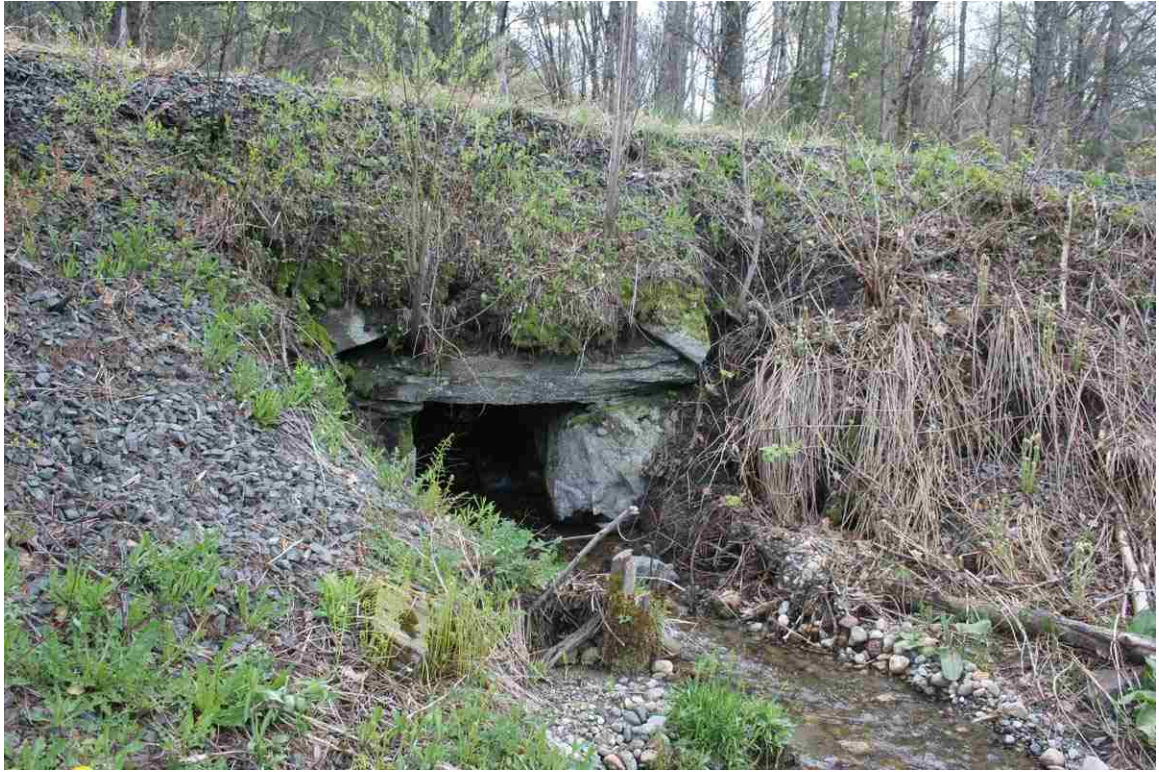
Photo # 51 description: Culvert No. 103.08, Landaff. Stone box, 2-6, fieldstone. nd. Outlet. (1 of 2)

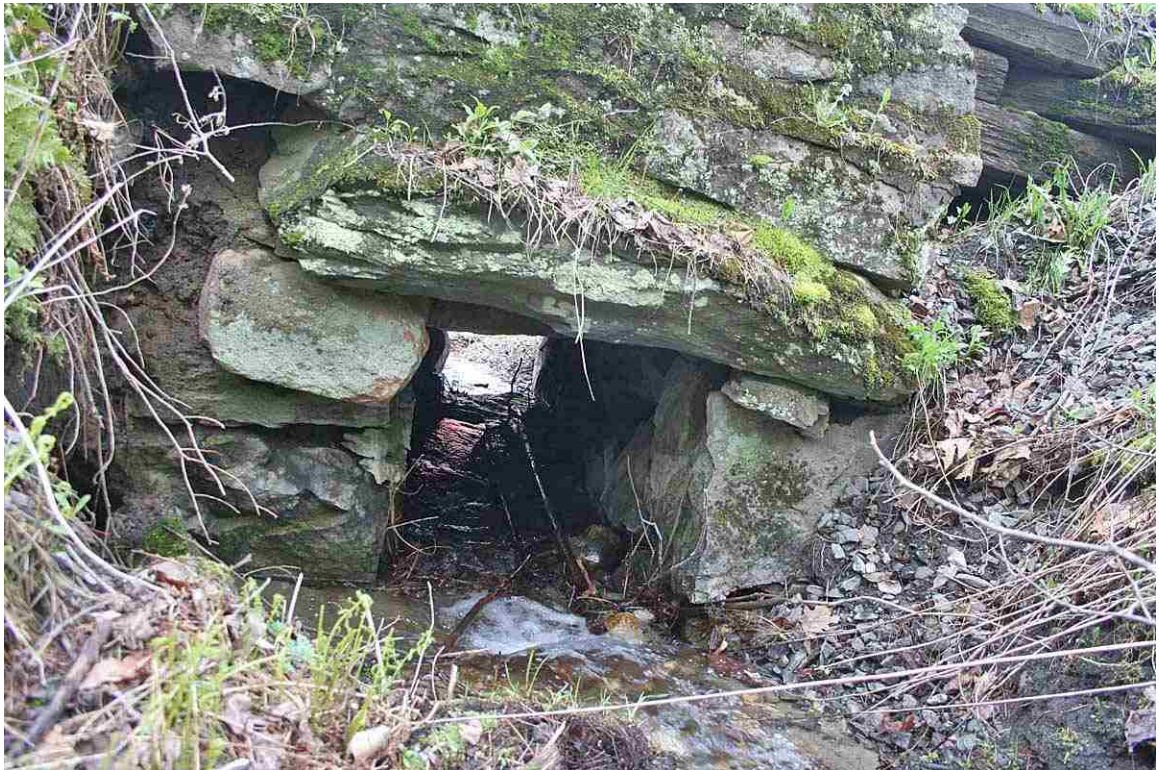
Photo # 52 description: Culvert No. 103.08, Landaff. Stone box, 2-6, fieldstone. nd. Inlet. Stonework detail. (2 of 2).

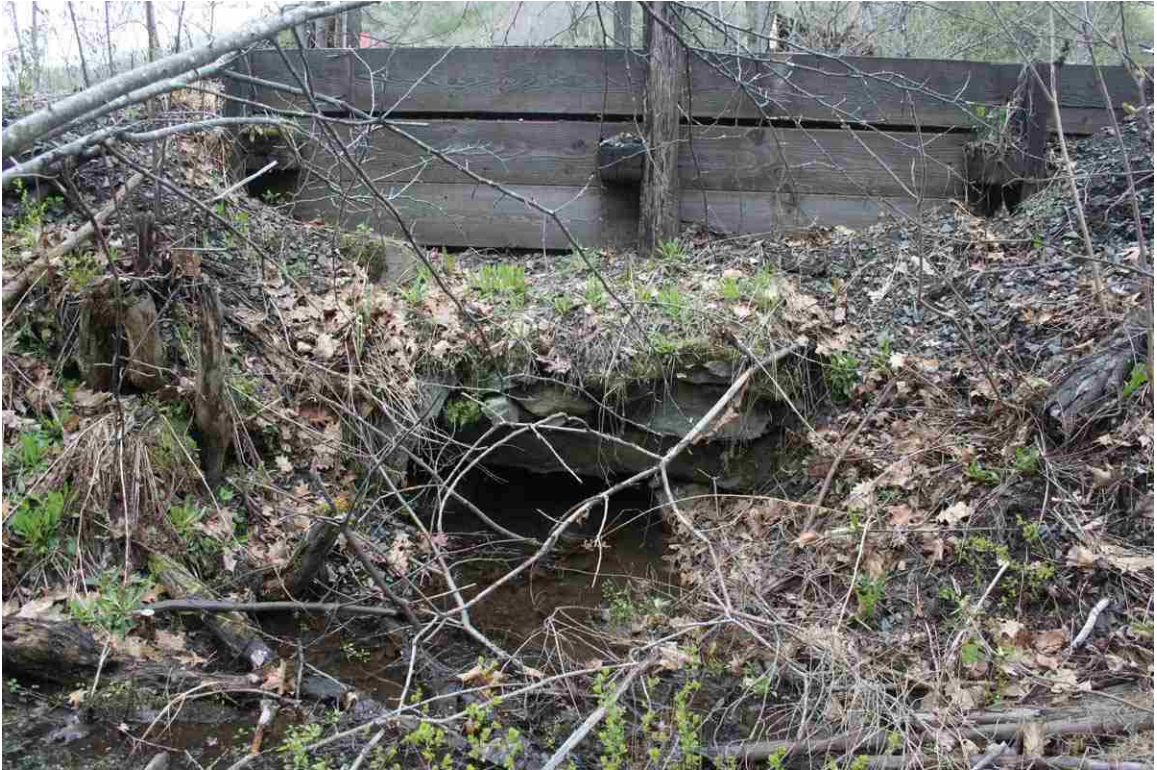
Photo # 53 description: Culvert No. 103.12, Landaff. Stone box, 3-0, fieldstone. nd. Outlet.

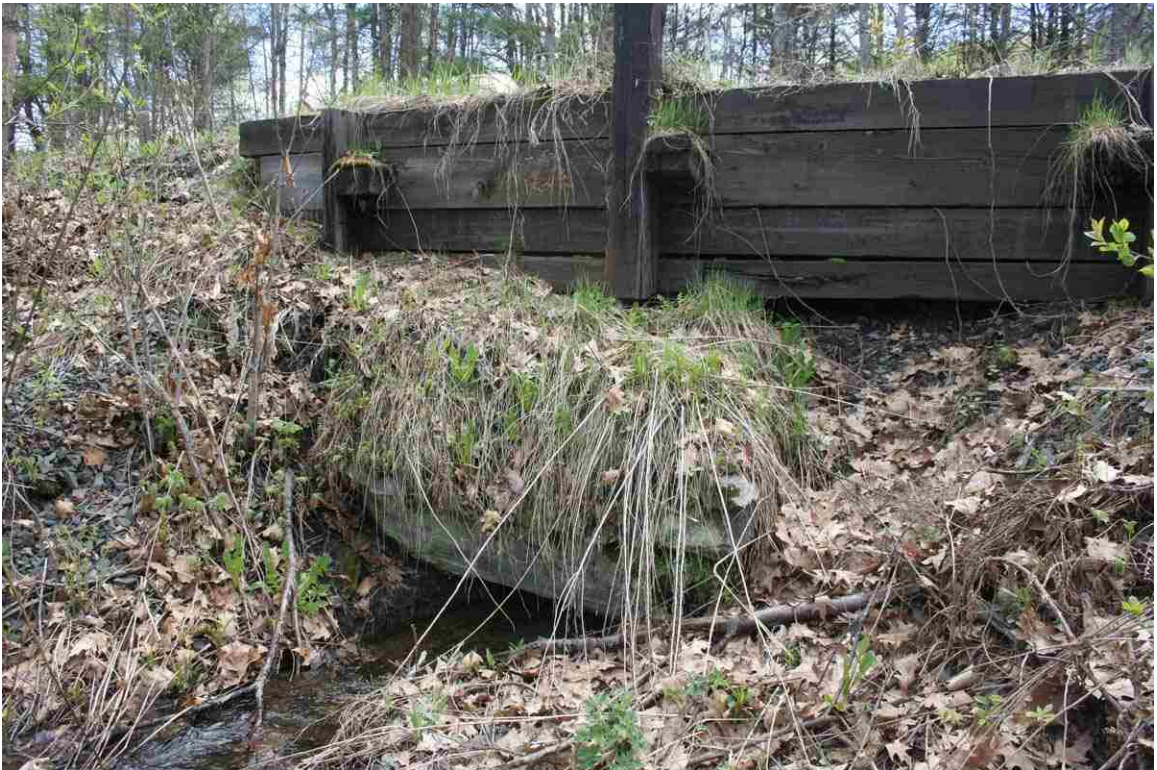
Photo # 54 description: Culvert No. 103.21, Landaff. Stone box, 3-0, fieldstone. nd. Outlet.

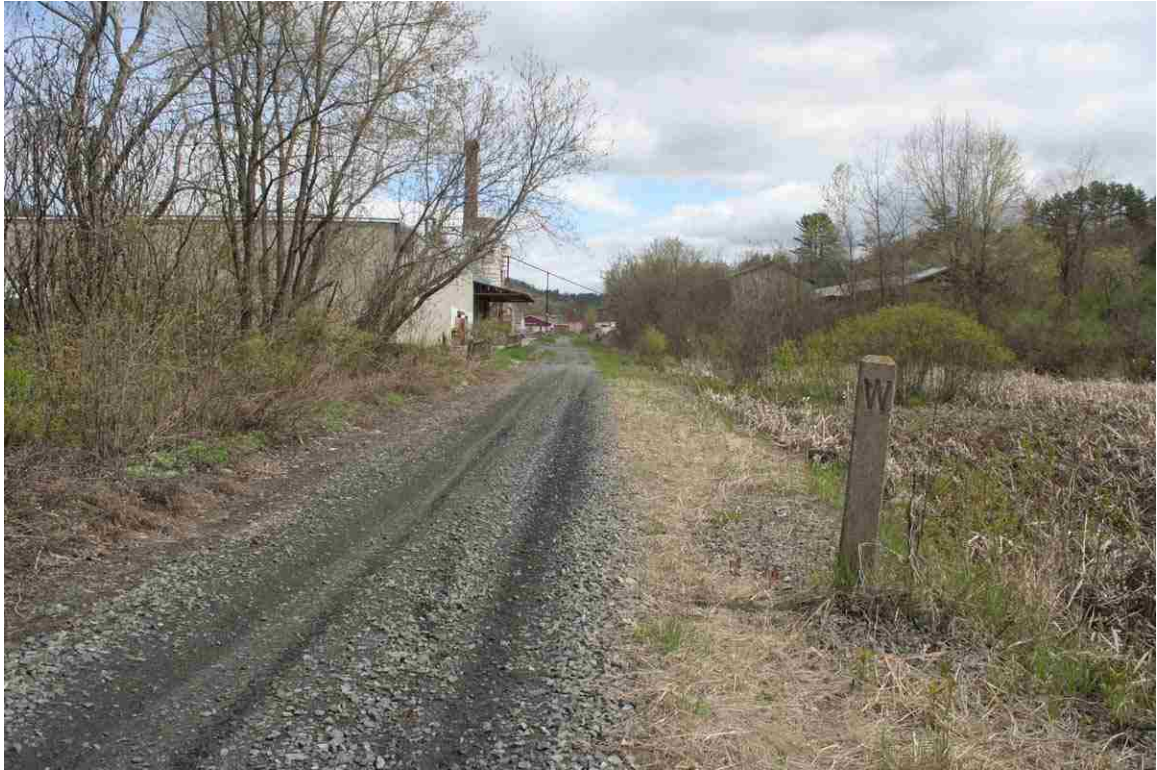
Photo # 55 description: Mile marker "W", 103.27, Landaff-Lisbon line. Concrete. nd.

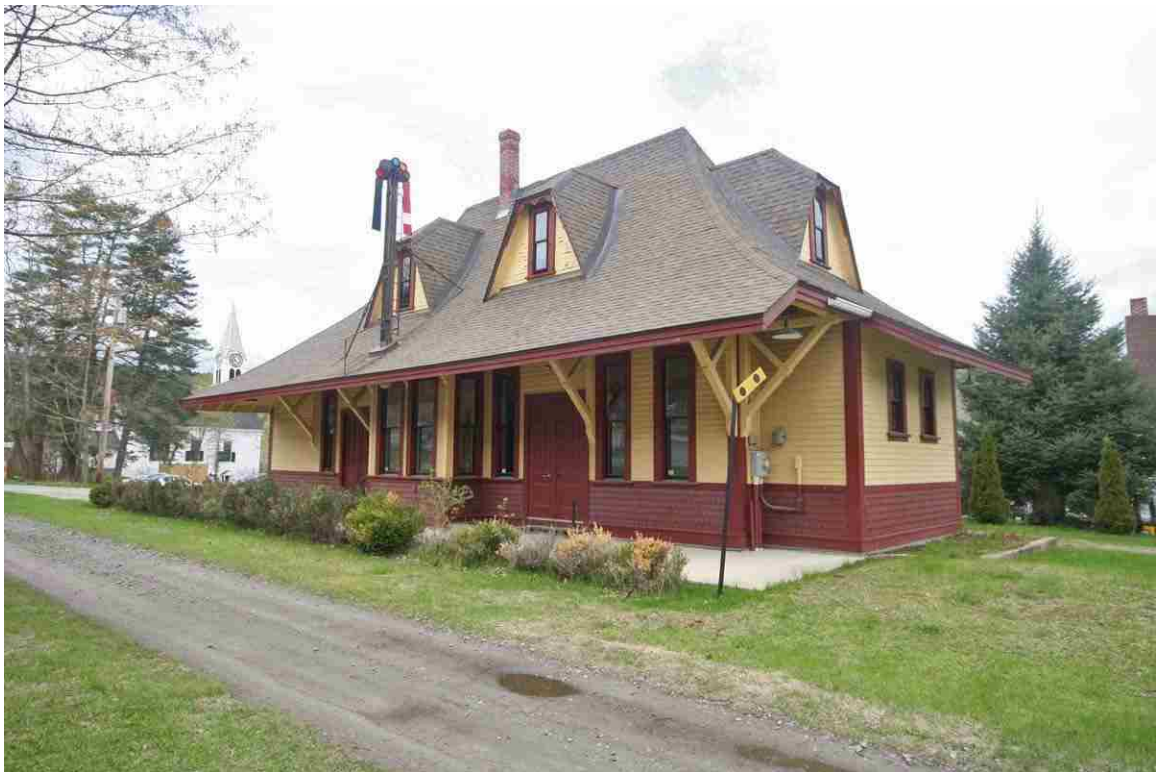
Photo # 56 description: Lisbon Station, South and east sides. mp 103.81. 1869. SR listed 2008. (1 of 2)

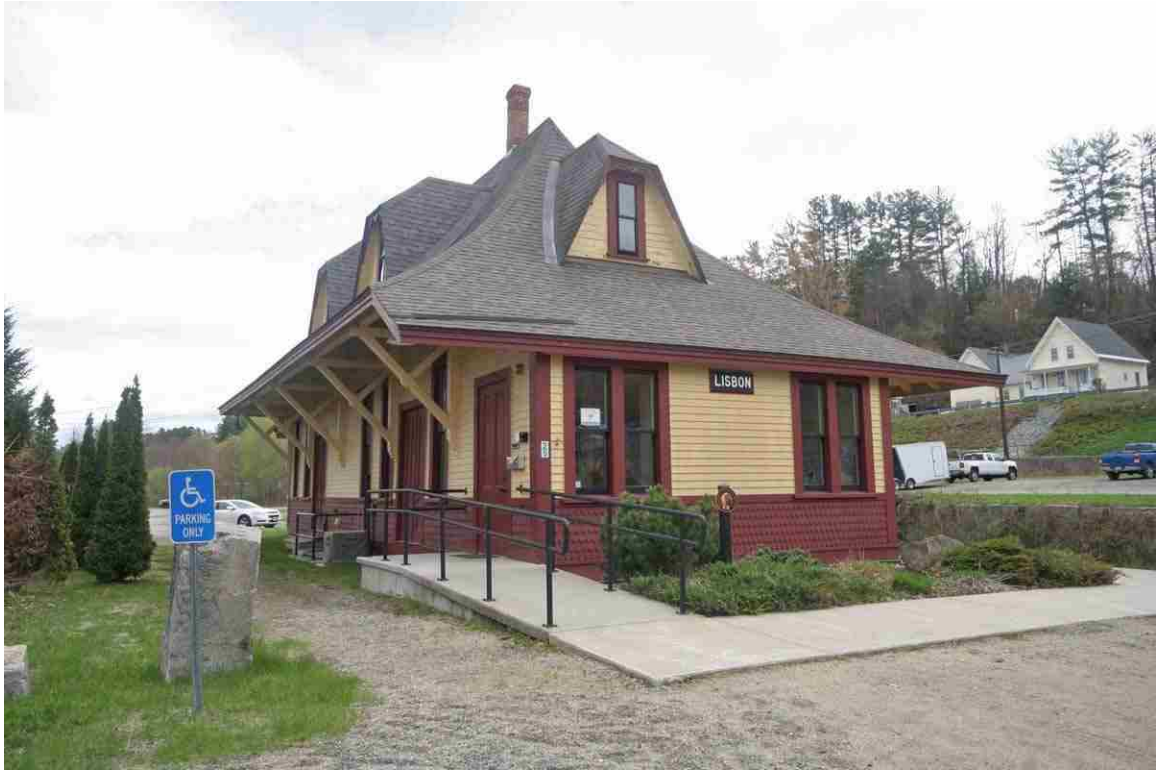
Photo # 57 description: Lisbon Station, North and west sides. mp 103.81. 1869. SR listed 2008. (2 of 2)
