**TABLE OF OBSERVED FEATURES
 SURVEY AREA 1
 ORIGINAL MAIN LINE
 CONNECTICUT RIVER BRIDGE, WOODSVILLE TO
 LITTLETON
 (PHOTO KEYS FOLLOW TABLES)**

**PHOTOGRAPHS SURVEY AREA 1
ORIGINAL MAIN LINE
CONNECTICUT RIVER BRIDGE, WOODSVILLE TO
LITTLETON**

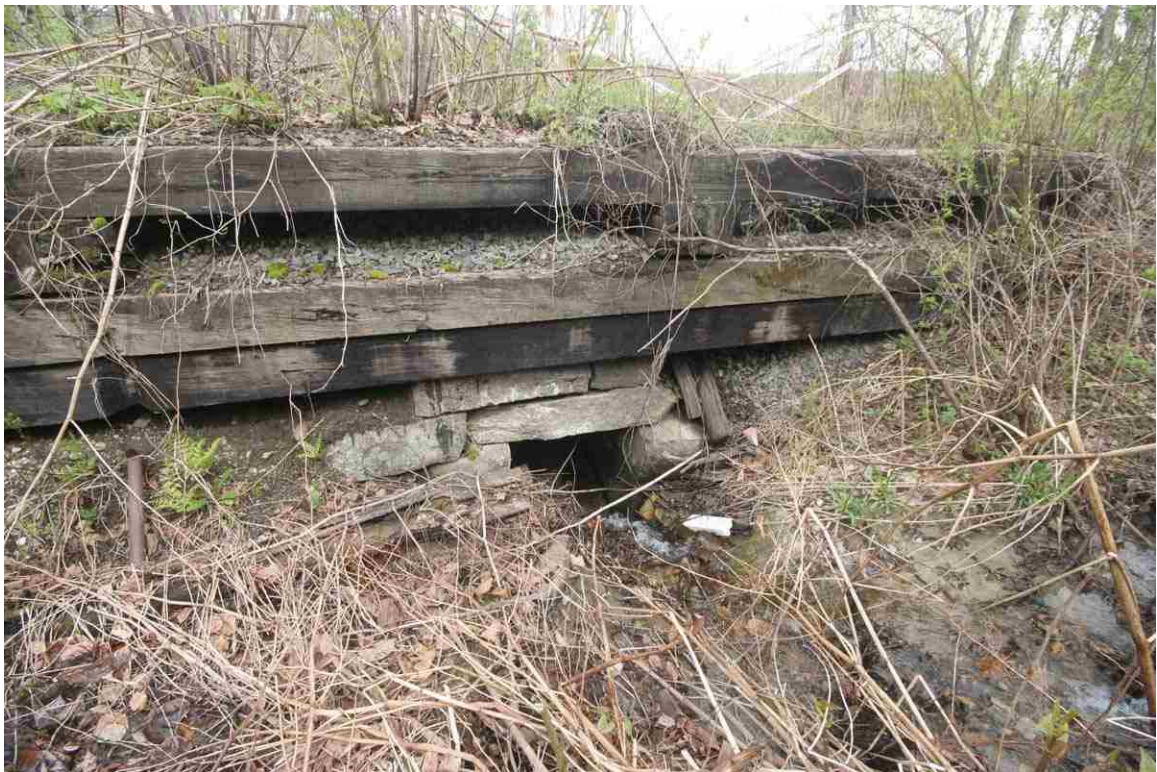
Photo # 58 description: Culvert No. 104.02, Lisbon. Stone box, 3-0, fieldstone. nd. Outlet.

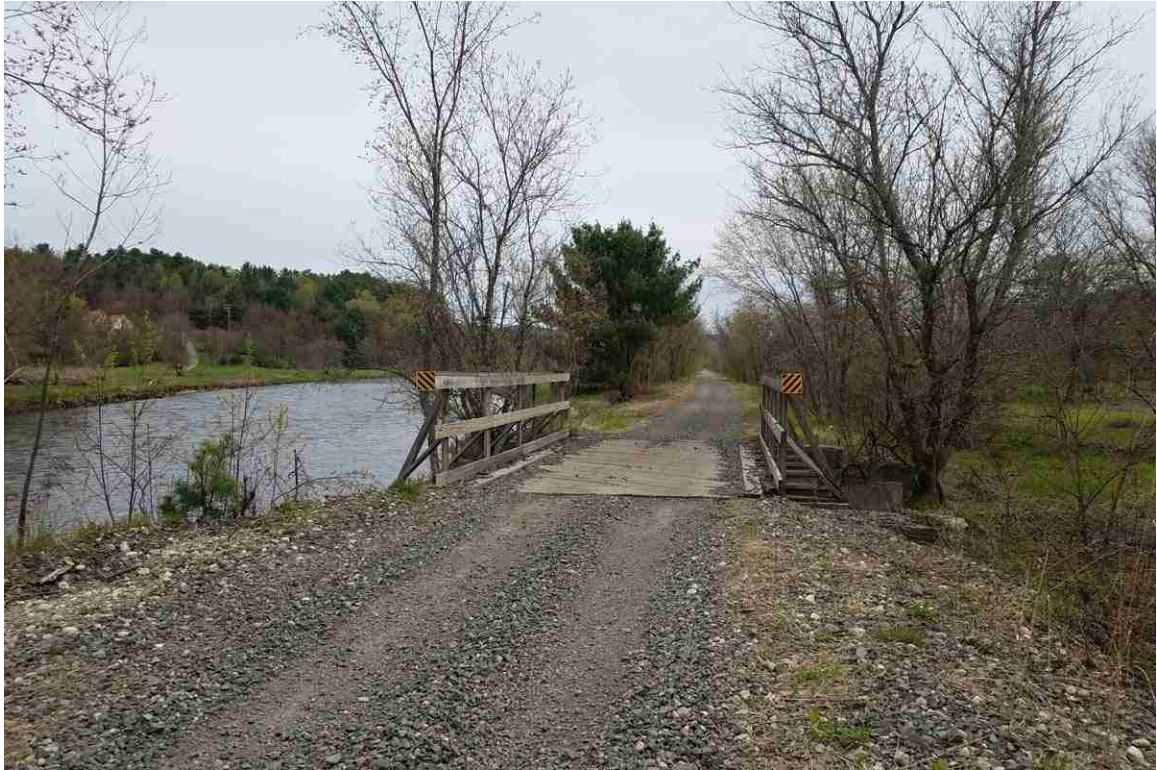
Photo # 59 description: Bridge 104.49 over Pearl Lake Brook, Lisbon. Steel deck plate girder, 22'-7" span. 1921. West approach. (1 of 3).

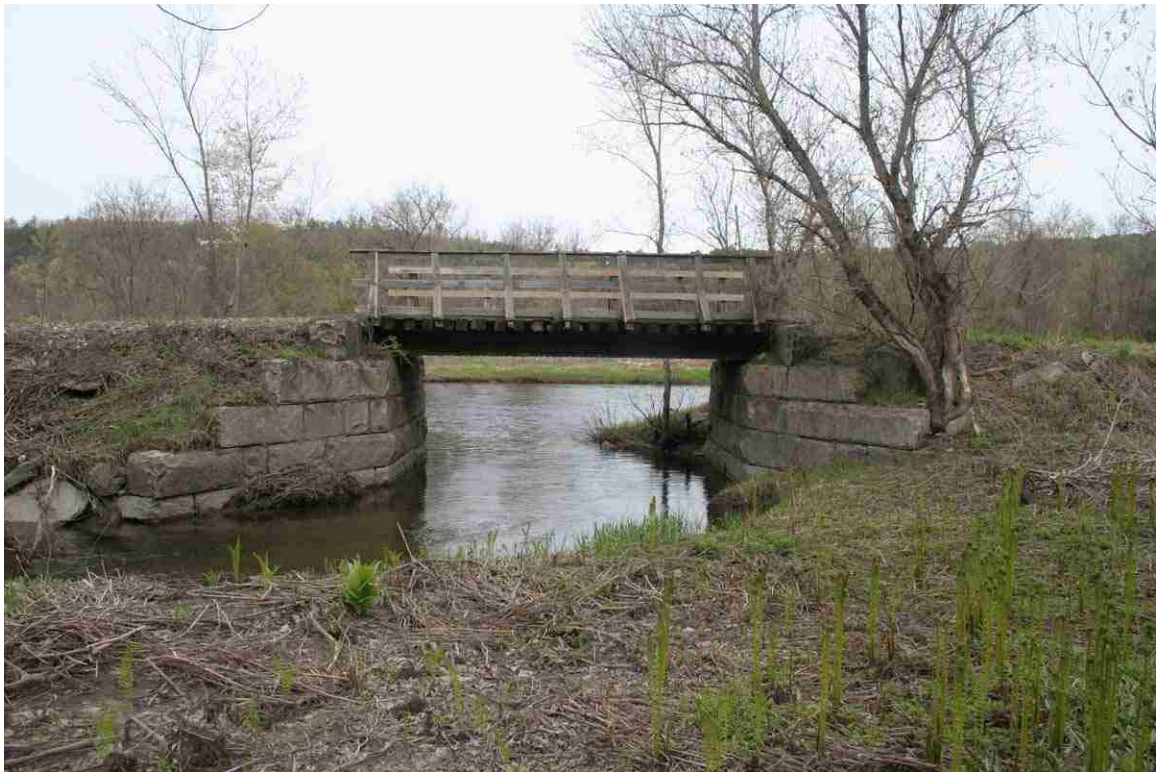
Photo # 60 description: Bridge 104.49, over Pearl Lake Brook, Lisbon. Steel deck plate girder, 22'-7" span. 1921. East side. (2 of 3).

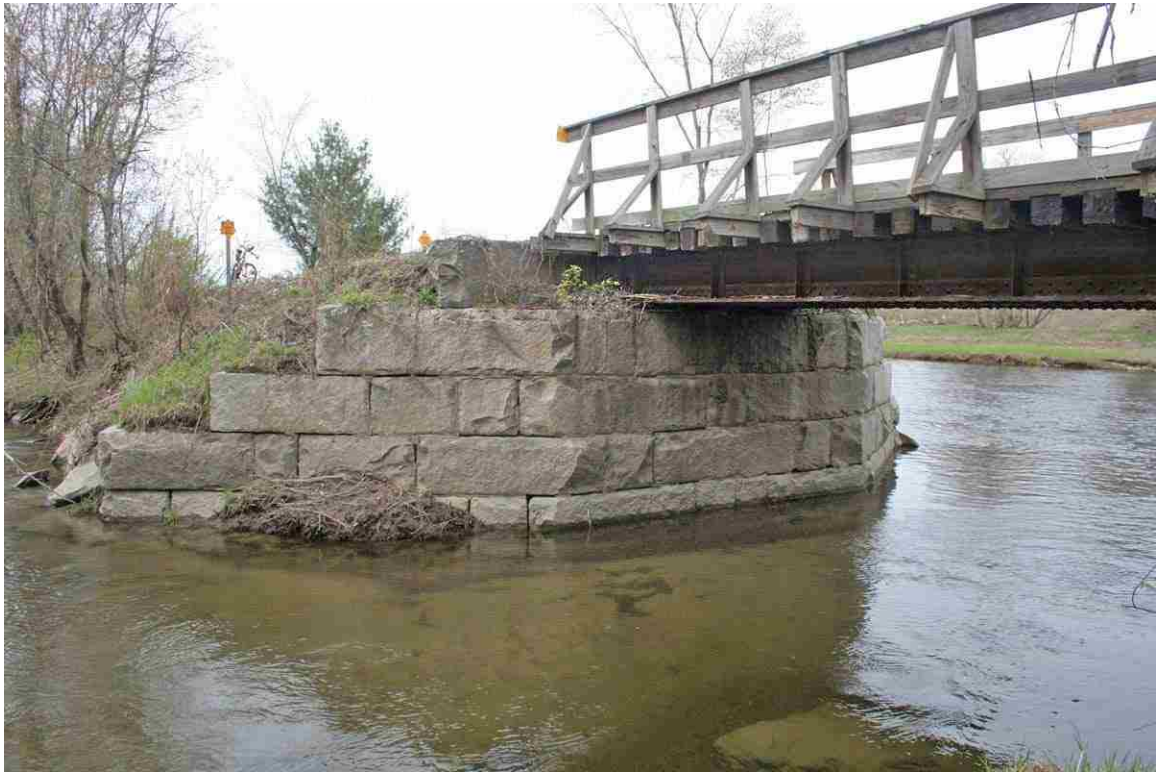
Photo # 61 description: Bridge 104.49, over Pearl Lake Brook, Lisbon. Steel deck plate girder, 22'-7" span. 1921. West abutment, detail of typical B&M stonework. (3 of 3).

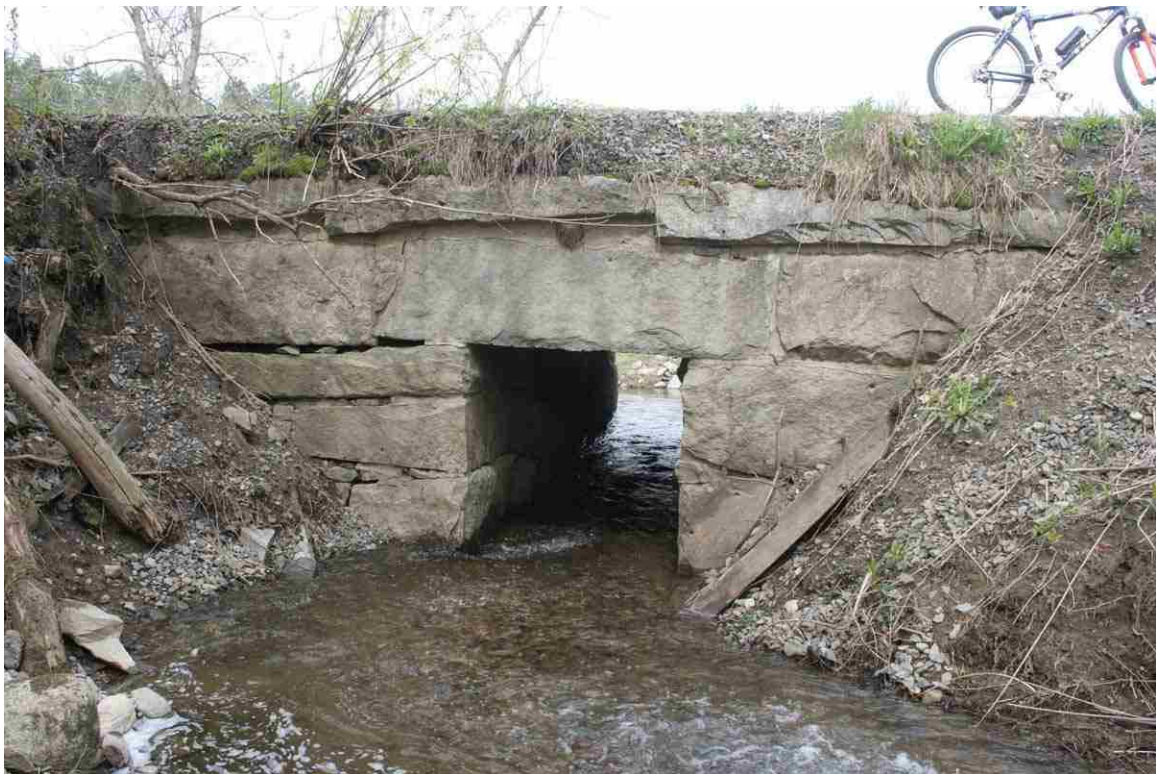
Photo # 62 description: Culvert No. 104.99, Lisbon. Stone box, 4-0, Quarry stone. nd. Inlet. (1 of 2).

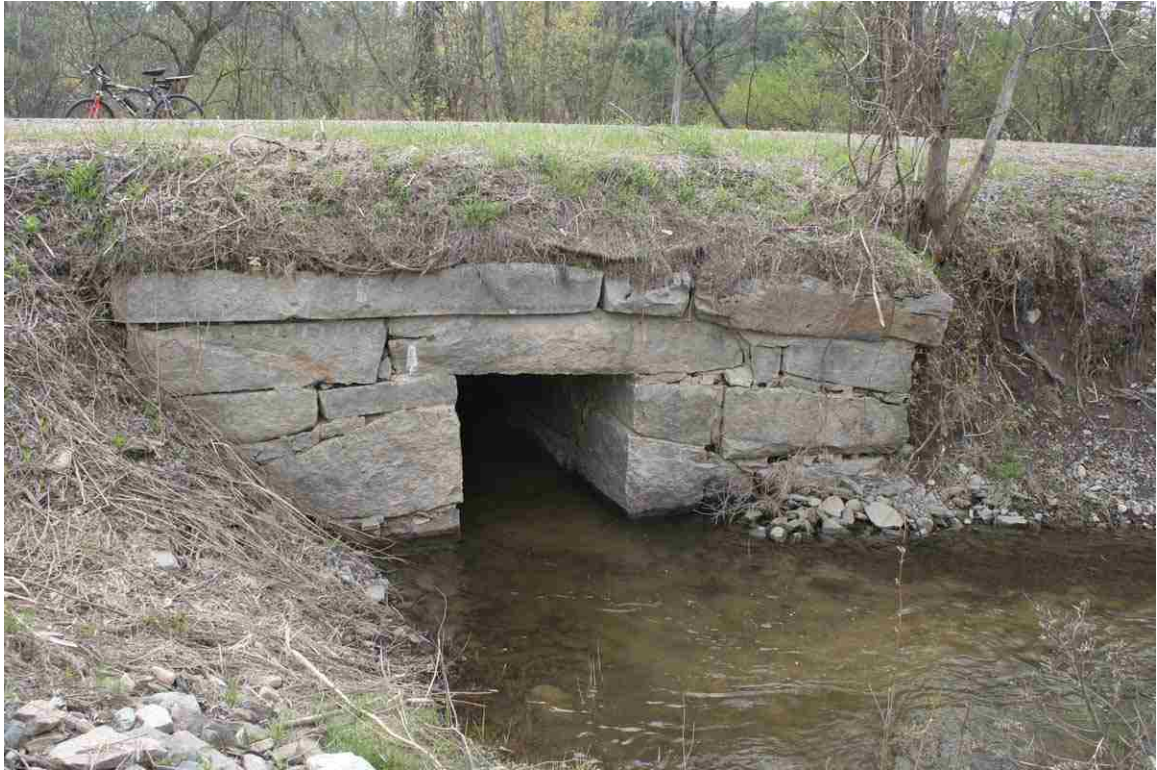
Photo # 63 description: Culvert No. 104.99, Lisbon. Stone box, 4-0, Quarry stone. nd. Inlet. (2 of 2).

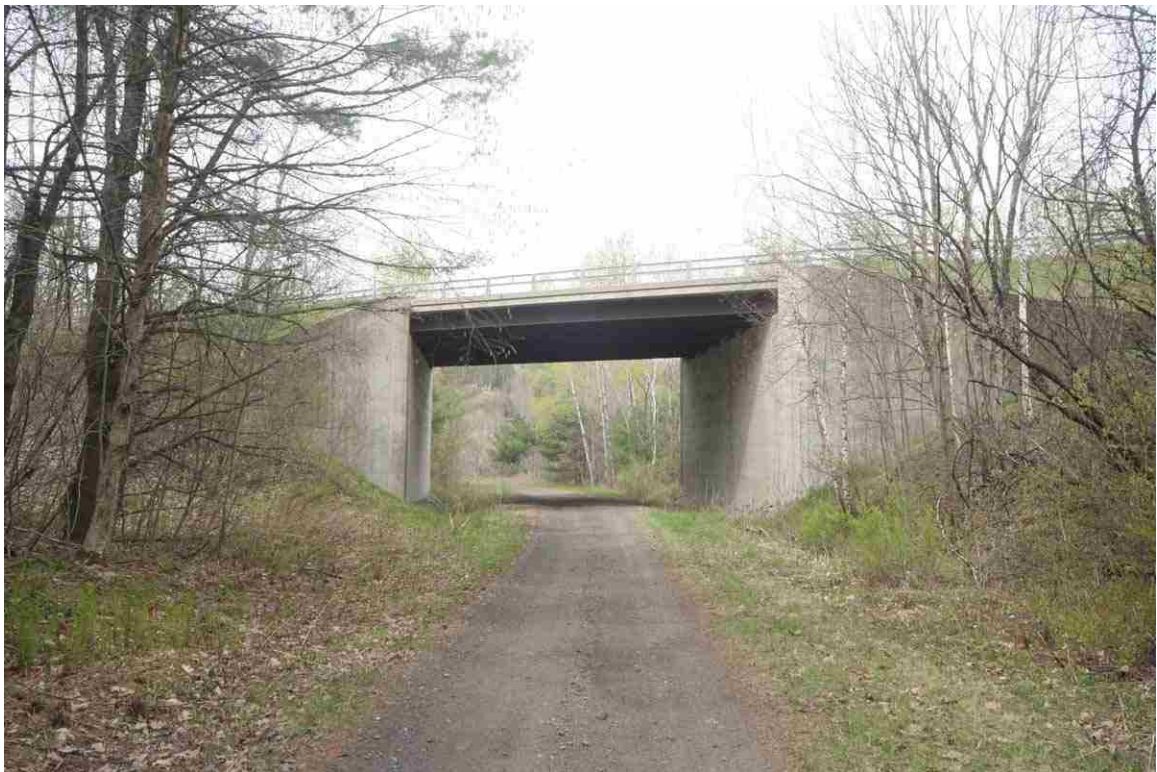
Photo # 64 description: US302/NH10 overpass, mp 106.19, Lisbon. NHDOT bridge # Lisbon 094/112, 1979. Replaced 80' framed trestle. nd.

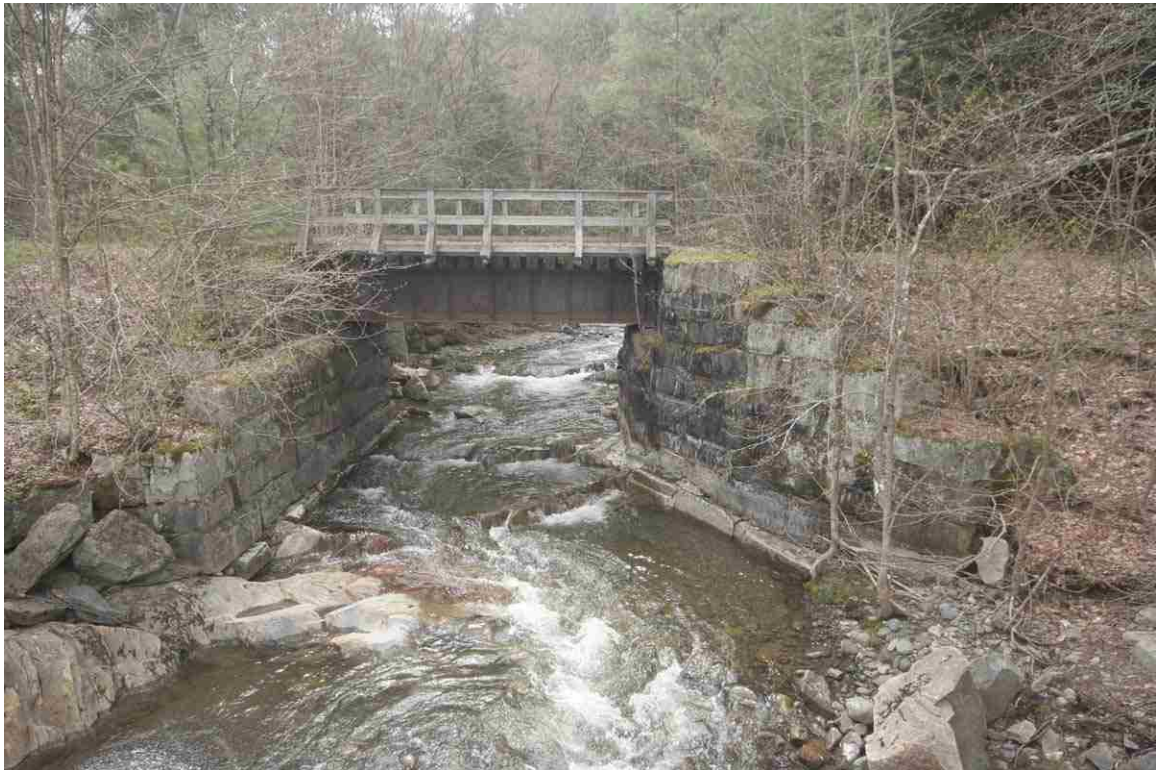
Photo # 66 description: Bridge 106.43, over Sugar Hill Brook, Lisbon. Steel deck plate girder, 21'-4" span. 1914. Downstream side. (1 of 2).

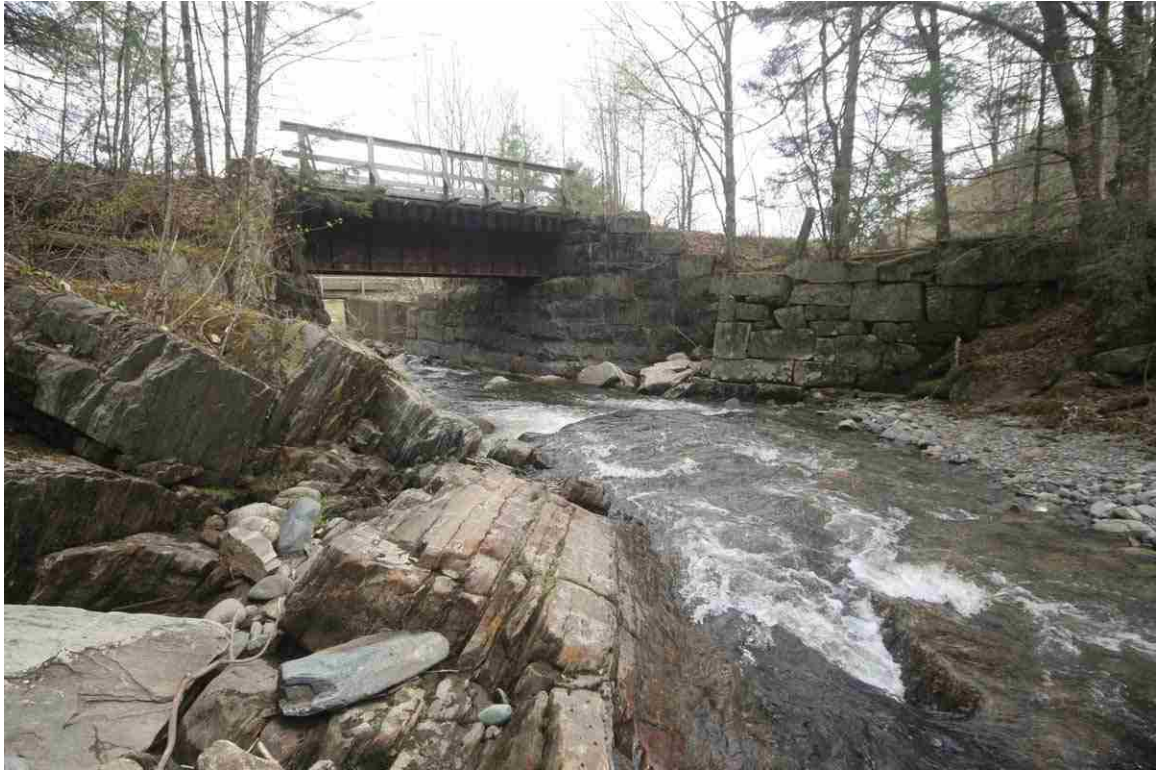
Photo # 67 description: Bridge 106.43, over Sugar Hill Brook, Lisbon. Steel deck plate girder, 21'-4" span. 1914. Upstream side. (2 of 2).

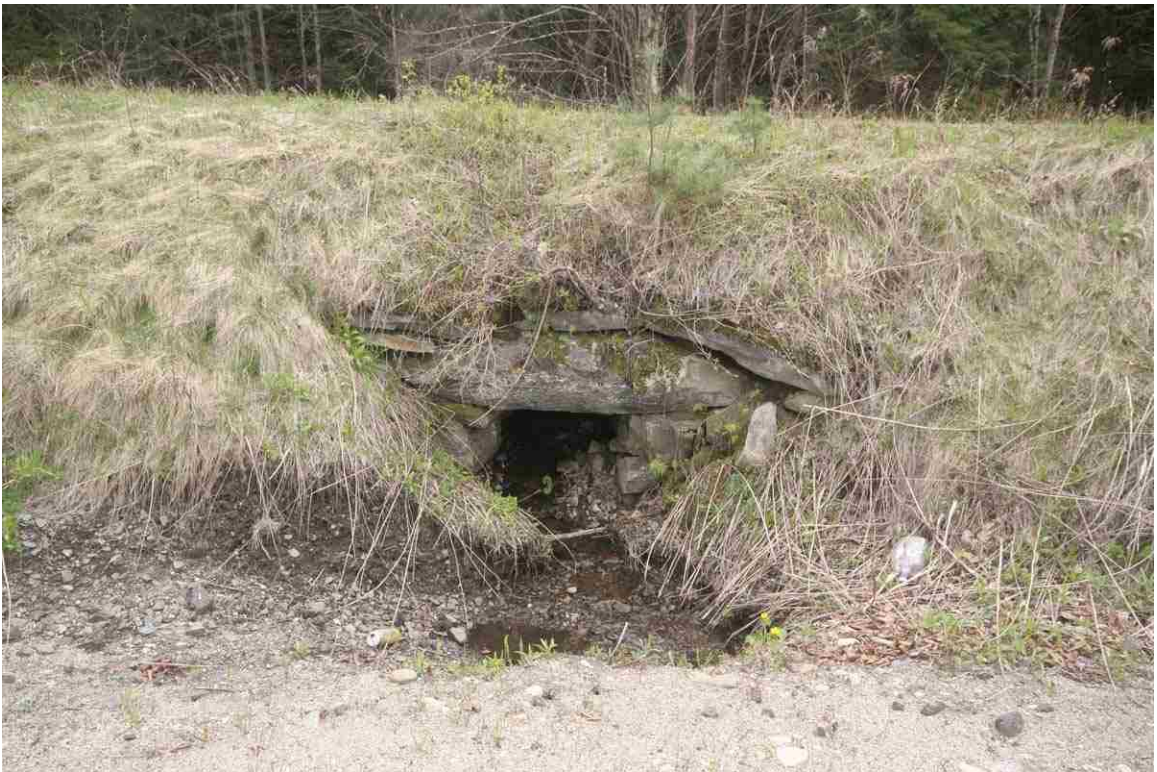
Photo # 68 description: Culvert No. 107.14, Lisbon. Stone box, 3-0, Fieldstone. nd. Outlet.

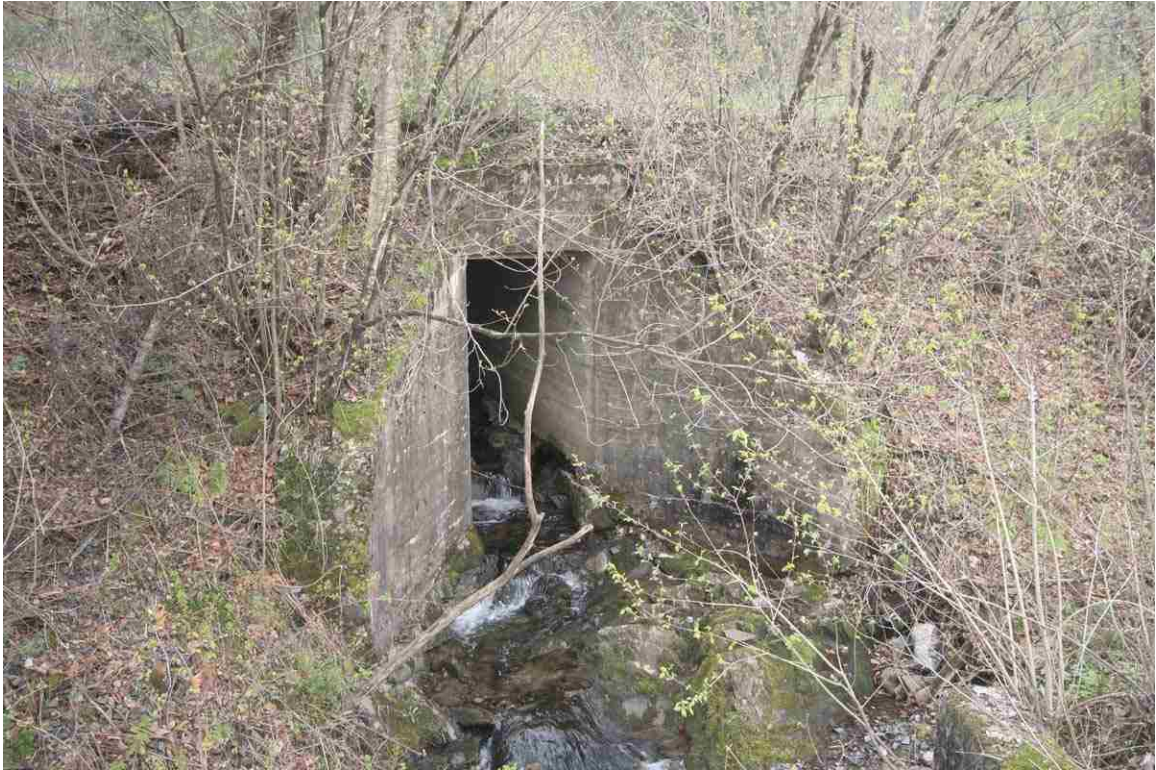
Photo # 69 description: Culvert No. 107.50, Lisbon. Railtop concrete slab. 4-0. Concrete wingwalls. nd. Outlet. (1 of 2).

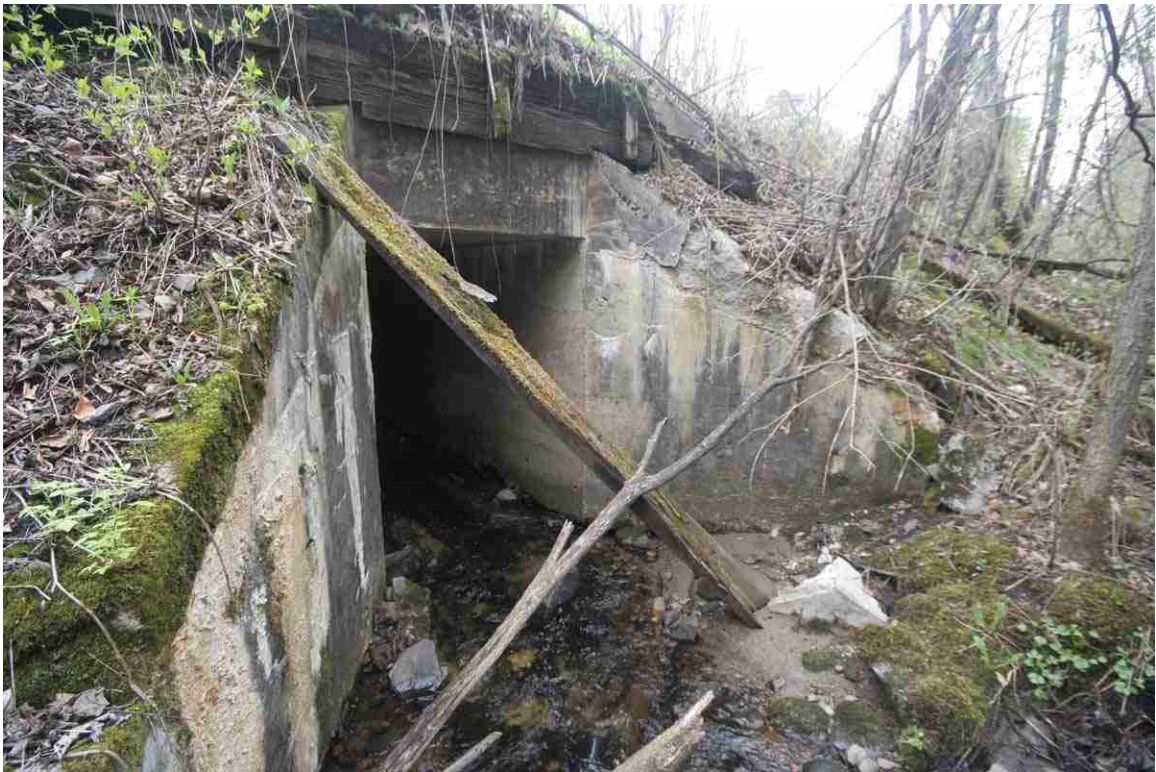
Photo # 70 description: Culvert No. 107.50, Landaff. Railtop concrete slab. 4-0. nd. Inlet. (2 of 2).

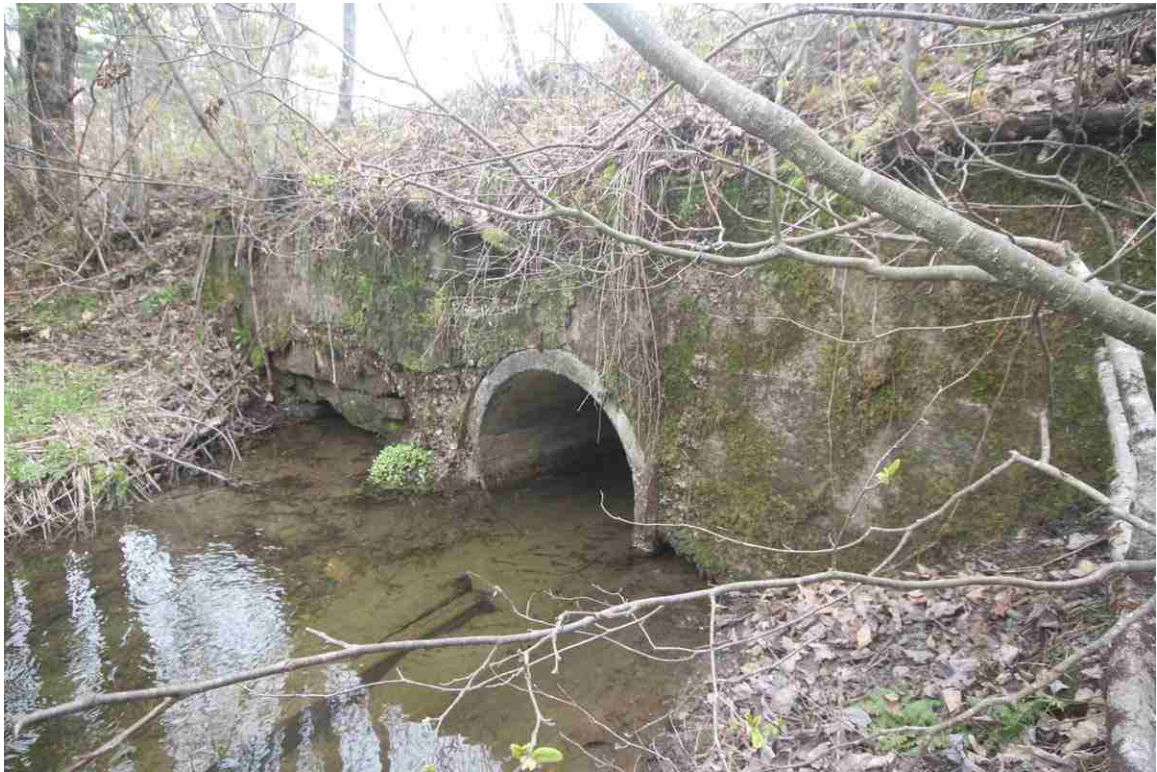
Photo # 71 description: Culvert No. 108.70, Lisbon. Concrete pipe, 5-6. nd. Concrete encased walls, probably replaced stone box. Outlet.

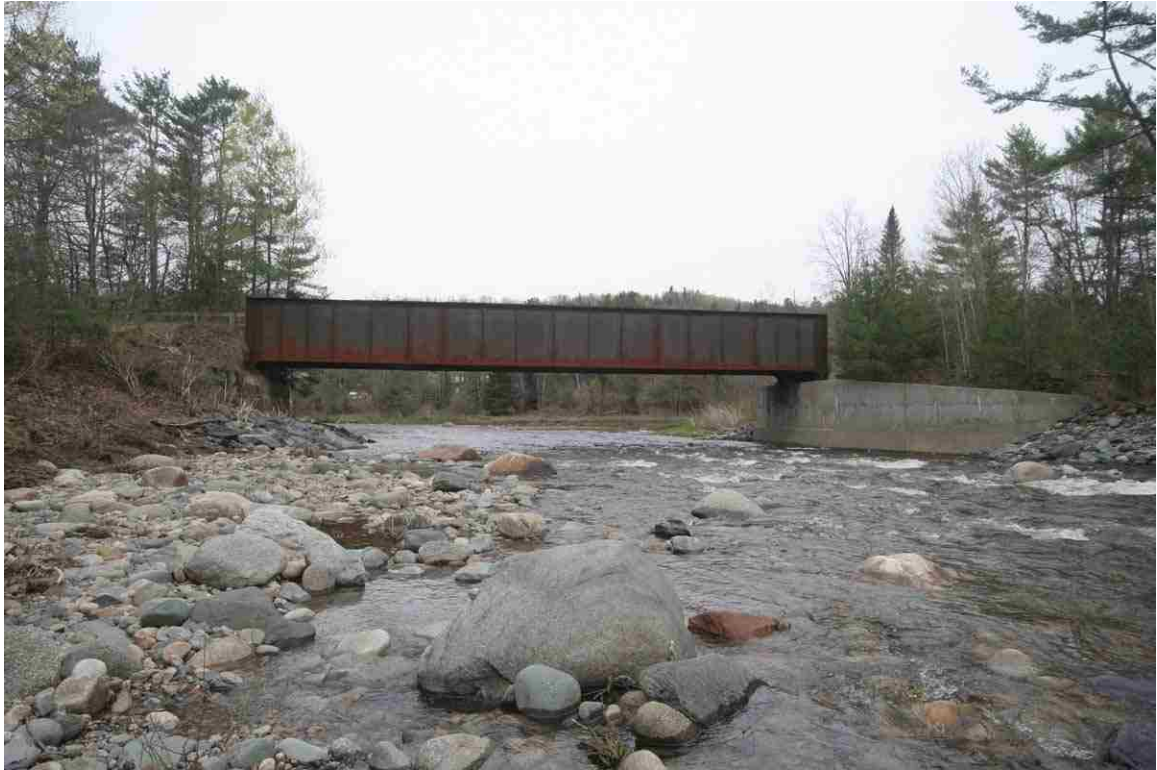
Photo # 73 description: Bridge 109.07, over Gale R., Lisbon. Steel thru plate girder, 92-10 span. 1929. (1 of 5).
Upstream side; Gale R emptying into Ammonoosuc R. just beyond bridge.

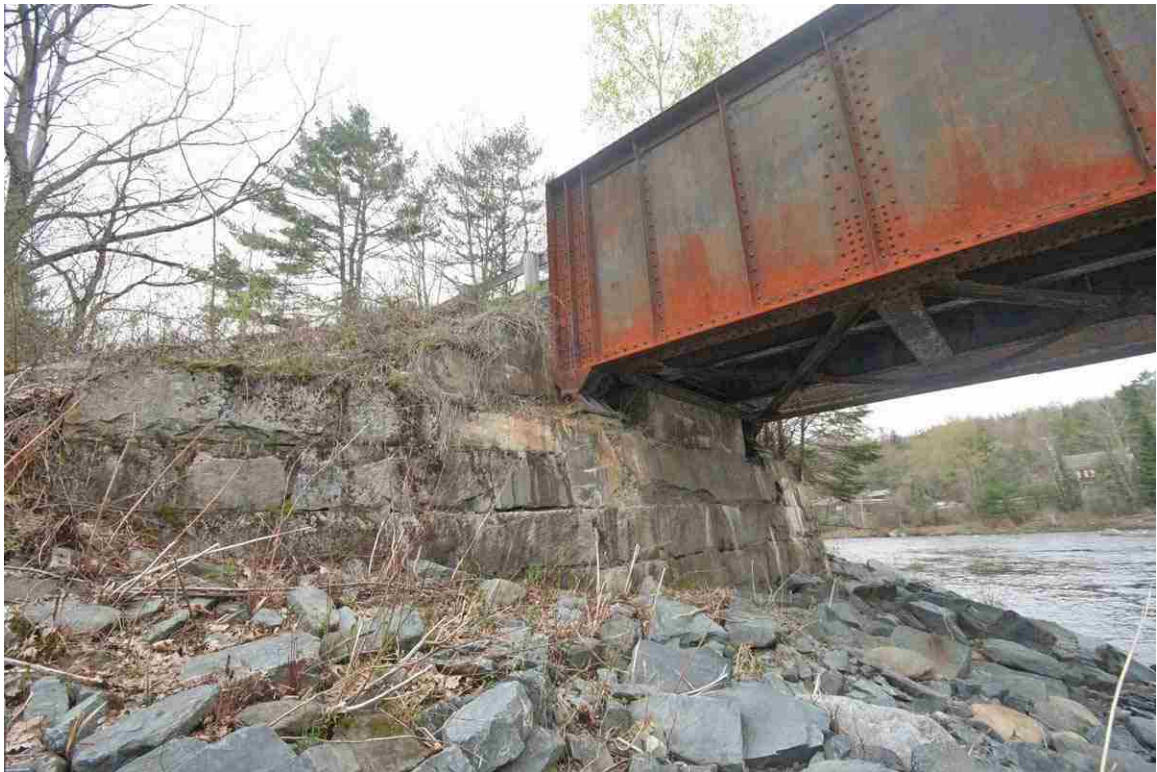
Photo # 74 description: Bridge 109.07, over Gale R., Lisbon. Steel thru plate girder, 92-10 span. 1929. (2 of 5).
West abutment, stone, bearing seat, concrete and underside.

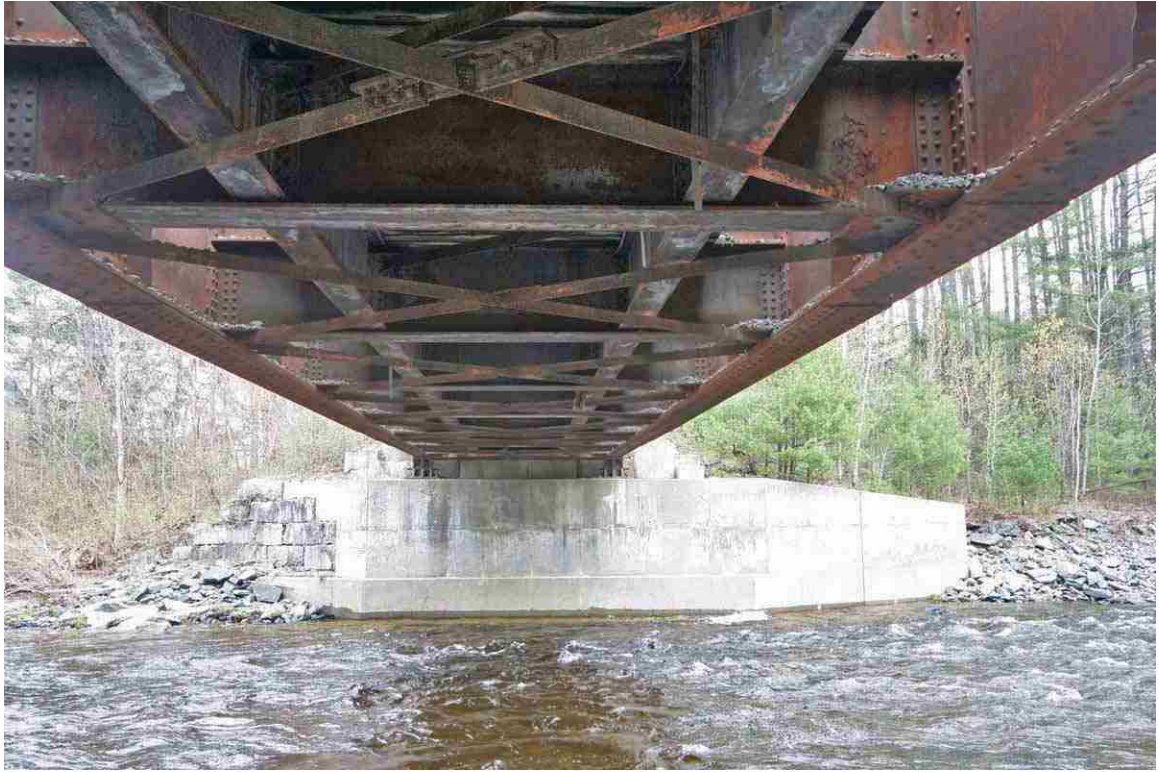
Photo # 75 description: Bridge 109.07, over Gale R., Lisbon. Steel thru plate girder, 92-10 span. 1929. (3 of 5).
Underside and new east concrete abutment joined to surviving stone abutment.

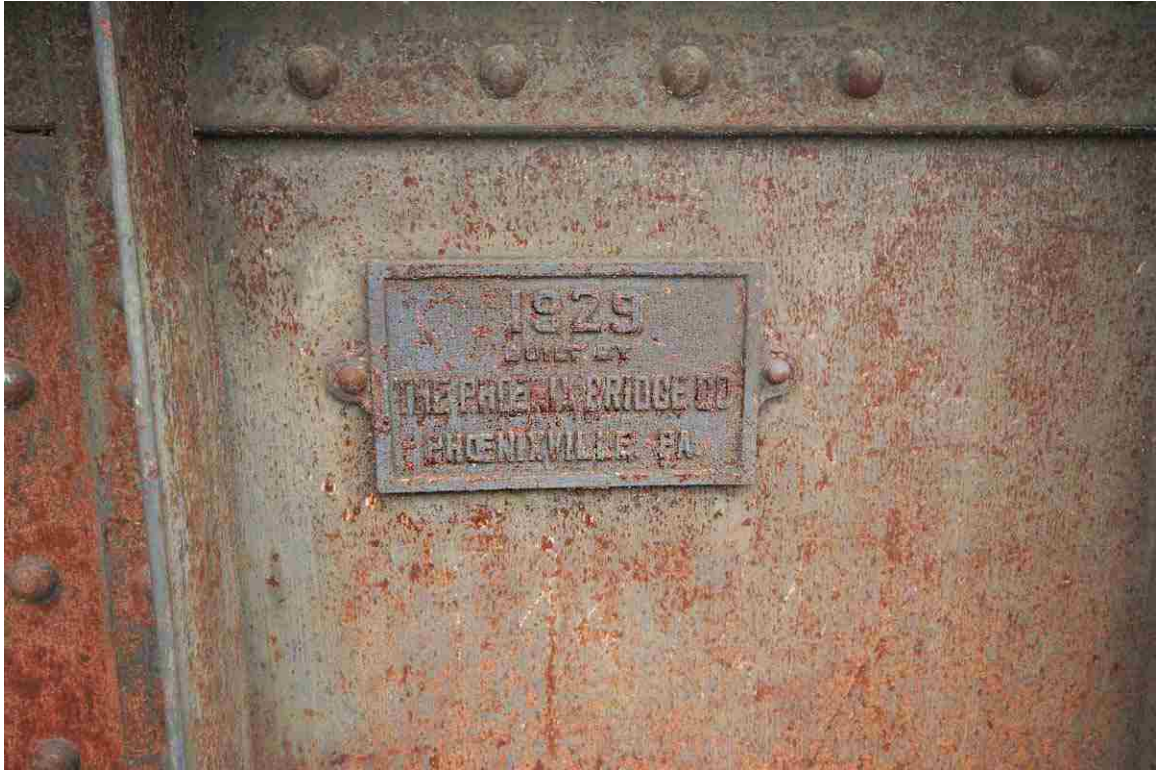
Photo # 77 description: Bridge 109.07, over Gale R., Lisbon. Steel thru plate girder, 92-10 span. 1929. (4 of 5).
Bridge makers plate: "1929 Built by The Phoenix Bridge Co., Phoenixville, P.A."

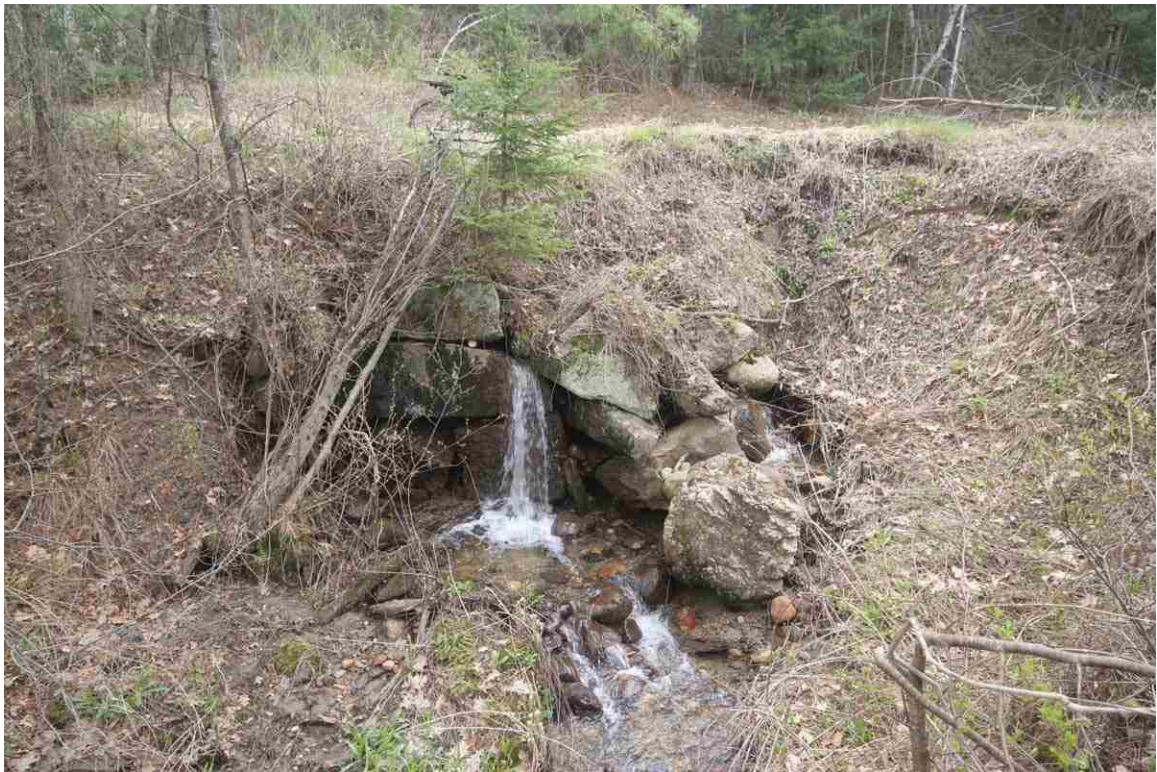
Photo # 78 description: Culvert No. 109.48, Lisbon. Stone box, 2-0, fieldstone. Collapsed and blocked. nd. Outlet.

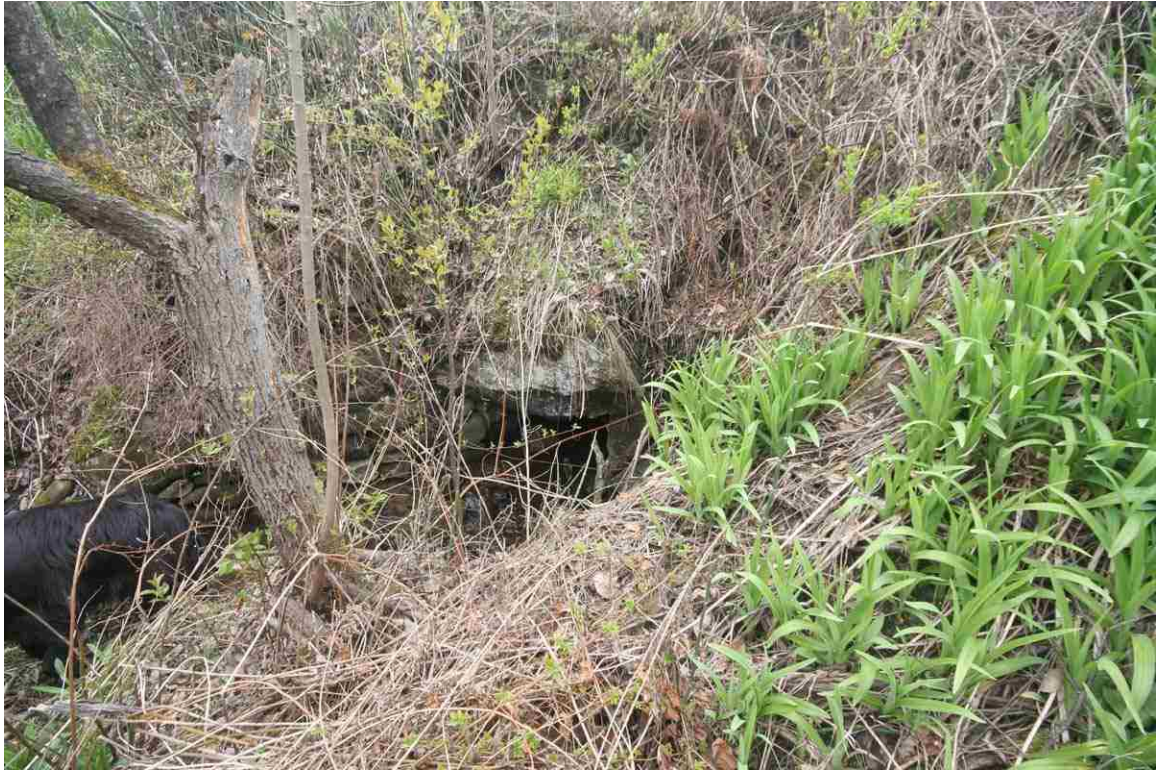
Photo # 79 description: Culvert No. 110.15, Lisbon. Stone box, 3-0, fieldstone. nd. Outlet.

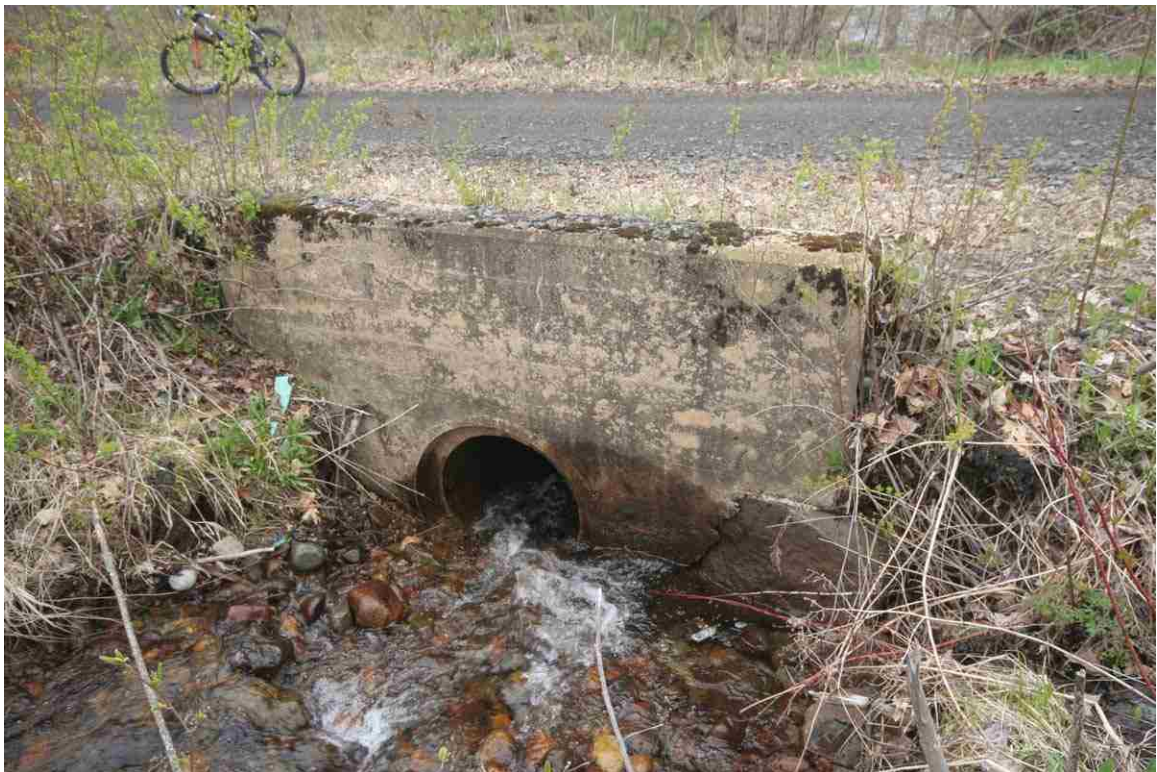
Photo # 80 description: Culvert No. 111.06, Littleton. Concrete pipe, 2-0, with concrete headwalls. B&M, 1943. Outlet. Example of mid-20th c. practice.

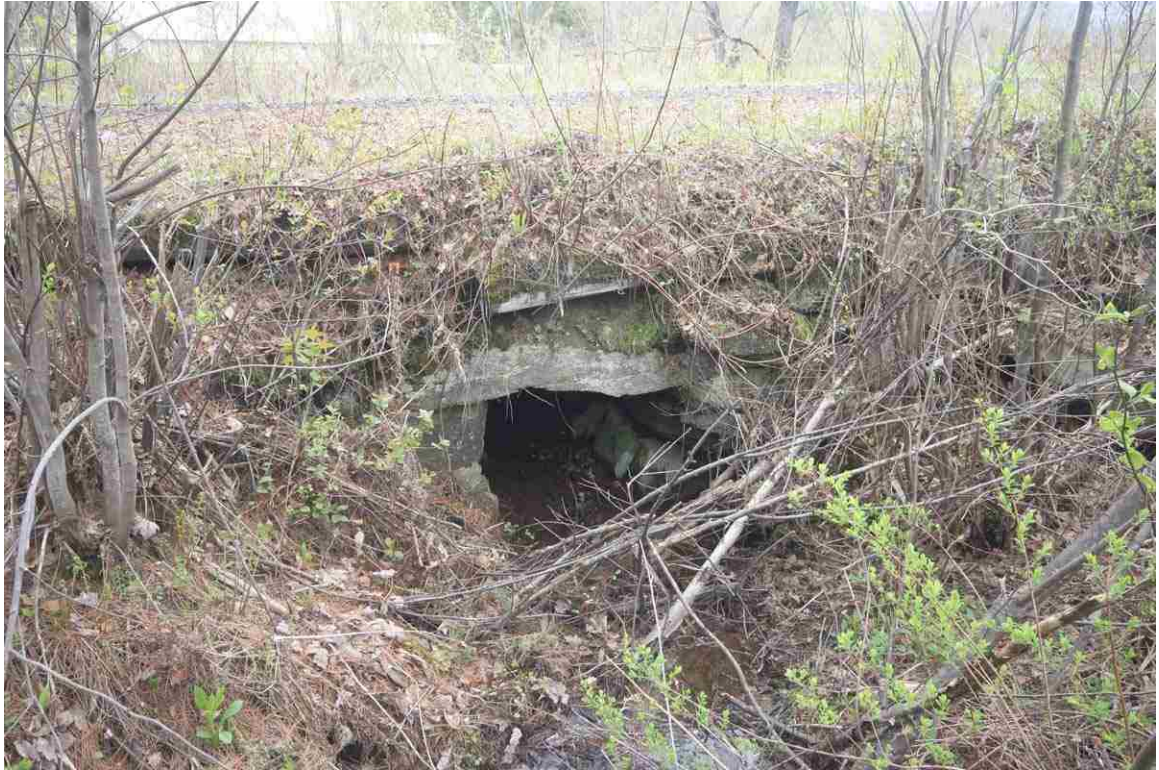
Photo # 81 description: Culvert No. 111.11, Littleton. Stone box, 3-0, fieldstone. nd. Inlet.

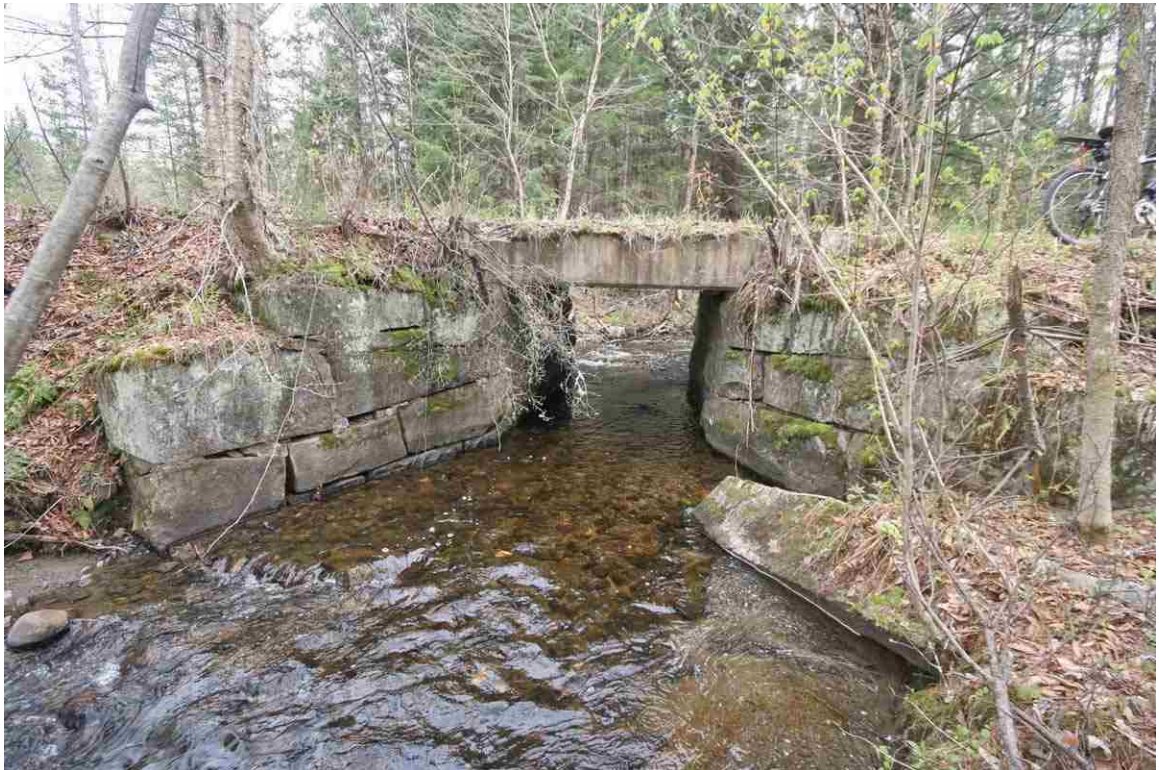
Photo # 82 description: Bridge 111.45, over unnamed stream, Littleton. Precast concrete slab on stone abutments, 8-0 span. Outlet. 1929. (1 of 2).

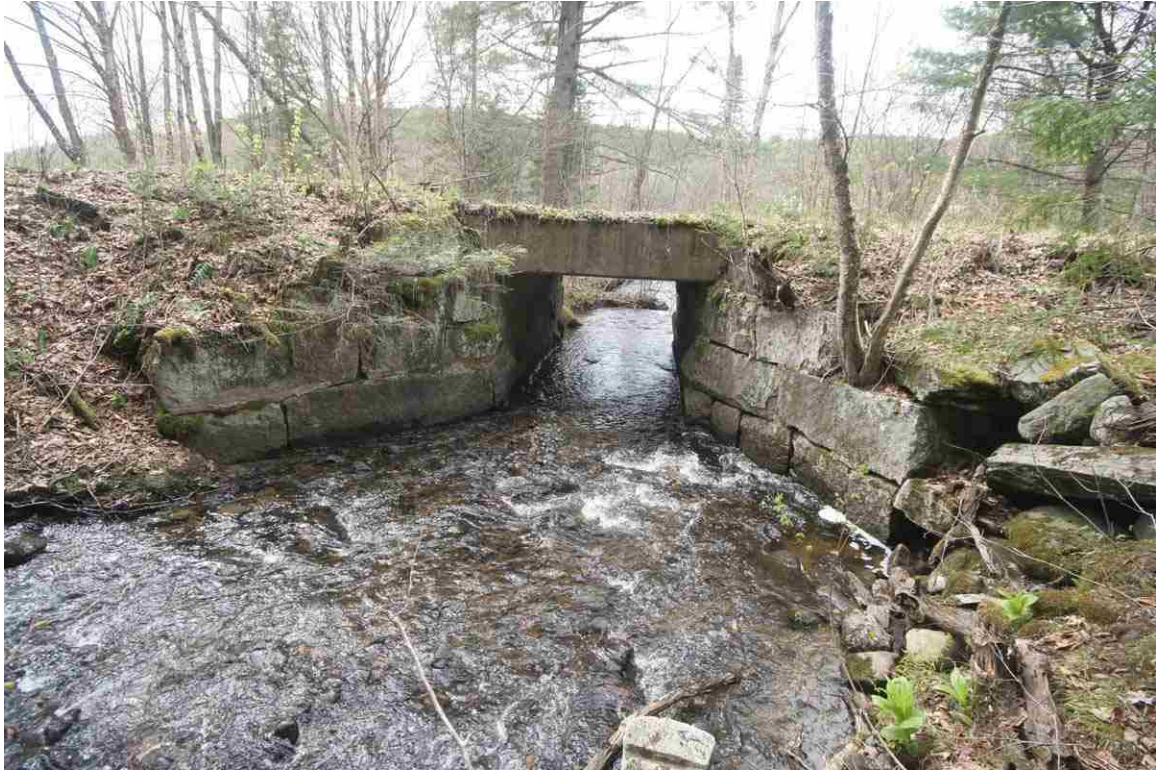
Photo # 83 description: Bridge 111.45, over unnamed stream, Littleton. Precast concrete slab on stone abutments, 8-0 span. Inlet. 1929. (2 of 2).

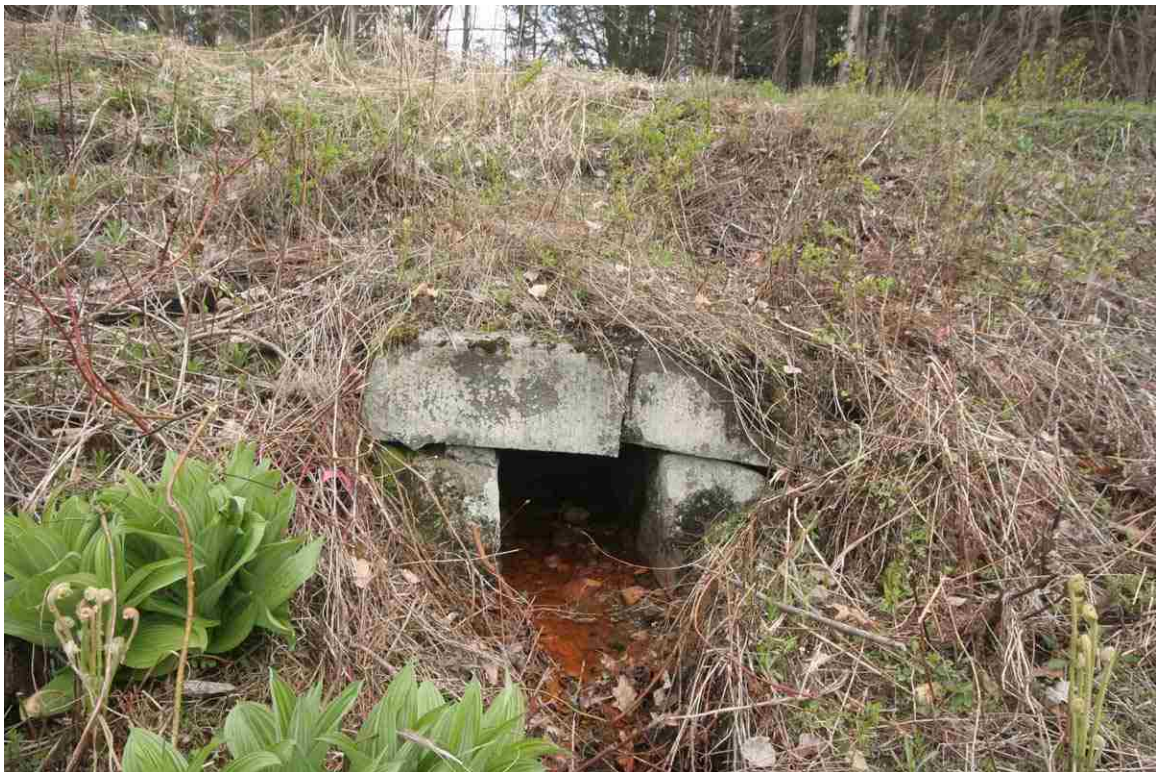
Photo ID #: S1_1124 Direction: E Date: 5/12/2019 Image stored at: HDC

Photo # 85 description: Culvert No. 111.90, Littleton. Stone box, 3-0, fieldstone. Outlet. nd.

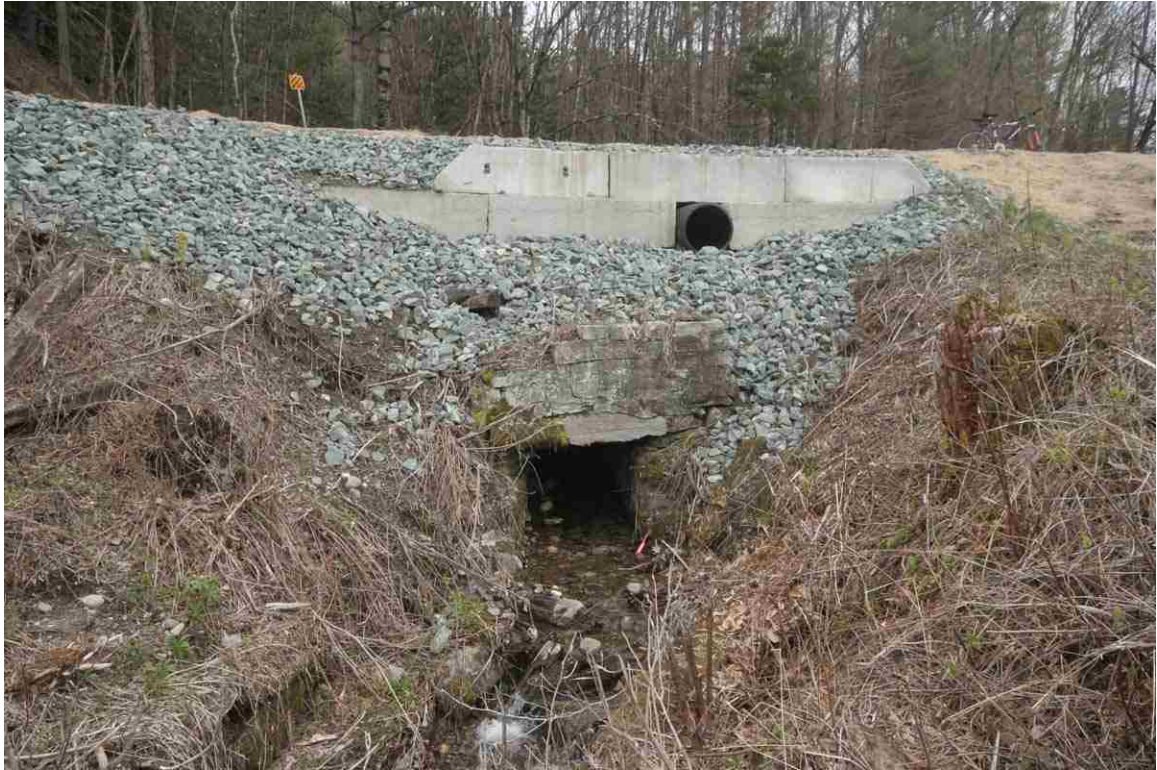
Photo ID #: S1_1125 Direction: E Date: 5/12/2019 Image stored at: HDC

Photo # 86 description: Culvert No. 111.98, Littleton. Stone box, 2-6, quarry stone. Outlet. nd.
