**TABLE OF OBSERVED FEATURES  
 SURVEY AREA 4  
 WHITEFIELD-GROVETON LINE  
 PAGE ROAD, DALTON TO  
 SUMMER STREET, LANCASTER (COOS JUNCTION)**

**PHOTOGRAPHS  
SURVEY AREA 4  
PROFILE HOUSE BRANCH  
WHITEFIELD-GROVETON LINE  
PAGE ROAD, DALTON TO  
SUMMER STREET, LANCASTER (COOS JUNCTION)**

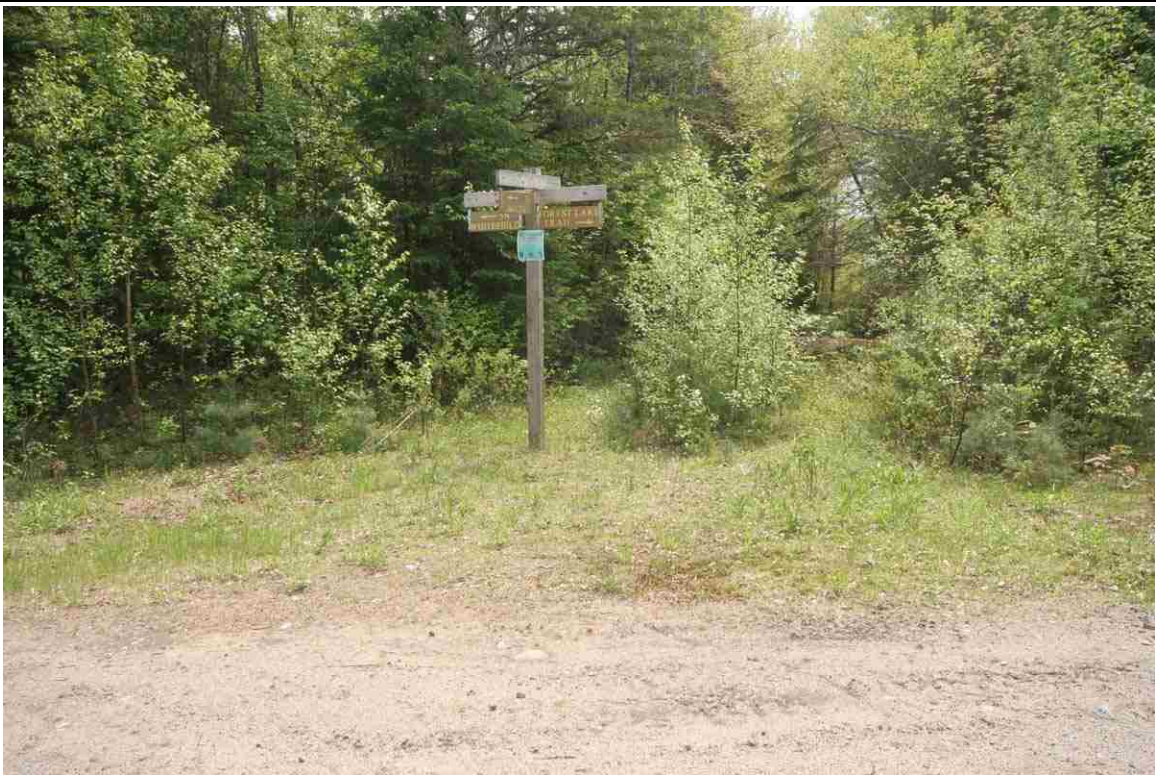
| Feature Name | Mile Post | Town | NR | Photo No. (s) | Date | Notes |
|---|---|---|---|---|---|---|
| Snowmobile Trail Marker | ~126.81 | Dalton | N/C | 4 | ? | ROW through Dalton is part of NH Snowmobile Association Trail No. 5 |

Photo # 4 description: Snowmobile Trail Marker, vicinity mp~126.81, Dalton. ROW through Dalton is part of NH Snowmobile Association Trail No. 5, maintained by Dalton Ridge Runners Snowmobile Club.

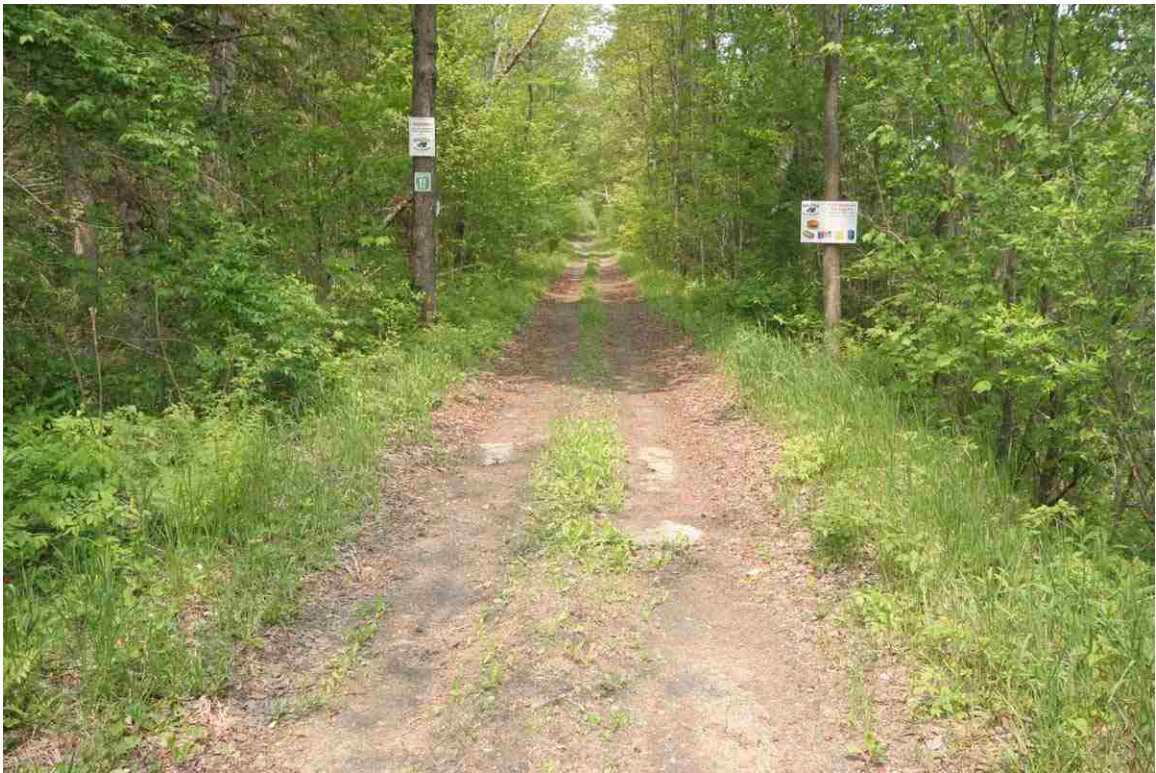
| Feature Name | Mile Post | Town | NR | Photo No. (s) | Date | Notes |
|---|---|---|---|---|---|---|
| ROW Railbed | ~126.81 | Dalton | N/C | 5 | ? | Character of ROW/Recreation Trail |

Photo # 5 description: Character of ROW/Trail, south end, vicinity mp~126.81, Dalton.

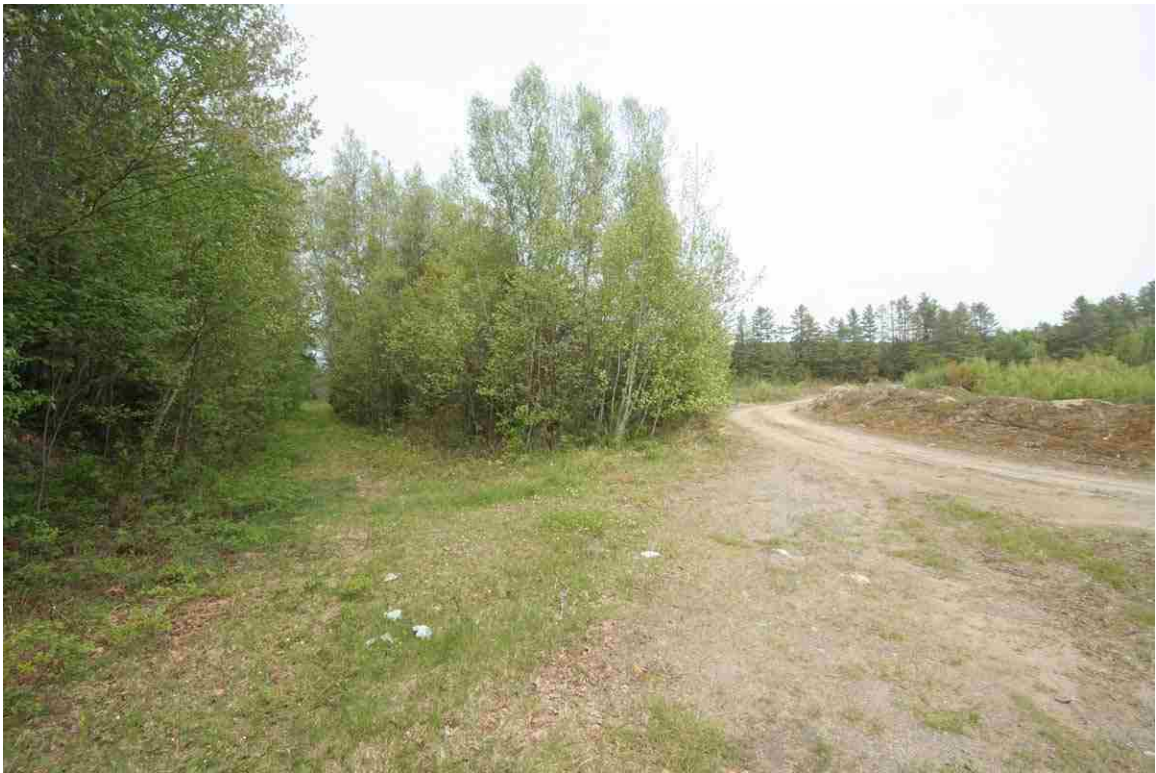
| Feature Name | Mile Post | Town | NR | Photo No. (s) | Date | Notes |
|---|---|---|---|---|---|---|
| ROW Railbed | ~127.63 | Dalton | N/C | 7 | ? | Character of ROW/Recreation Trail |

Photo # 7 description: Character of ROW/Trail, at left, bordering gravel pit, at right, vicinity mp~127.63, Dalton.

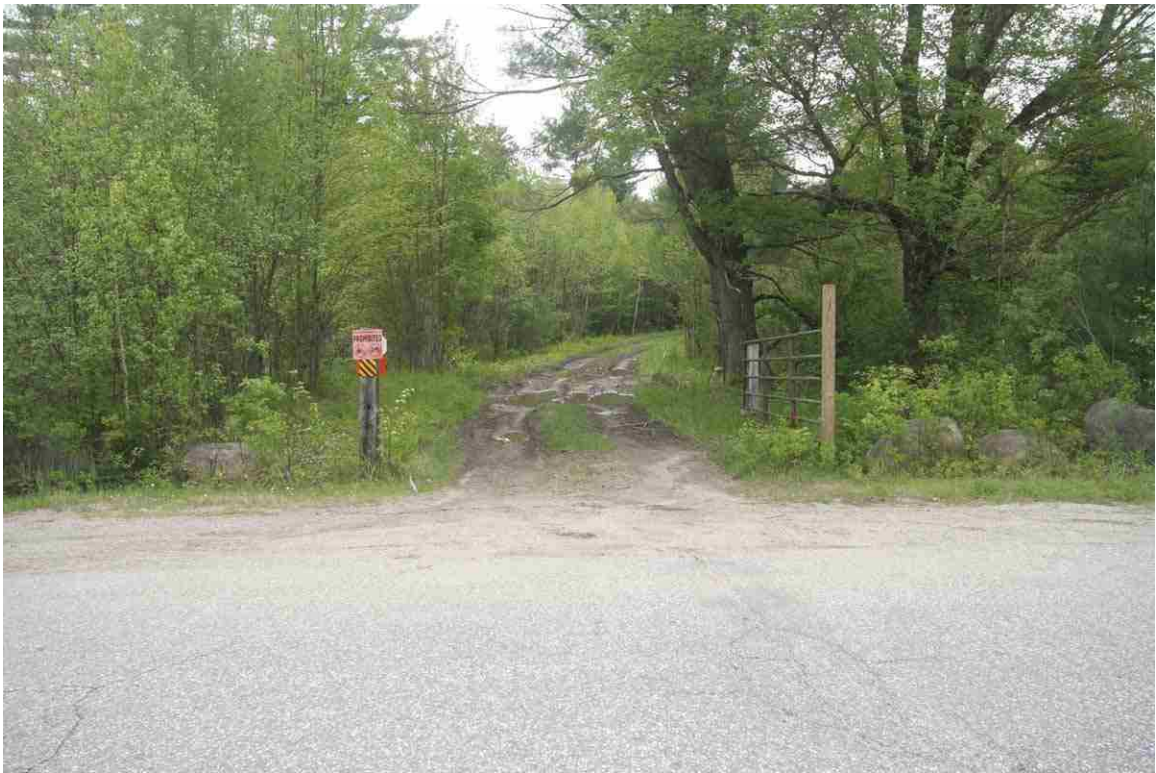
| Feature Name | Mile Post | Town | NR | Photo No. (s) | Date | Notes |
|---|---|---|---|---|---|---|
| ROW at French Road crossing | 128.36 | Dalton | N/C | 9-10 | ? | No evidence of railroad resources. |

Photo # 9 description: Character of ROW at French Road crossing, mp 128.36, Dalton. (1 of 2).

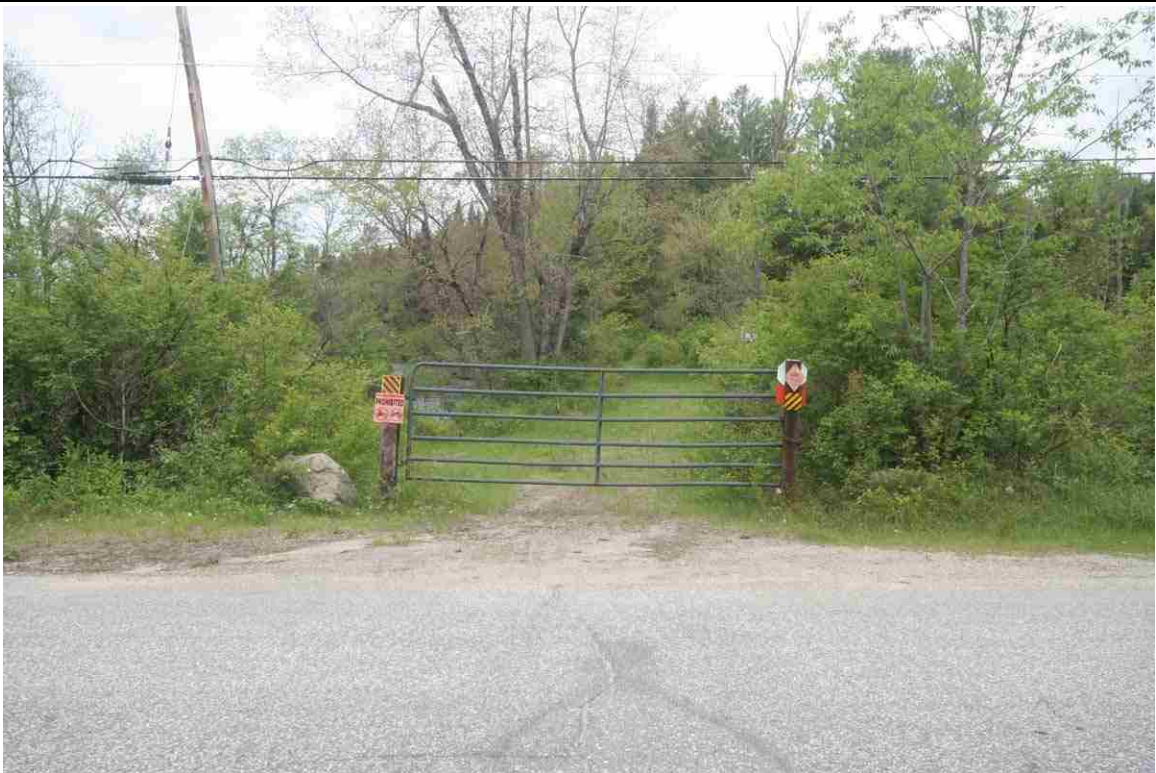
Photo # 10 description: Character of ROW at French Road crossing, mp 128.36, Dalton. (2 of 2).

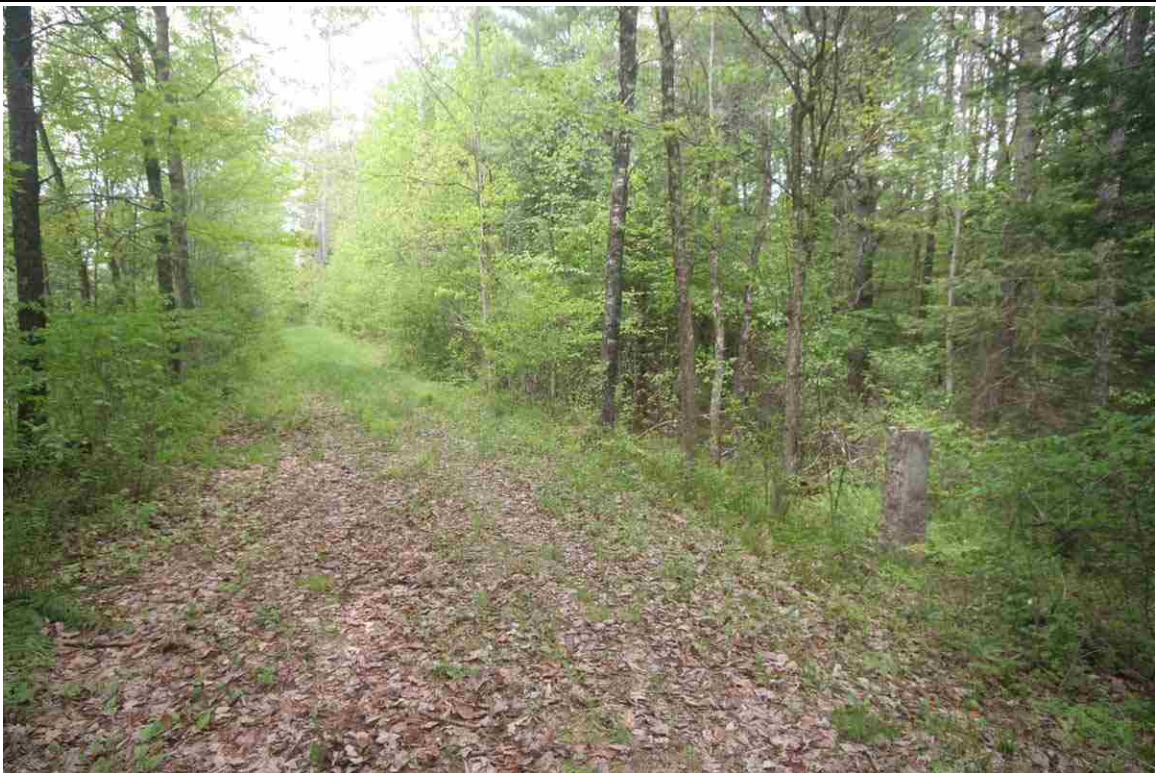
| Feature Name | Mile Post | Town | NR | Photo No. (s) | Date | Notes |
|---|---|---|---|---|---|---|
| Mile marker | ~128.4 | Dalton | C | 12-13 | ? | Granite post, unmarked. Typical condition of ROW/Recreation Trail |

Photo # 12 description: Character of ROW at granite milepost ~128.4, Dalton. (1 of 2).

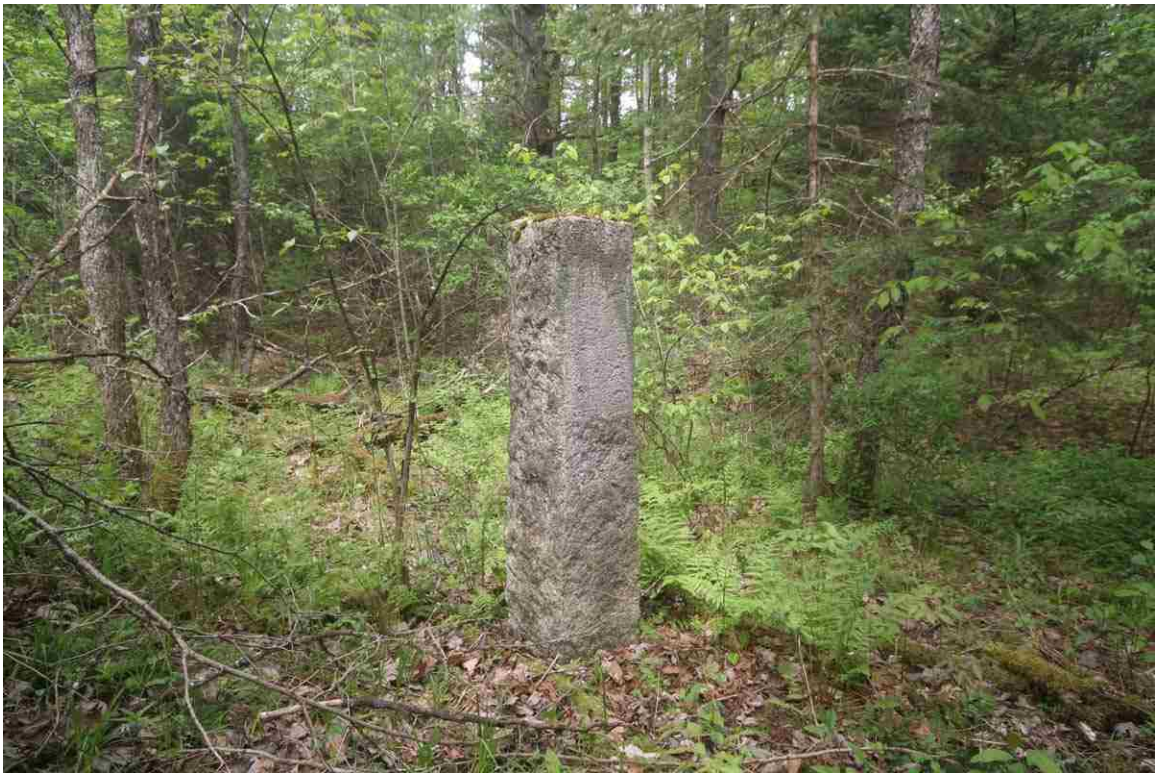
Photo # 13 description: Detail of granite milepost ~128.4, Dalton. (2 of 2).

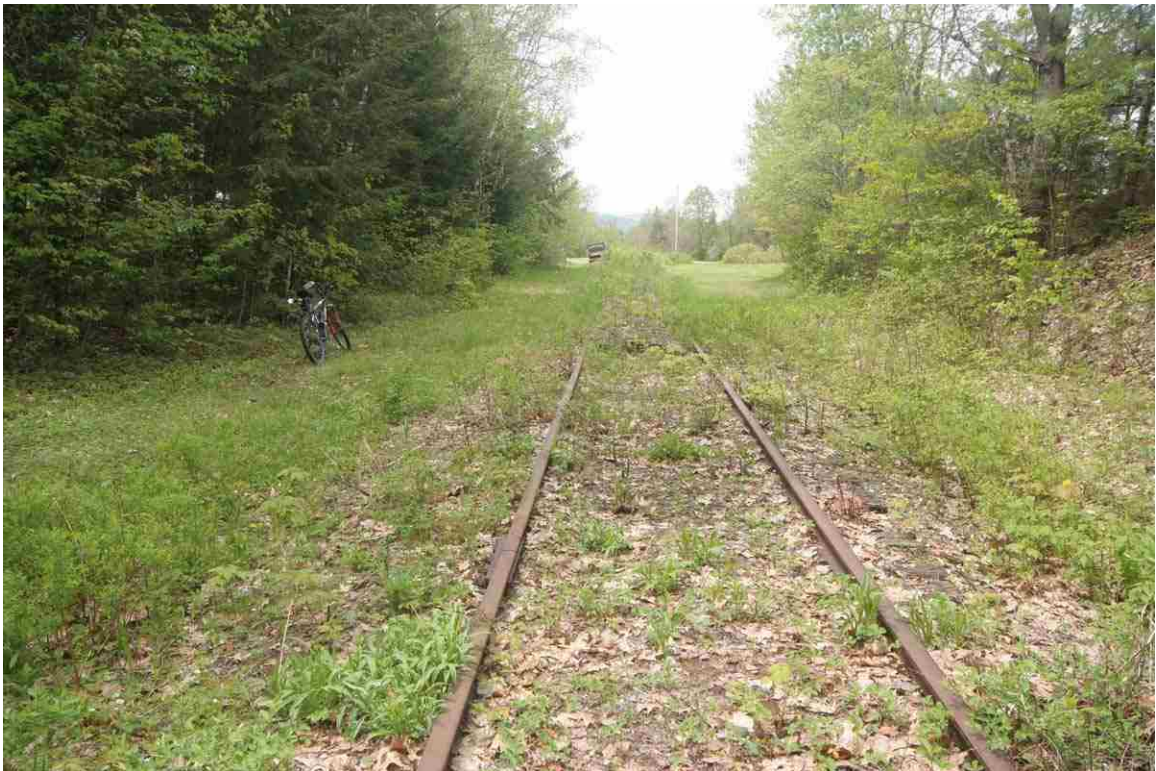
Photo # 16 description: Scotts Junction, view south. Extant MC tracks in foreground; bicycle is parked on slightly raised bed of B&M ROW just before it crosses the MC line. (2 of 2).

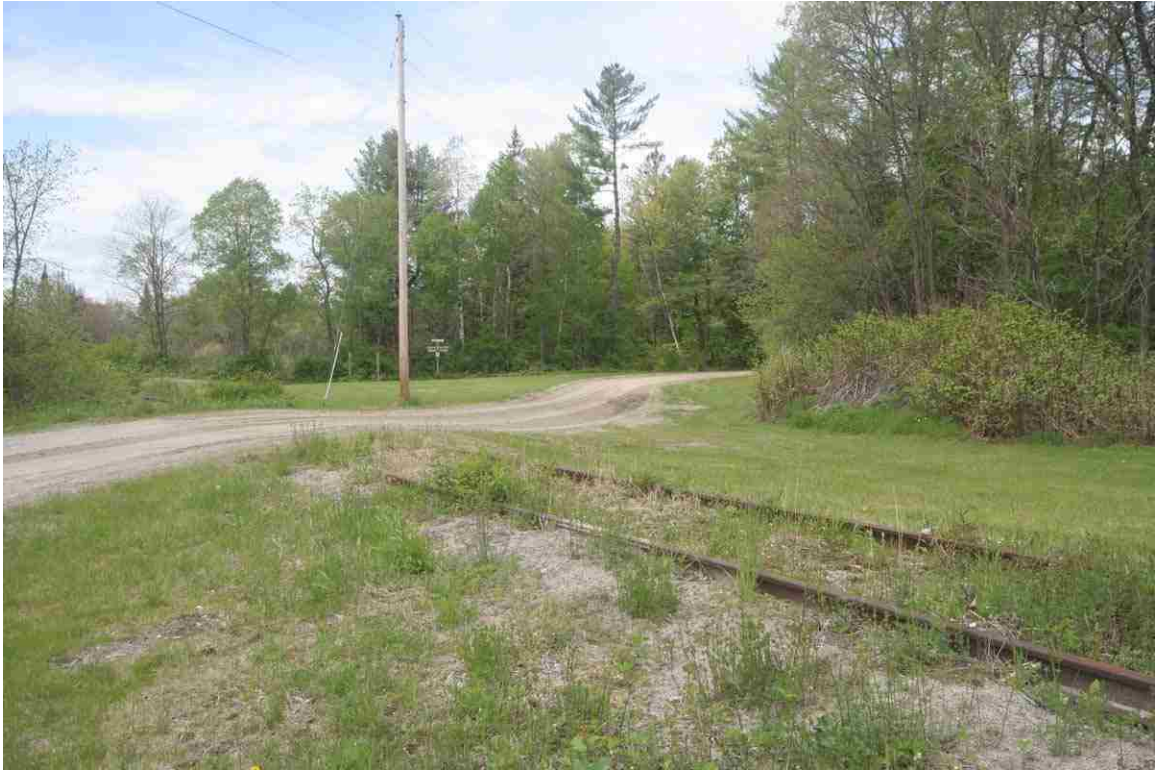
Photo # 17 description: Scotts Junction Road Crossing, Dalton. mp 128.55. B&M ROW is on west side of MC tracks, running to right of utility pole toward trail sign in distance. (1 of 2).

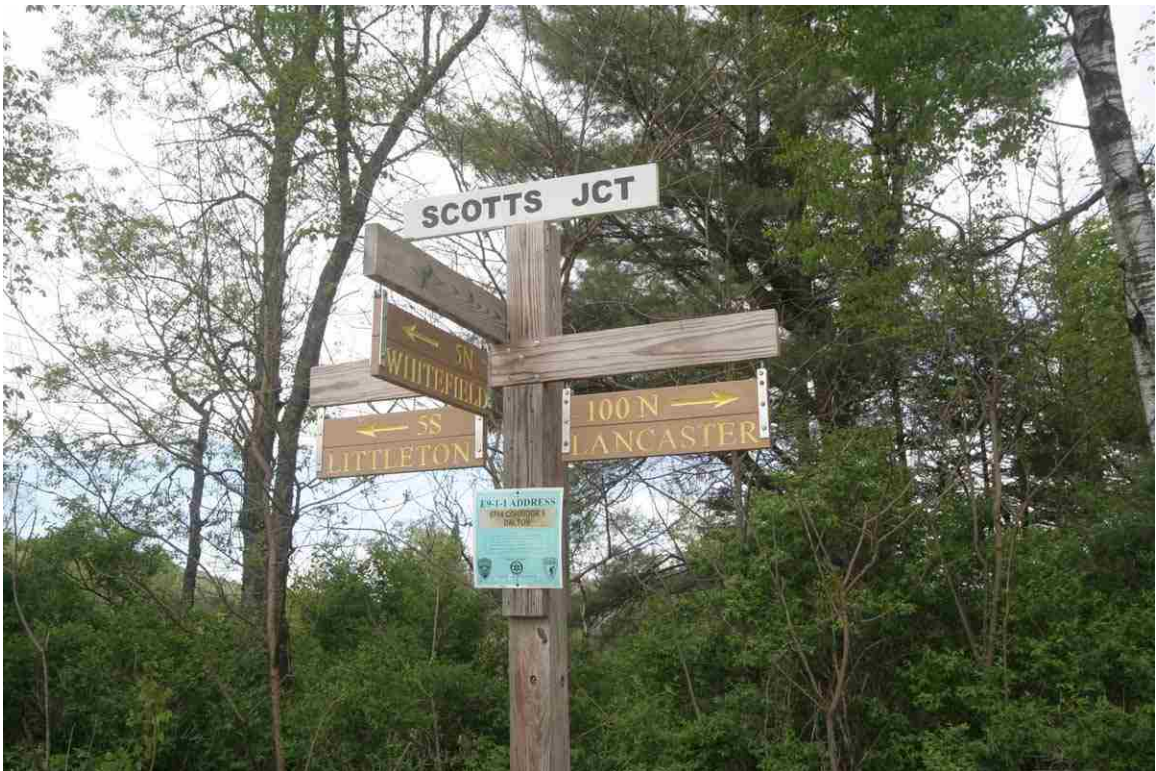
Photo # 18 description: Scotts Junction, Snowmobile Trail marker. B&M ROW continues as Trail No. 100N to Lancaster. (2 of 2).

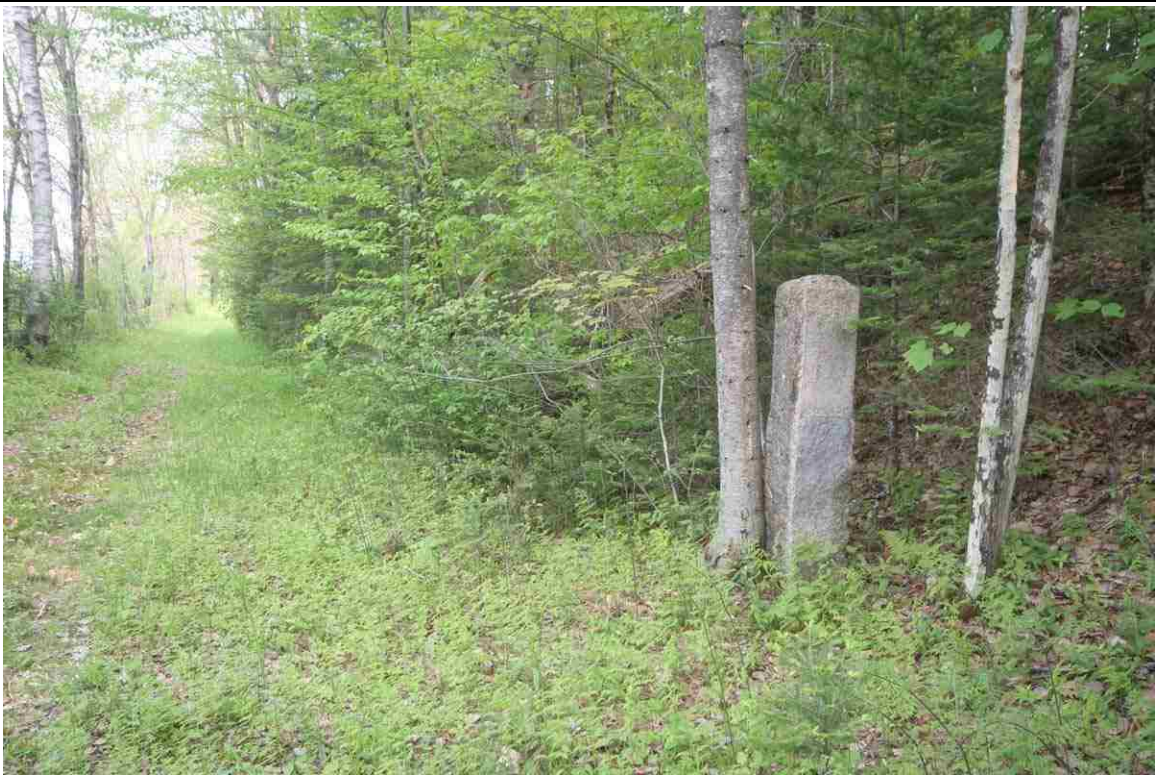
Photo # 22 description: Granite milepost 129.00, Dalton.

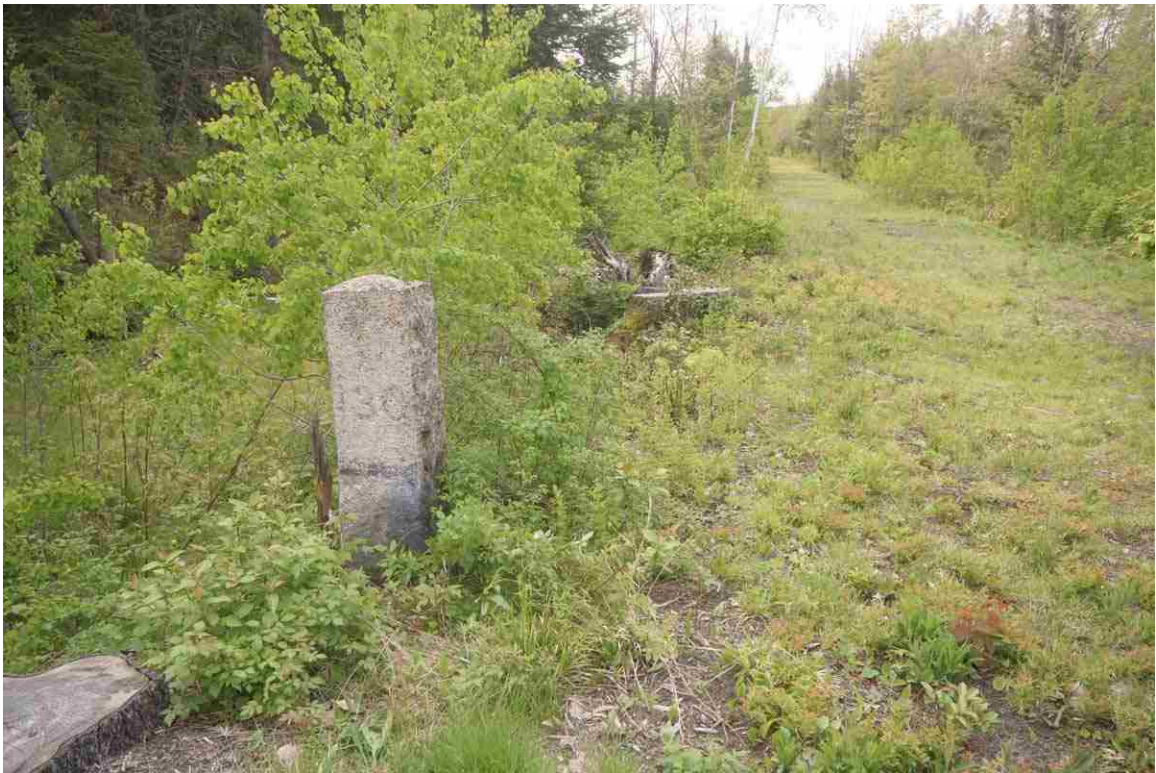
Photo # 25 description: Granite milepost 130.00, Dalton.

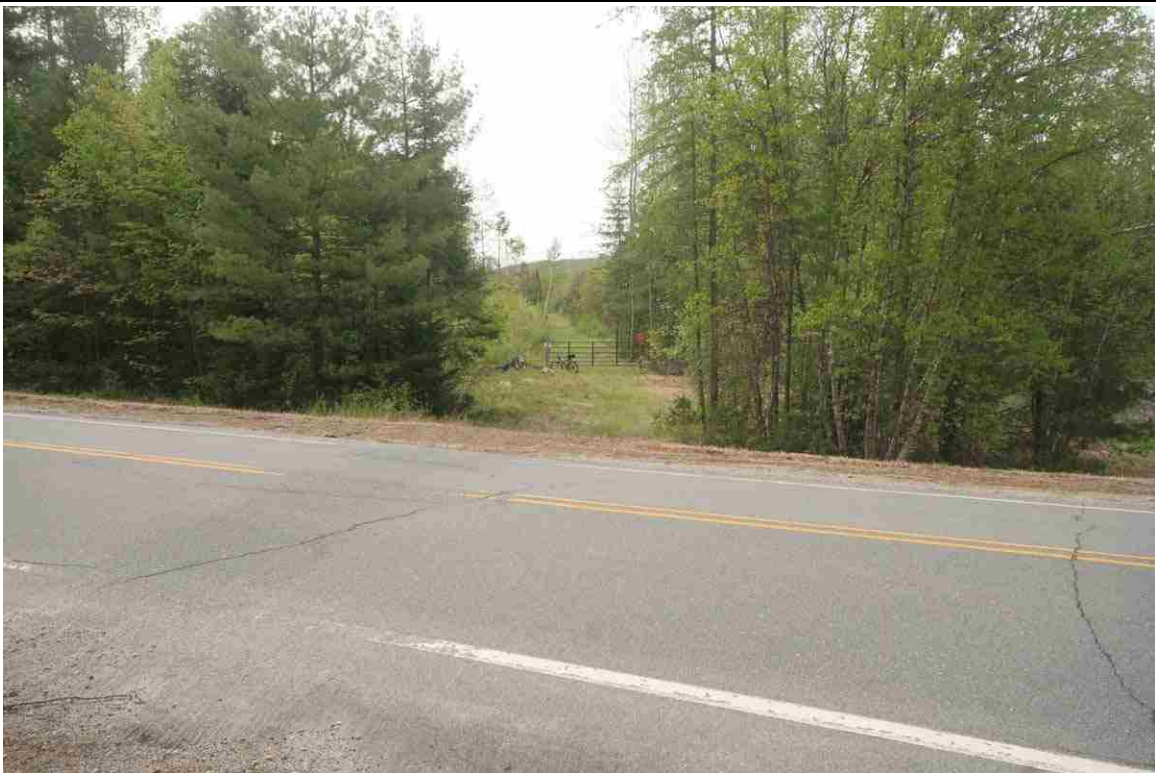
Photo # 26 description: ROW/Trail looking south at Whitefield Road, NH142, Dalton, mp~130.1. Dalton Station and other resources removed; land owned by town used for waste transfer station.

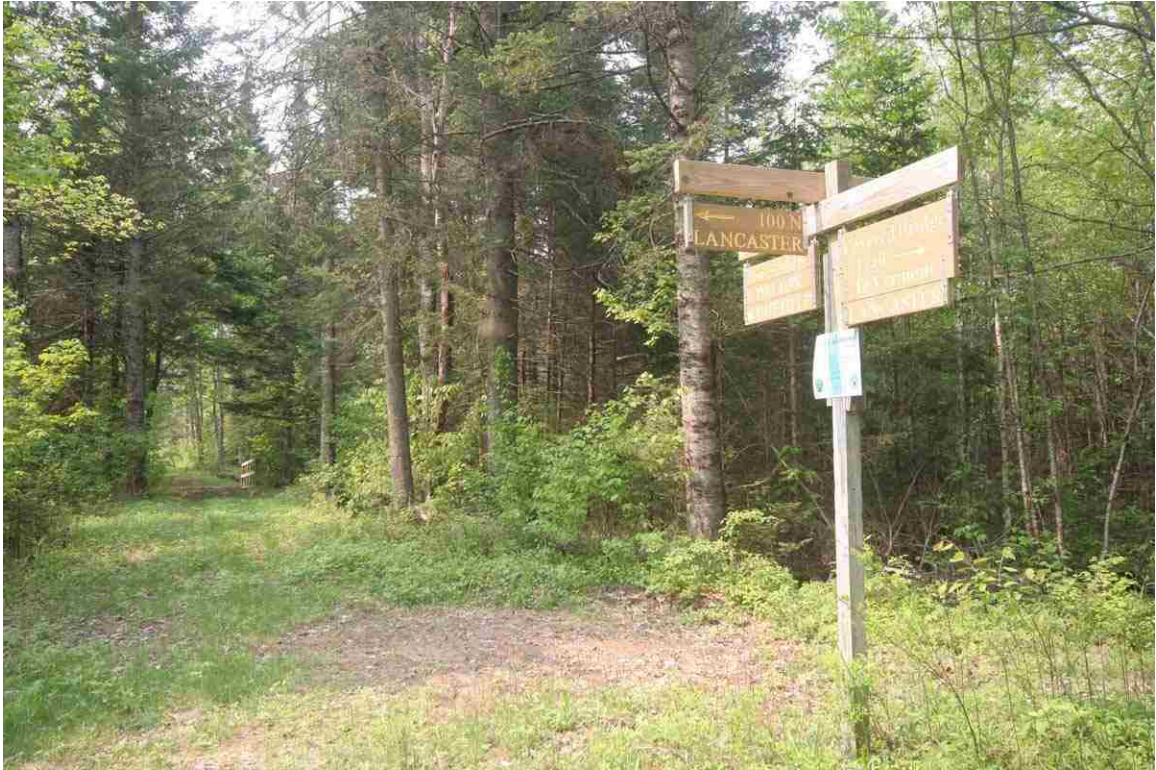
Photo # 29 description: Snowmobile Trail Marker, vicinity mp~130.50, Approximate Dalton-Lancaster line, junction of Trail No. 100 with Covered Bridge Trail. Character of ROW/trail.

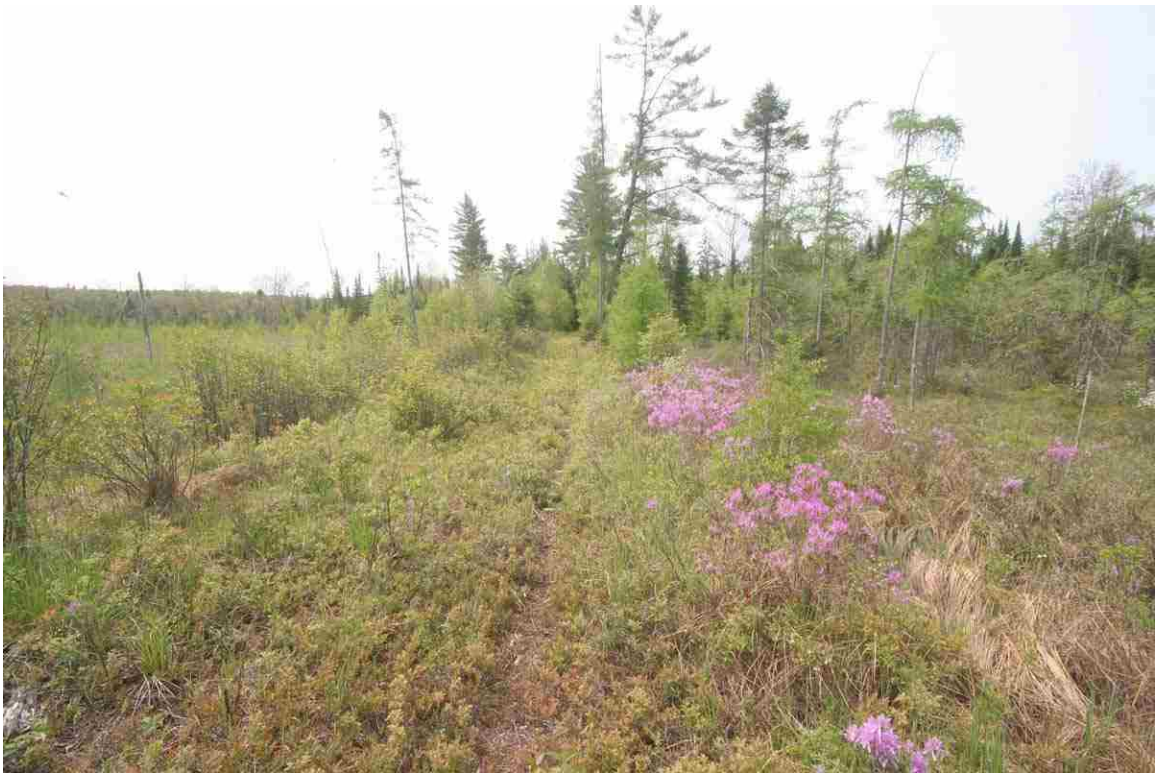
Photo # 31 description: Character of ROW at mp~131.26, Lancaster, looking south (1 of 2).

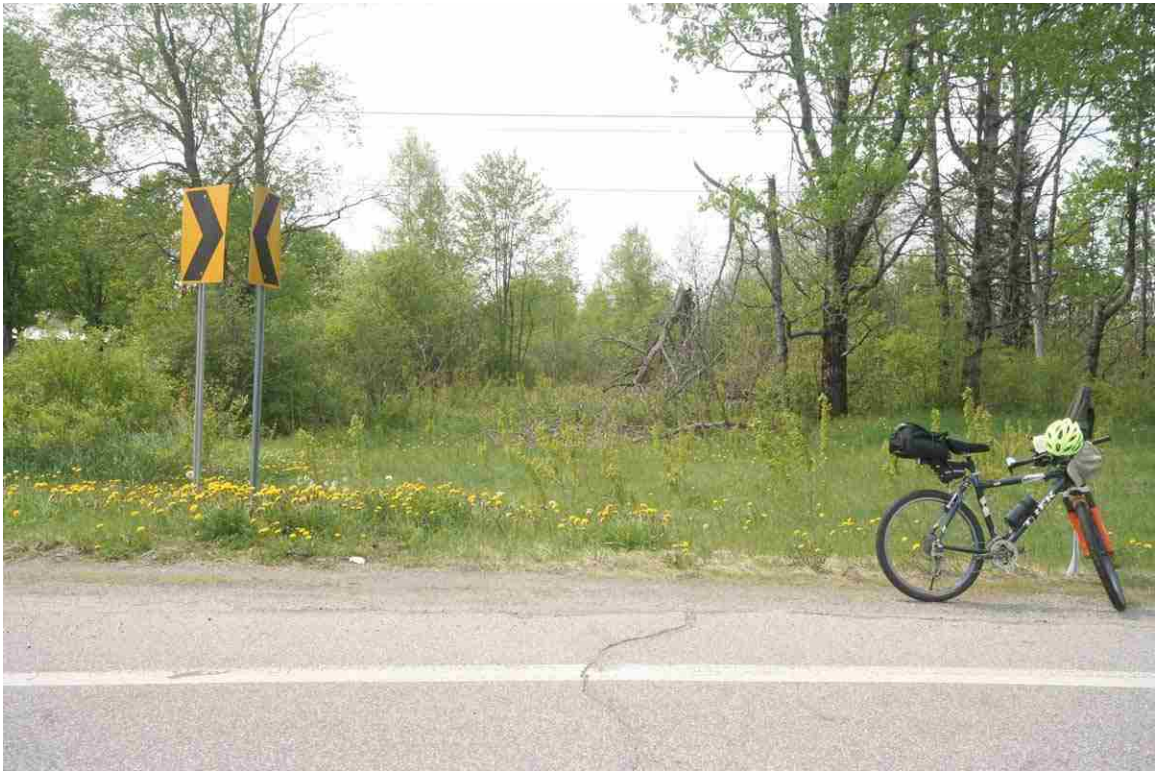
Photo # 33 description: ROW/Trail looking south from Elm St. NH135, Lancaster, mp~132.00. Trail terminates at Elm Street. (1 of 2).

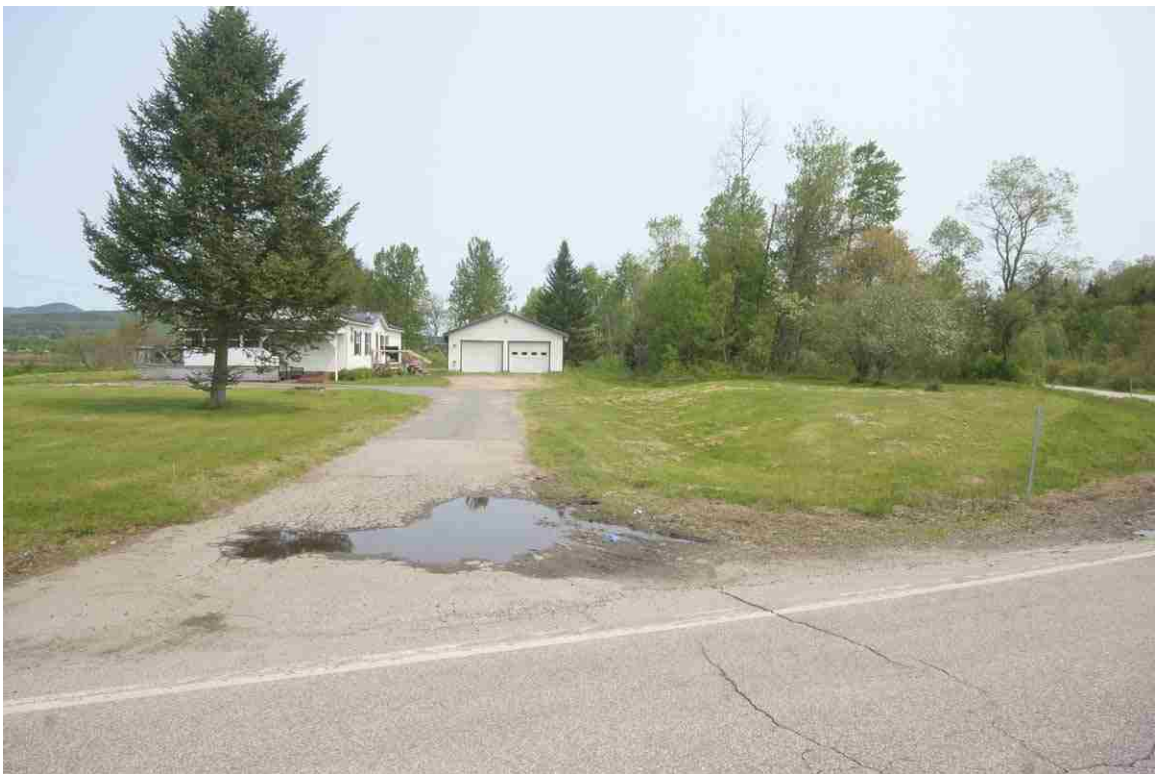
Photo # 34 description: Former ROW looking north Elm St. NH135, Lancaster, mp~132.00. (2 of 2). ROW now private; driveway and garage built on ROW.

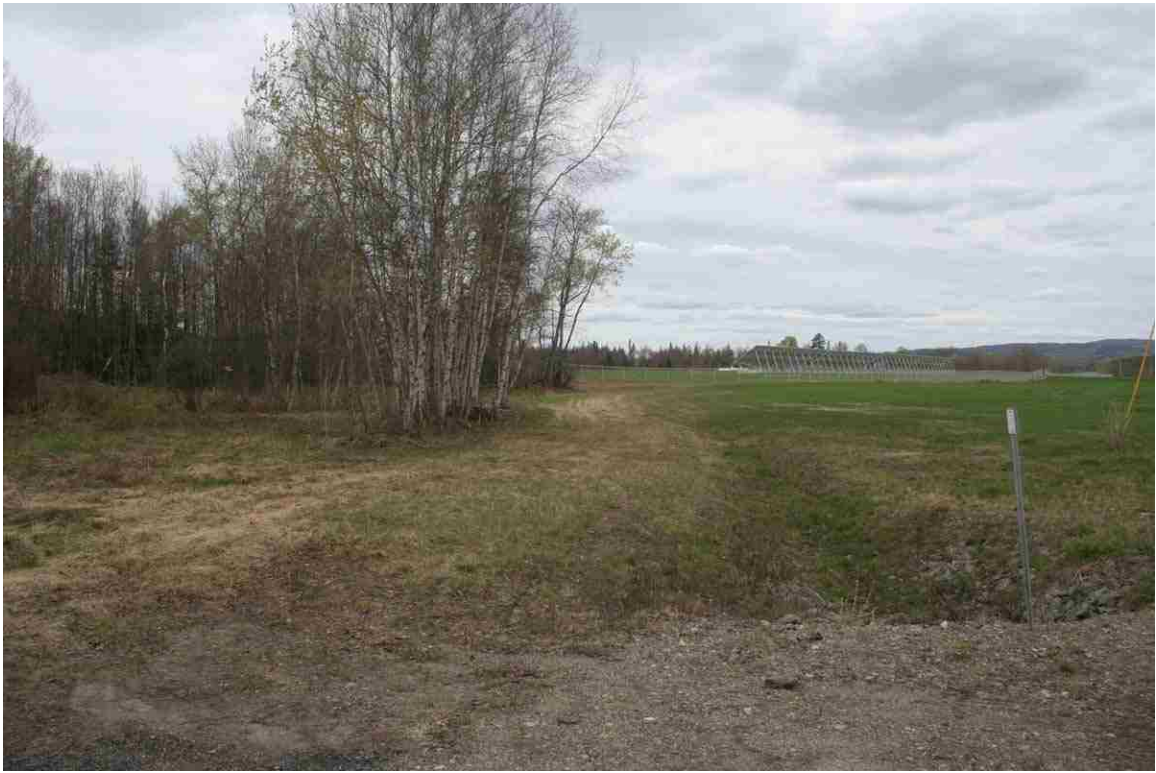
Photo # 35 description: Character of former ROW at Water St. Lancaster, mp~135.43. Looking south across town property. No visible physical evidence of ROW. (1 of 2).

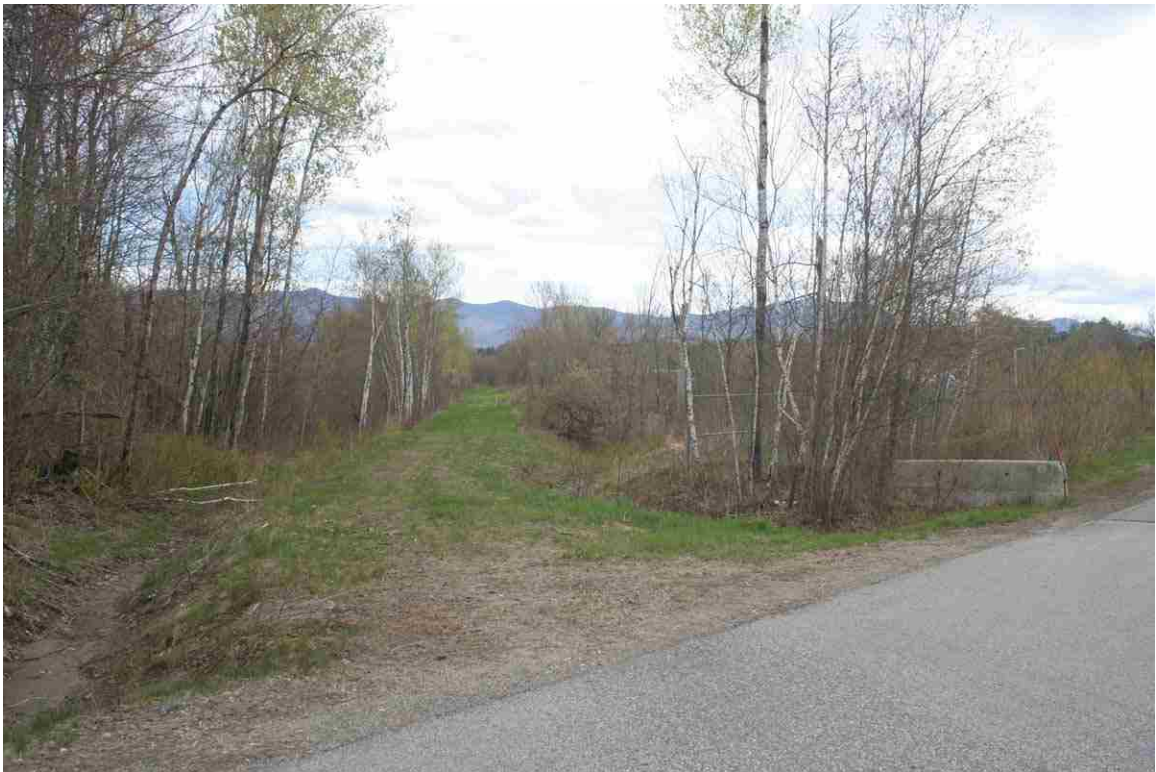
Photo # 36 description: Character of former ROW at Water Street, Lancaster, mp~135.43. Looking north (2 of 2). ROW located on Town property, used as snowmobile trail but not designated as such.

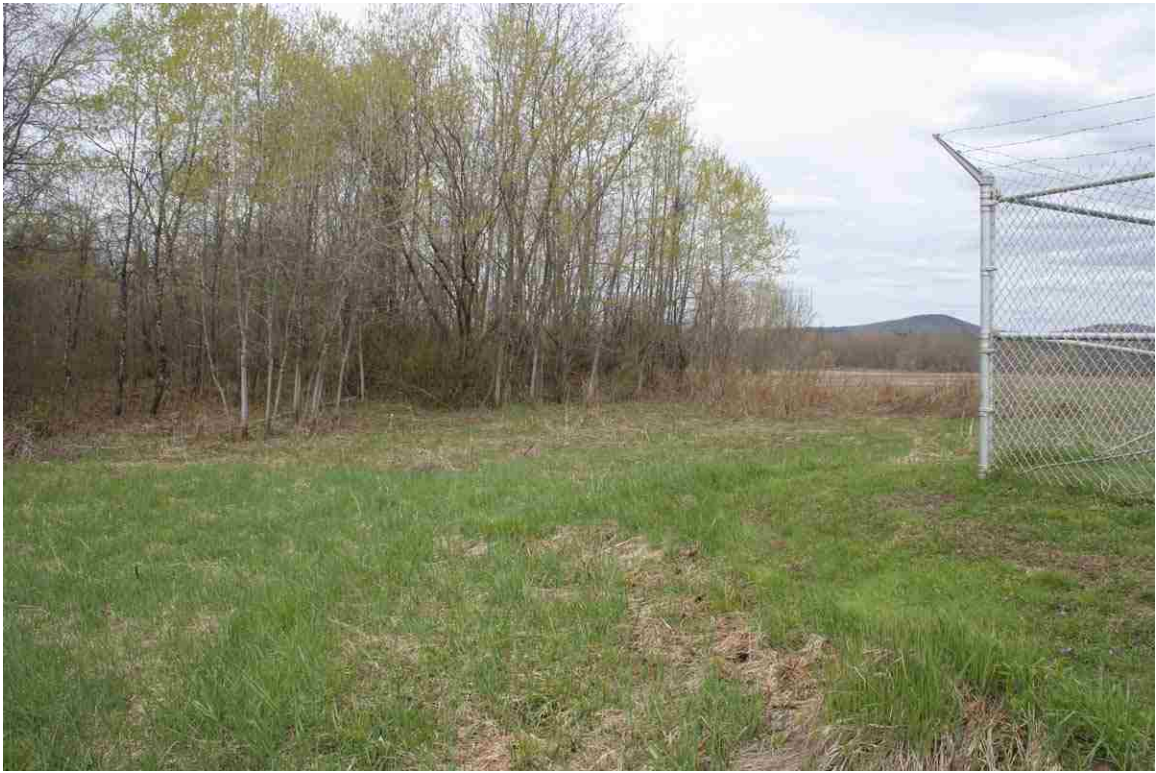
Photo # 37 description: Character of former ROW located in dense impassable tree line at center of photo. ~mp 136.00. Fence at right is Lancaster Water Treatment plant built on ROW. (1 of 2).

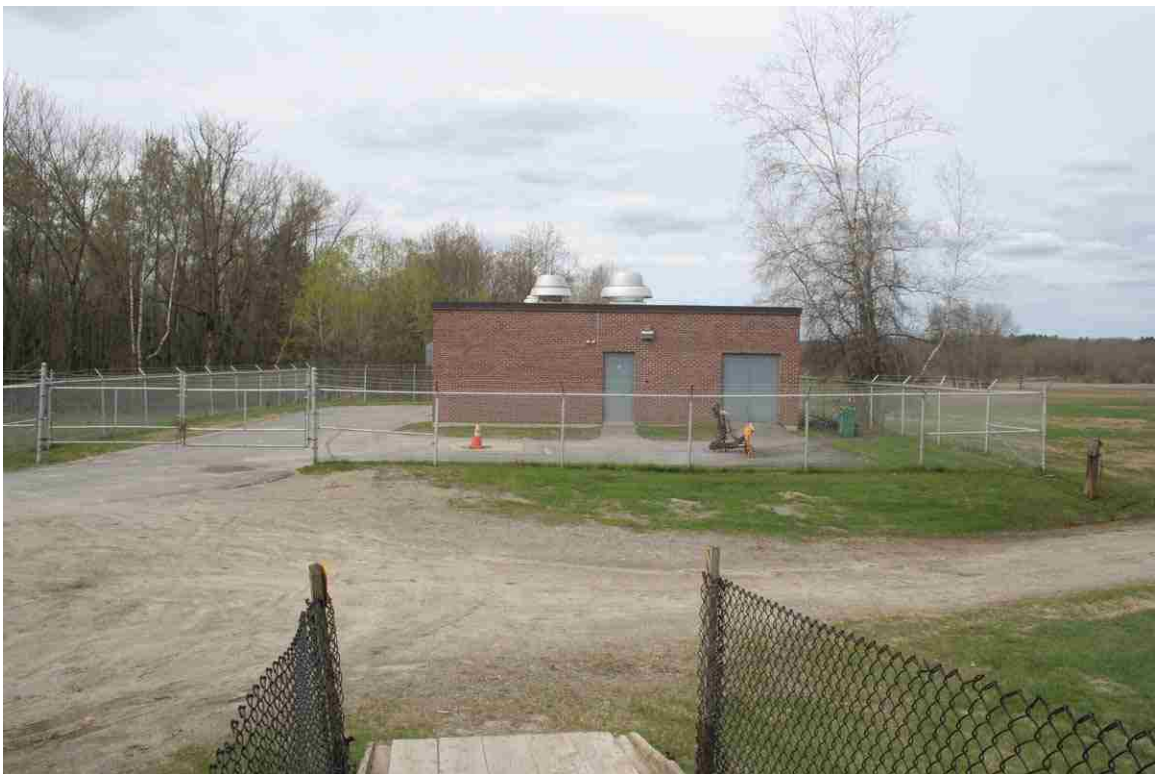
Photo # 38 description: Lancaster Water Treatment plant built on ROW at foot of Heath St. on Israel R. ~mp 136.00. (2 of 2). Photo from Israel R. snowmobile bridge built next to ROW crossing.

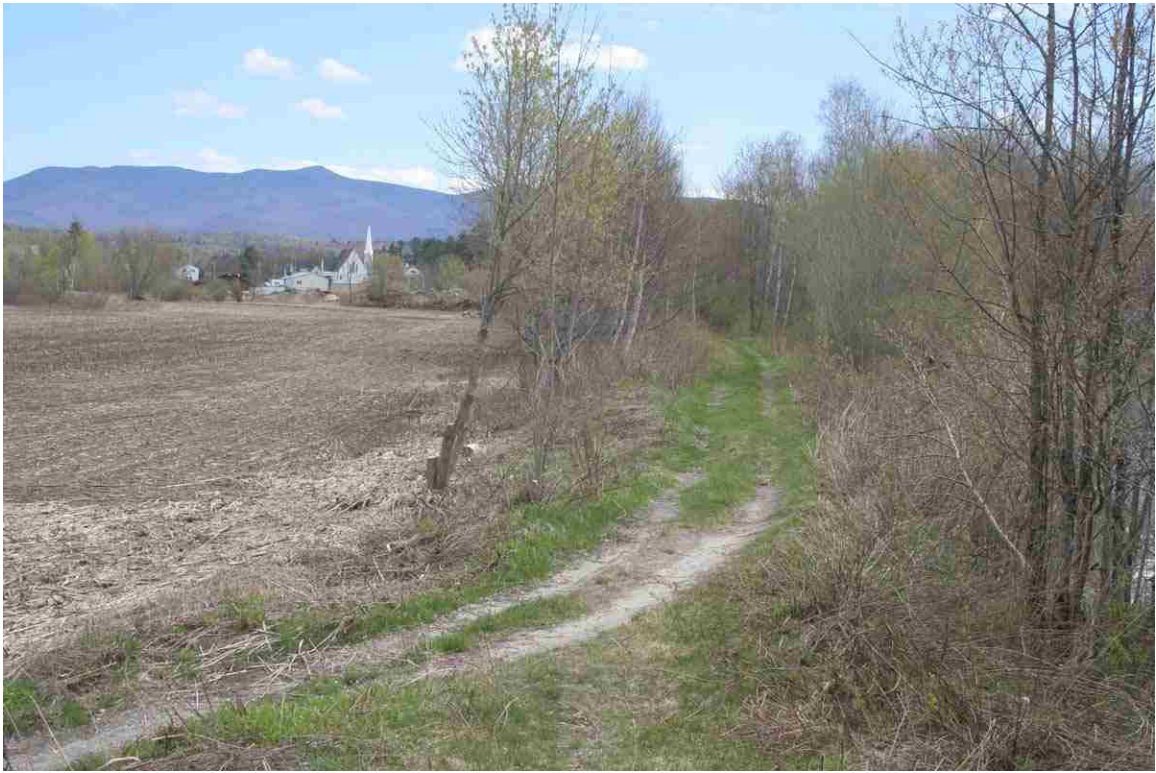
Photo # 41 description: Character of former ROW running northeast from Israel R. Bridge. ~mp 136.02. On Lancaster town property. Main Street visible in distance.

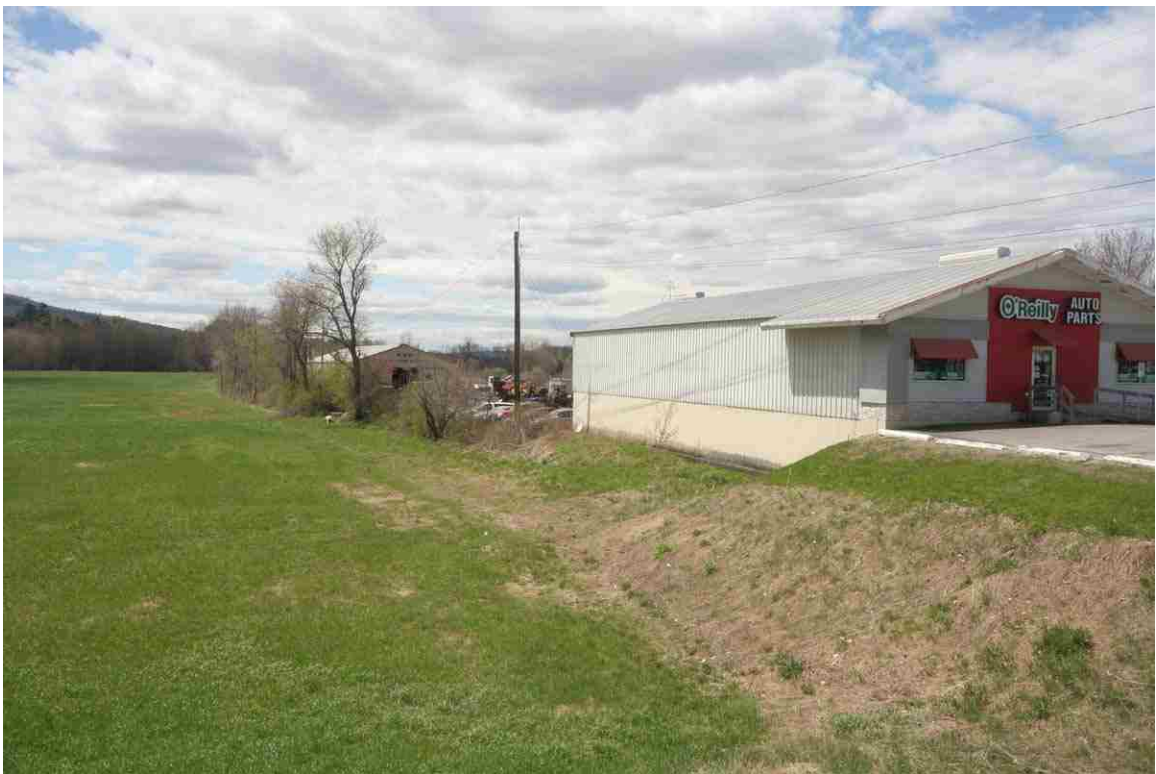
Photo # 42 description: Character of former ROW south of Main St., Lancaster. ~mp 136.49. Tree line marks east edge of ROW now privately owned and occupied by metal commercial buildings. (1 of 3).

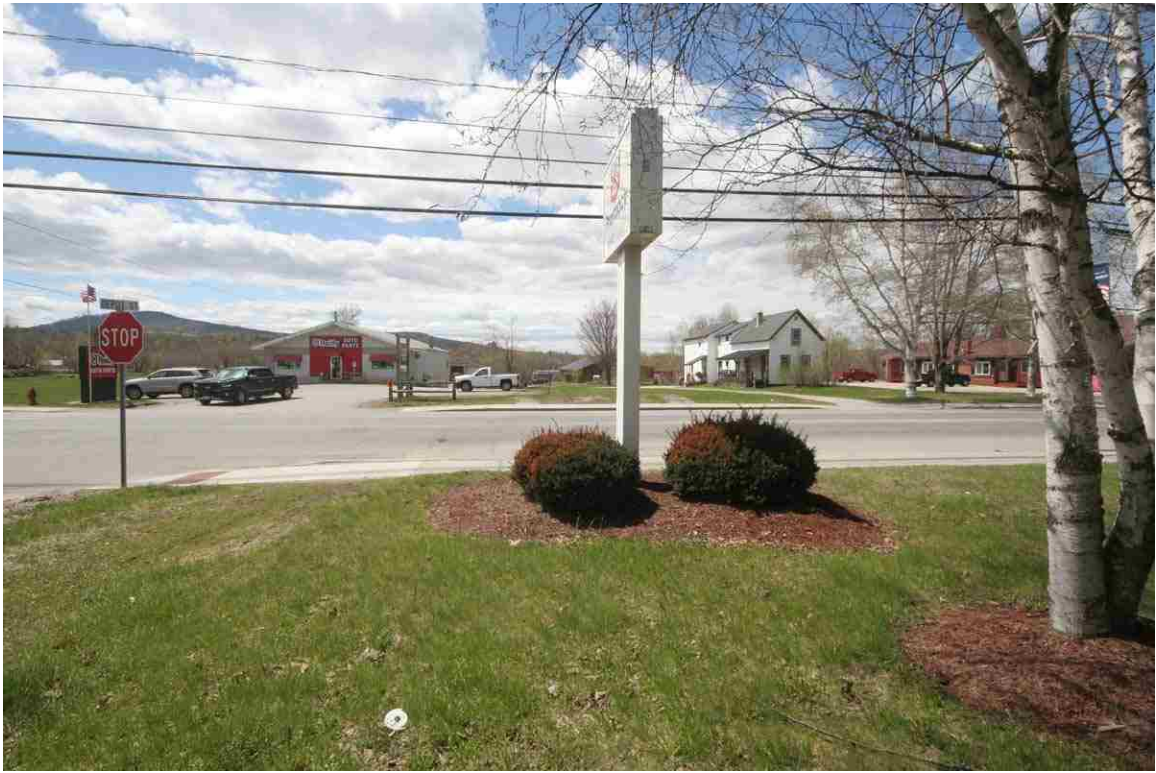
Photo # 43 description: Character of former ROW crossing Main St., Lancaster onto Depot Street and partly through city park. ~mp 136.49. View to commercial buildings south of Main St. (2 of 3).
