**TABLE OF OBSERVED FEATURES  
 SURVEY AREA 4  
 WHITEFIELD-GROVETON LINE  
 PAGE ROAD, DALTON TO  
 SUMMER STREET, LANCASTER (COOS JUNCTION)**

**PHOTOGRAPHS  
SURVEY AREA 4  
PROFILE HOUSE BRANCH  
WHITEFIELD-GROVETON LINE  
PAGE ROAD, DALTON TO  
SUMMER STREET, LANCASTER (COOS JUNCTION)**

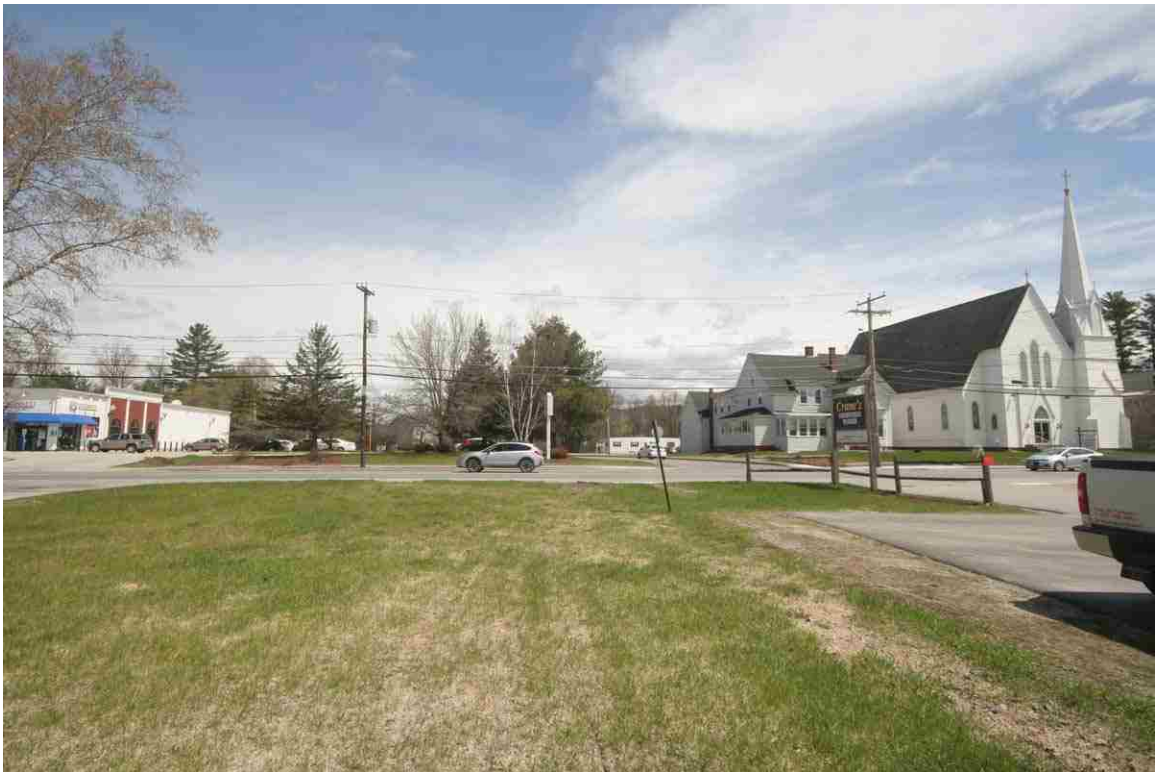
Photo # 44 description: Character of former ROW crossing Main St., Lancaster, ~mp 136.49. Running northeast along Depot St. and city park. (3 of 3).

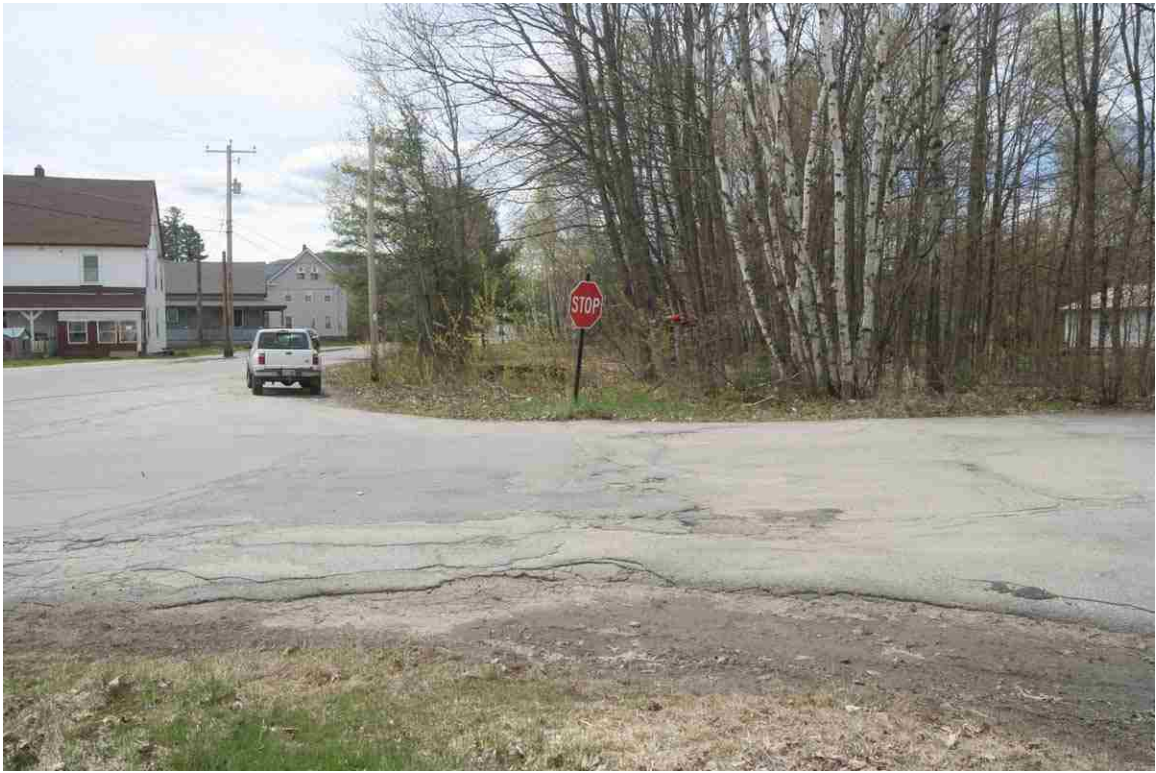
Photo # 45 description: Character of former ROW at Depot St. & Railroad St, Lancaster. ~mp 136.65. Stop sign in approx. middle of ROW. Station was located here. (1 of 2).

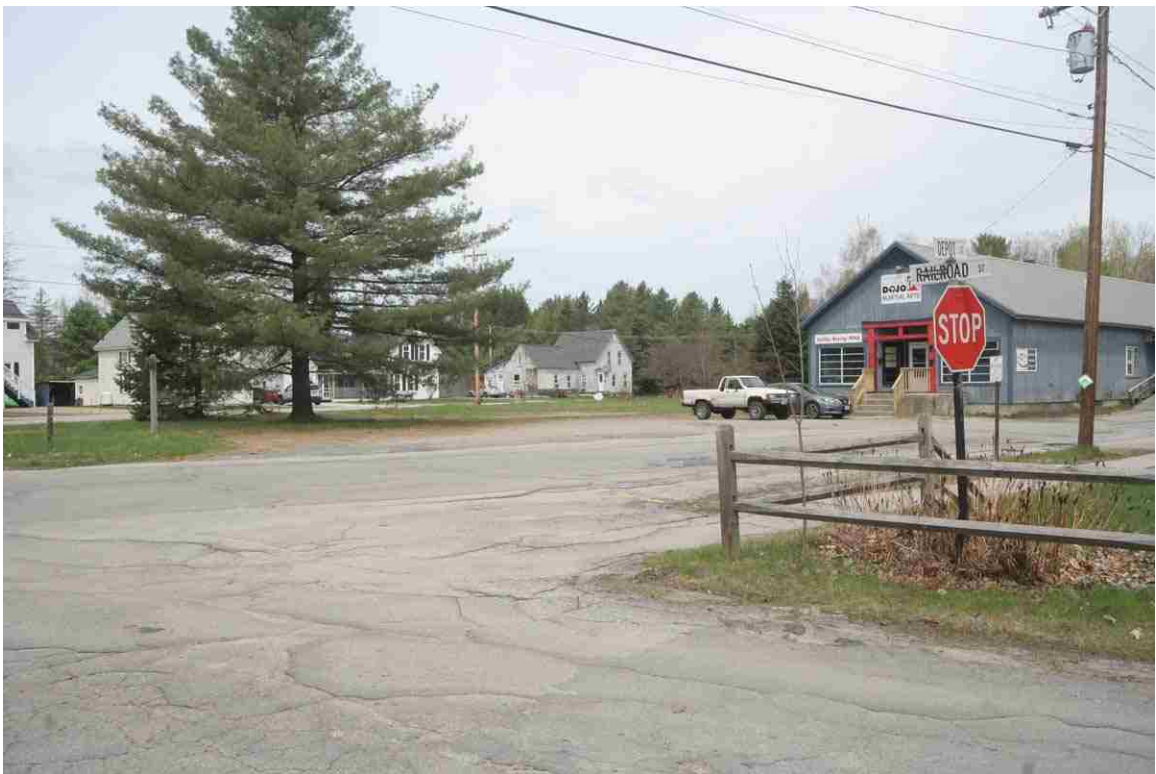
Photo # 46 description: Character of former ROW at Depot St. & Railroad St, Lancaster. ~mp 136.65. Former feed store at right begins line of former depot buildings.

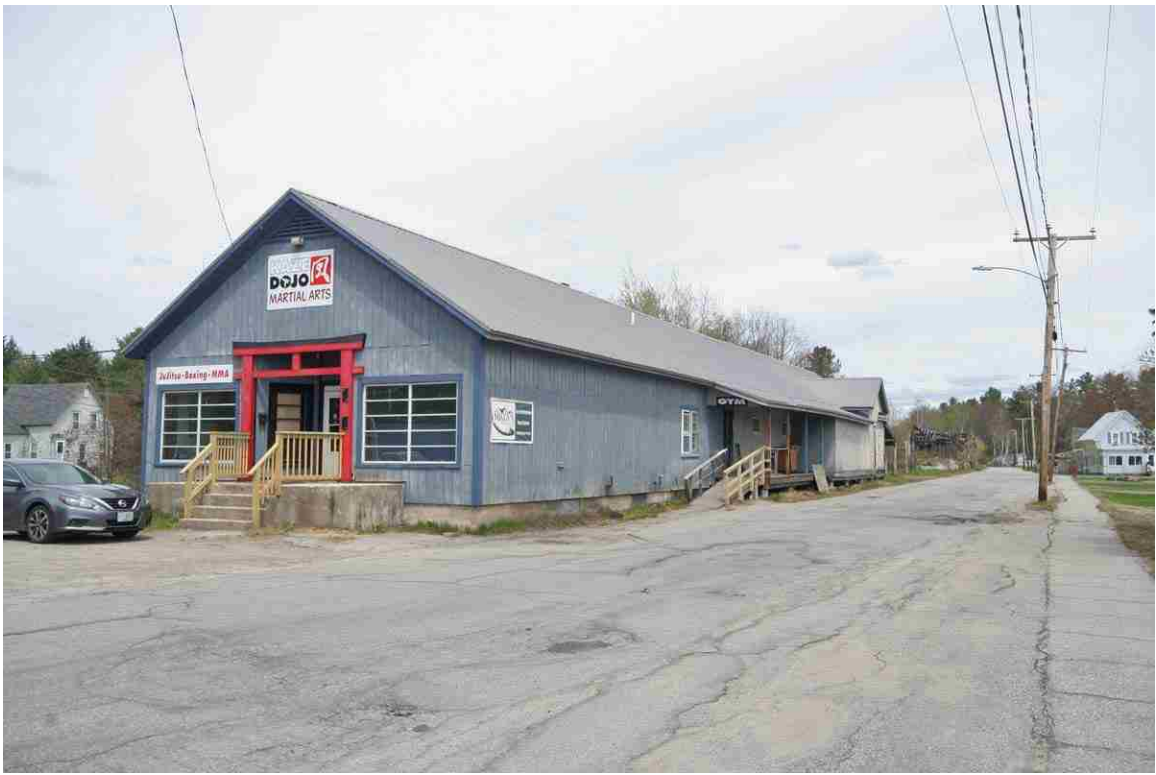
Photo # 47 description: Former "Feed & Supply" building on Depot St. (at right), Lancaster. ~mp 136.72. B&M ROW ran behind (west side) of Depot buildings. nd. (1 of 3).

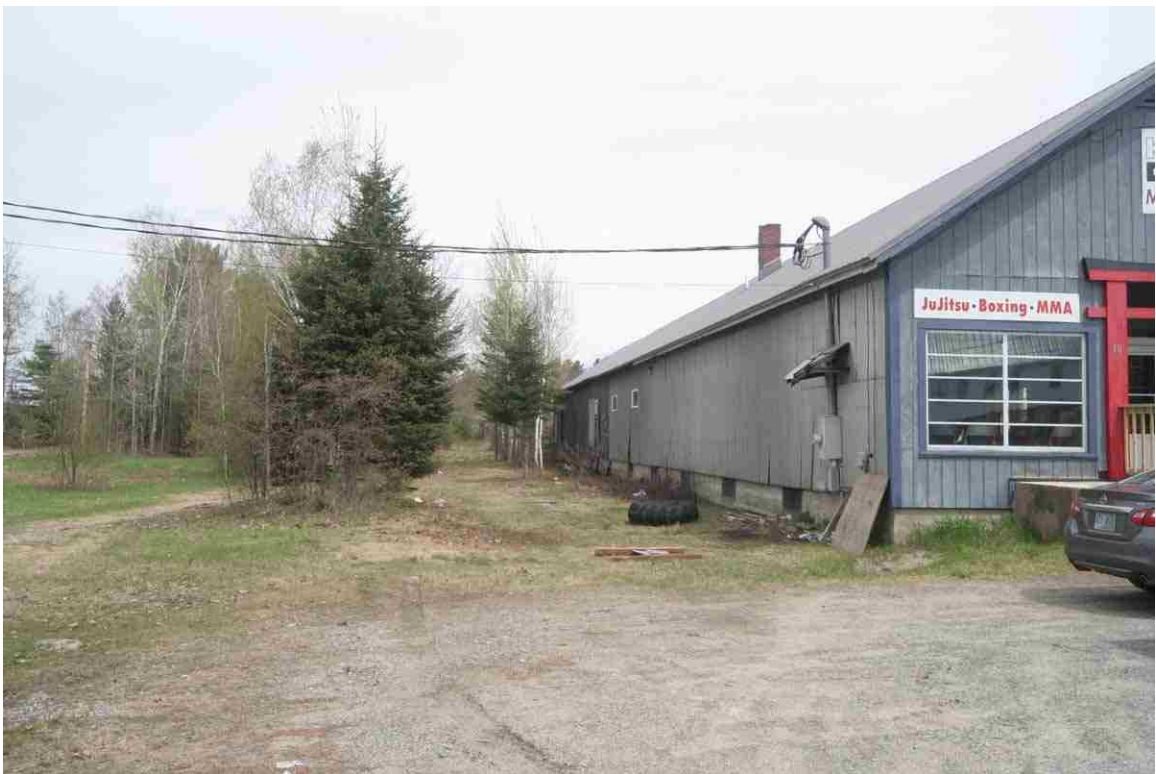
Photo # 48 description: Former ROW on west side of "Feed & Supply" building on Depot St. (at right), Lancaster. ~mp 136.72. (2 of 3).

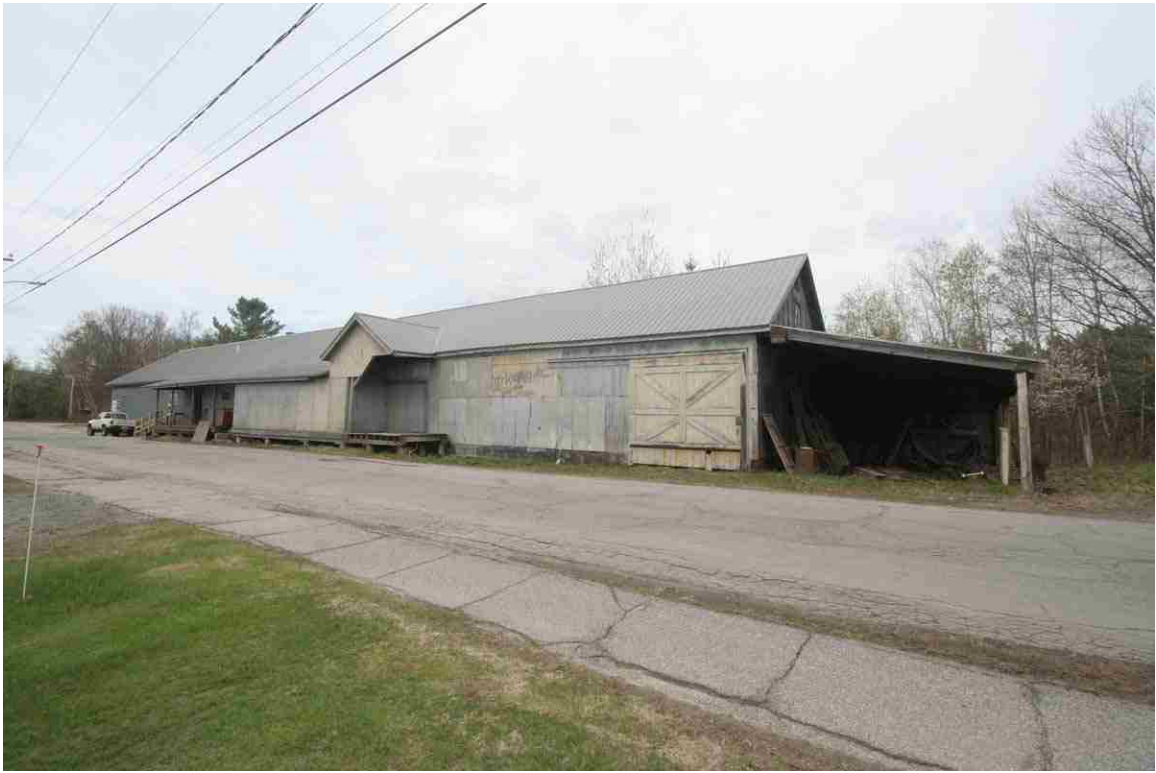
Photo # 49 description: Former "Feed & Supply" building on Depot St., Lancaster. ~mp 136.72. (3 of 3).

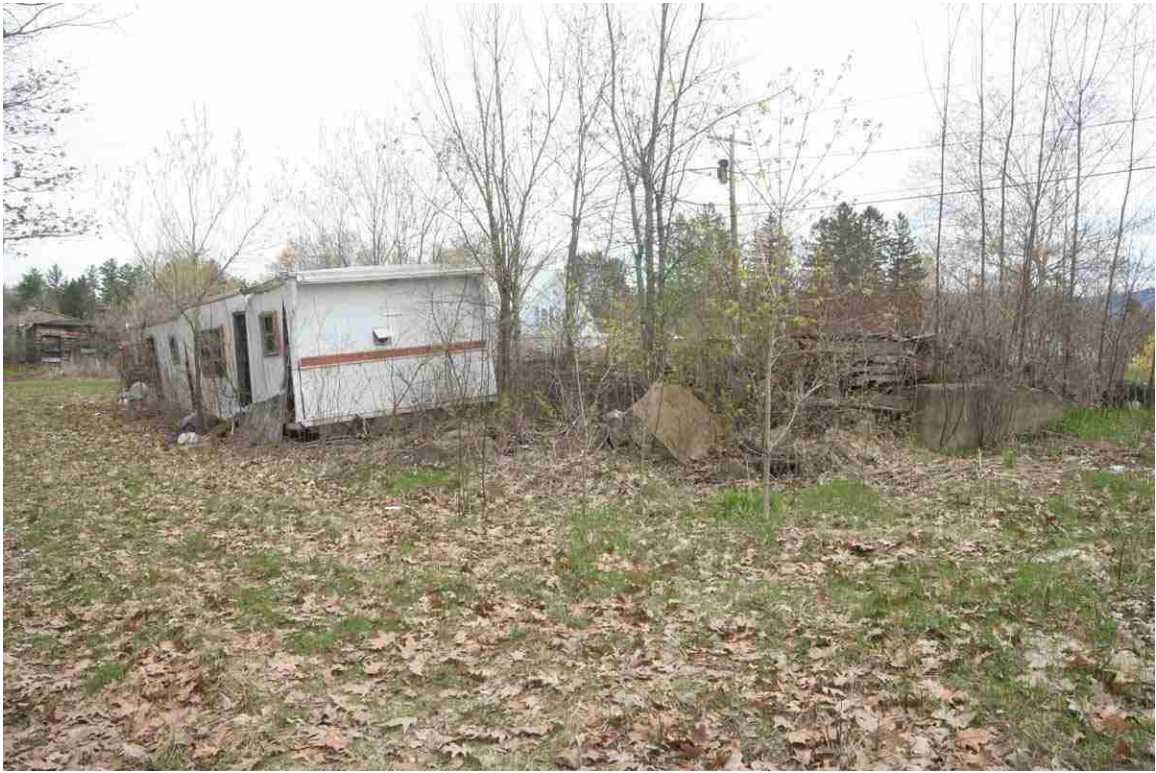
Photo # 51 description: ROW along west side of former B&M Depot building foundation on Depot St., Lancaster. Trailer sits on ROW. Two tracks ran behind depot buildings; no evidence of tracks remains.

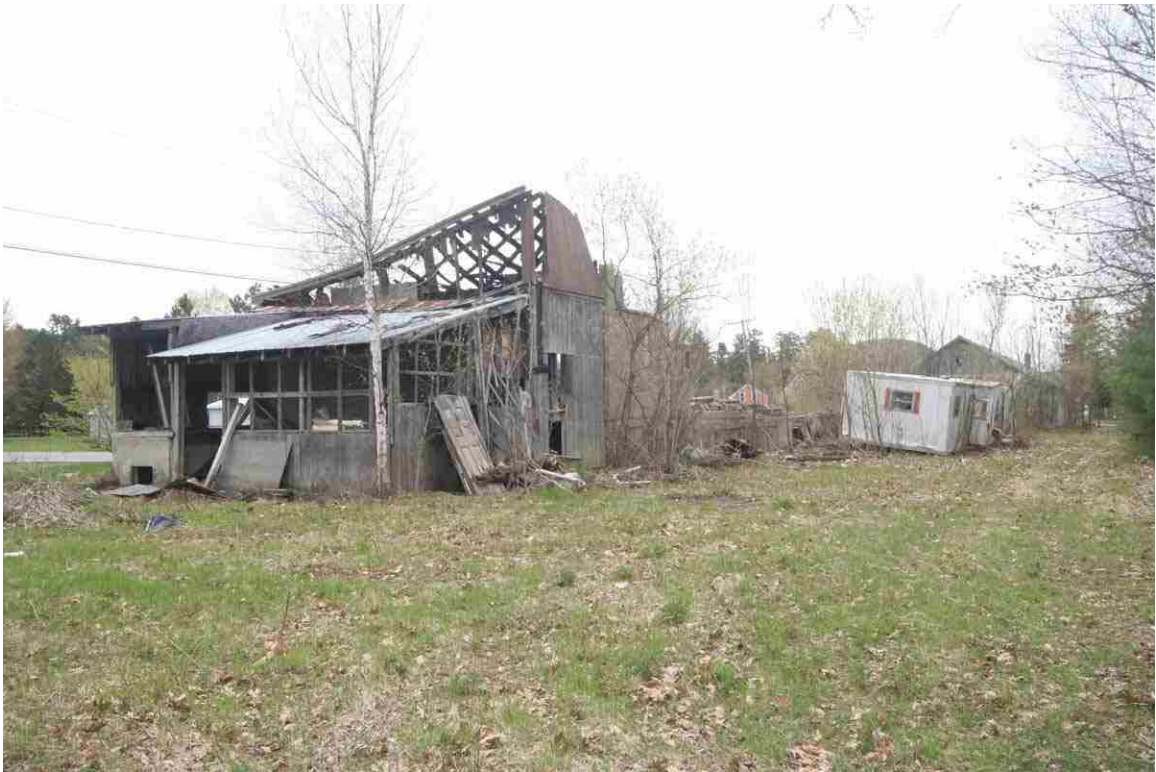
Photo # 52 description: Remains of depot buildings along Depot St., Lancaster. ~mp 136.78. Photo from center of former ROW, looking south.

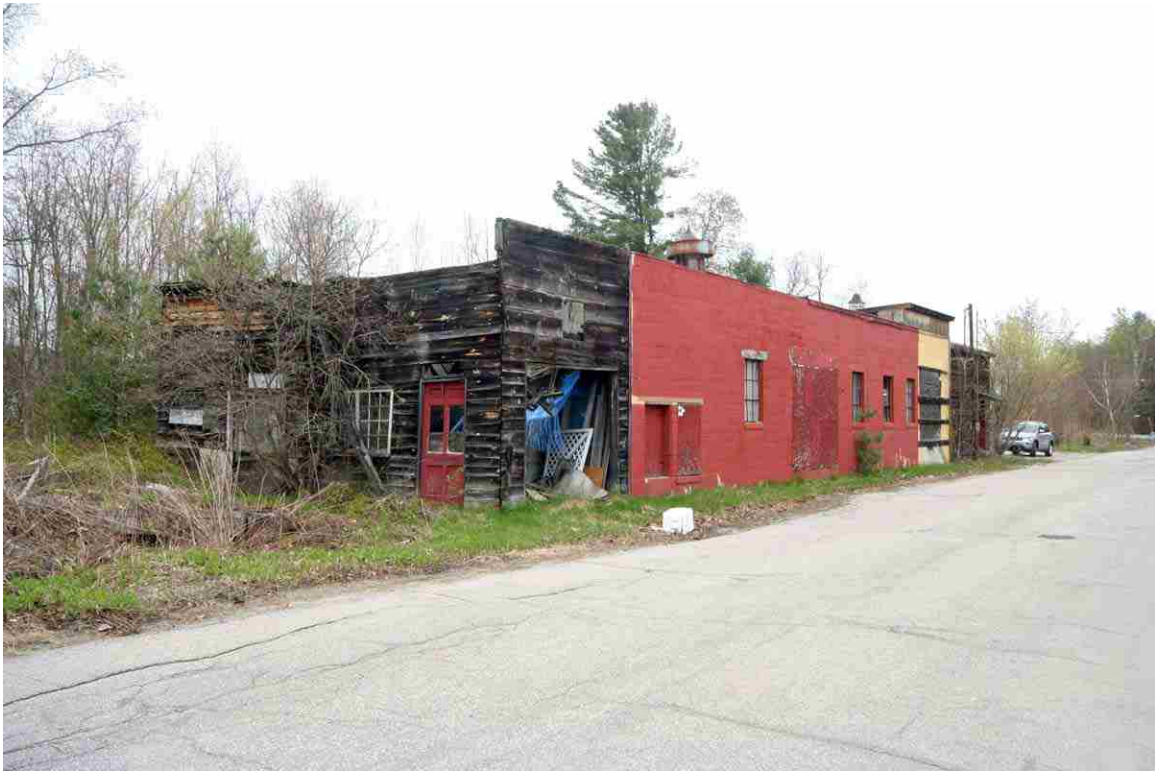
Photo # 53 description: Former railroad depot-related building(s) at north end of Depot St. Lancaster. ~mp 136.82.  
(1 of 2).

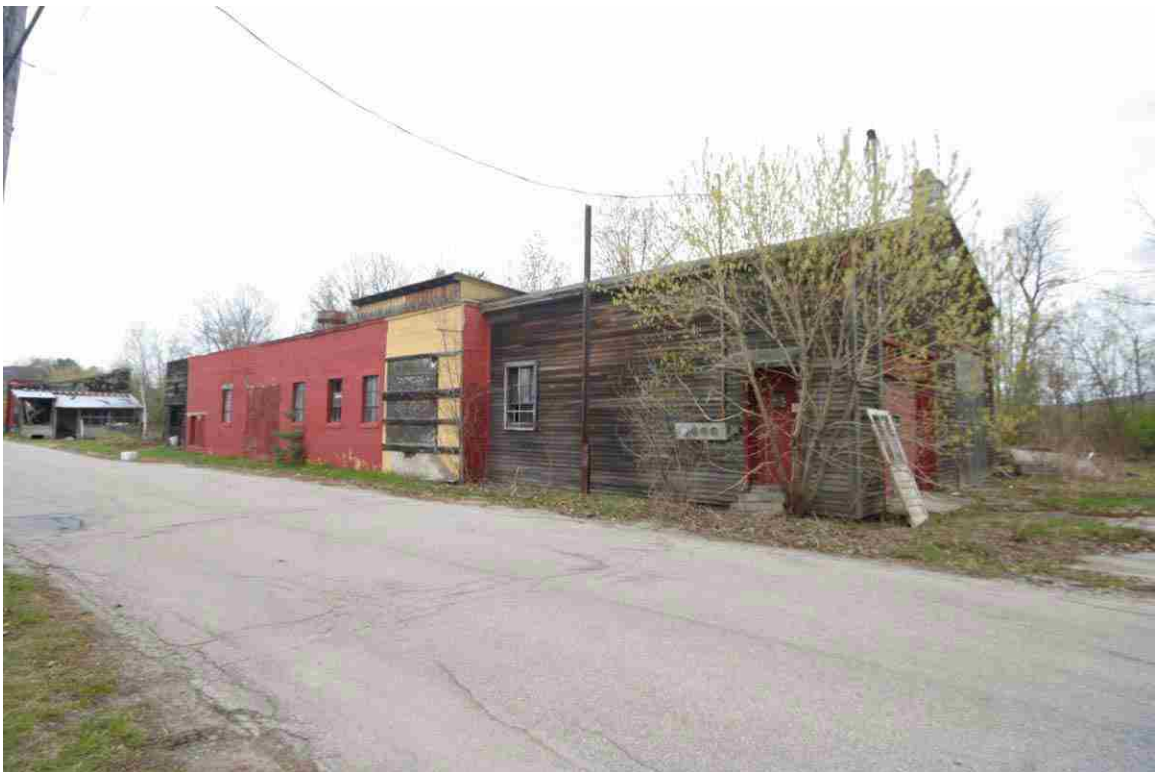
Photo # 54 description: Former railroad depot-related building(s) at north end of Depot St. Lancaster. ~mp 136.82.  
(2 of 2).

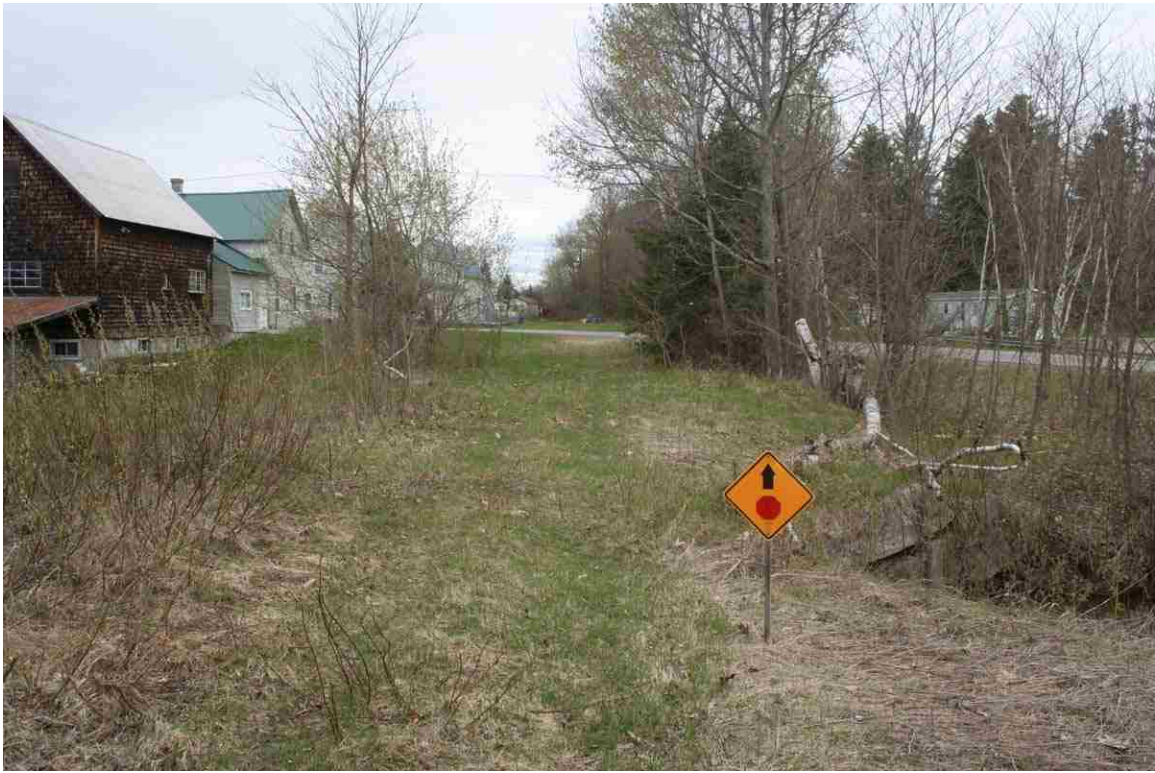
Photo # 55 description: ROW at north end of Depot St. before crossing metal culvert and Kilkenny St., Lancaster. ~mp 136.84.

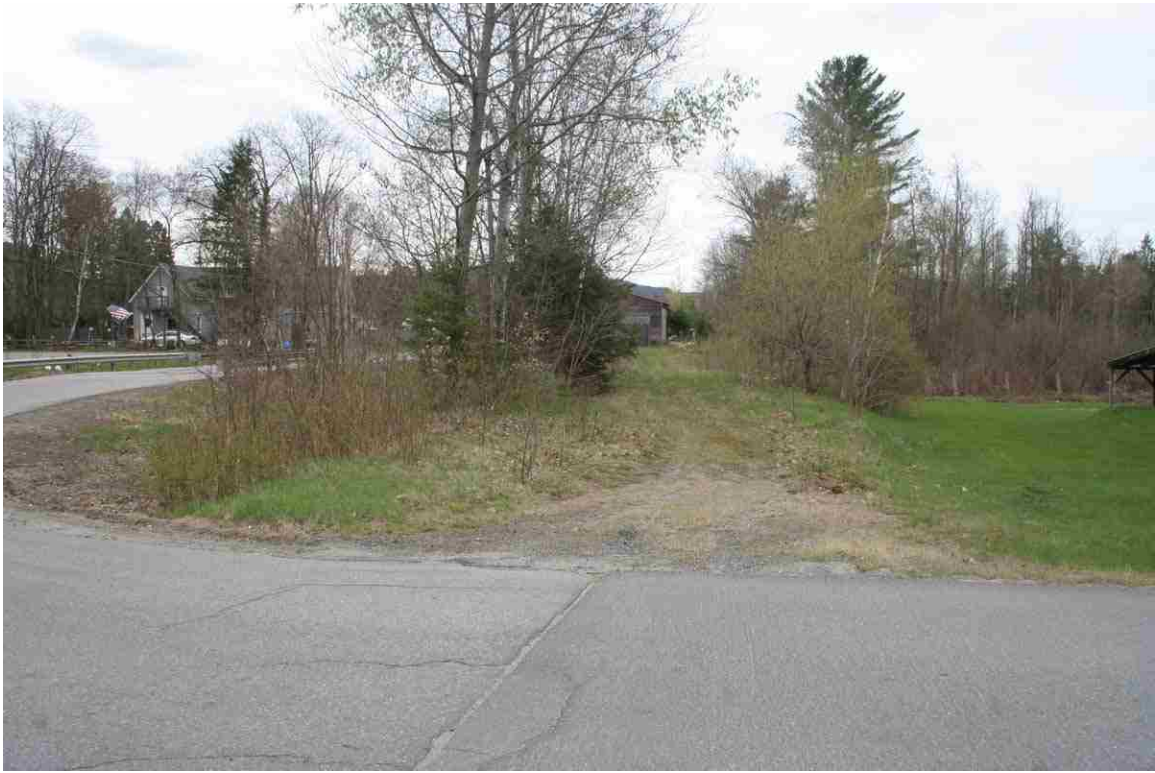
Photo ID #: S4\_1140 Direction: W Date: 5/13/2019 Image stored at: HDC

Photo # 56 description: Metal arch culvert carrying ROW over unnamed stream near Kilkenny St., Lancaster. ~mp 136.84. Stone walls possible remains of box culvert.

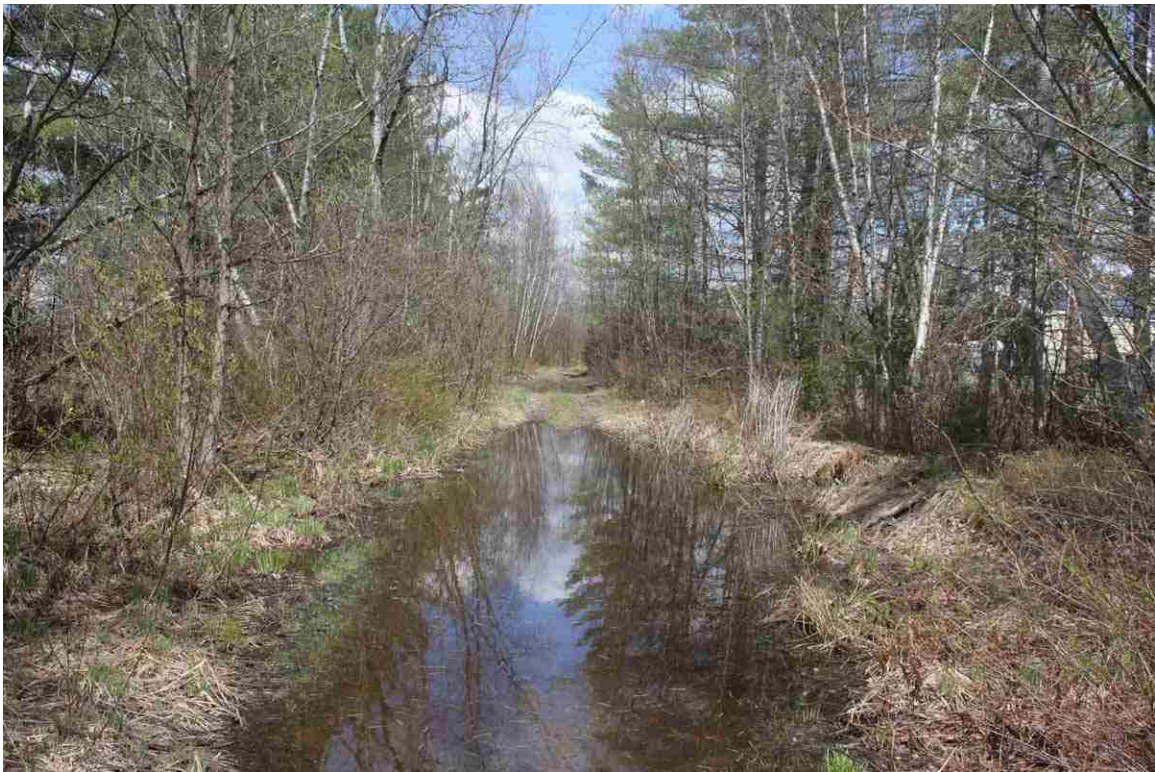
Photo ID #: S4\_1141 Direction: S Date: 5/13/2019 Image stored at: HDC

Photo # 57 description: ROW crossing Kilkenny Street, Lancaster. Depot St. at left. ~mp 136.85.

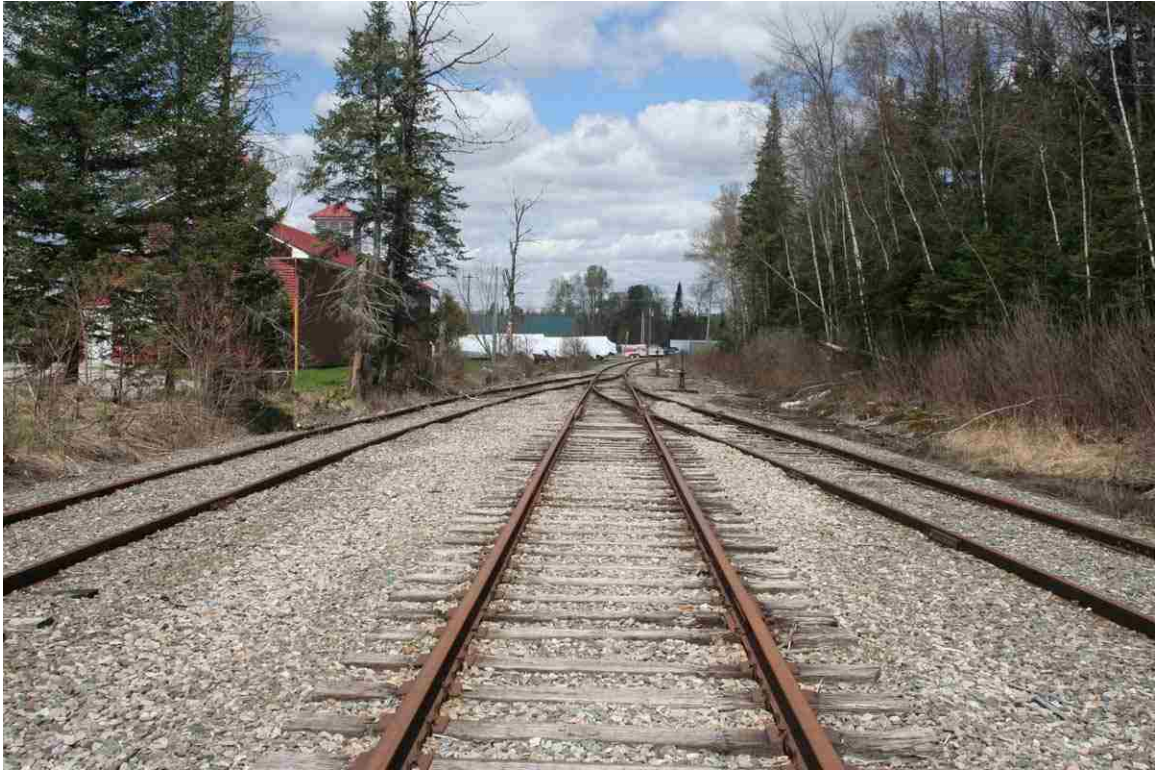
Photo ID #: S4\_1162 Direction: N Date: 5/13/2019 Image stored at: HDC

Photo # 58 description: Character of ROW approaching Coos Junction, running behind industrial/commercial buildings along west side of Summer St., Lancaster. mp~137.25.

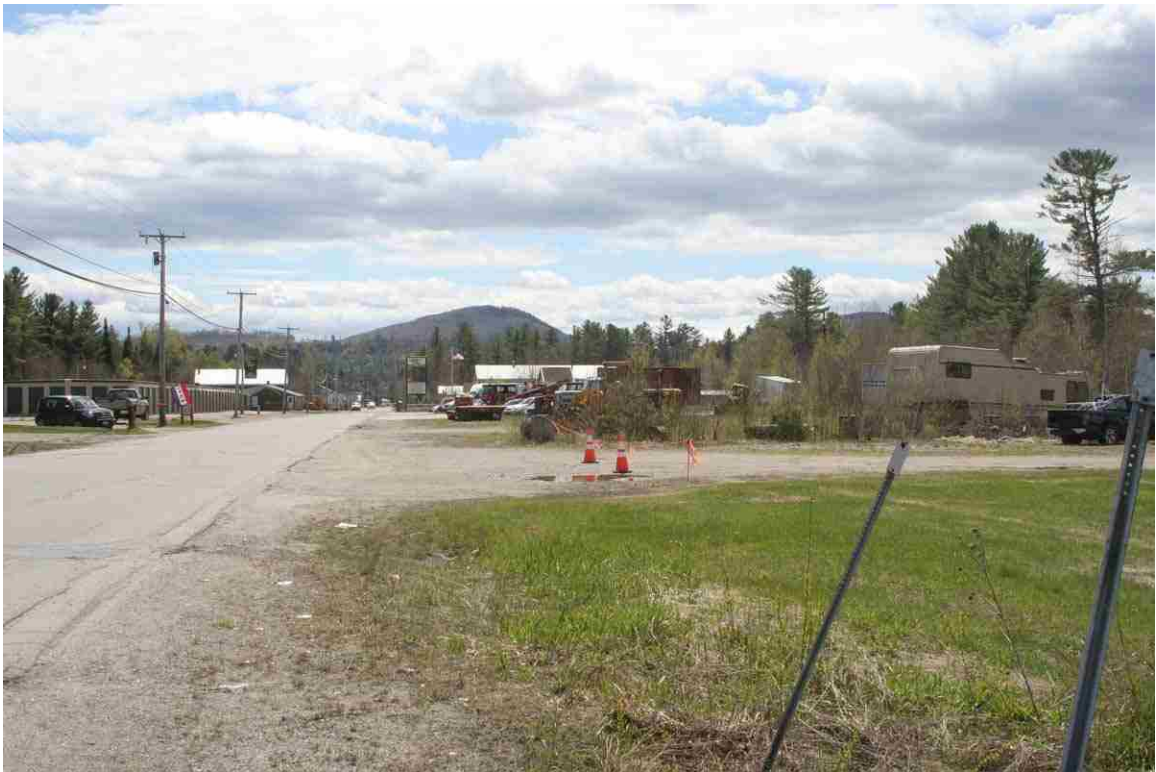
Photo ID #: S4\_1158 Direction: N Date: 5/13/2019 Image stored at: HDC

Photo # 59 description: MC lines approaching Coos Junction, Lancaster. Line runs behind commercial/industrial buildings along east side of Summer Street.
