Bath Village Covered Bridge Bath, New Hampshire

Rehabilitation Project Report

November 2011

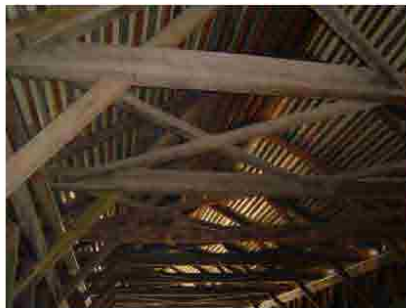
Upper Lateral Bracing

The upper lateral bracing is in fair to good condition. Several of the crossbeams have been scraped on the bottom face from over height vehicles and have mild rot at their ends. Previous repairs have been made to nine (9) crossbeams. The two (2) knee braces at the West portal have been cut off

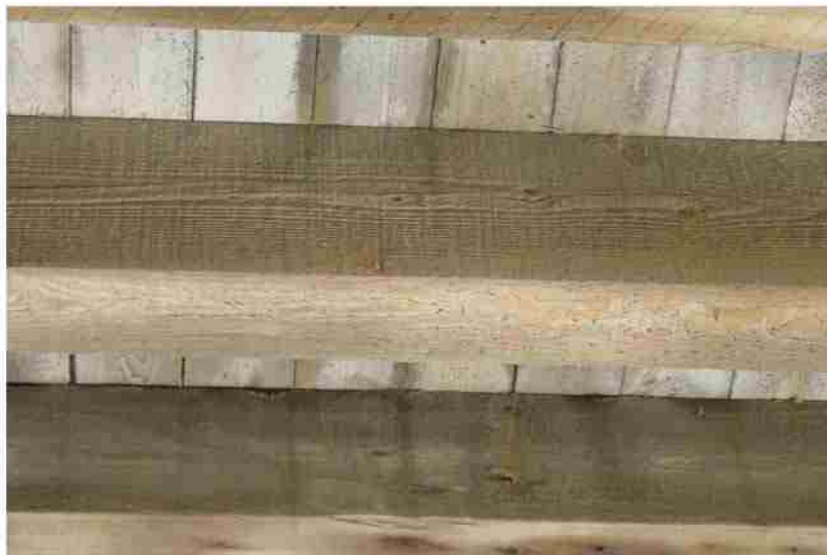
The new floor beams of 1987-88 appear to have been band-sawn on their sides, and cut to depth on a circular sawmill, leaving curved saw marks on their soffits, as seen below:

Bottom: re-used floor beam. Middle and top: band-sawn floor beams sawn to depth on a circular saw

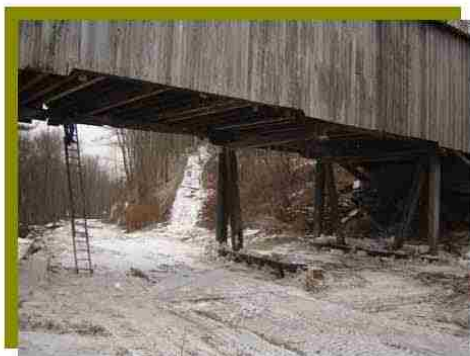
Western Bridge Span at Bents

- Bent 1. The northern vertical member of the bent was shifted west approximately 7 inches with the rest of the bent remaining intact and undamaged.
- Bent 2. The northern vertical and diagonal brace members were missing while the remaining southern members had minor abrasion damage.
- Bent 3. This bent was completely removed by the ice.

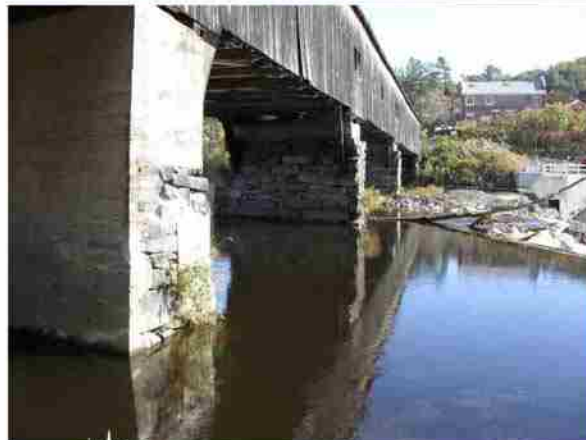
A287 38

DOWNSTREAM ELEVATION
OF PIERS AND EAST
ABUTMENT VIEW FROM
ATV TRAIL. LARGE TREE
TRUNK CAUGHT UP ON
RIVER PIER #3. (MUNICIPAL
RED LIST)

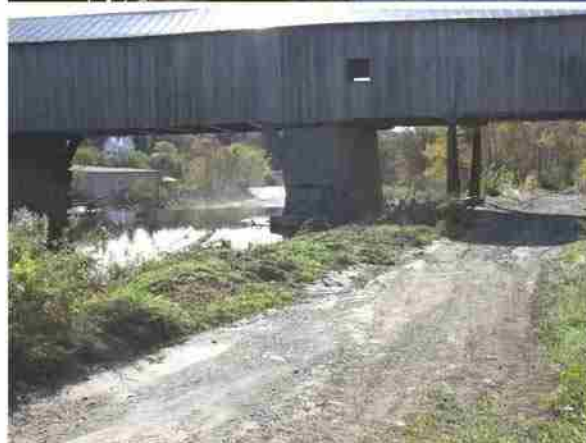
A287 39

LARGE TREE TRUNK
CAUGHT UP AT RIVER PIER
#1. ATV TRAIL ERODING.
(MUNICIPAL RED LIST)

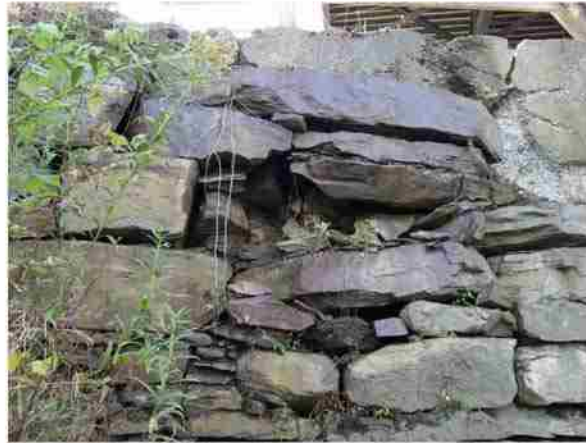
A287 29

29: LOOSE AND MISSING STONES IN NE WING: CONCRETE CAP CRACKED AND SPALLED.

LOOSE AND MISSING STONES IN NE WING; CONCRETE CAP CRACKED AND SPALLED. (MUNICIPAL RED LIST)

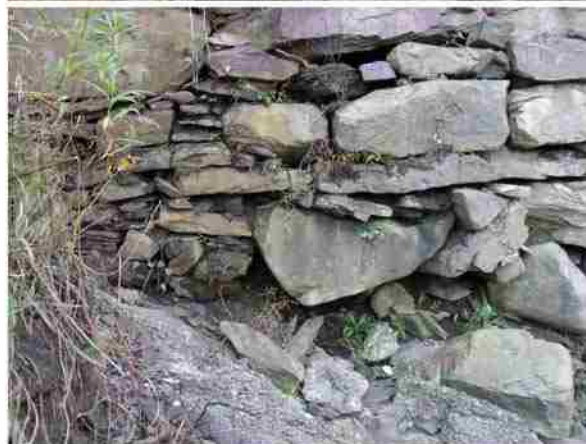
A287 30

30: LEFT HALF (FACING DOWNSTREAM) OF NE WING JUST BELOW MISSING STONES AND SPALLED CAP AREA.

LEFT HALF (FACING DOWNSTREAM) OF NE WING JUST BELOW MISSING STONES AND SPALLED CAP AREA. (MUNICIPAL RED LIST)

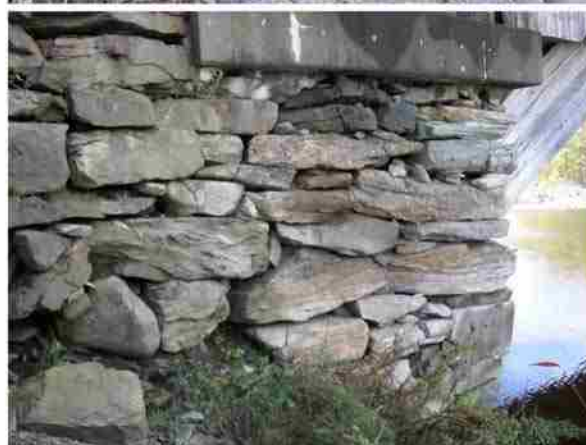
A287 31

RIGHT HALF NE WING / ABUTMENT (FACING DOWNSTREAM). (MUNICIPAL RED LIST)

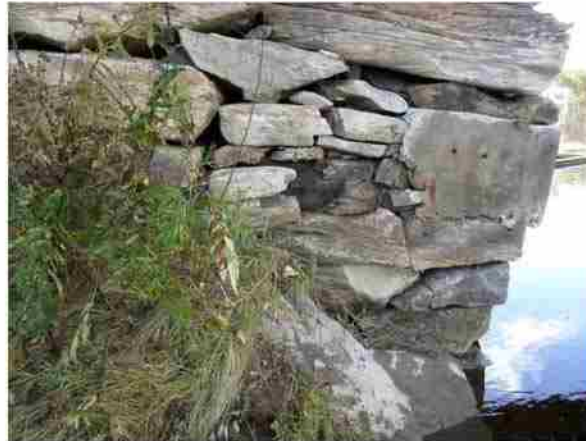
A287 32

CRACKED, BROKEN AND
SHIFTED STONES AT
LOWER END OF EAST
ABUTMENT. (MUNICIPAL
RED LIST)

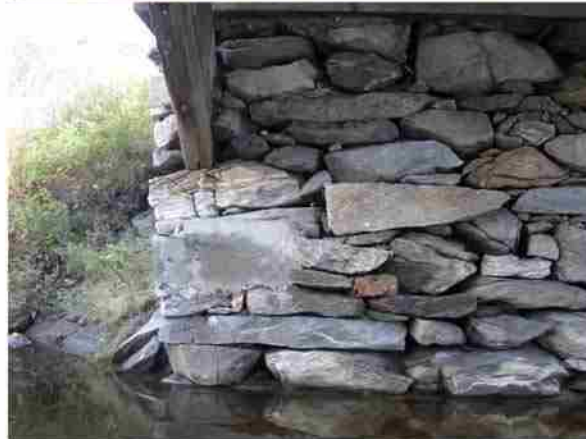
A287 33

32: CRACKED, BROKEN AND SHIFTED STONES AT LOWER END OF EAST ABUTMENT.

CRACKED, BROKEN AND
SHIFTED STONES IN
UPSTREAM HALF OF EAST
ABUTMENT. (MUNICIPAL
RED LIST)

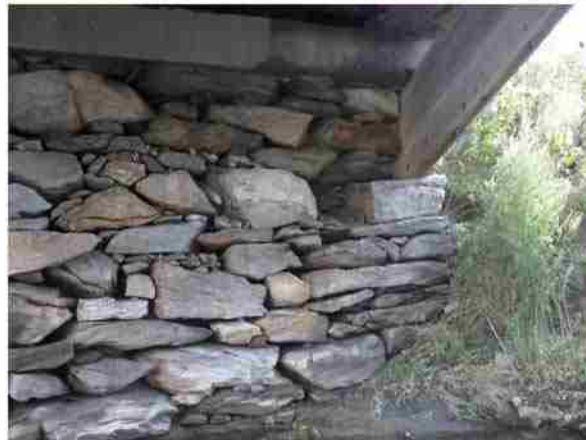
A287 34

33: CRACKED, BROKEN AND SHIFTED STONES IN UPSTREAM HALF OF EAST ABUTMENT.

CRACKED, BROKEN AND A
MISSING STONE IN
DOWNSTREAM HALF OF
EAST ABUTMENT.
(MUNICIPAL RED LIST)

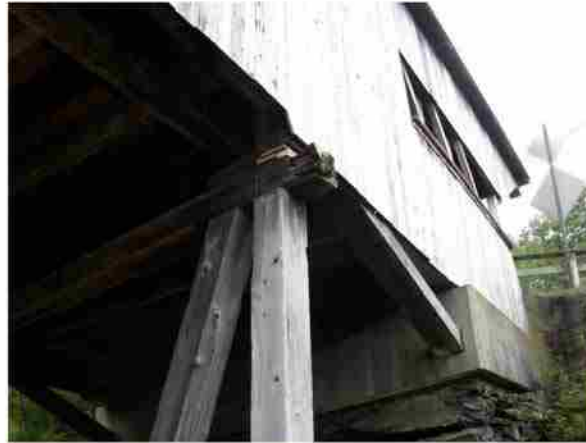
A285 65

DAMAGED ARCH ROD
BEARING BLOCK SPAN #6
AT WEST US ARCH END.
RED LIST.

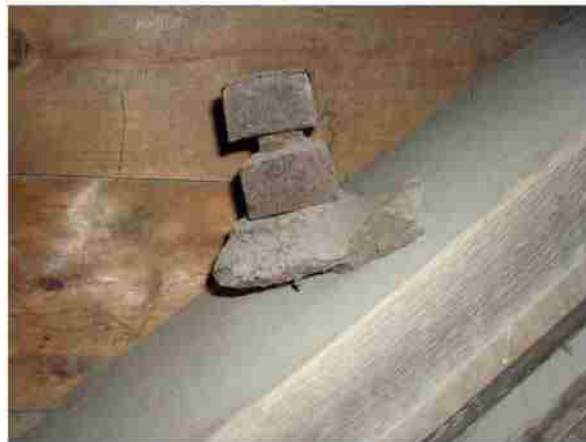
A285 66

FALLEN ROOF NAILER MID-
SPAN OF #6 DS; TYPICAL IN
A FEW AREAS. RED LIST.

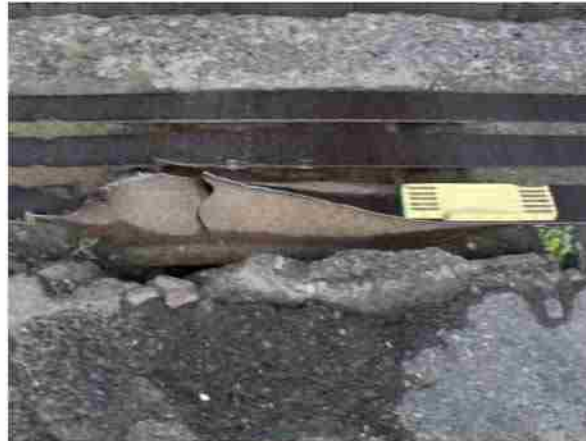
A285 67

DAMAGED, TORN DRAIN
ARMOR AT EAST DECK
END. RED LIST.

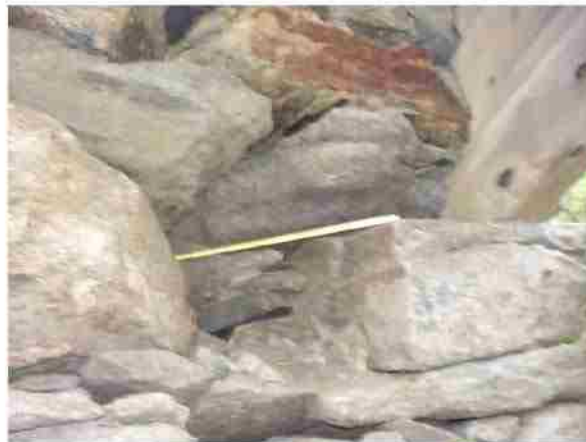
A285 68

SE ABUTMENT: LARGE VOID
FROM STONE FALLEN OUT.
RED LIST.

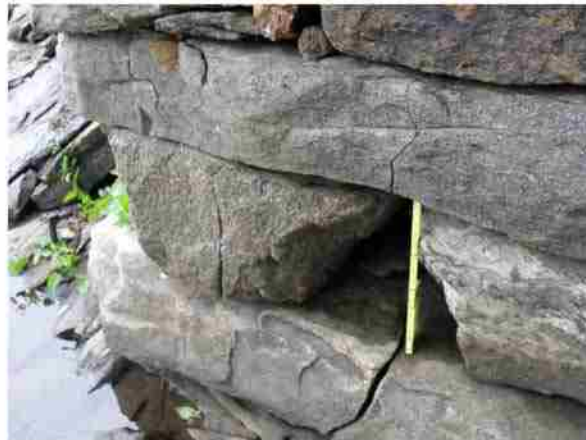
A285 69

NE ABUTMENT BASE
CORNER STONE AND
SURROUNDING STONES
CRACKED AND SETTLED.
RED LIST.

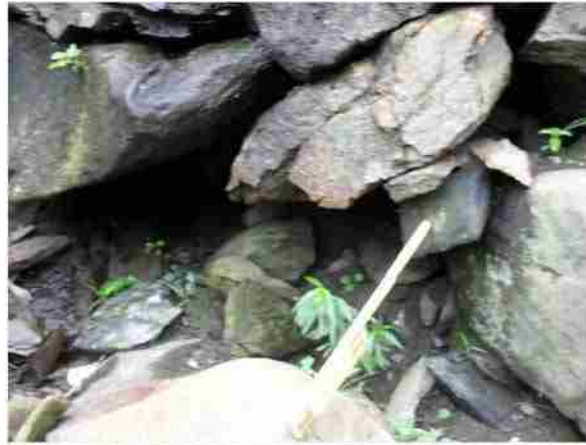
A285 70

VOIDS AND A SINGLE
SMALL STONE THAT
APPEARS TO BE
BOLSTERING THE ENTIRE
NE WING AT THE NW
CORNER. RED LIST.

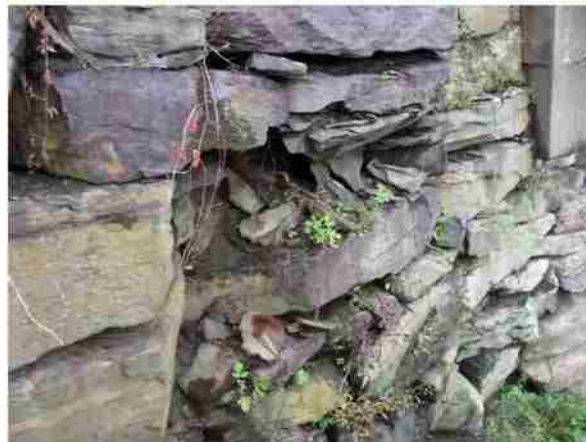
A285 71

NE WING; MANY VOIDS AND
UNSTABLE BULGED OR
OVERHANGING STONES.
RED LIST.

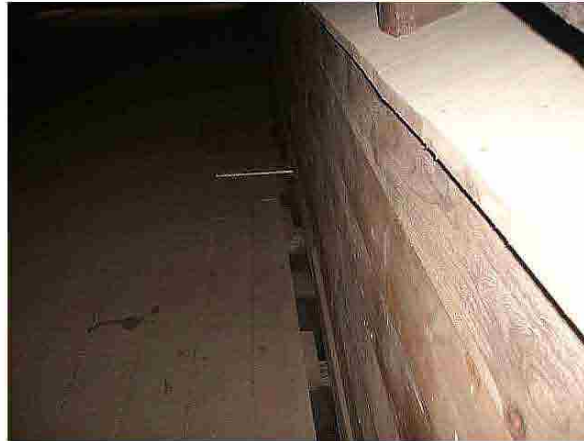
A266 24

TENSION RODS, AND TWO
VERTICAL MEMBERS
SISTERED IN TRUSS ON
DOWNSTREAM SIDE SPAN
#3.

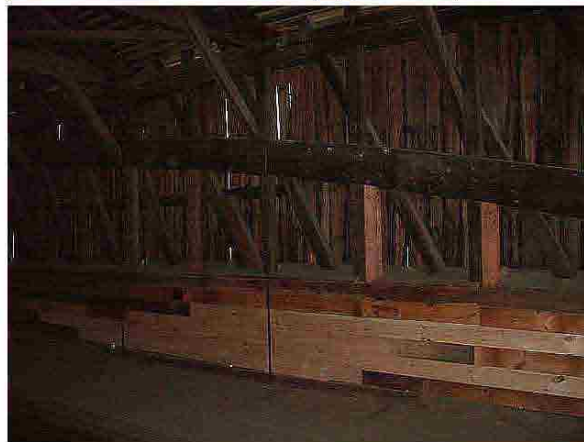
A266 25

25: BEARING TIMBER MEMBER DECAYED AND CRUSHED APPEARING TO CAUSE TRUSS
TO ROLL Laterally toward DOWNSTREAM SIDE OVER BENT #2.

BEARING TIMBER MEMBER
DECAYED AND CRUSHED
APPEARING TO CAUSE
TRUSS TO ROLL
Laterally Toward
Downstream Side Over
Bent #2.

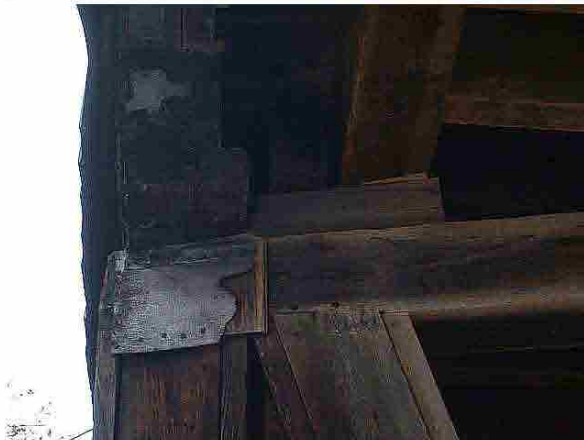
A266 26

26: DECAY AND CRUSHING IN LOWER BEARING TIMBER OVER DOWNSTREAM END OF
CAP ON BENT #2.

DECAY AND CRUSHING IN
LOWER BEARING TIMBER
OVER DOWNSTREAM END
OF CAP ON BENT #2.

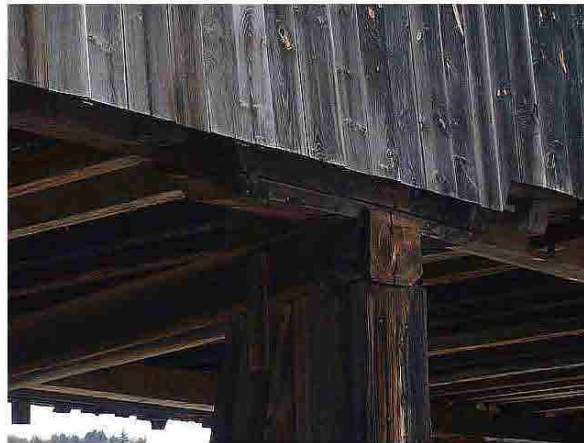
A266 27

27: DETAIL OF BLOCKING AND NEW CHORD REPLACEMENT BEAM ON DOWNSTREAM
SIDE.

DETAIL OF BLOCKING AND
NEW CHORD
REPLACEMENT BEAM ON
DOWNSTREAM SIDE.

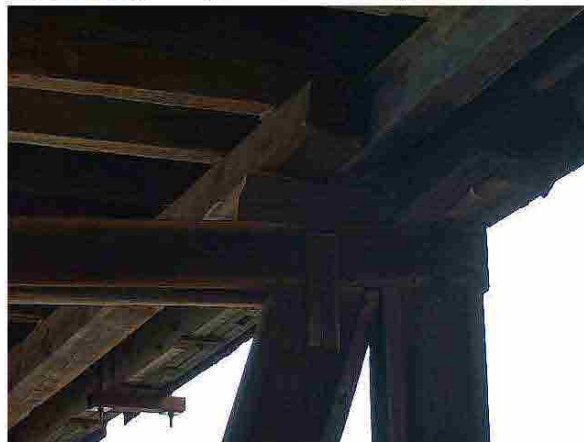
A266 28

28: SHIMS AND BLOCKING ADDED OVER DECAYED AREA IN CAP ON BENT #1 UPSTREAM
SIDE.

SHIMS AND BLOCKING
ADDED OVER DECAYED
AREA IN CAP ON BENT #1
UPSTREAM SIDE.

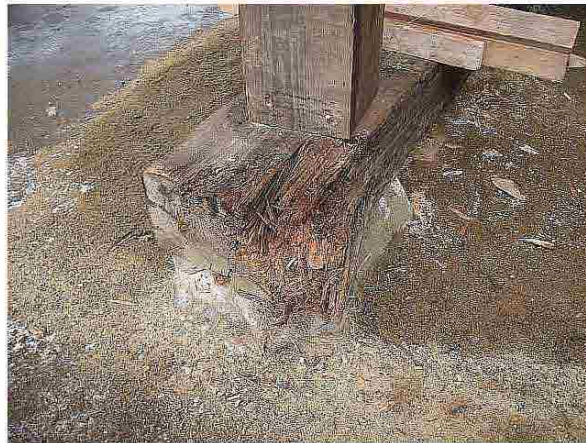
A266 29

29: DAMAGE AND DECAY IN BASE TIMBER UPSTREAM END BENT #2.

DAMAGE AND DECAY IN
BASE TIMBER UPSTREAM
END BENT #2.

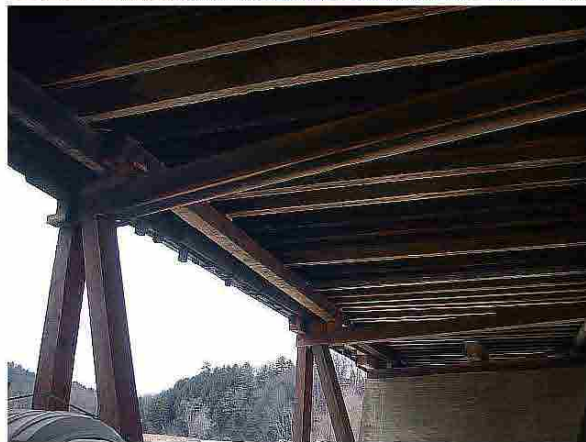
A266 30

DETAIL OF NEW TIMBERS
IN BENTS #2 AND #3.

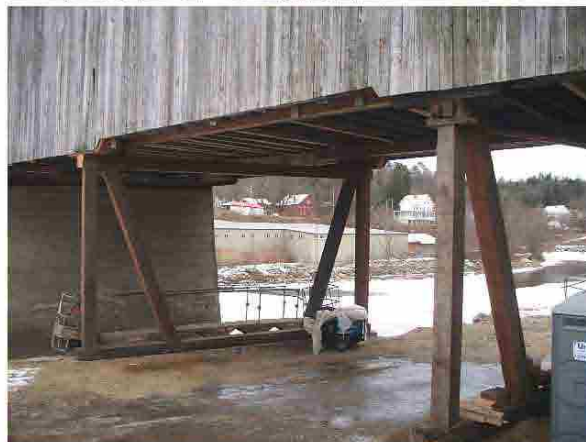
A266 31

OVERALL DETAIL OF NEW
TIMBER BENTS, CHORD
REPLACEMENT TIMBERS
AND BLOCKING OVER CAPS.

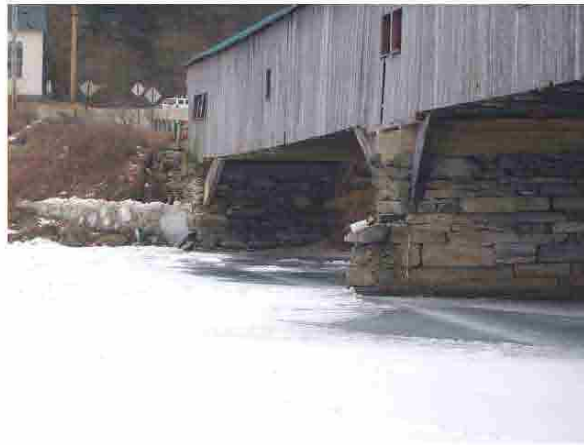
A266 32

SETTLEMENT IN EAST
ABUTMENT; POSSIBLY
ADDITIONAL DISPLACED
STONES AT BASE.

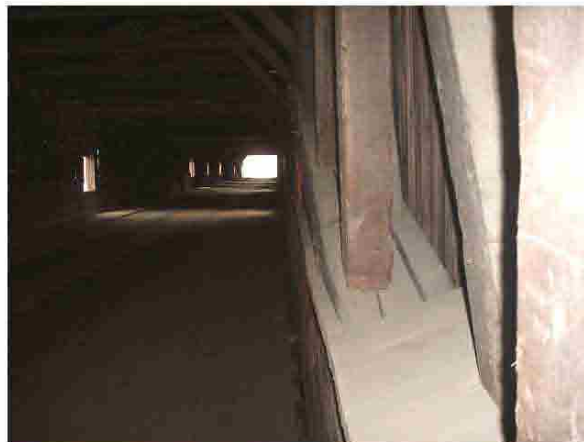
A266 33

LATERAL BOW IN TRUSS AS
EVIDENCED BY SIDE
BOARDS DOWNSTREAM
SIDE SPAN #2 AND #3.

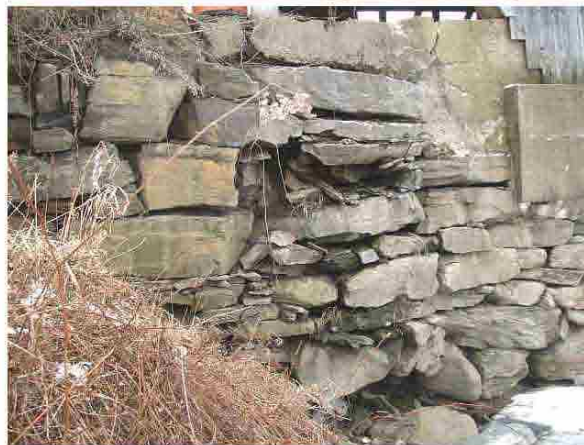
A266 34

SETTLEMENT AND
DISPLACED STONES IN NE
END OF EAST
ABUTMENT/APPROACH
RETAINING WALL.

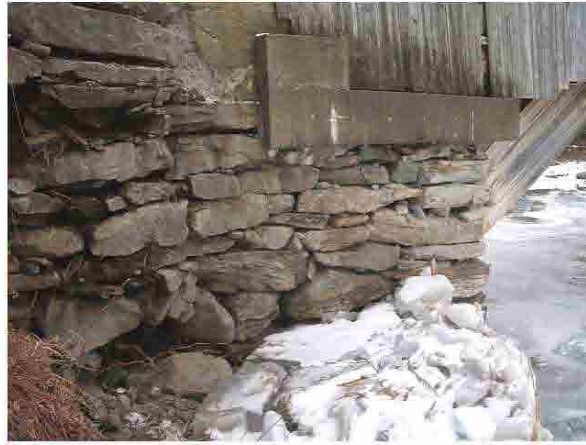
A266 35

SETTLEMENT AND MISSING
CHINK STONES IN NE END
OF EAST ABUTMENT.

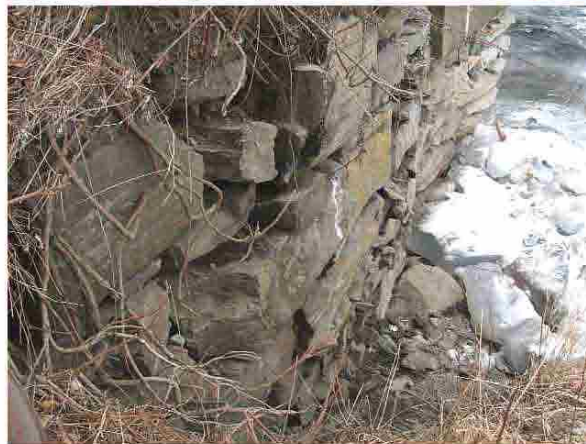
A266 36

SETTLEMENT AND
OUTWARD BOW IN
STONework AT NE.

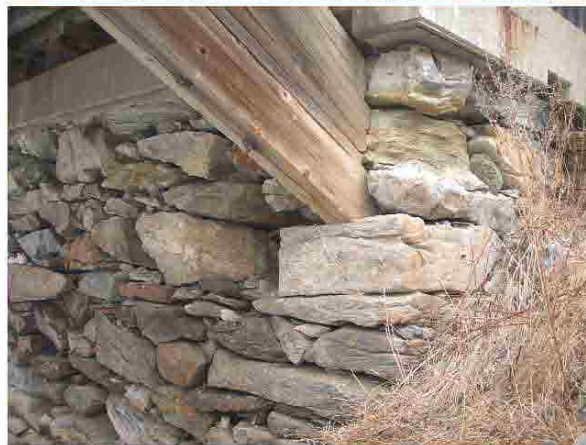
A266 37

SETTLEMENT AND MISSING
STONE IN EAST ABUTMENT
JUST INSIDE OF ARCH AT
SE.

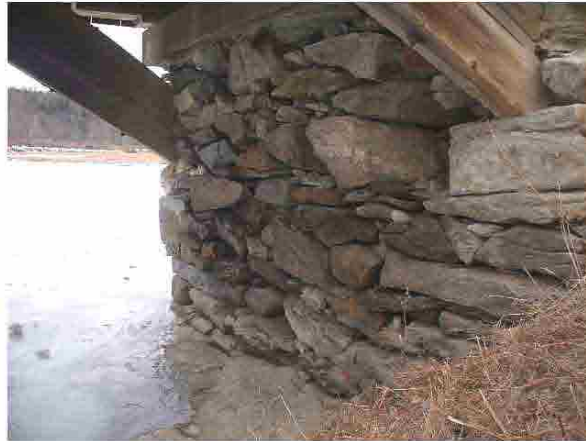
A266 38

OVERALL SETTLEMENT
AND SHIFTING
STONEWORK ALONG FACE
EAST ABUTMENT; SEVERAL
STONES APPEAR
SOMEWHAT UNSTABLE.

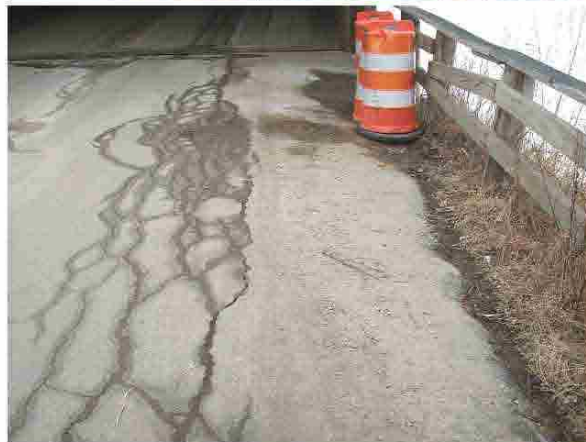
A266 39

CRACKS AND SETTLEMENT
IN PAVEMENT EVIDENT AT
NE APPROACH SHOULDER.

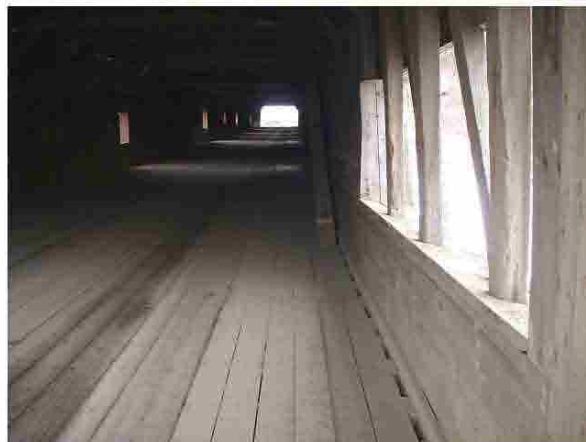
A266 40

LATERAL DEFORMATION IN
ARCH AT NE END.

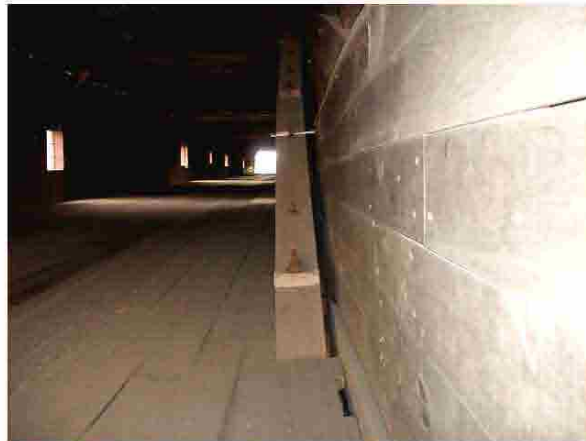
A266 41

ARCH ROTATED UP TO 3
INCHES MEASURED FROM
FACE OF SIDE BOARDS AND
TIGHT TO SIDEWALK
TIMBERS AT NE END.

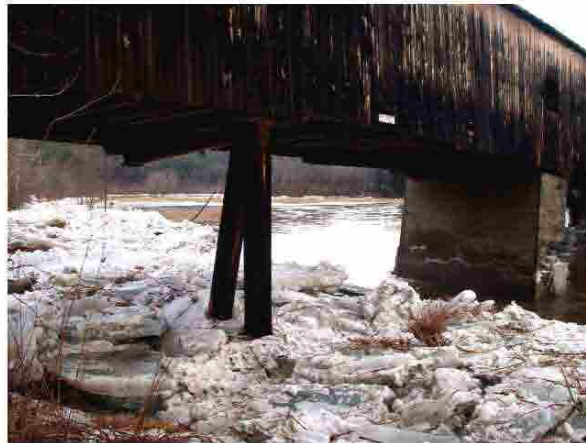
A266 04

MISSING UPSTREAM
COLUMNS IN BENT #2.

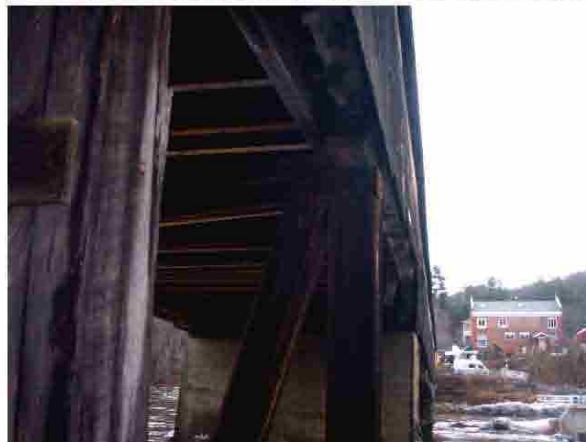
A266 05

BOTTOM CHORD
LATERALLY BOWED
TOWARD DOWNSTREAM
WHERE BENT #3 WAS.

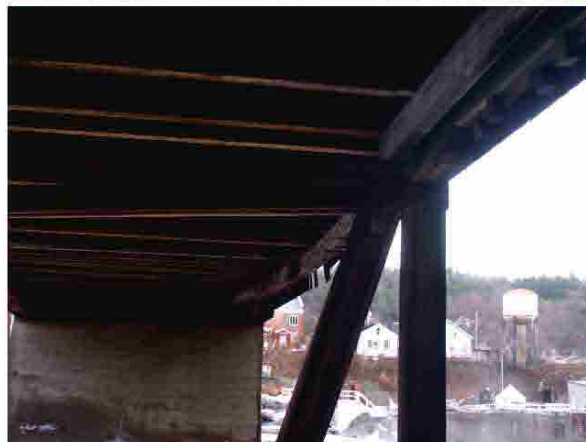
A266 06

INNER CHORD
REPLACEMENT BEAM AND
CHORD DEFLECTING DUE
TO LOSS OF BENT #3.

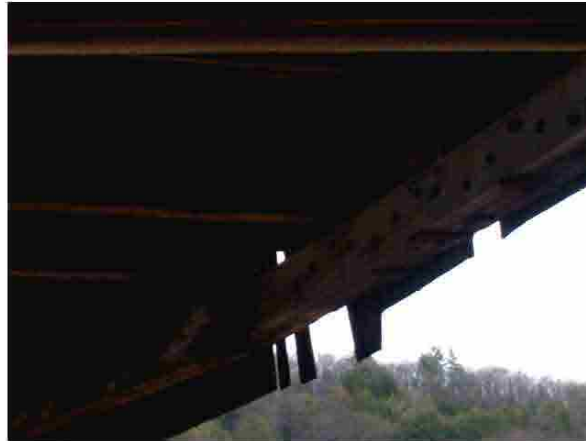
A266 07

FLOORBEAMS NO LONGER
SUPPORTED AT BOWED
CHORD AREA ON
DOWNSTREAM SIDE.

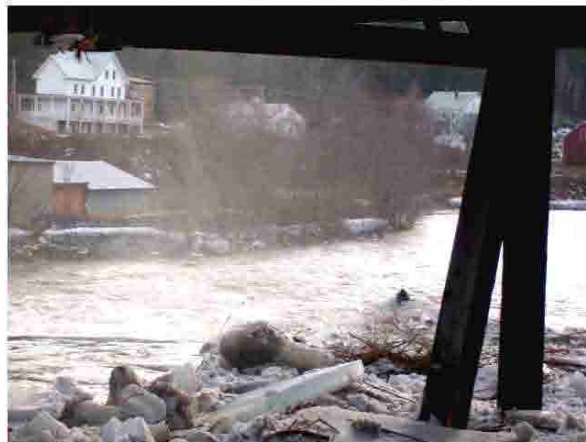
A266 08

UPSTREAM VIEW OF
MISSING COLUMNS ON
BENT #2.

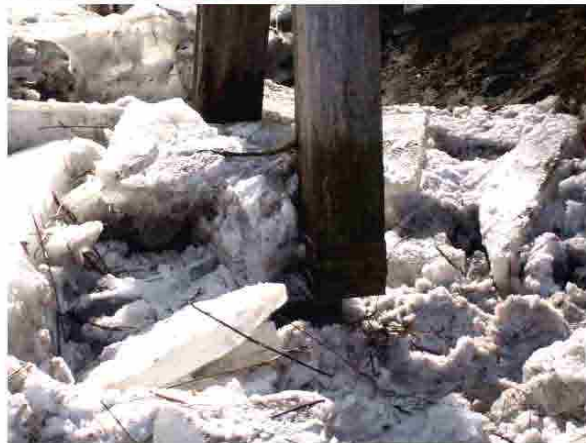
A266 09

UPSTREAM EXTERIOR
COLUMN KNOCKED OUT OF
POSITION AT BENT #1.

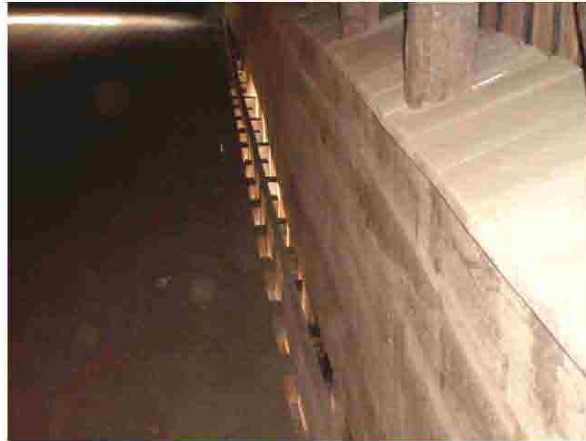
A266 10

TOPSIDE VIEW OF GAP
BETWEEN INNER SIDE
BOARDS AND DECKING
WITH ENDS OF SEVERAL
FLOORBEAMS NOT
SUPPORTED OVER BOWED
CHORD AREA.

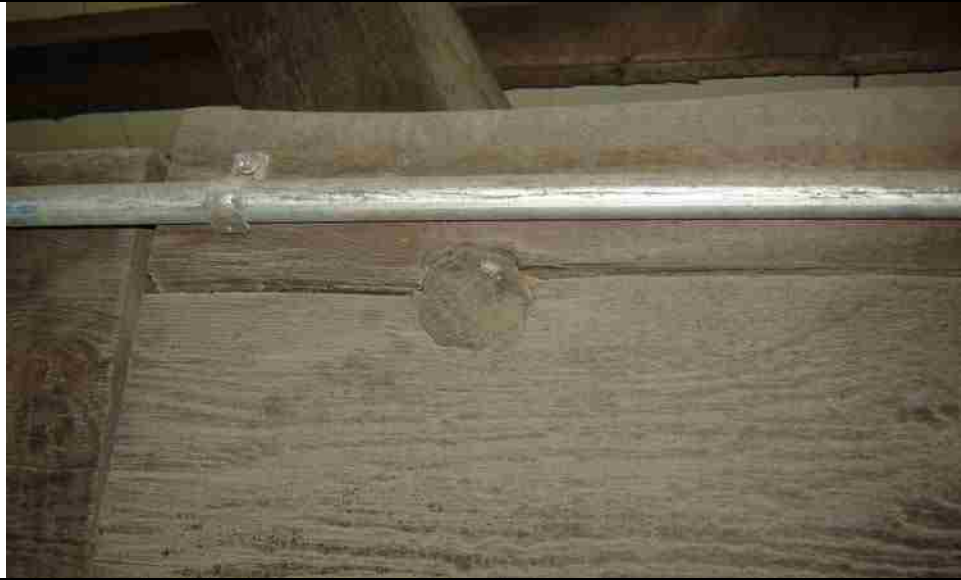
Photo No. 1-6 Top Chord S92 – S96 C, 24” Split at S92

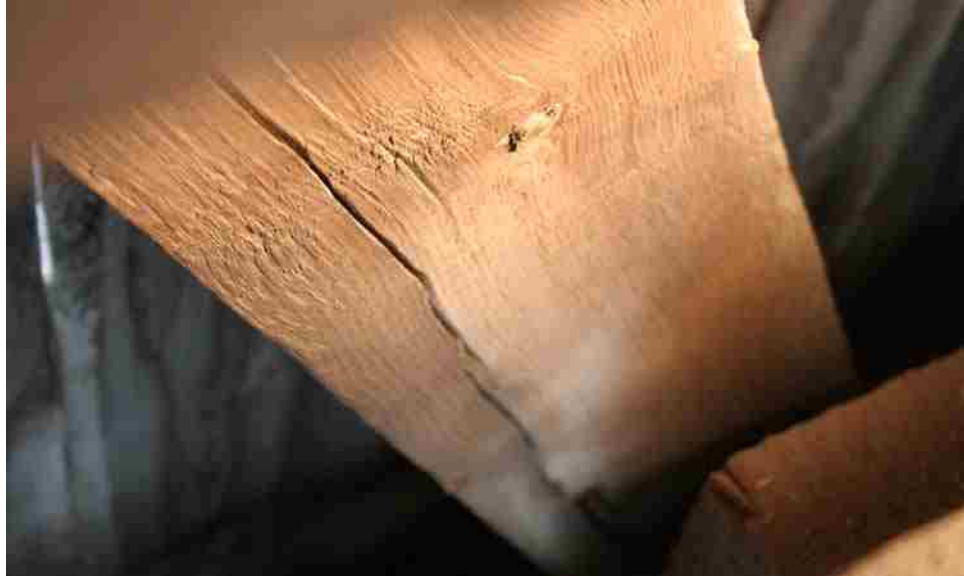
Photo No. 4-15 Diagonal N66L – N67U, Splits in Upper Tail

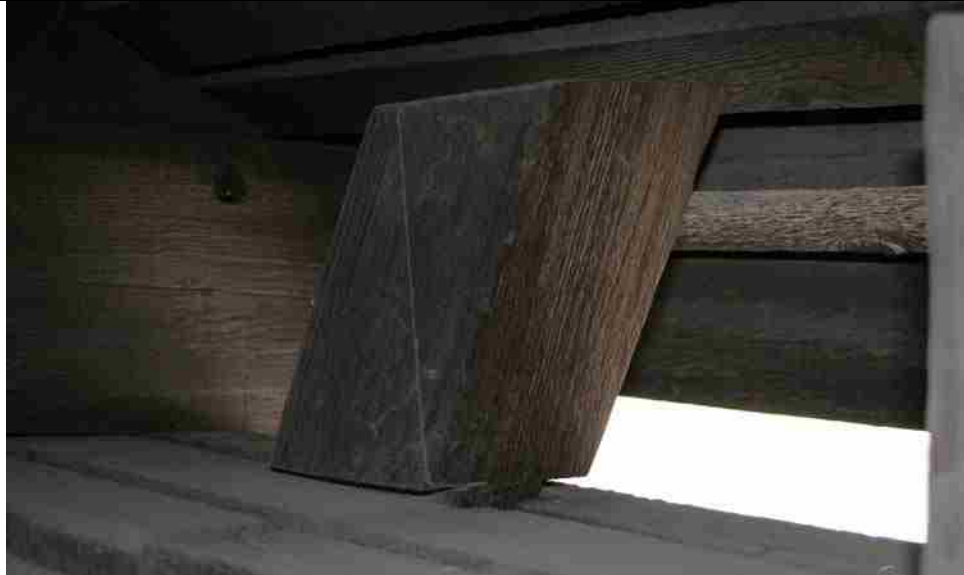
Photo No. 4-16 N73L-N74U, Split at Base, Waning

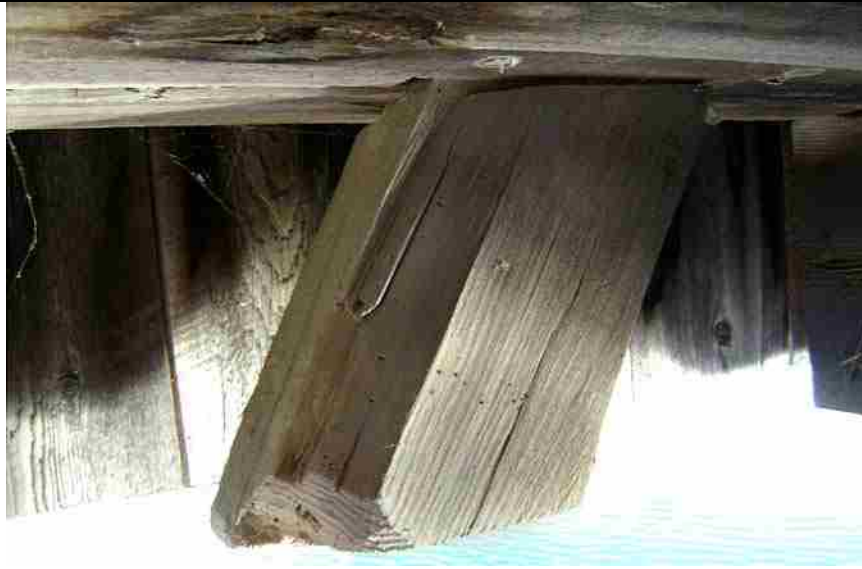
Photo No. 4-17 Diagonal N92L – N91U, Rot at base under window

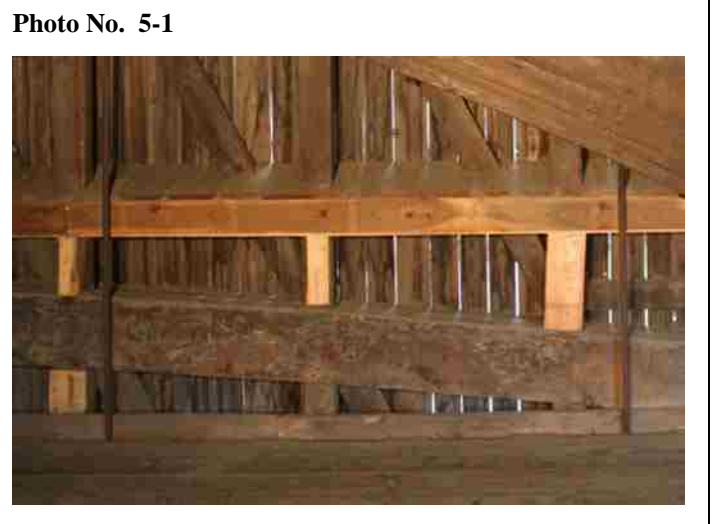
<p>Photo No. 5-1</p>

<p>Condition: The built-in arches are in good condition with only localized rot due to water infiltration.</p>			
<p>Describe Work: Disassemble arches and remove and replace defective members. General conditions the same as specified for other truss members: Existing bridge shall be jacked and braced as required to straighten, release stresses, plumb and re-align the trusses and arches (RS-3, Sheet 2). Special care shall be taken to avoid damage to members that are to remain and to avoid movement of the truss that could result in distortion or misalignment of the truss and its joints (GC-10, Sheet 2). All joints in replaced members shall match the existing joint, including all nails, bolts or screws required unless noted otherwise (GC-11, Sheet 2). All existing members shown to be replaced are to be replaced "in-kind" with new members identical in dimensions and configurations as the members originally used in the covered bridge (GC-12, Sheet 2).</p>

Table: Built-in Arch Members Affected				
Member No.	Date	Reason	Reason for Replacement	Photo No.
N61-N62 Ply A	1832	vertical saw marks	Rot	5-1
N61-N62 Ply B	"	"	"	5-1
N61-N62 Ply C	"	"	"	5-1
S17-S14 Ply A	"	"	"	5-2
S16-S14 Ply B	"	"	"	5-2
S17-S15 Ply C	"	"	"	5-2

<p>Project Need: The built-in arches are original and integral structural members of the trusses that contribute to the stiffness and load capacity of the bridge. Localized rot due to due to established ambient moisture wood decaying organisms is recommended to be removed to prevent spread of decay. The members identified for replacement are rotted and so not possess the required structural integrity.</p>			
<p>Impacts: Less than 10 percent of the total linear feet of members making up the Built-in Arches require replacement. Members to be replaced will be replaced "in-kind" with wood members of the same size and workmanship.</p>			
<p>Alternatives: Due to the laminated design of the arches, there are no other practical repair alternatives that meet engineering requirements and the Secretary's Standards other than "replacement in-kind."</p>			
Drawings: 35, 36, 37, 38, 39, 41, 42		Photos: See table below

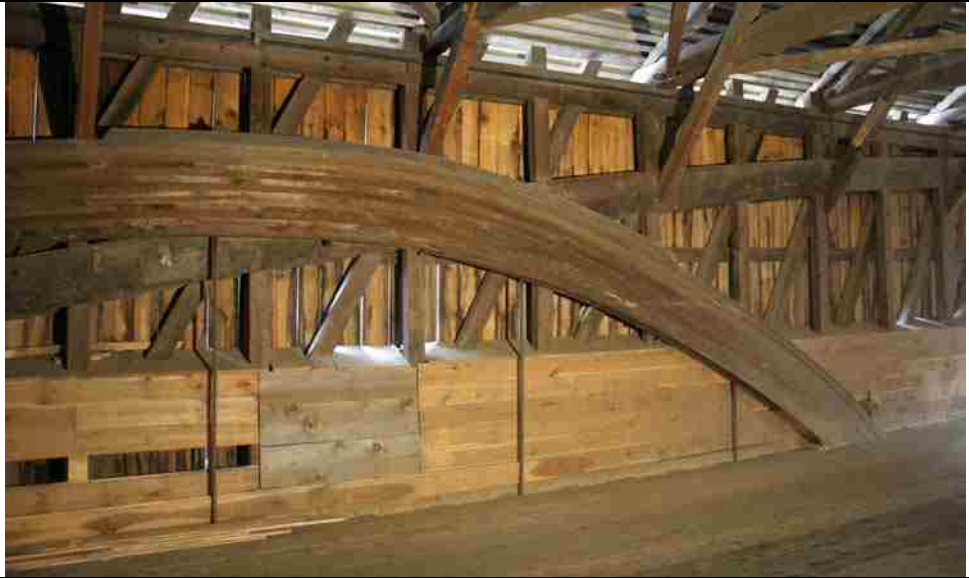
Photo No. 5-5 Built In Arch S31 Oblique

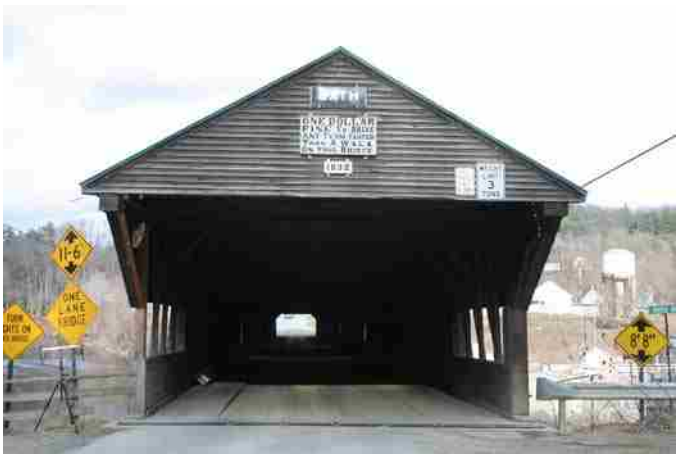
Photo No. 16-2 West Portal siding, weathering, splits

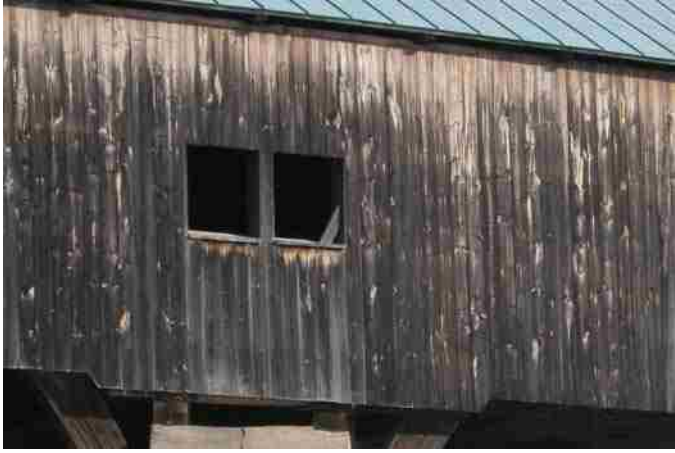
Photo No. 17-2 Siding S Pier 2 – Pier 3, Weathering

<p>Condition: The 1988 replacement siding on the south side is in fair condition; north side siding ranges from poor to fair condition.</p>	
<p>Describe Work: All siding is to be removed and replaced in kind (W-17, Sheet 2). Existing boards with vertical saw marks will be preserved and reinstalled.</p>	
<p>Project Need: Siding must be removed to effect repairs to truss members. Siding is at the end of its service life.</p>	
<p>Impacts: The siding as a whole lacks integrity of original materials, with only seven boards out of approximately 1200 boards showing vertical saw marks that could possibly be original to the bridge. Vertically sawn siding boards will be preserved; other siding will be replaced in-kind with rough sawn boards of varying widths.</p>	
<p>Alternatives: There are no other practical repair alternatives that meet engineering requirements and the Secretary's Standards other than "replacement in-kind" and preservation of the presumed historic fabric.</p>

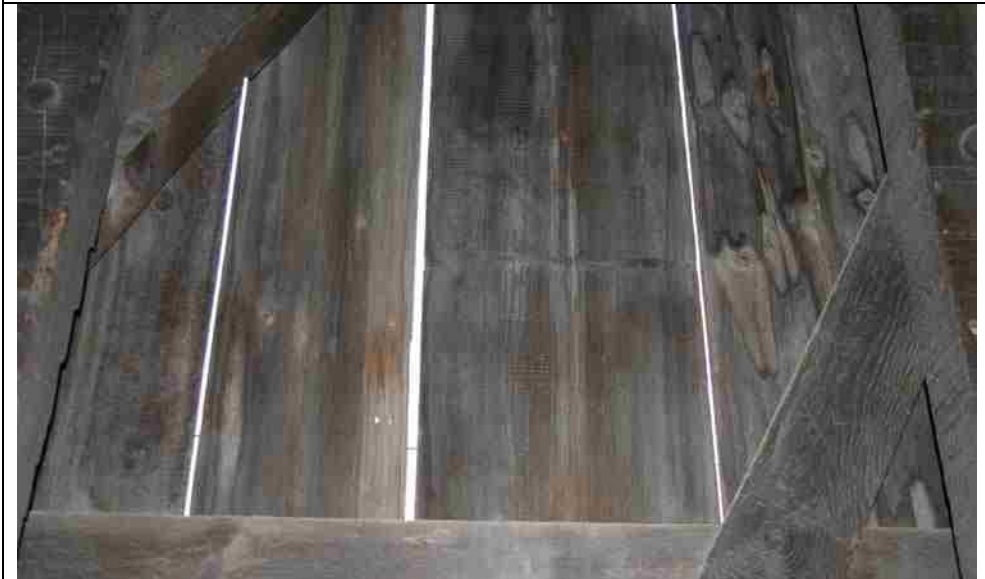
Photo No. 17-6: Detail of 15-1/2" board @ Post N10-N11 showing vertical saw marks

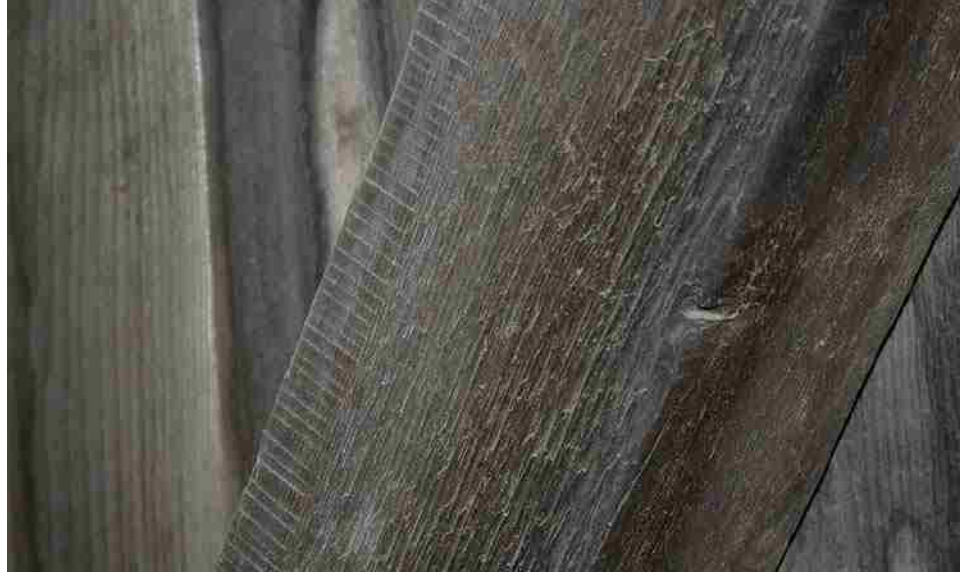
Photo No. 17-9: Double circular saw marks (cross-hatch) on 9-.5" & 7.5" boards

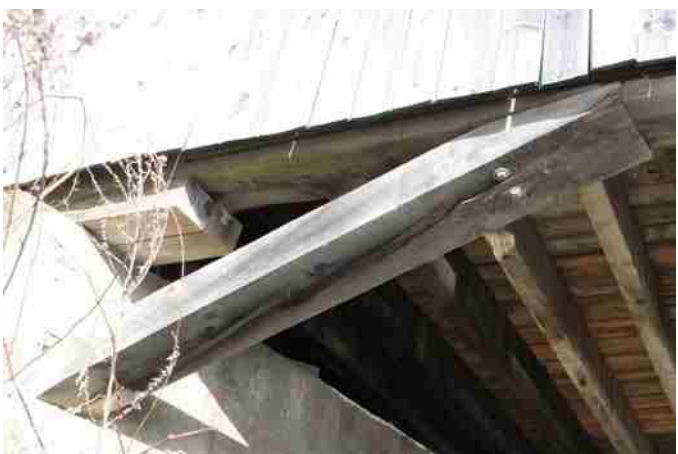
Photo No. 22-2 Sleeper North West Abutment, Drying Splits

Describe Work: Struts will be evaluated for replacement during construction. All Sleeper and bedding timbers are scheduled for replacement in-kind to the extent possible with treated timbers of both soft and hardwood. Low-profile reinforced concrete bearing seats will be installed on top of piers and abutments to provide a uniform and structurally sound bearing for the sleepers.			
Project Need: The bridge members must have structurally sound decay-free bearings.			
Impacts: The struts, bedding and sleeper timbers are assumed to be features of the 1918-19 bridge rehabilitation when the bridge was raised to increase clearance over the railroad tracks. They do not have any significant association with the original bridge design and are sacrificial elements of the design.			
Alternatives: There are no other practical repair alternatives that meet engineering requirements and the Secretary's Standards other than "replacement in-kind." .
