Stark Covered Bridge Stark, New Hampshire

Historic Structure Report

July 2012

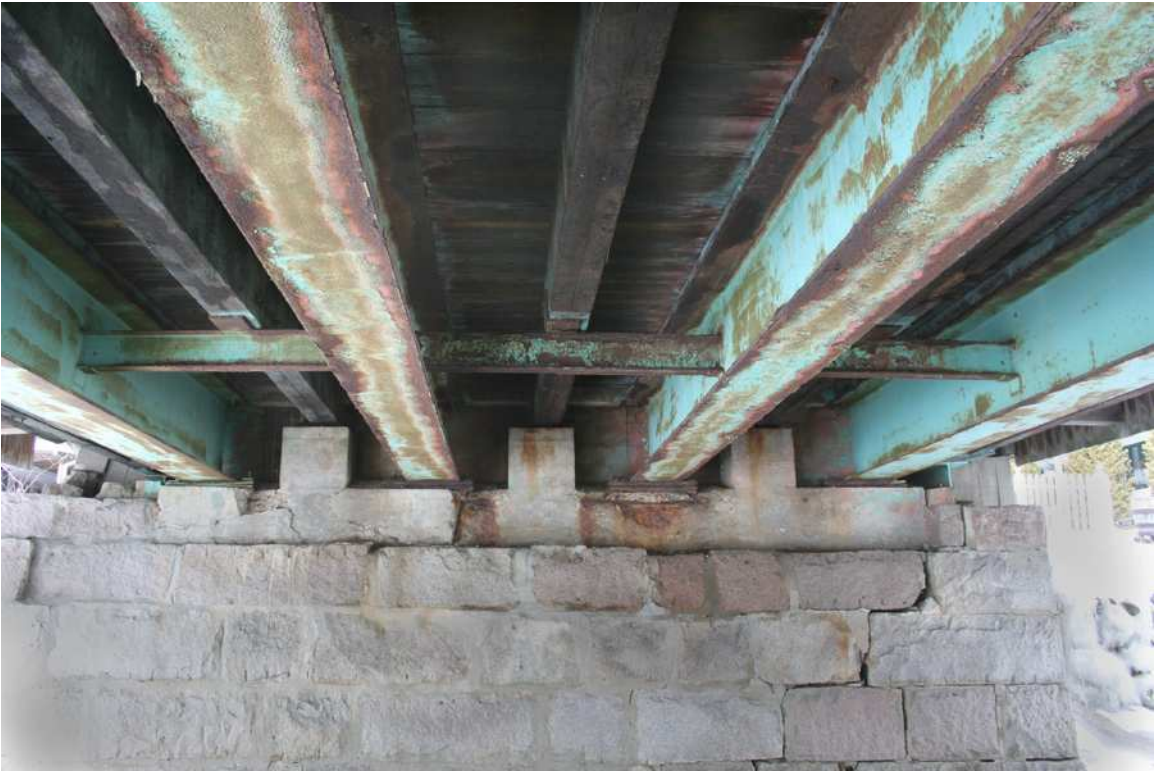
FIGURE: 4.1-3: I-beam stringers, diaphragms and intermediate stringers.

<p>Condition: (information from HEB 2012 Engineering Study)</p> <p>The two interior steel stringers show severe deterioration and rusting of the top and bottom flanges with an estimated average section loss of 25%. The two exterior steel girders appear in good condition with estimated average section loss on the flanges less than 5%. The steel pedestal bearings and steel diaphragms are in poor condition with heavy rusting and section loss.</p>	
<p>Proposed Treatment:</p> <p>Retain, clean and epoxy paint the two exterior steel stringers; replace the two interior stringers. Replace steel diaphragms. Remove intermediate wood stringers and install wood glue-laminated transverse deck beams resting on steel stringers.</p>	
<p>Project Need:</p> <p>Rehab and replacement of the steel stringers is required to meet federal design load specifications. The work will allow for several of the wood truss diagonal members to be returned to their original positions restoring the truss to its original two-span Paddleford configuration and the proper distribution of loads. The work will allow installation of transverse floor beams (originals removed in 1954) closely replicating original configuration, providing proper distribution of truss and sidewalk loads.</p>

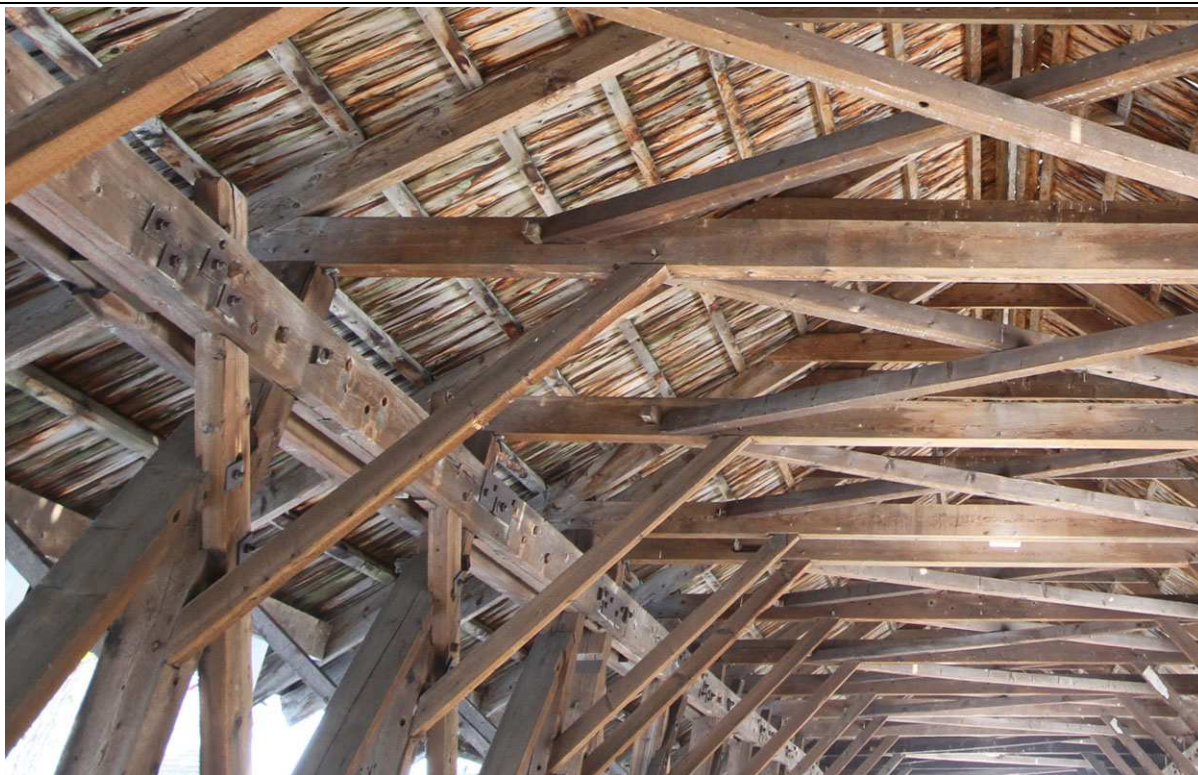
FIGURE: 4.6-4: Upper cross (tie) beams and knee braces showing connection details.

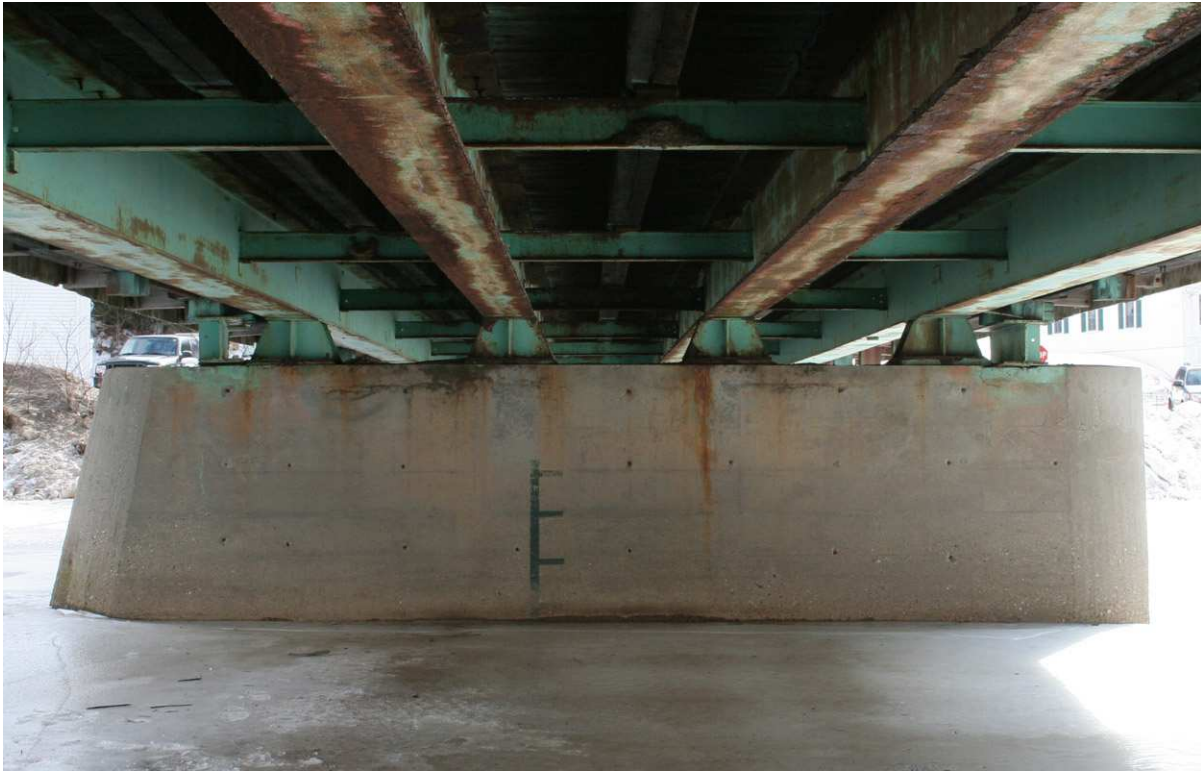
FIGURE: 4.11-5: Elevation view of pier and bearings.

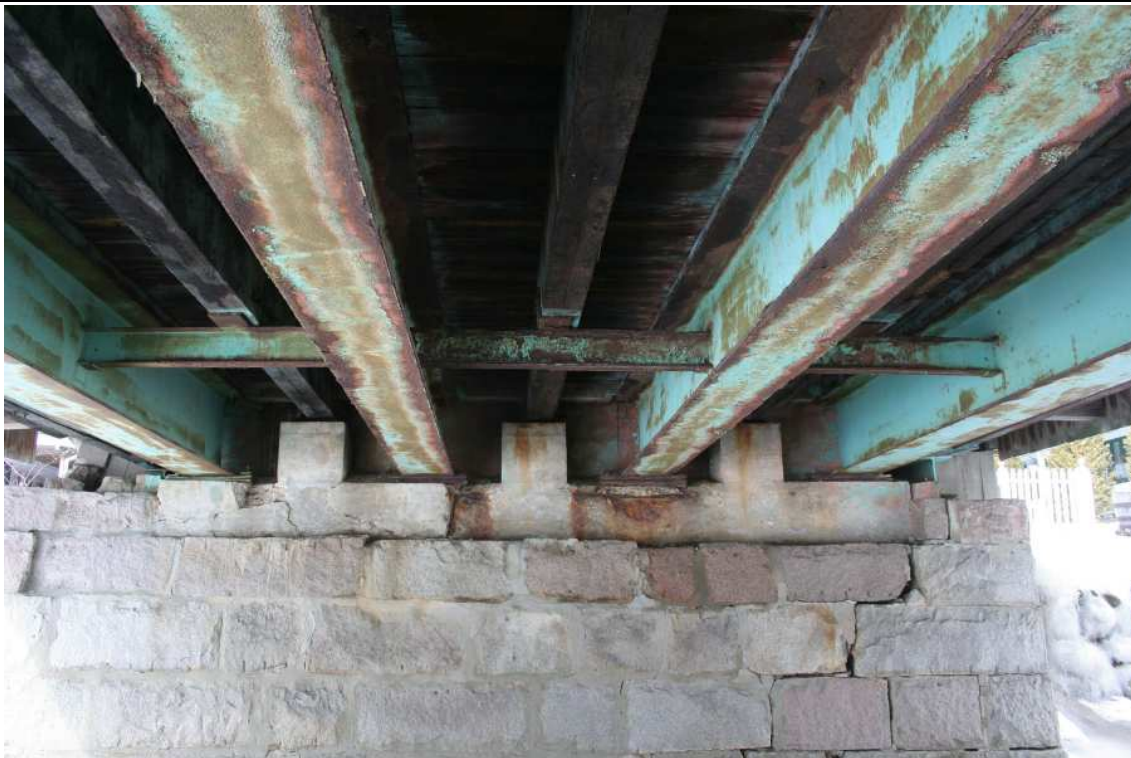
FIGURE: 4.11-6: Concrete bearing seats and steel plate bearings, 1954 rehab, on original stone abutment.

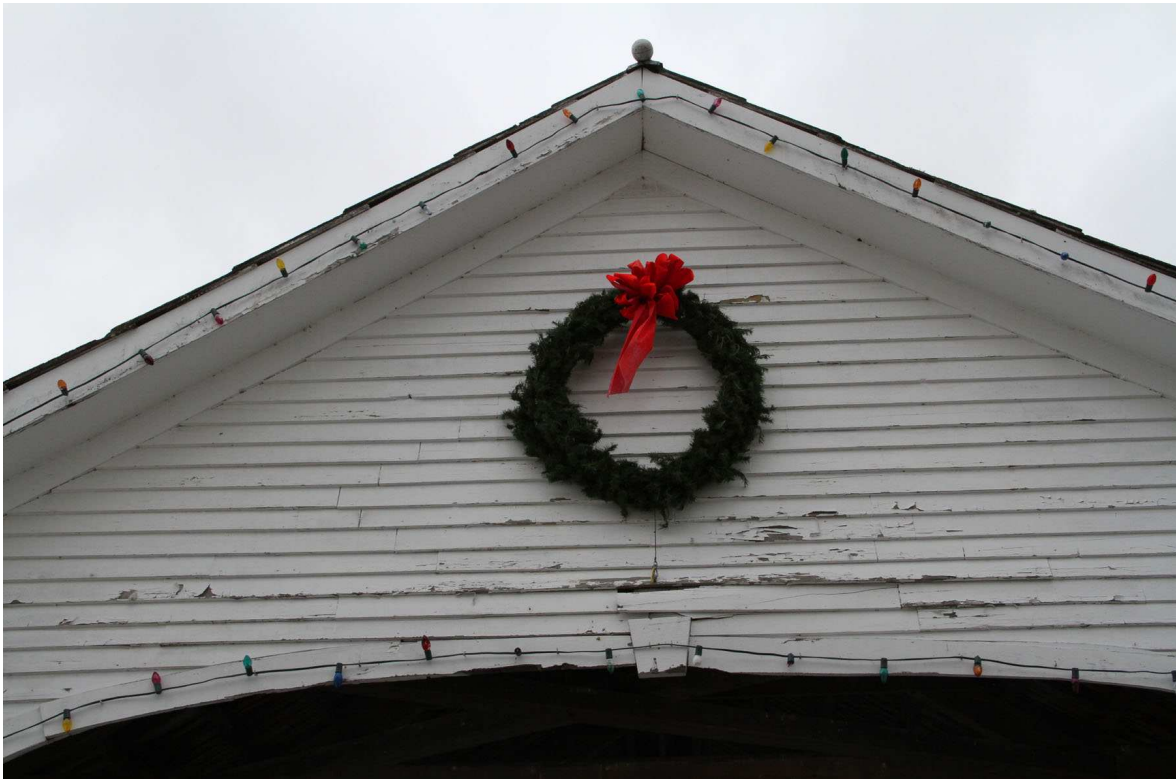
<p>Condition: The portal components are in good condition with the exception of peeling paint and several loose and cracked clapboards.</p>	
<p>Proposed Treatment: The portals will be stripped of paint, loose boards glued and refastened, and repainted.</p>	
<p>Project Need: The portals require the proposed maintenance to prevent further deterioration and extend service life.</p>	
<p>Impacts: The work impacts historic character-defining feature of the bridge. The proposed maintenance will be done in-kind and consistent with Secretary of the Interior's Standards for Rehabilitation (SOI Standards)</p>	
<p>Alternative Treatments Considered: None.</p>

FIGURE: 4.12-4: Detail of portal eaves and siding.
